**Newburyport Central Waterfront Bulkhead  
Existing Conditions – Center Embayment**

**Newburyport Central Waterfront Bulkhead  
Existing Conditions – Steel Cells - East Bulkhead**

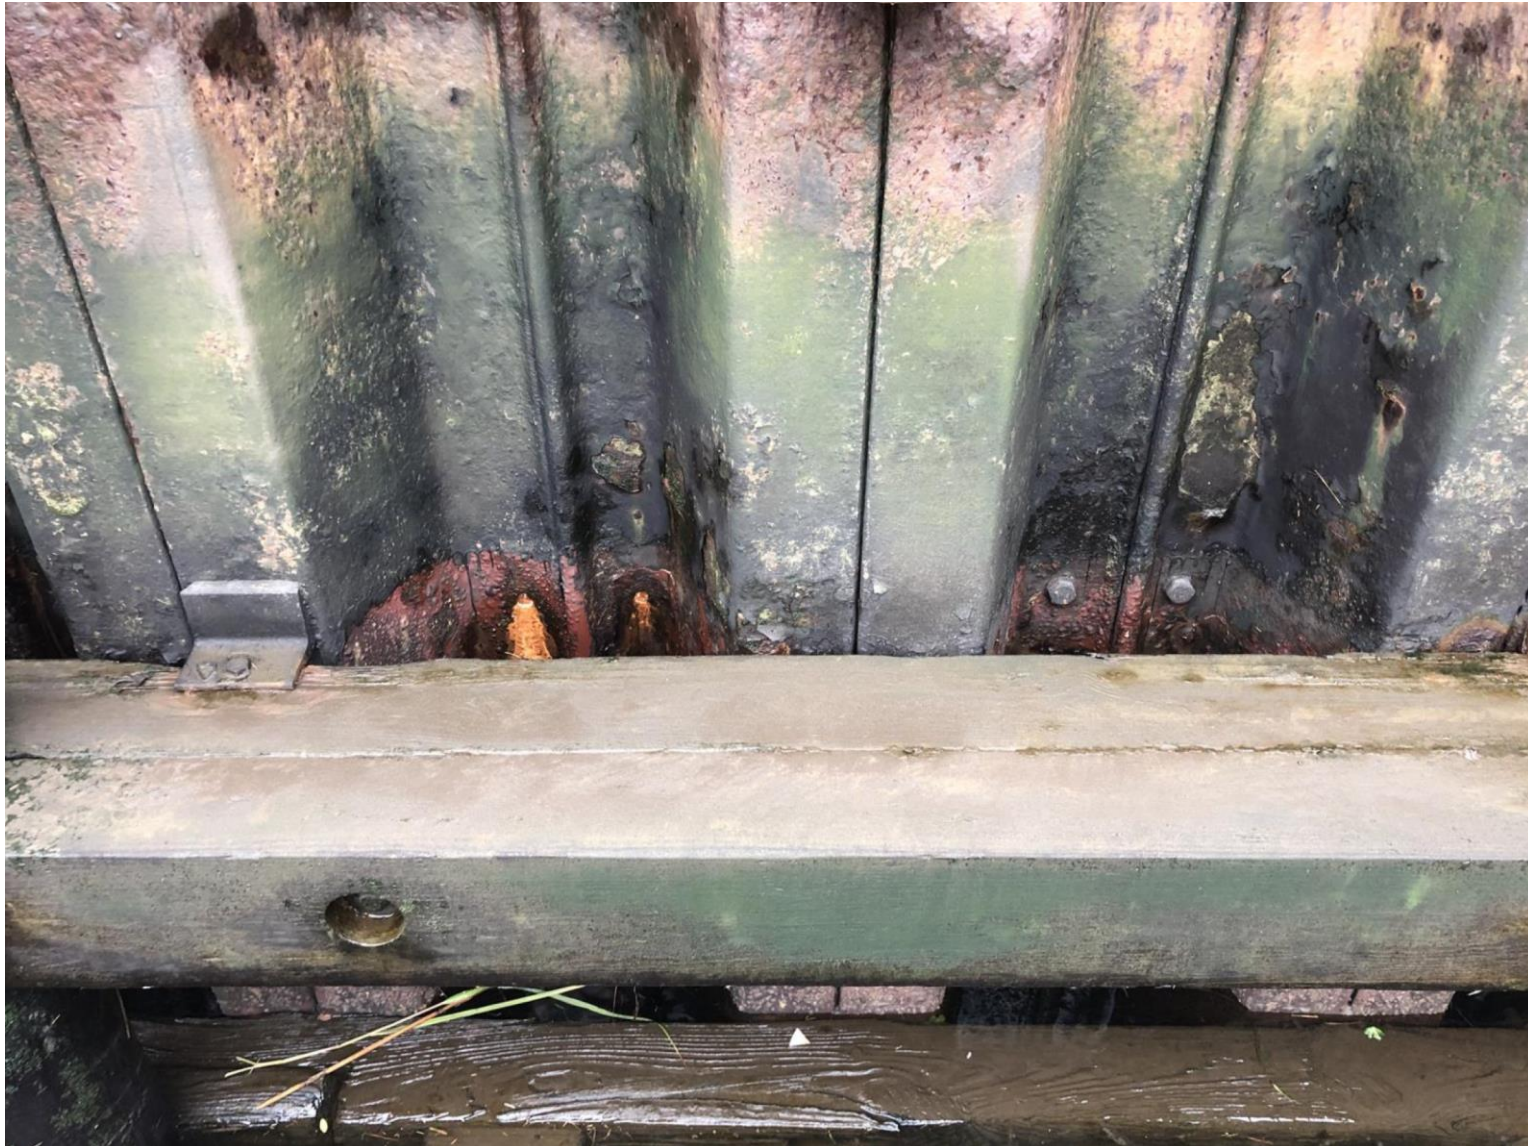
***Failing Tie Back Anchor Bolts – Structural Concern***

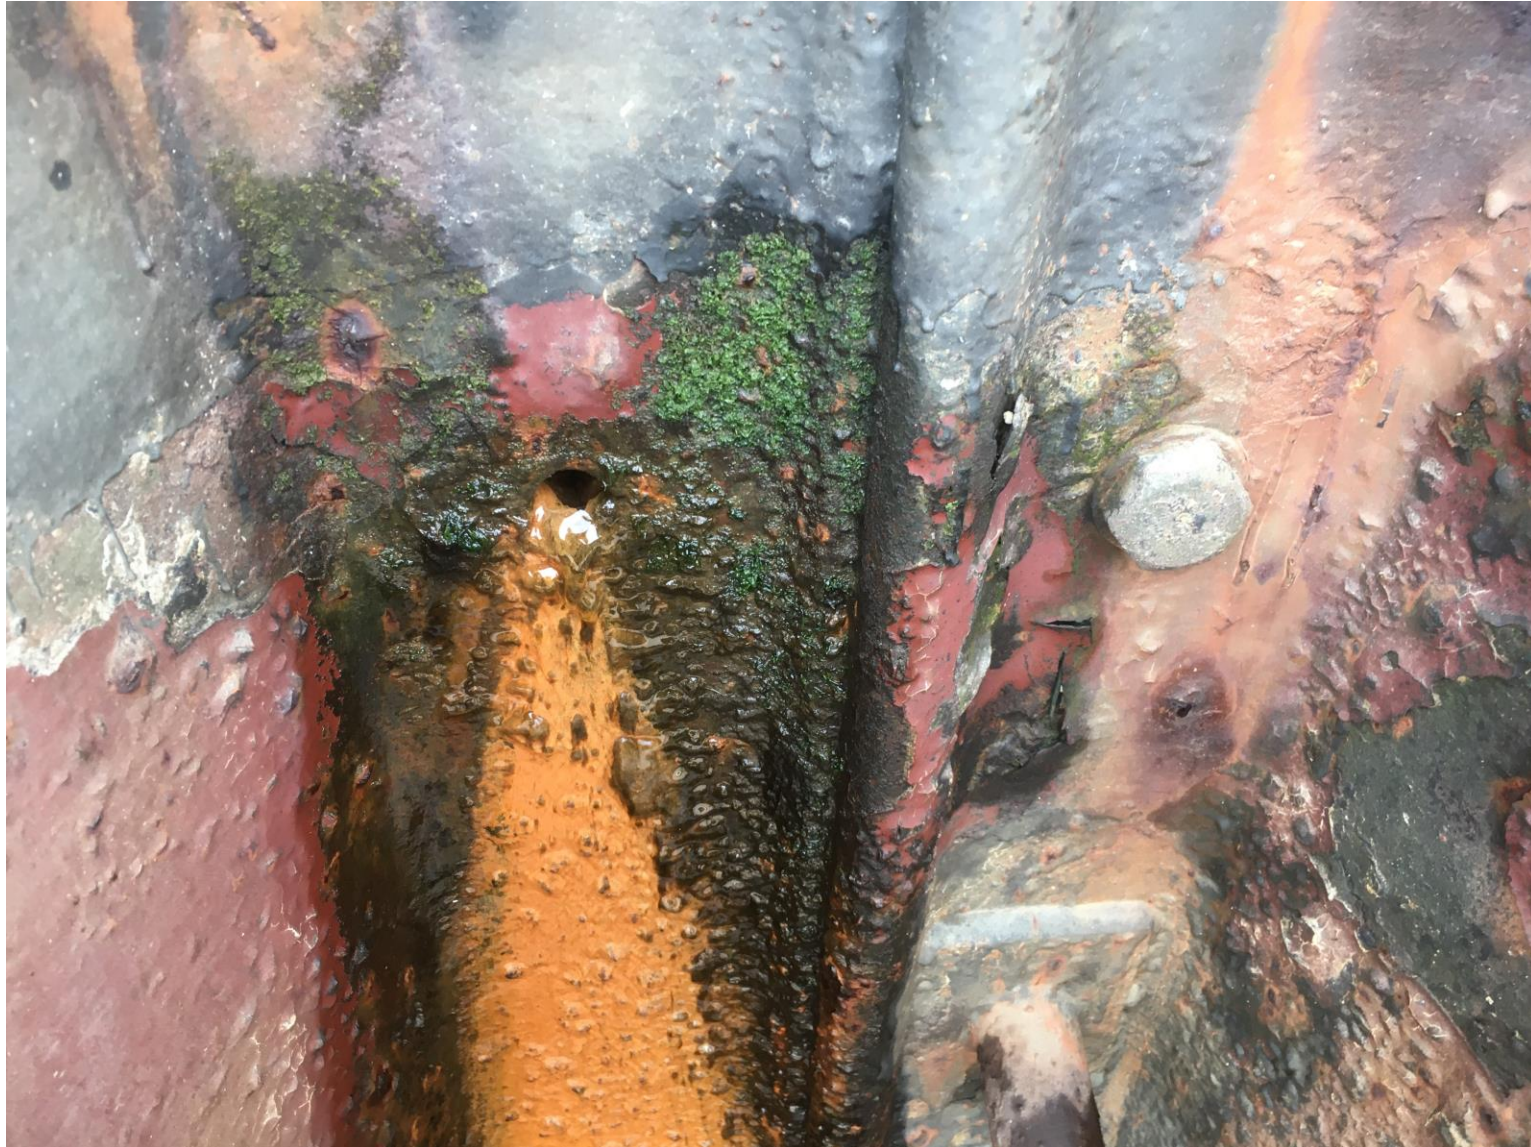
***Failing Tie Back Anchor Bolts – Structural Concern***

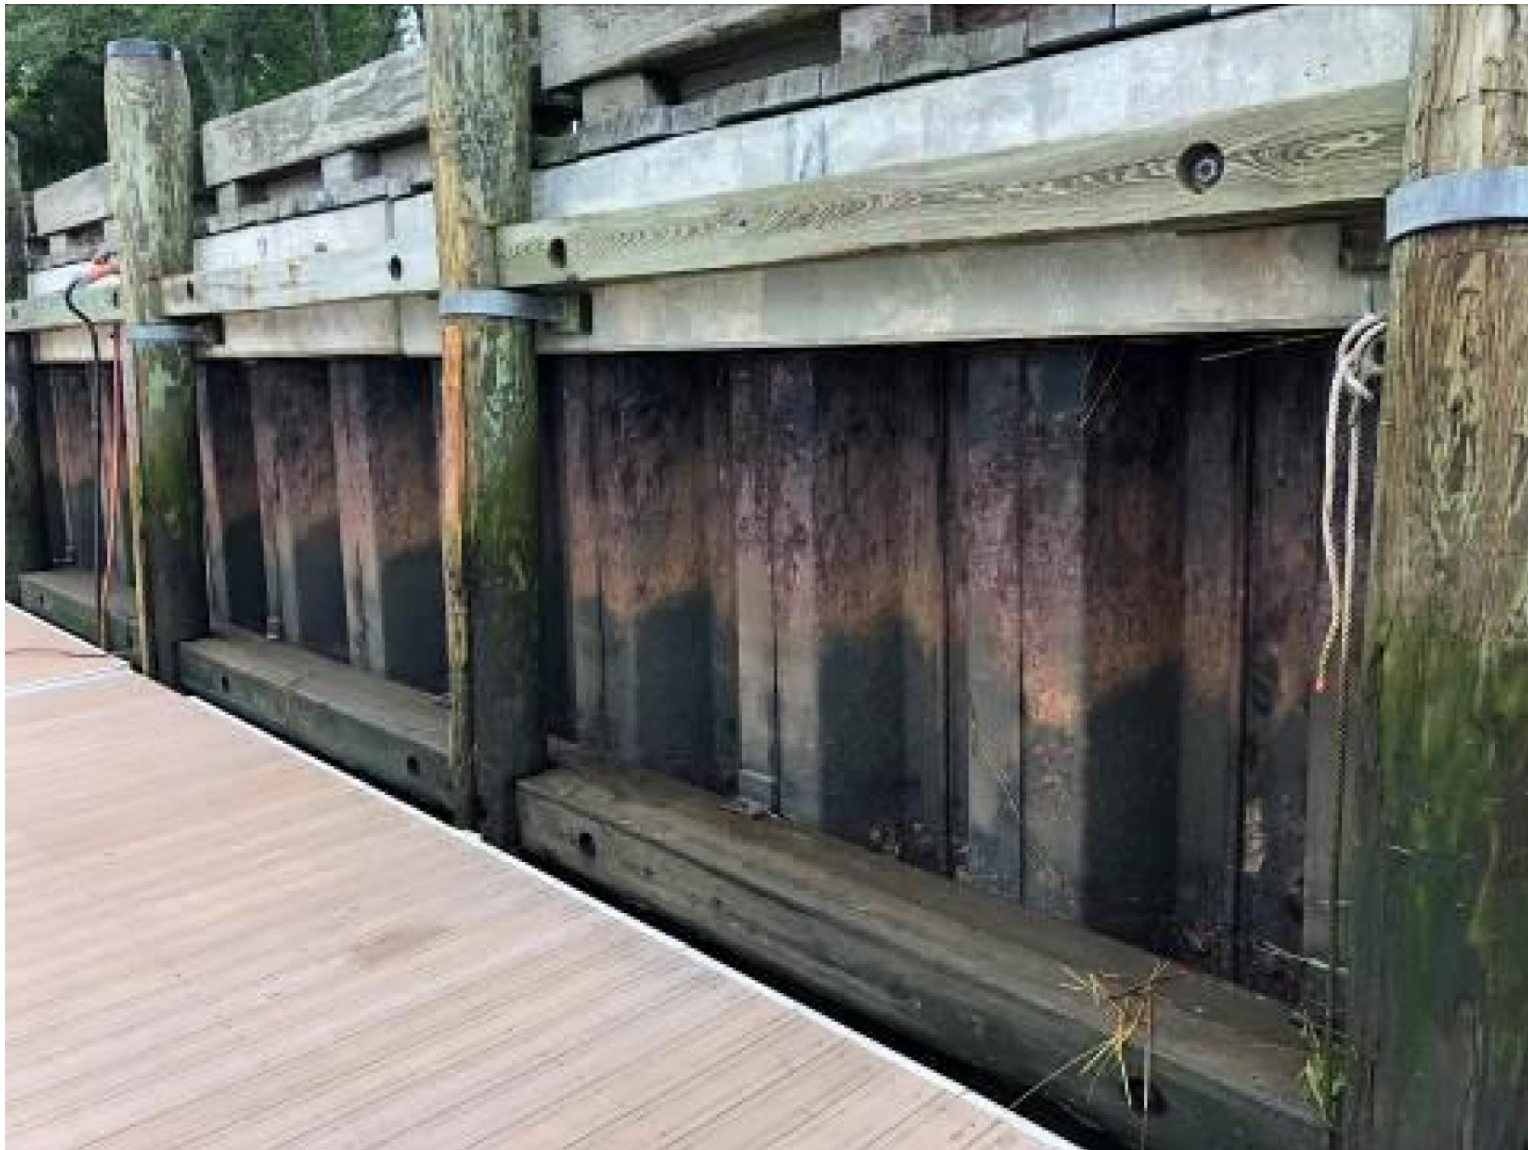
**Splash zone steel section loss - loss of fill behind bulkhead**

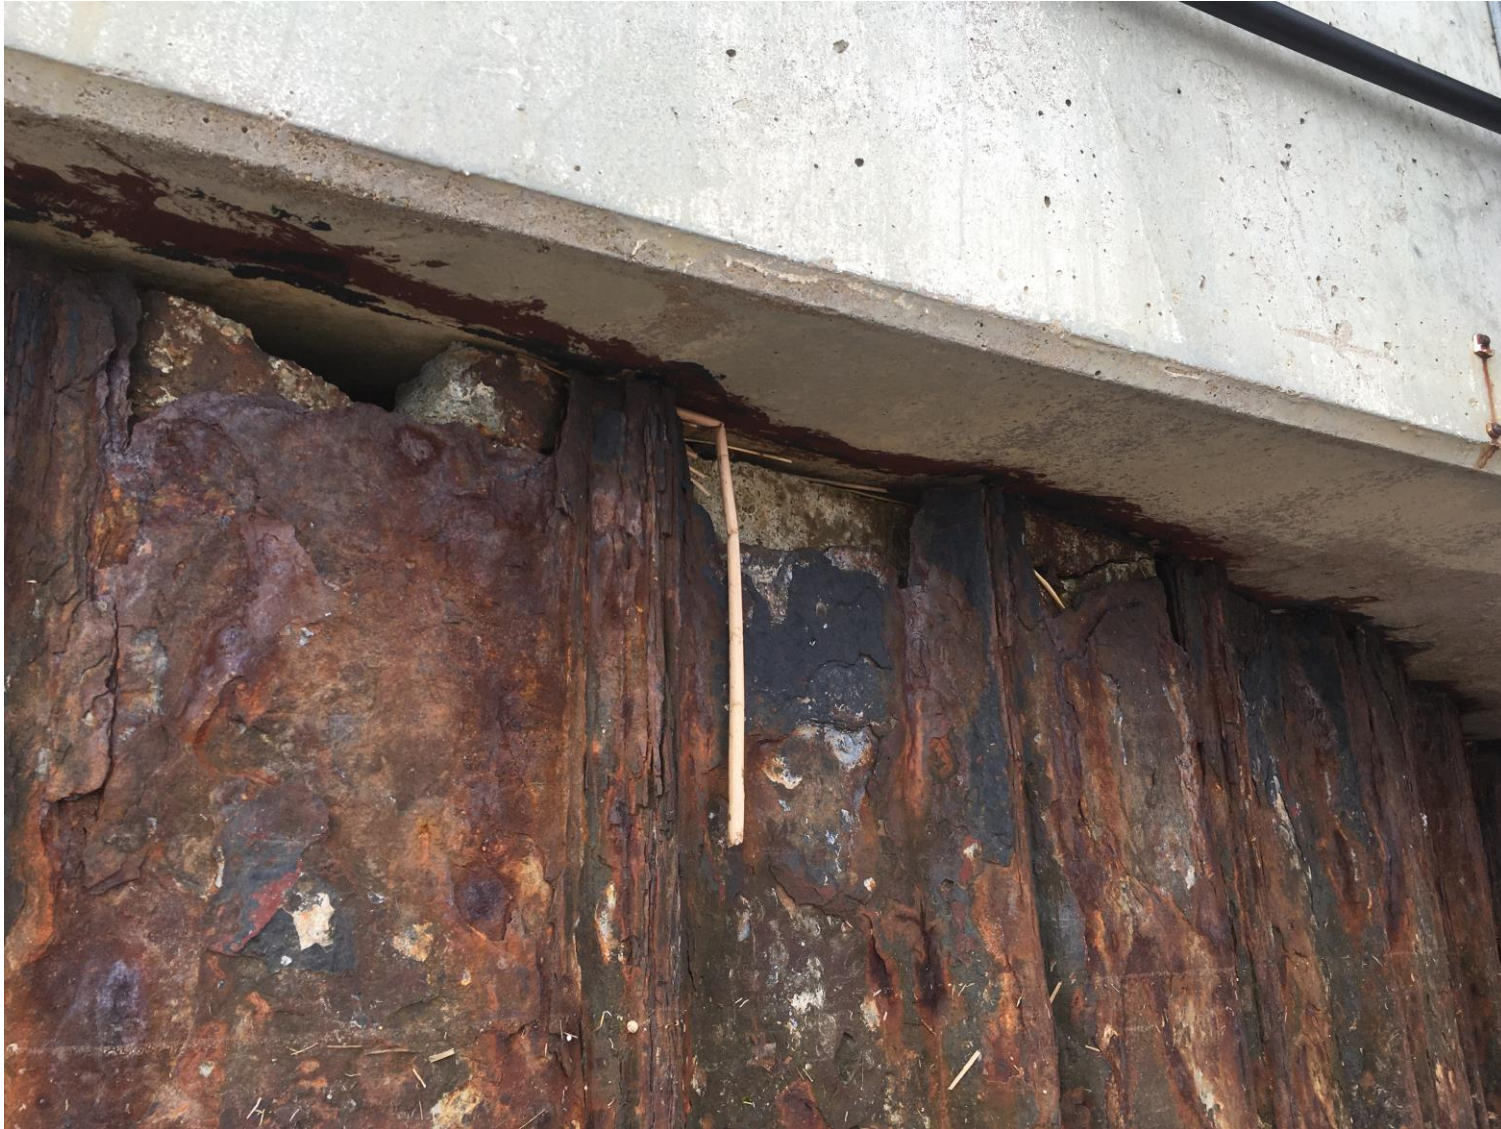
**Splash zone steel section loss - loss of fill behind bulkhead**

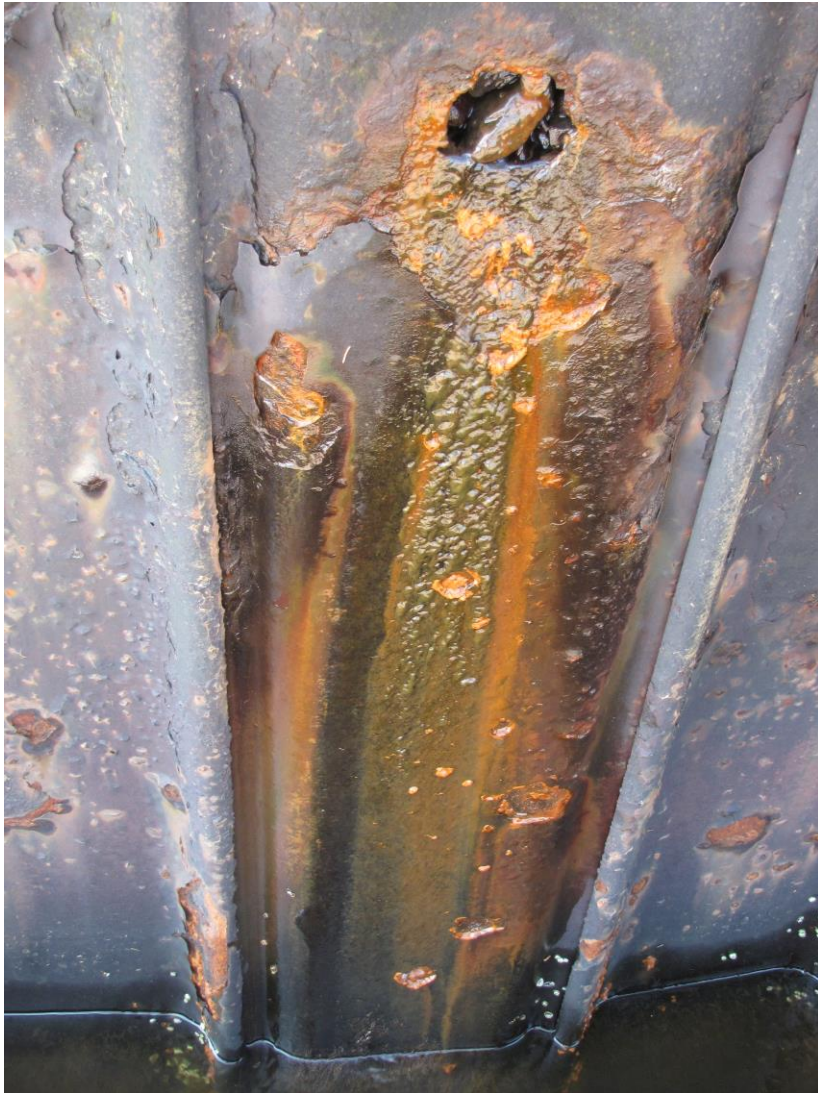
**2013 typical conditions: corroding weep hole**

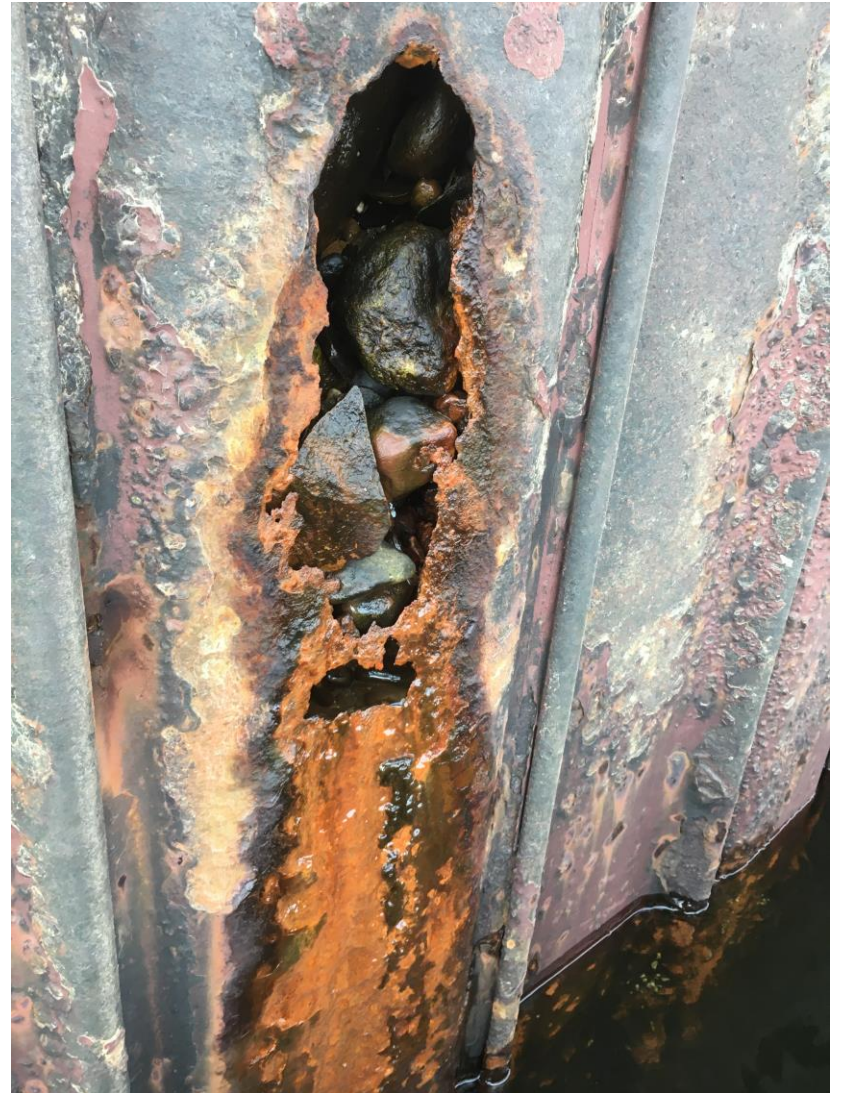
**2021 typical conditions: enlarged weep hole**

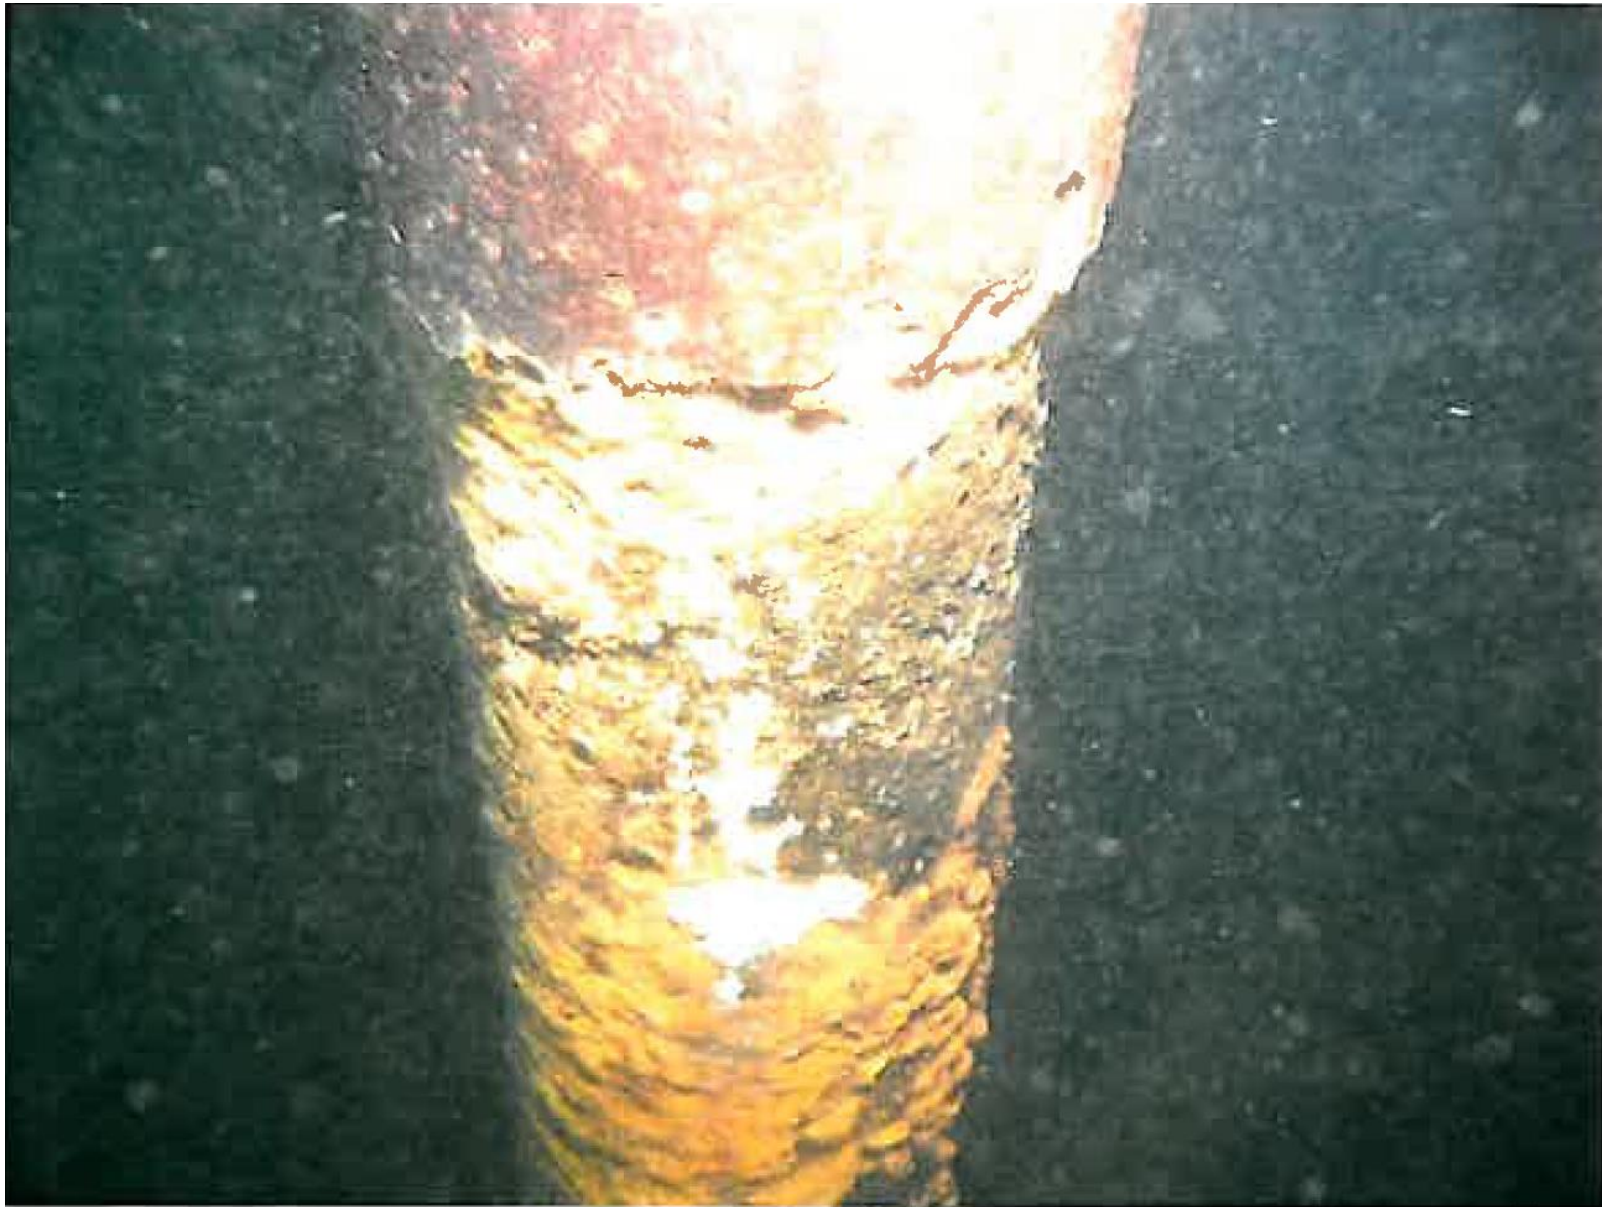
**Mooring piling underwater – loss of steel and exposed concrete**

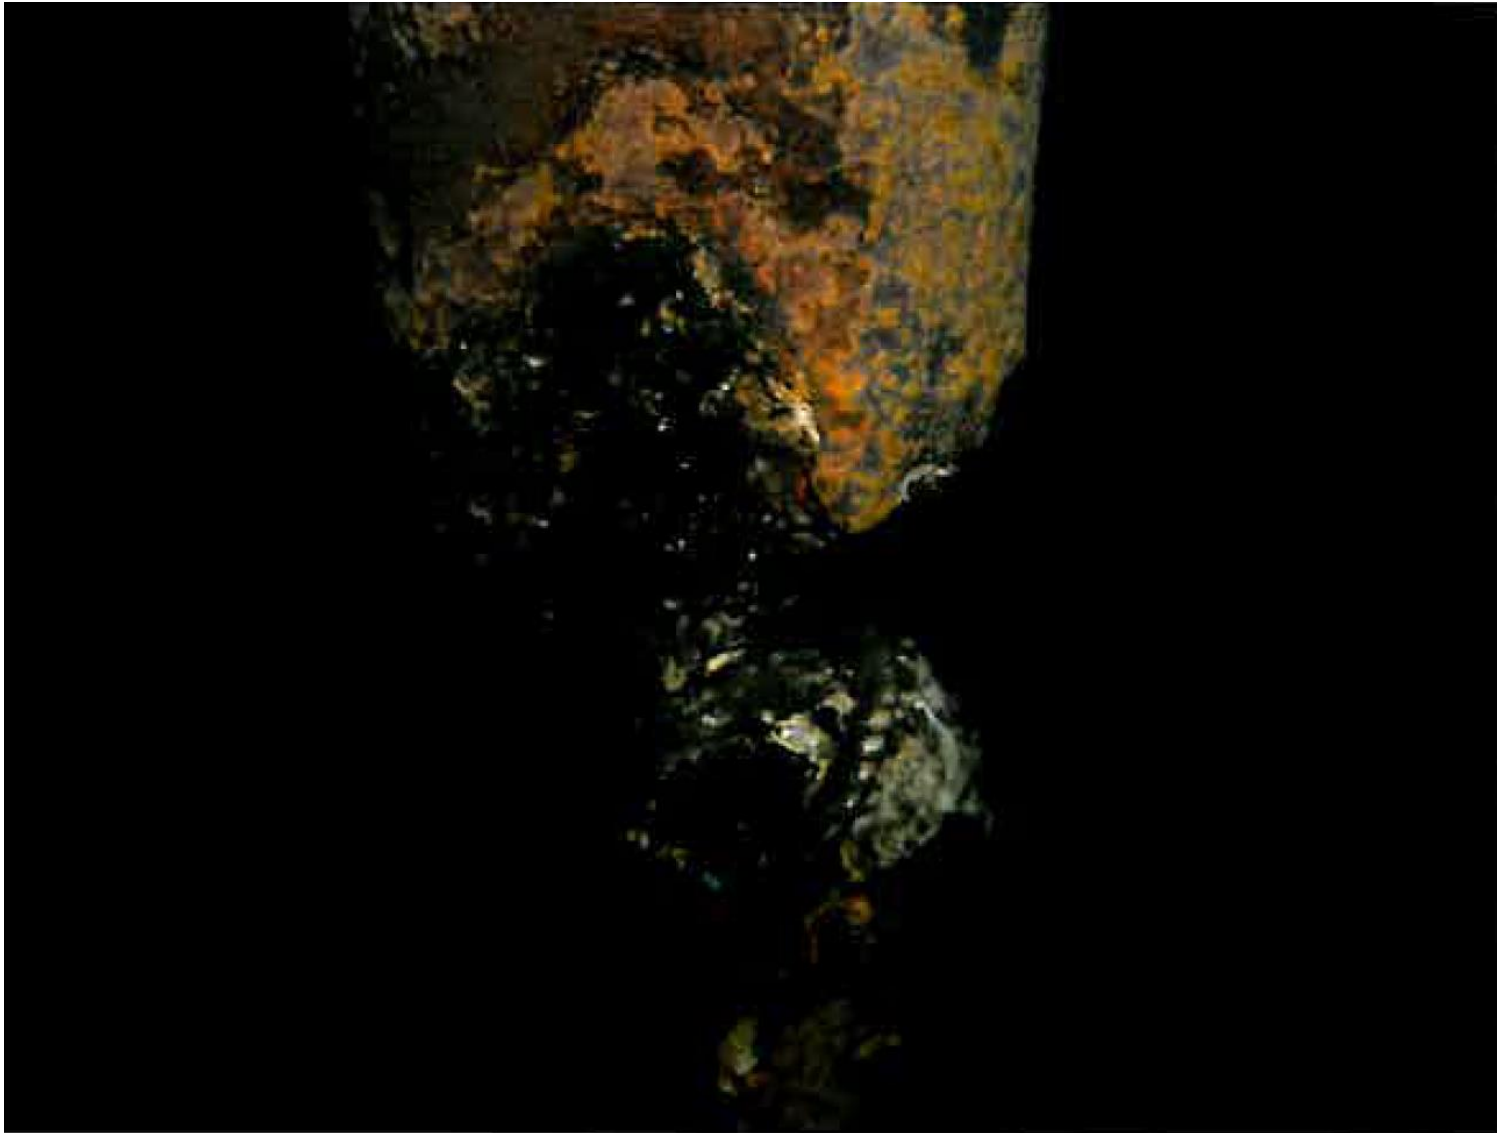
**Mooring piling underwater – no steel remaining and loss of concrete fill**
