**CITY OF NEWBURYPORT**  
DEPARTMENT OF PUBLIC SERVICES  
16A PERRY WAY  
NEWBURYPORT, MA 01950

**Phillips Drive Neighborhood Drainage and Flooding Problems**  
**Evaluation Report and Recommended Solutions**

January 2018

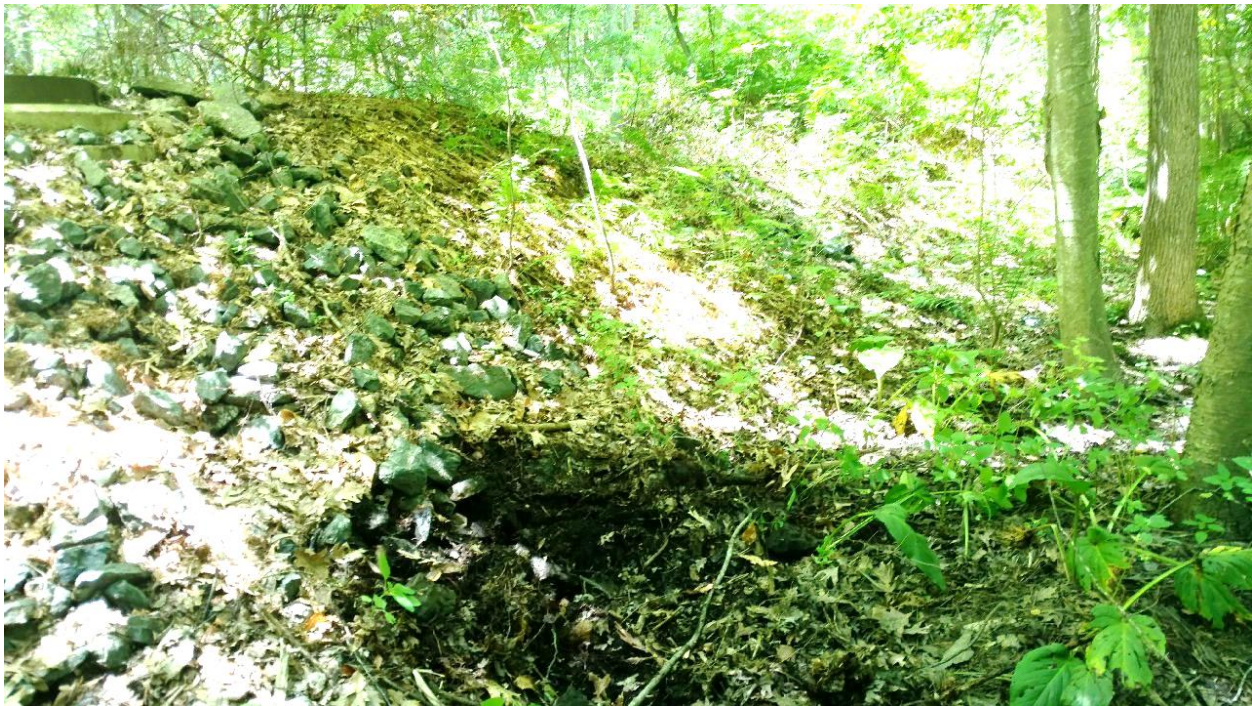
Picture 1: Fall 2017. Standing at the base of the berm/road looking northwest – road on left, detention pond on right. Notice drain manhole structure top left and stone in front of it.

The top picture shows that the inlet pipes are completely buried and are not functioning as designed (the bottom sketch). The stone is too small and the voids have since clogged preventing direct flow of runoff to pass downstream.

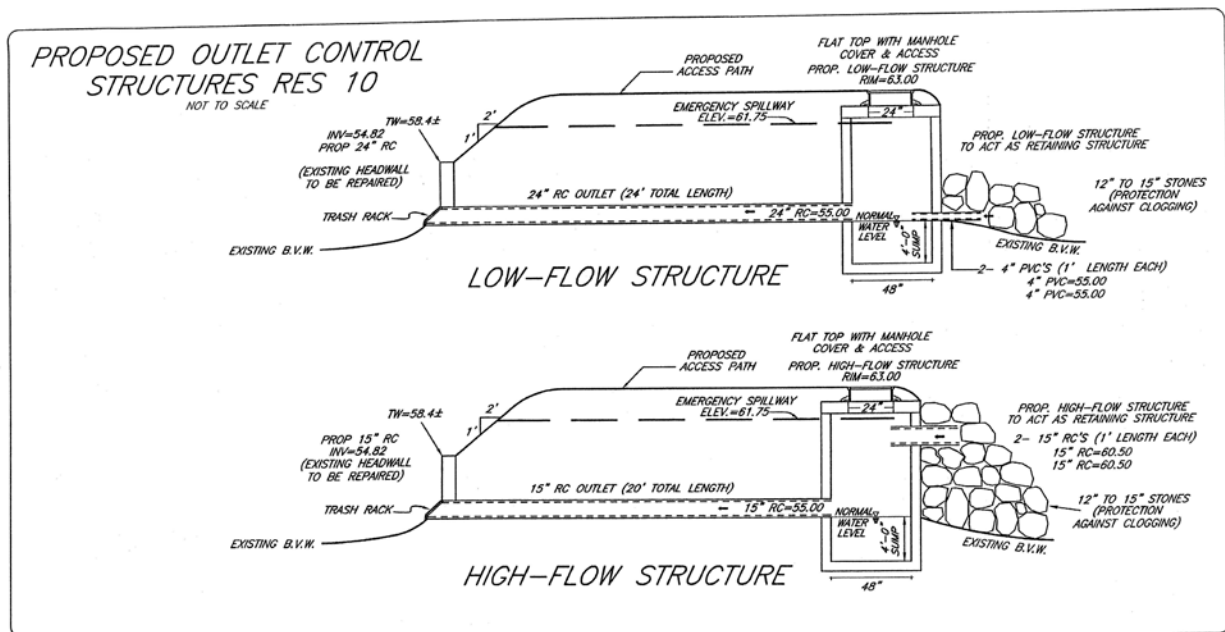
Design sketch from Cherry Hill Subdivision Plans. The outlet control structure is a drain manhole with two pipes collecting flow from the pond.

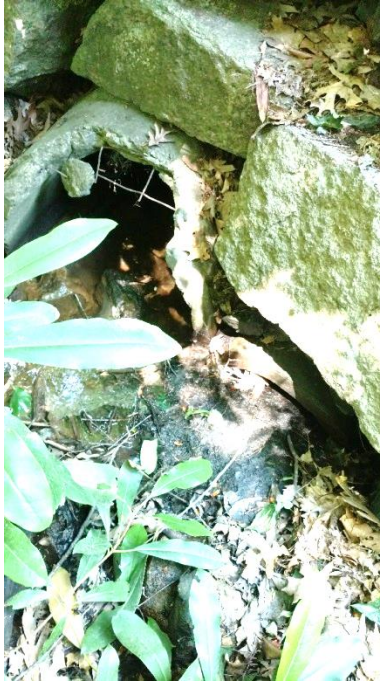
Picture 2: Two outlet pipes downstream of the road/berm. Pipe to right completely clogged.

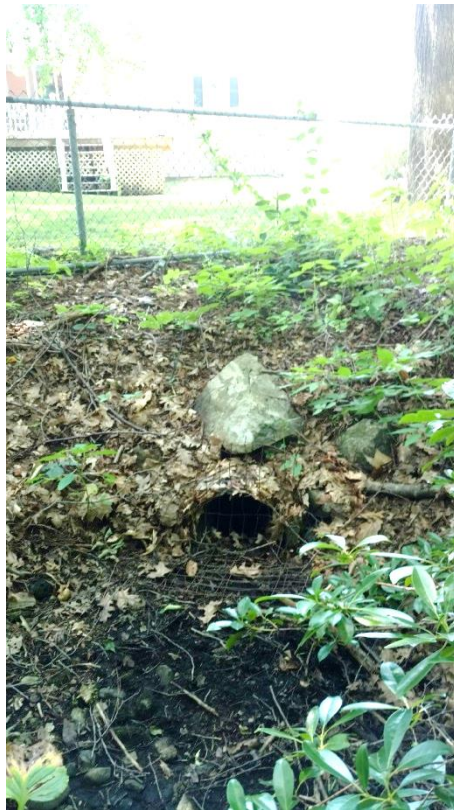
Picture 3: Inlet of 12" pipe behind 37 Phillips Drive. This pipe collects all the discharge flows from Cherry Hill's detention pond RES 10.

See Response to Common Problem #3 above. In addition, there are three drain lines installed between the homes on Phillips Drive directly abutting Cherry Hill. It is highly recommended to replace these lines with larger-diameter pipes to help alleviate overland flooding onto their backyards and to construct grassed swales sized to handle the more intense storms.
