**Subject: Phase II Environmental Site Assessment, Rev 1  
Brown School - 42 Milk Street  
Newburyport, Massachusetts 01950**

# **Phase II Environmental Site Assessment, Rev 1**

**Brown School  
42 Milk Street  
Newburyport, Massachusetts**

**Appendix B – Photo Log**  
**Brown School**  
**42 Milk Street, Newburyport, Massachusetts**

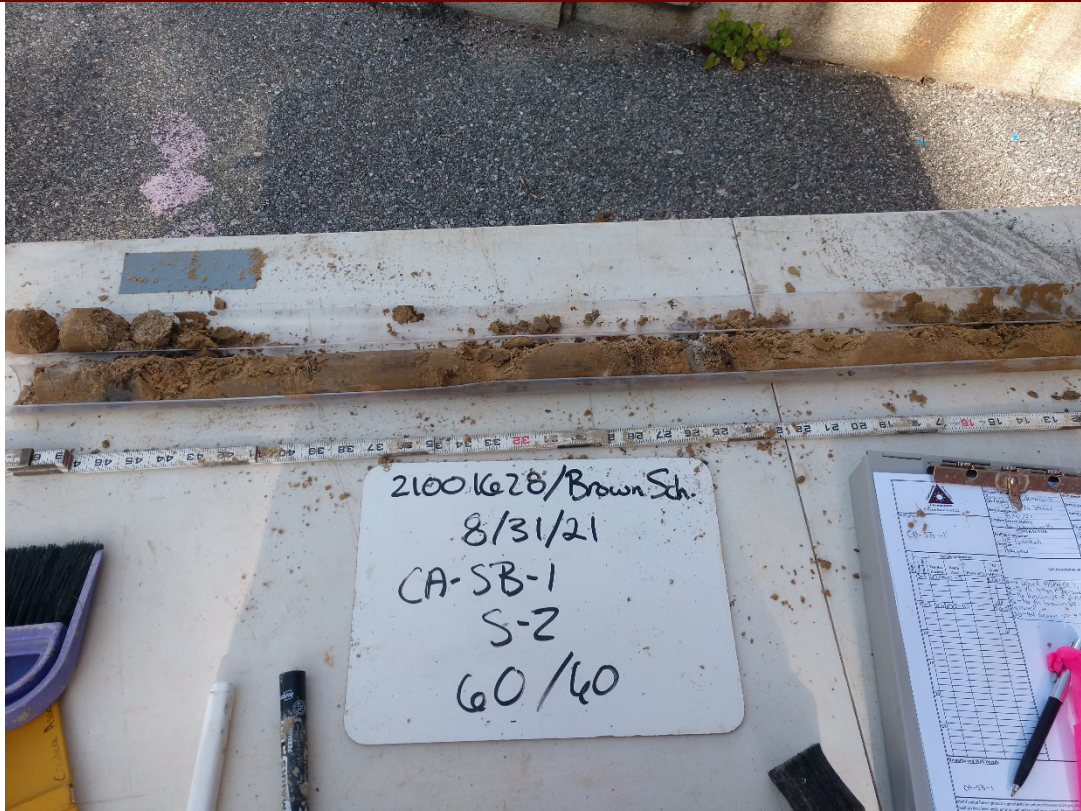
1. Representative view of soil core collected during soil boring work

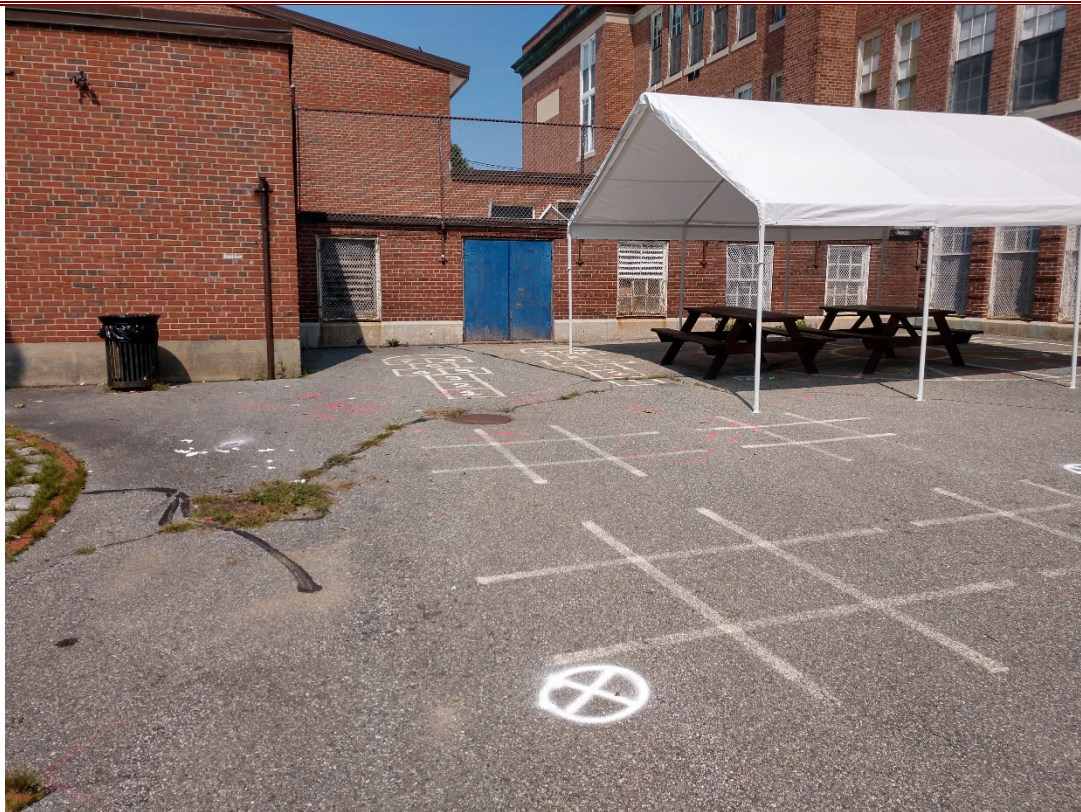
2. View of soil boring locations and UST GPR location markings

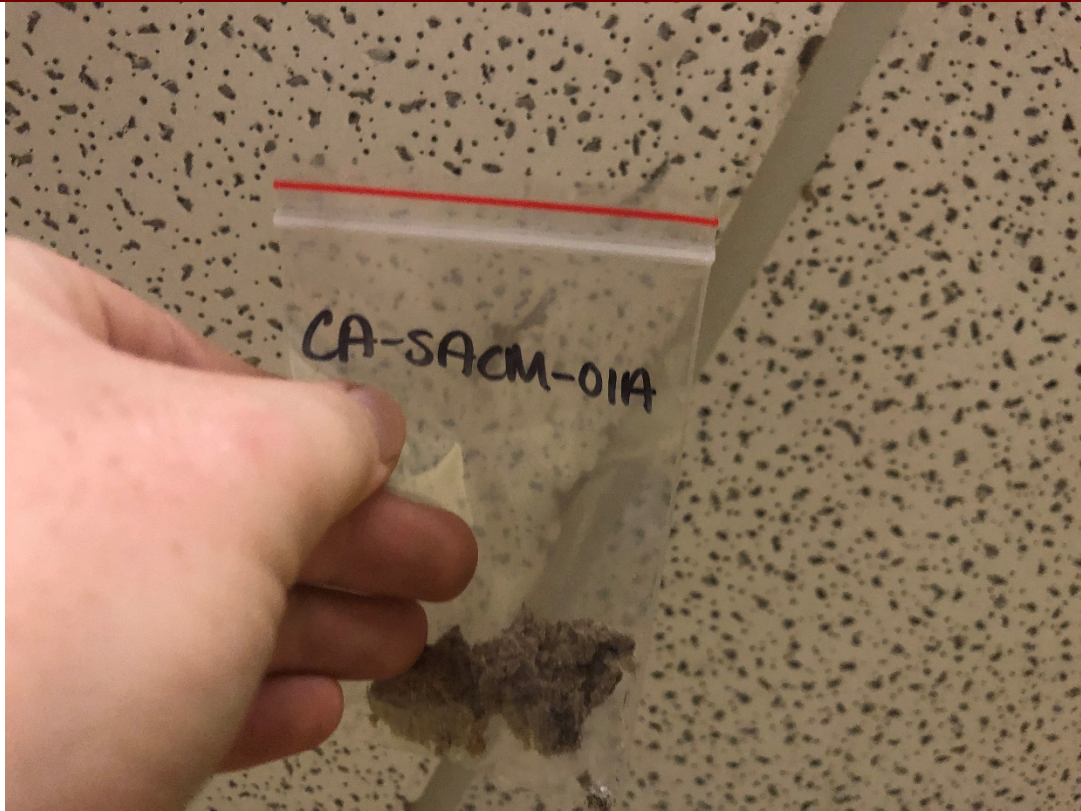
3. View of CA-SACM-01, 2' x 3' ceiling tile with dot squiggle pattern

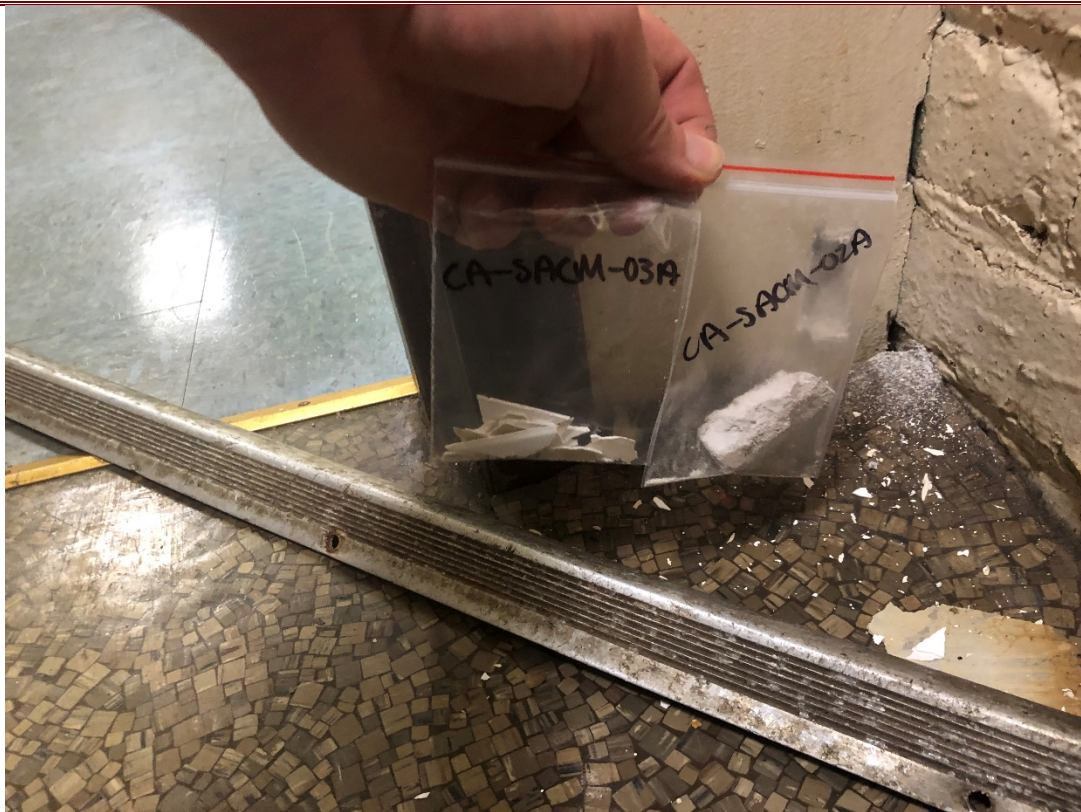
4. View of CA-SACM-02, sheetrock, white, and CA-SACM-03, joint compound, white

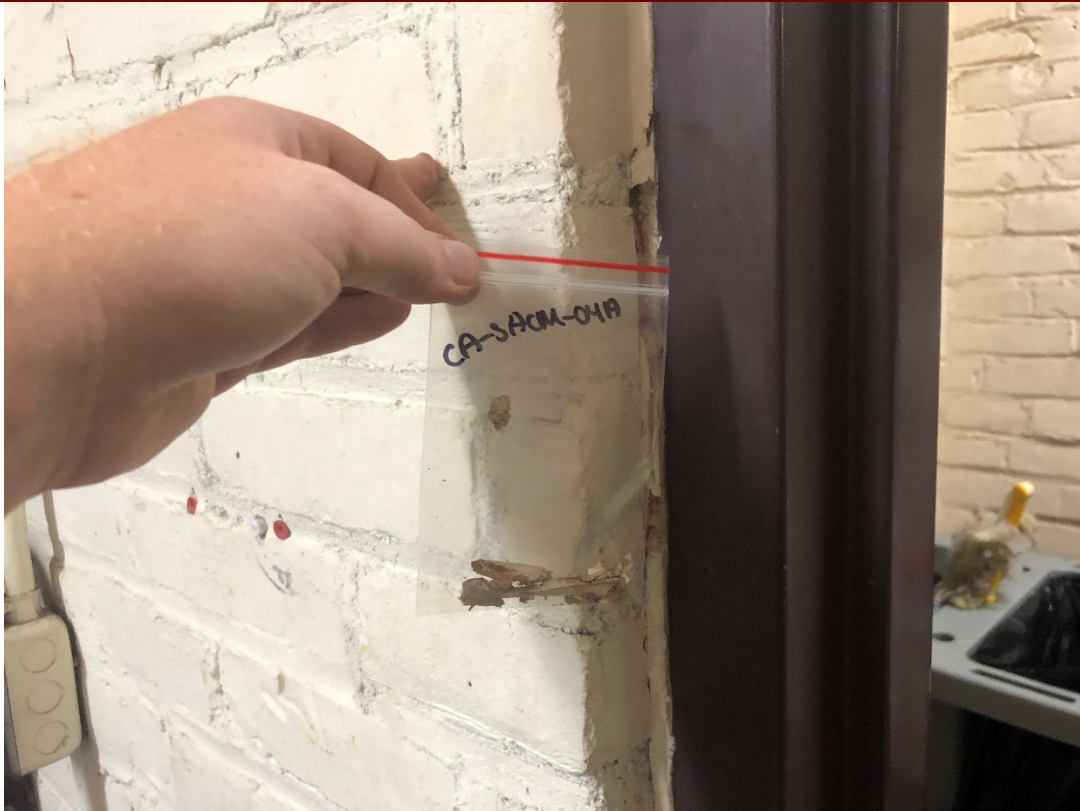
5. View of CA-SACM-04, caulk, tan (Rooms J-3 and C-7)

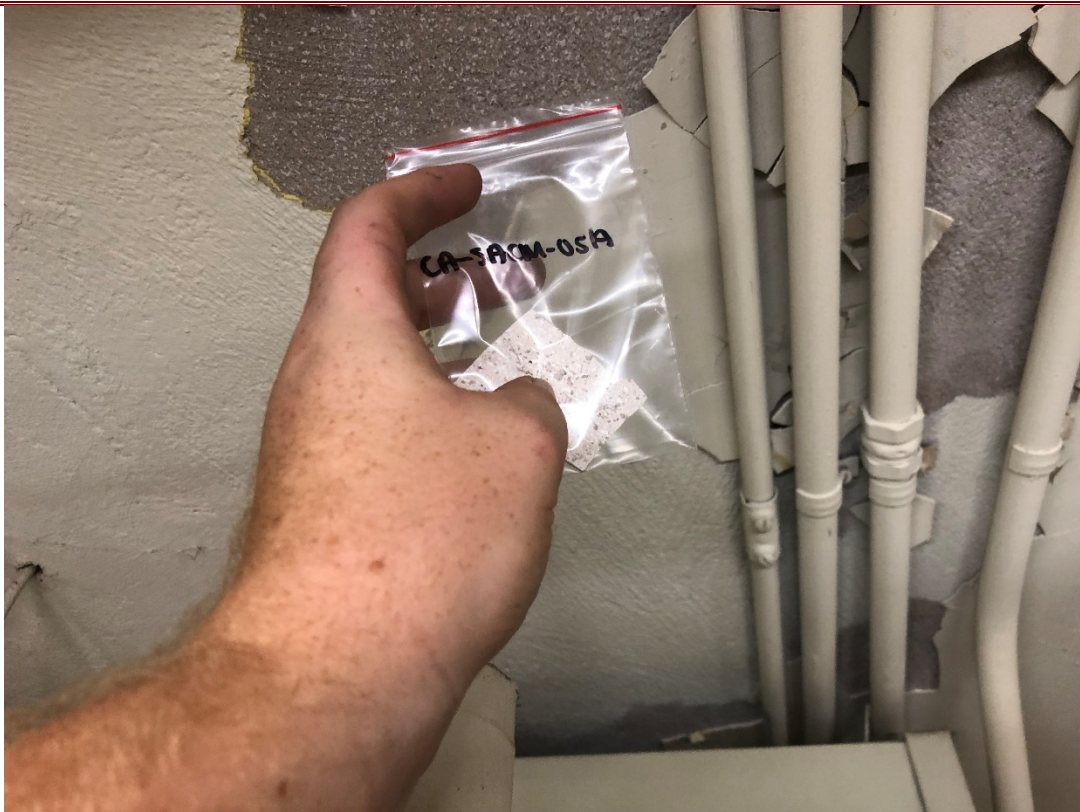
6. View of CA-SACM-05, plaster topcoat, white and CA-SACM-06, plaster basecoat, gray (multiple rooms)

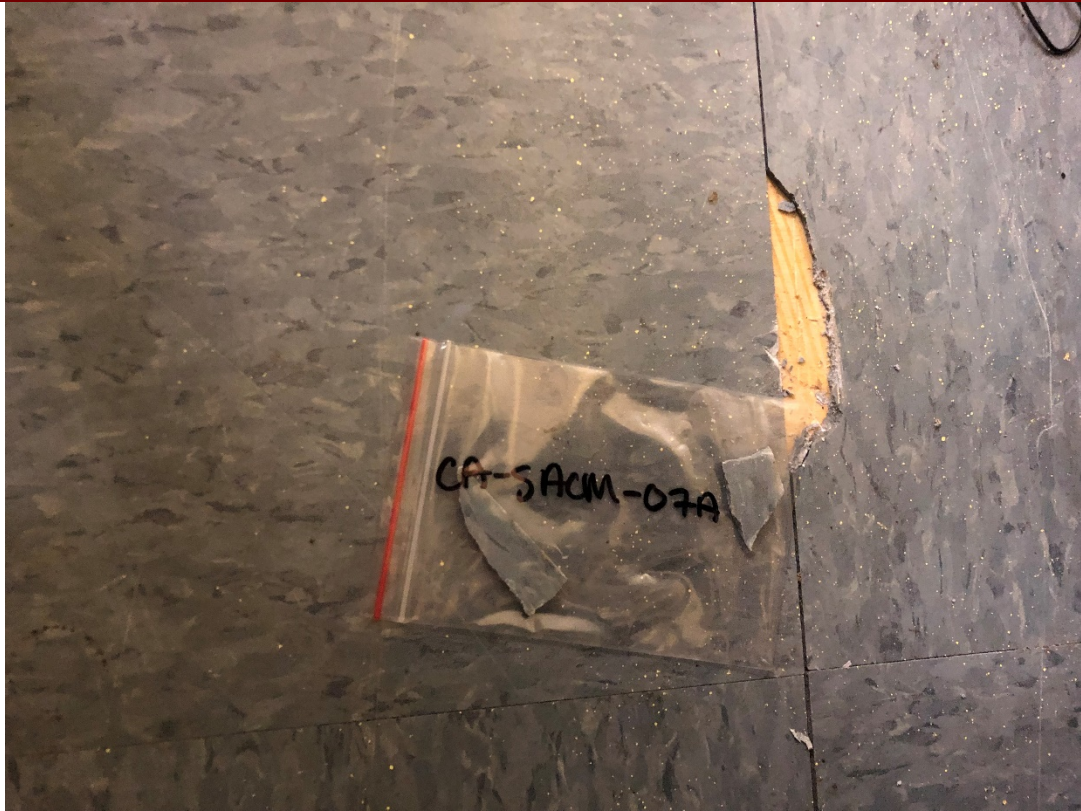
7. View of CA-SACM-07, 12" x 12" floor tile, blue (Rooms 15 and 16)

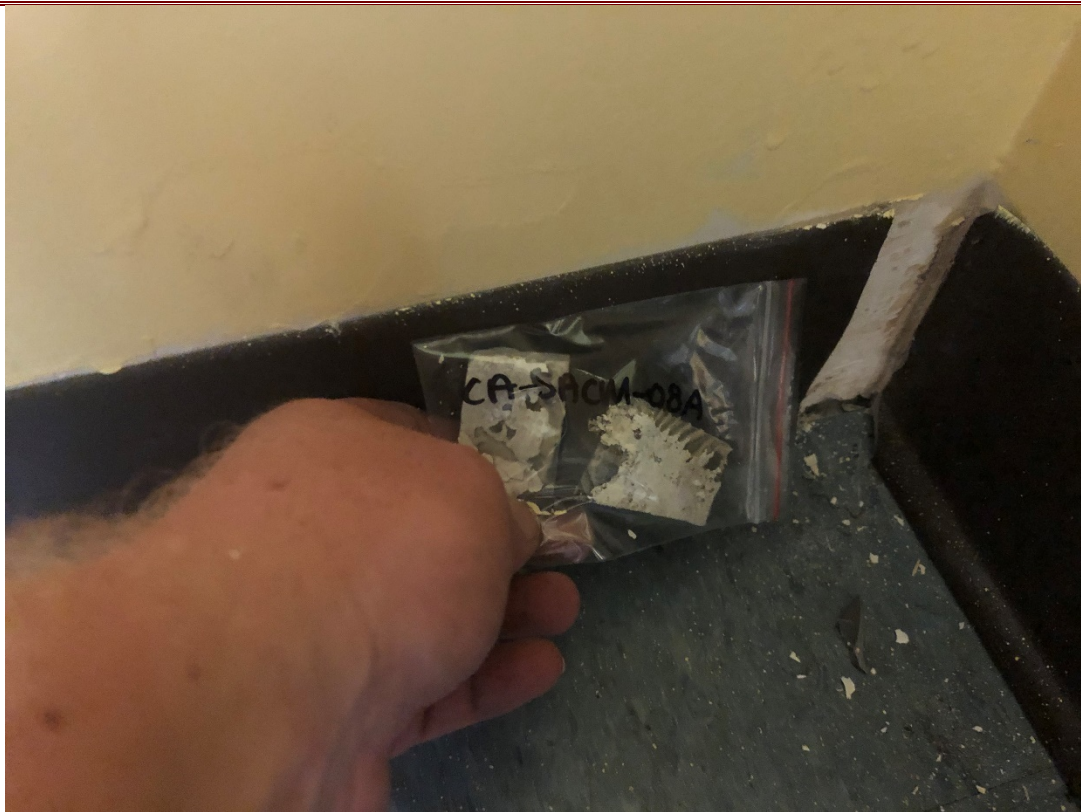
8. View of CA-SACM-08, baseboard adhesive, off-white (Rooms 15 and 16)

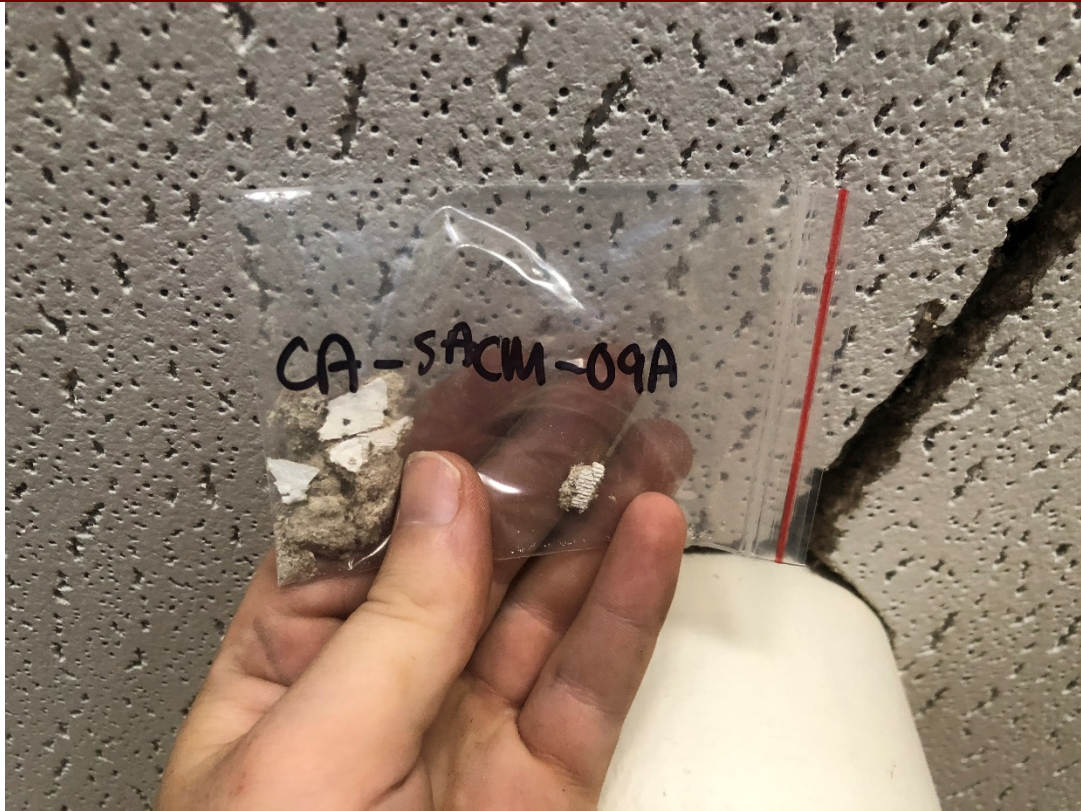
9. View of CA-SACM-09, 2 x 3 ceiling tile, dot squiggle pattern #2 (Rooms 15 and T-5)

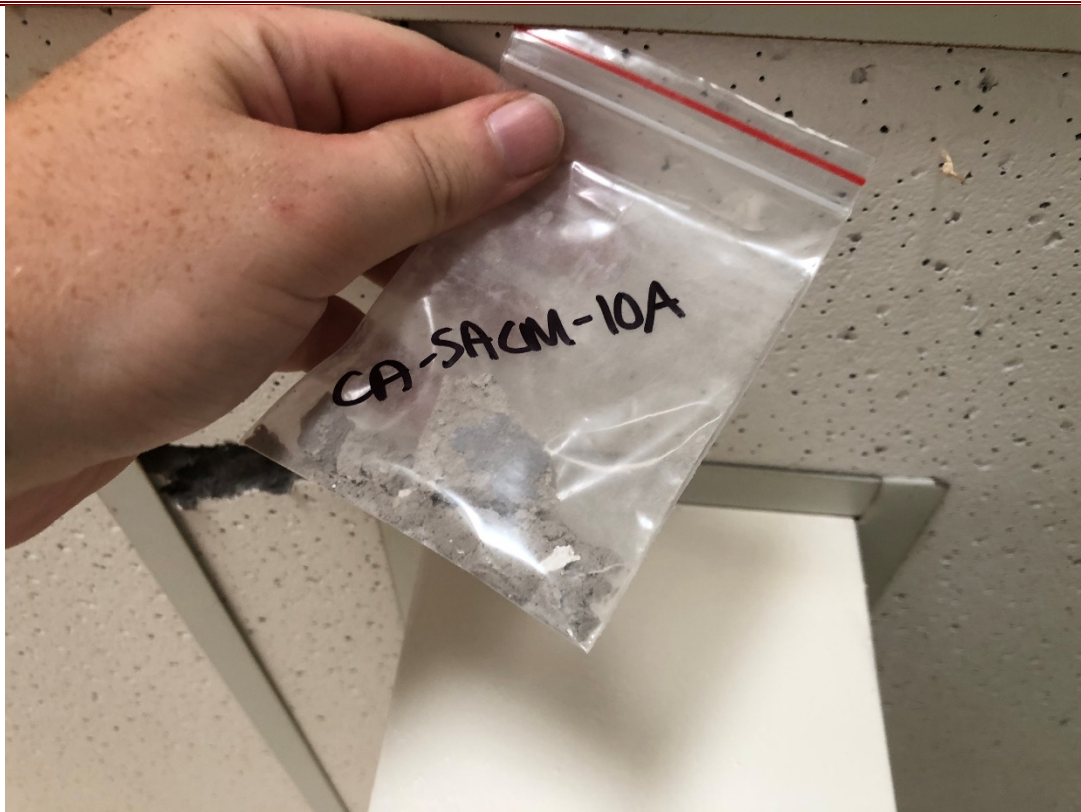
10. View of CA-SACM-10, 2' x 3' ceiling tile, small dents pattern (Rooms T-5 and T-4)

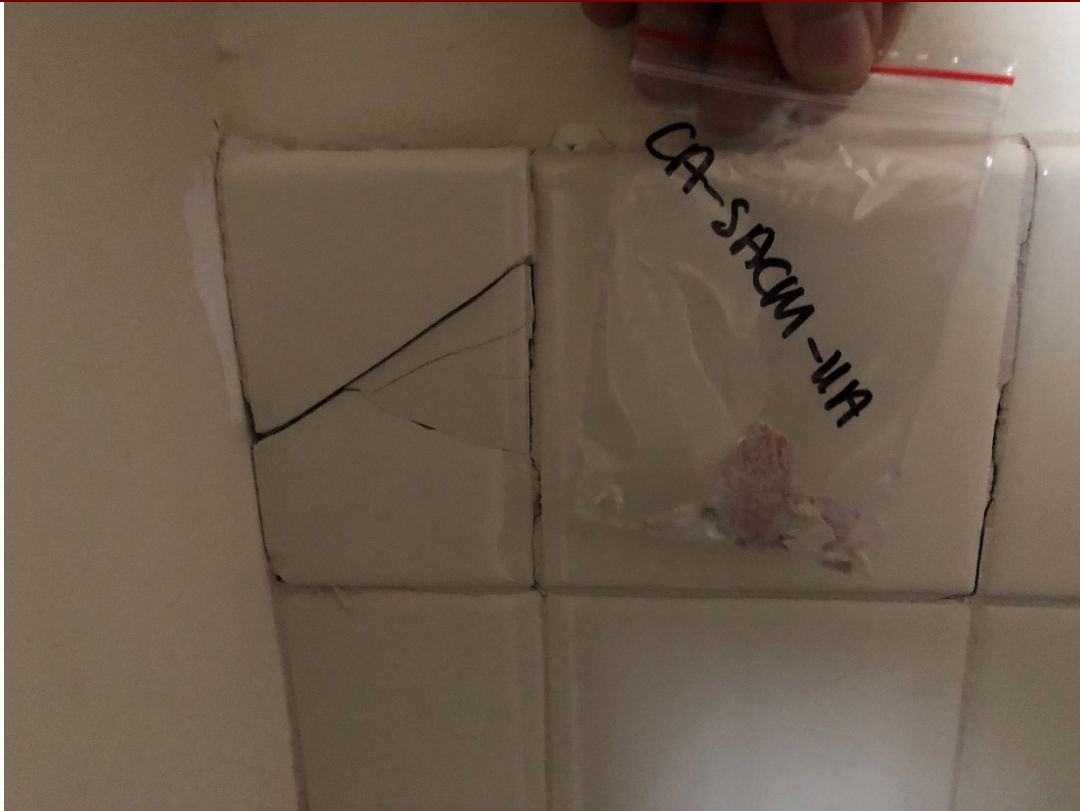
11. View of CA-SACM-11, tile underlayment, light gray (Rooms T-4 and T1-2)

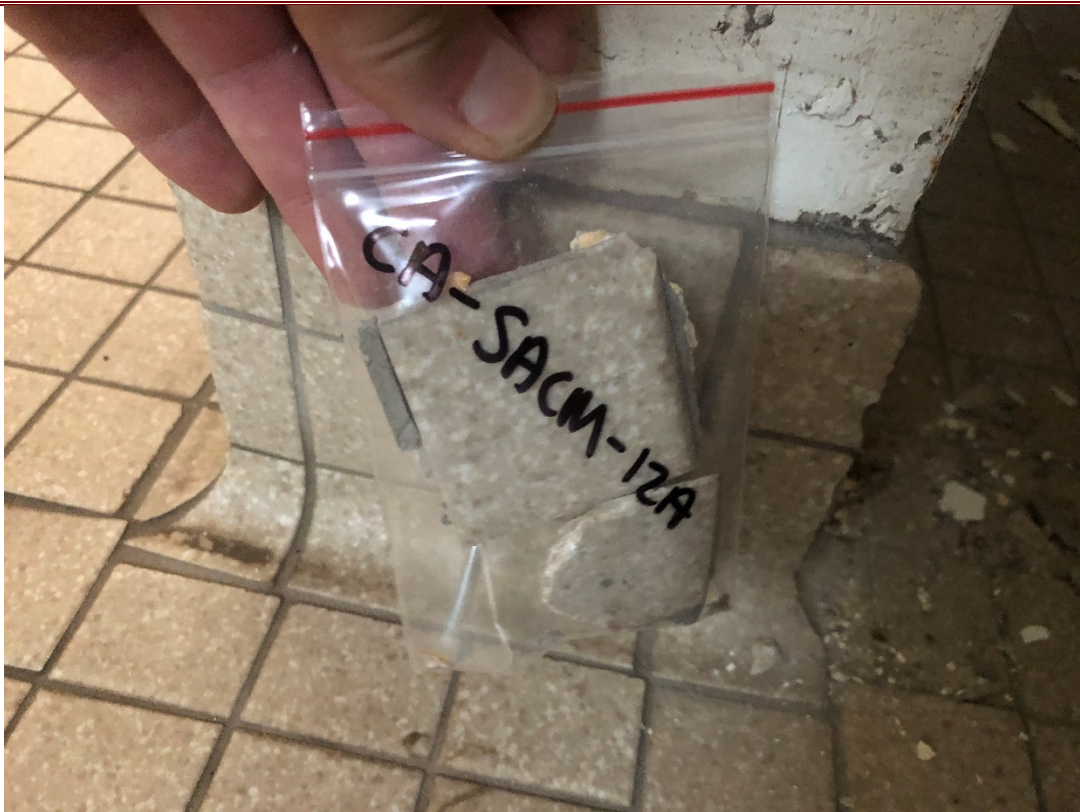
12. View of CA-SACM-12, tile underlayment, gray (Rooms T-4 and T1-2)

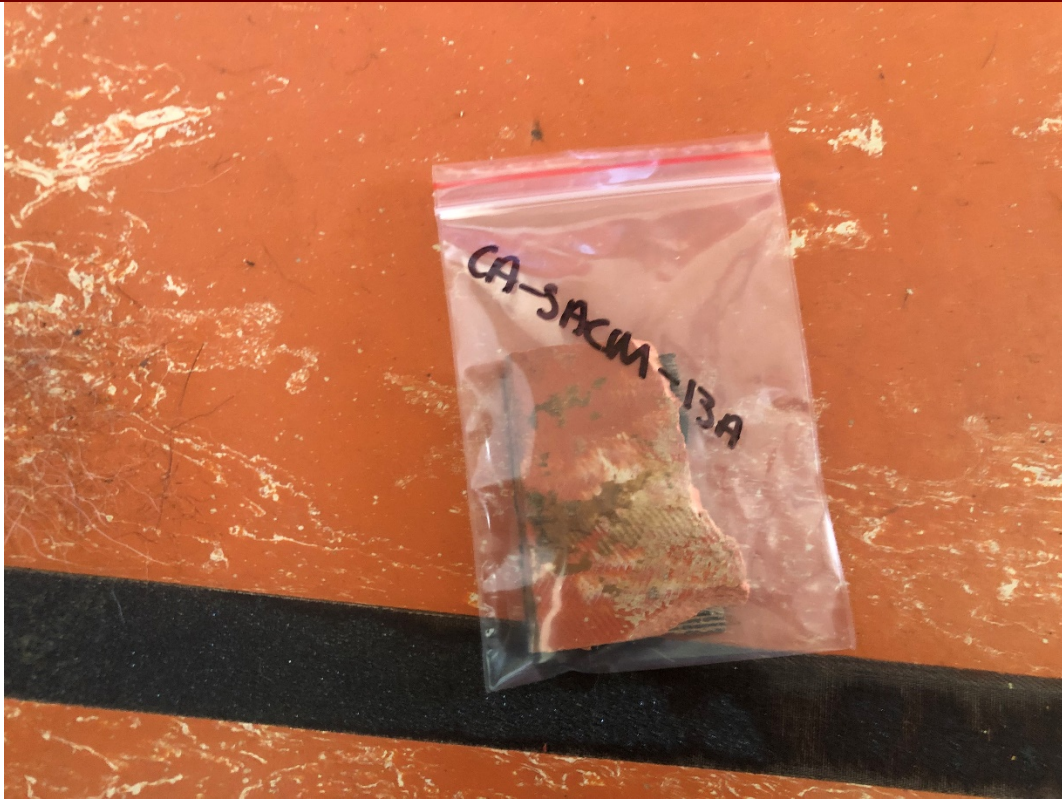
13. View of CA-SACM-13, stair tread, orange (Stair 1 and Stair 2)

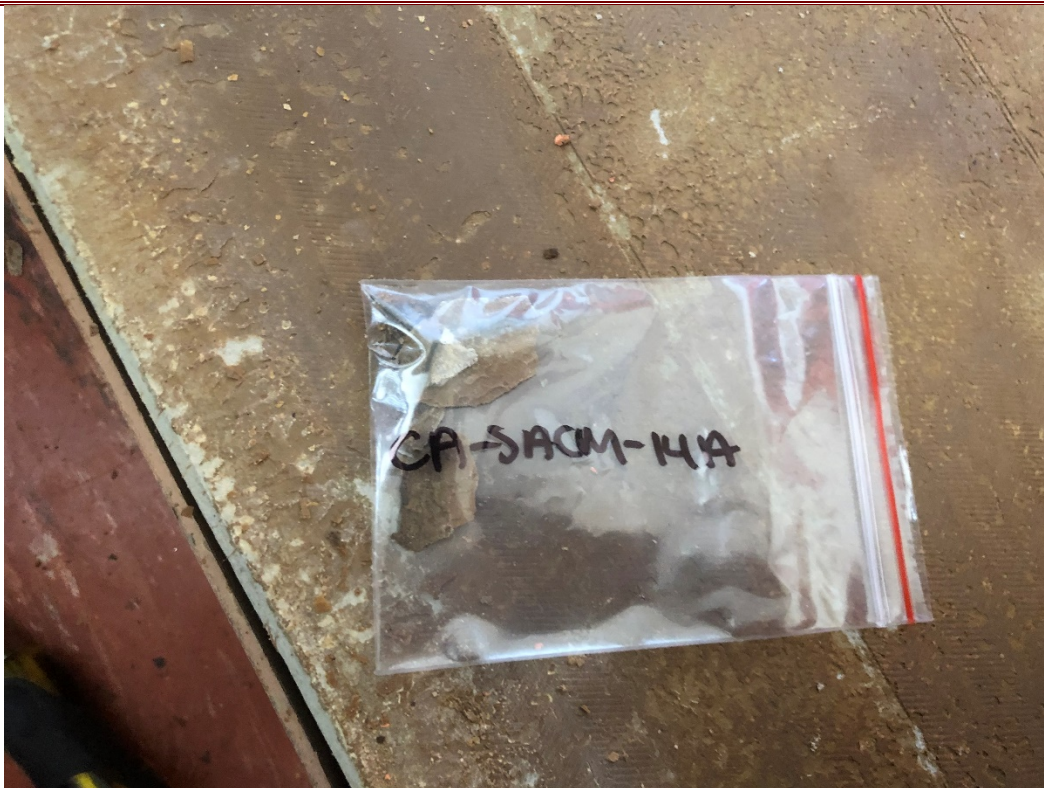
14. View of CA-SACM-14, stair tread mastic, brown (Stair 1 and Stair 2)

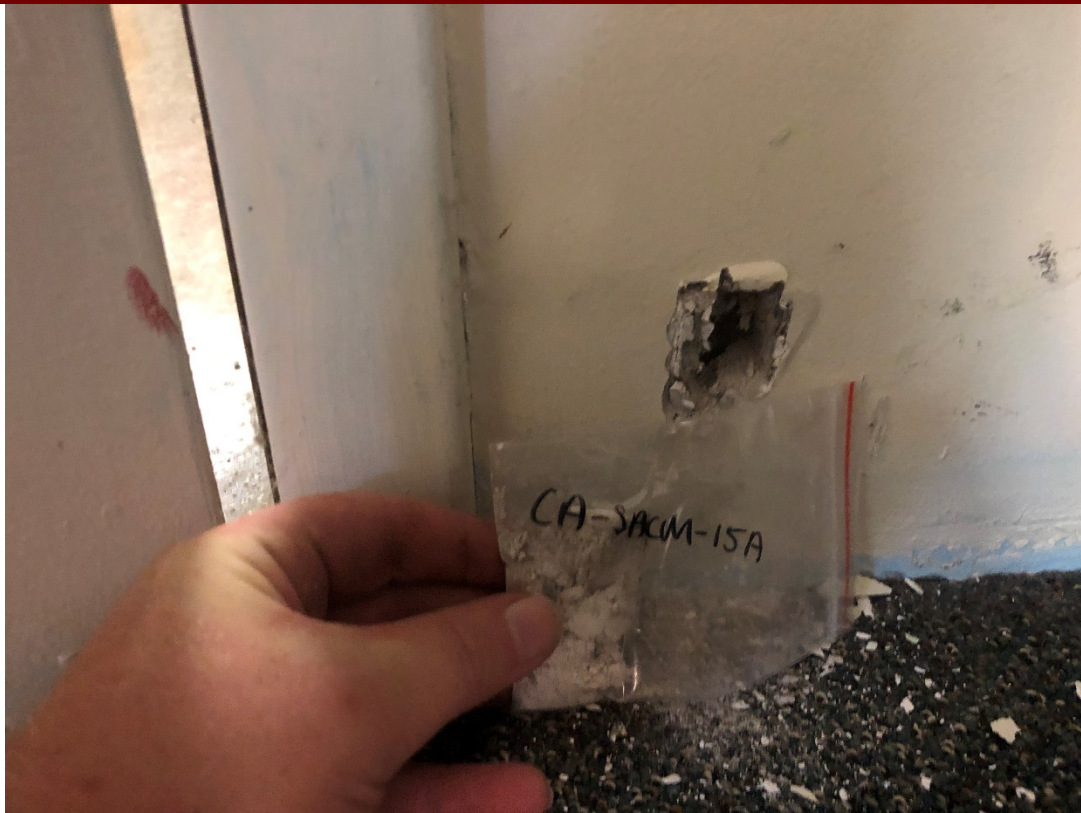
15. View of CA-SACM-15, sheetrock, gray – gym addition (Room GL-1)

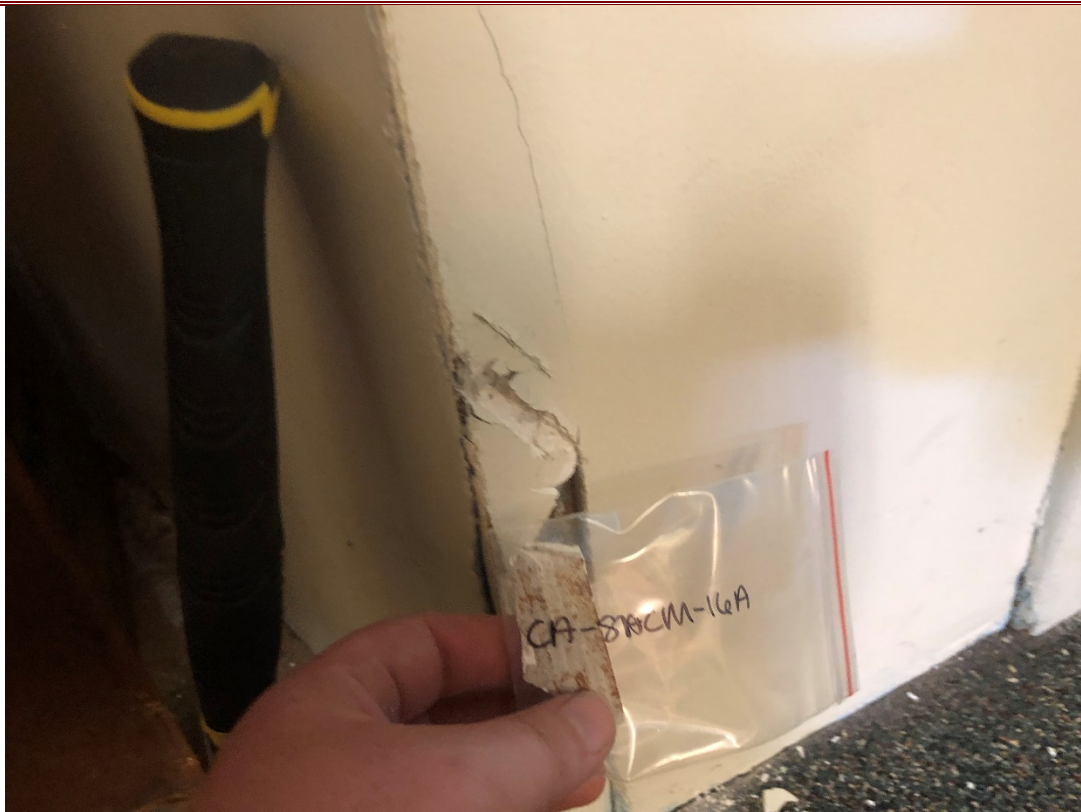
16. View of CA-SACM-16, joint compound, white – gym addition (Room GL-1)

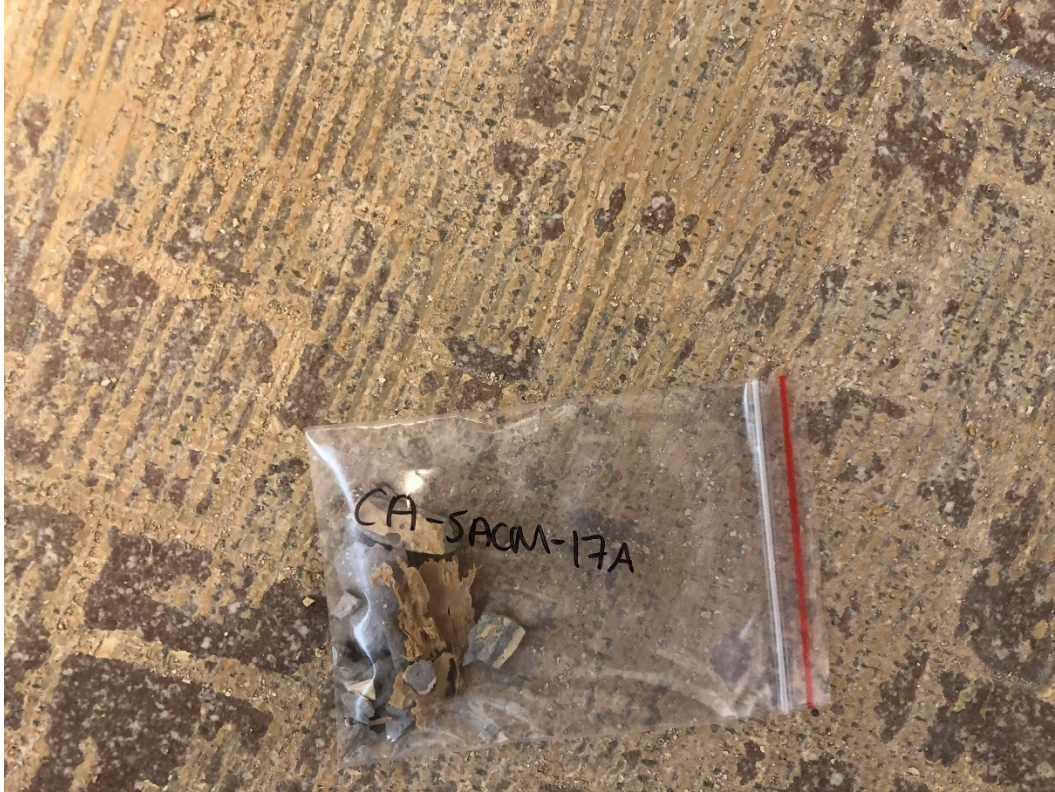
17. View of CA-SACM-17, carpet adhesive, beige (Room GL-1)

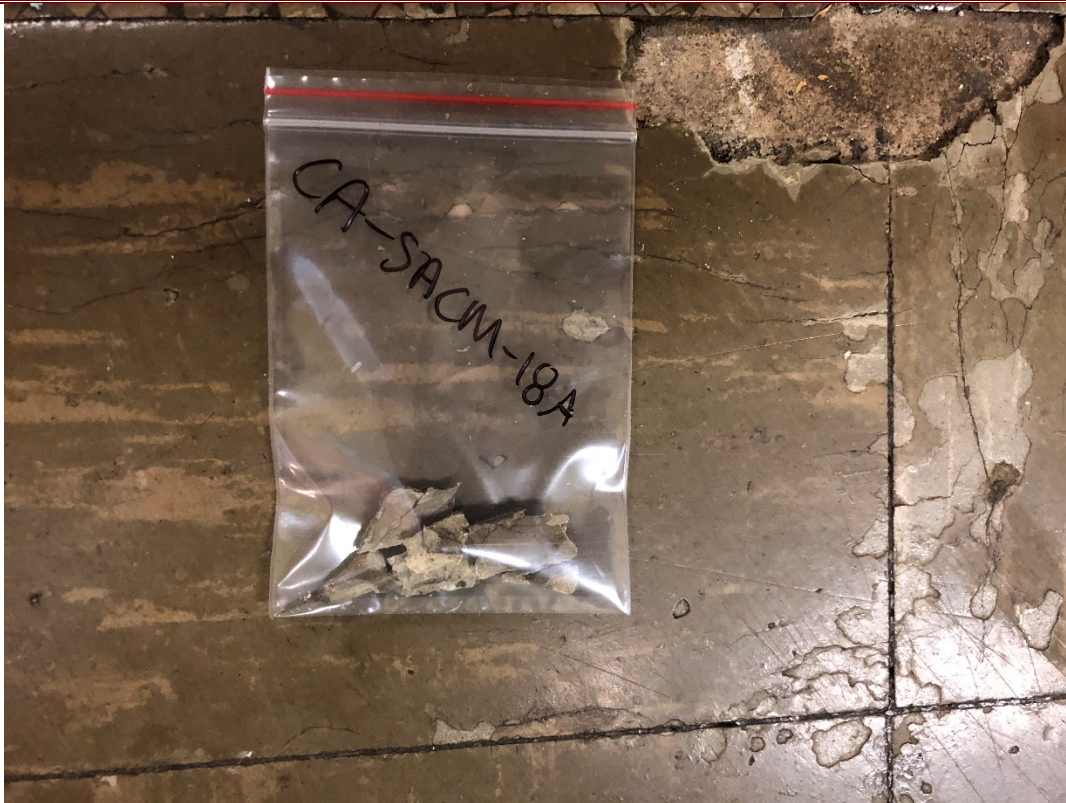
18. View of CA-SACM-18, 9" x 9" floor tile, tan (Rooms C-1 and C-2)

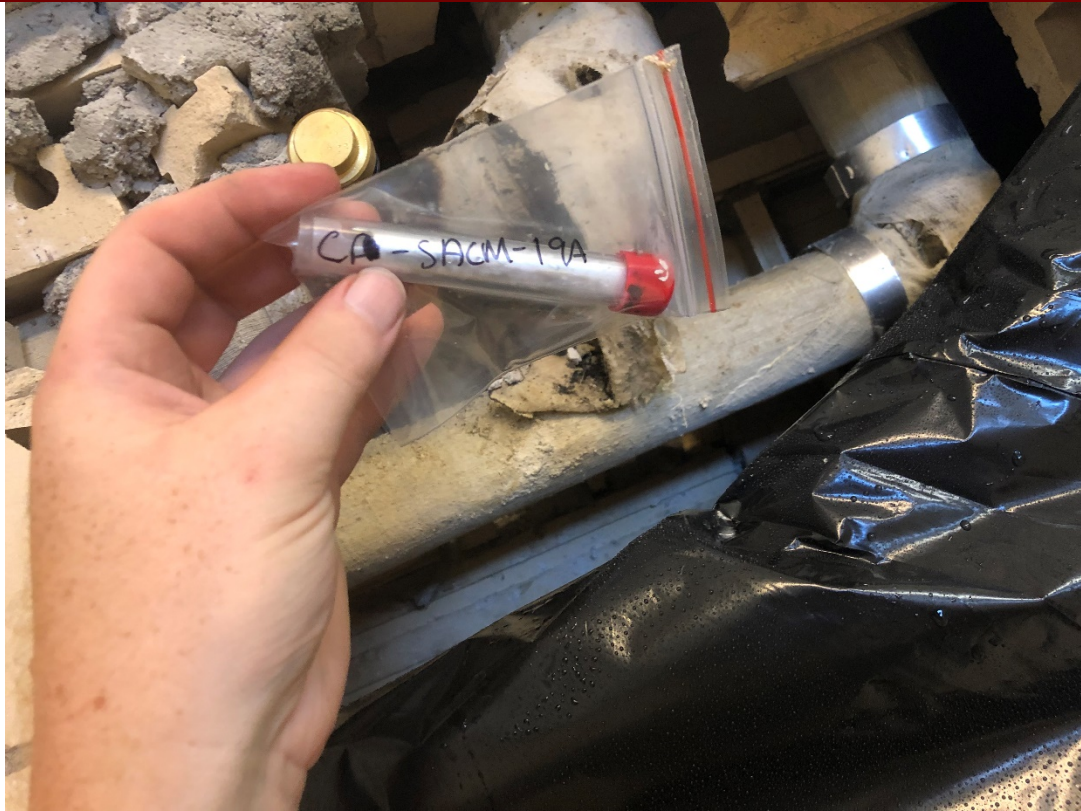
19. View of CA-SACM-19, pipe insulation, layered paper (Room GL-1)

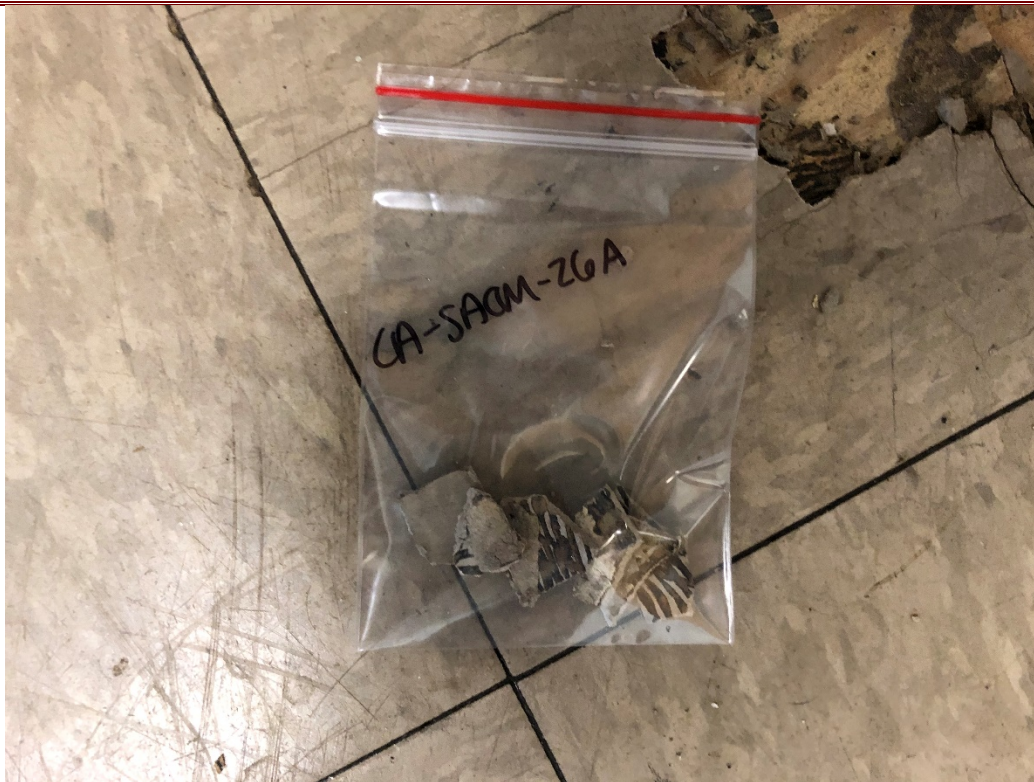
20. View of CA-SACM-26, 12" floor tile, off-white (Gym)

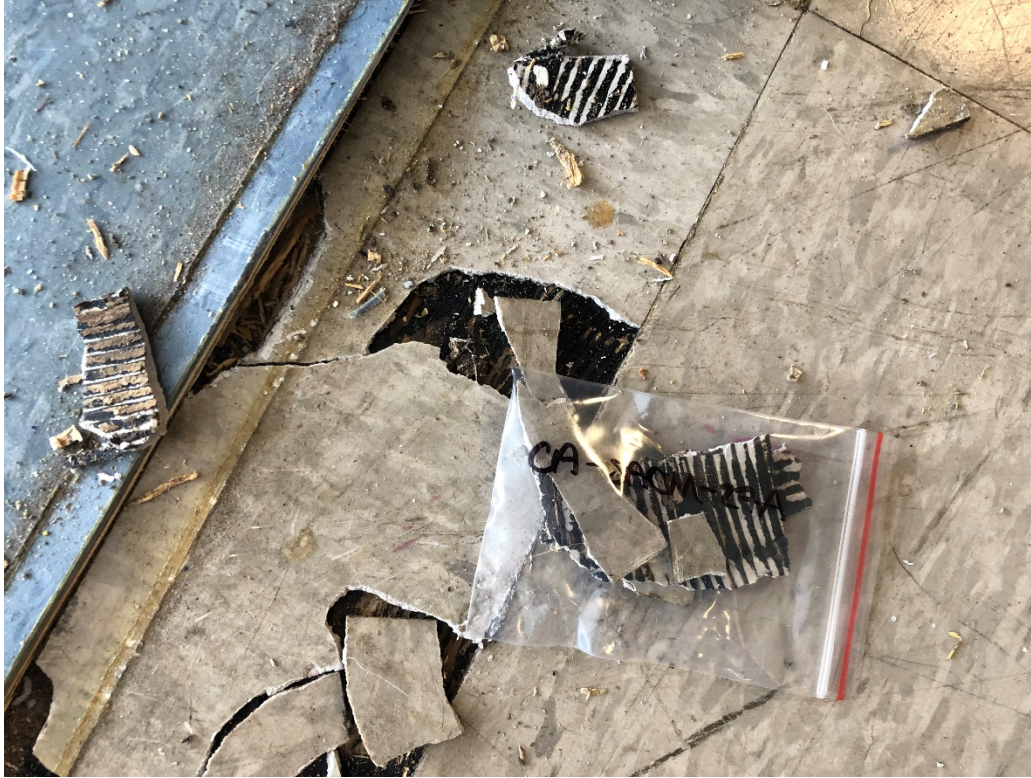
21. View of CA-SACM-27, mastic, black (Rooms C1-1 and C2-3)

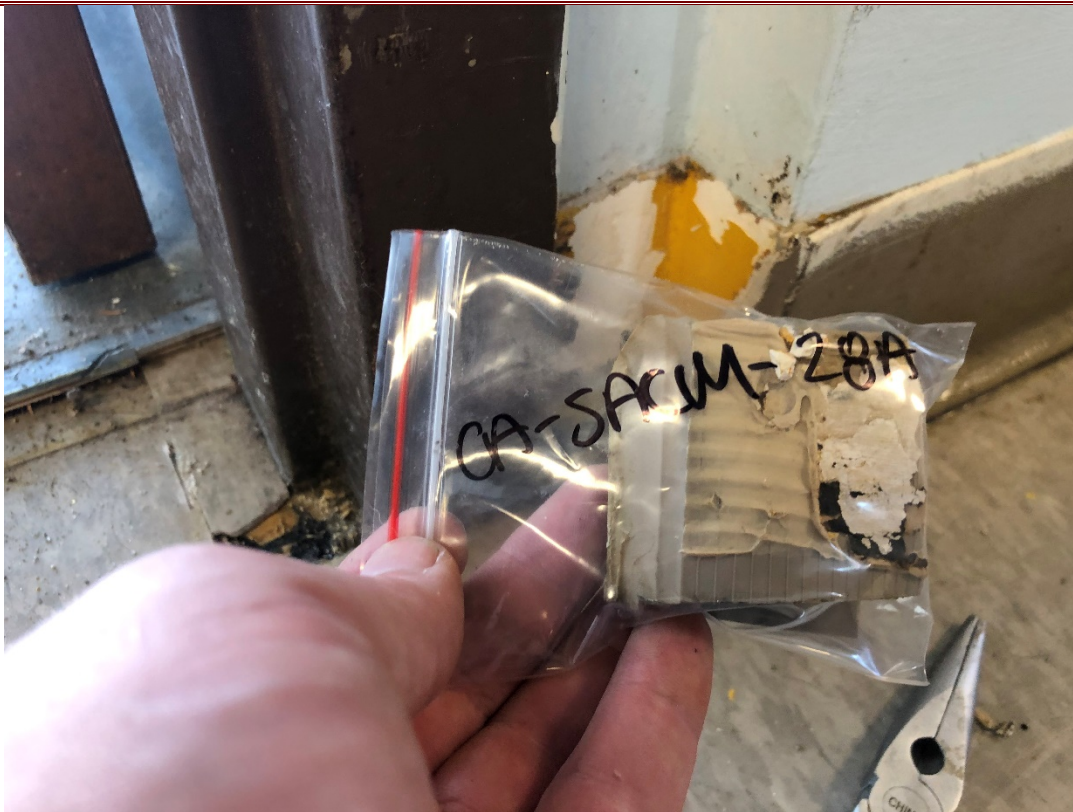
22. View of CA-SACM-28, base adhesive, cream (Rooms C1-1 and C2-3)

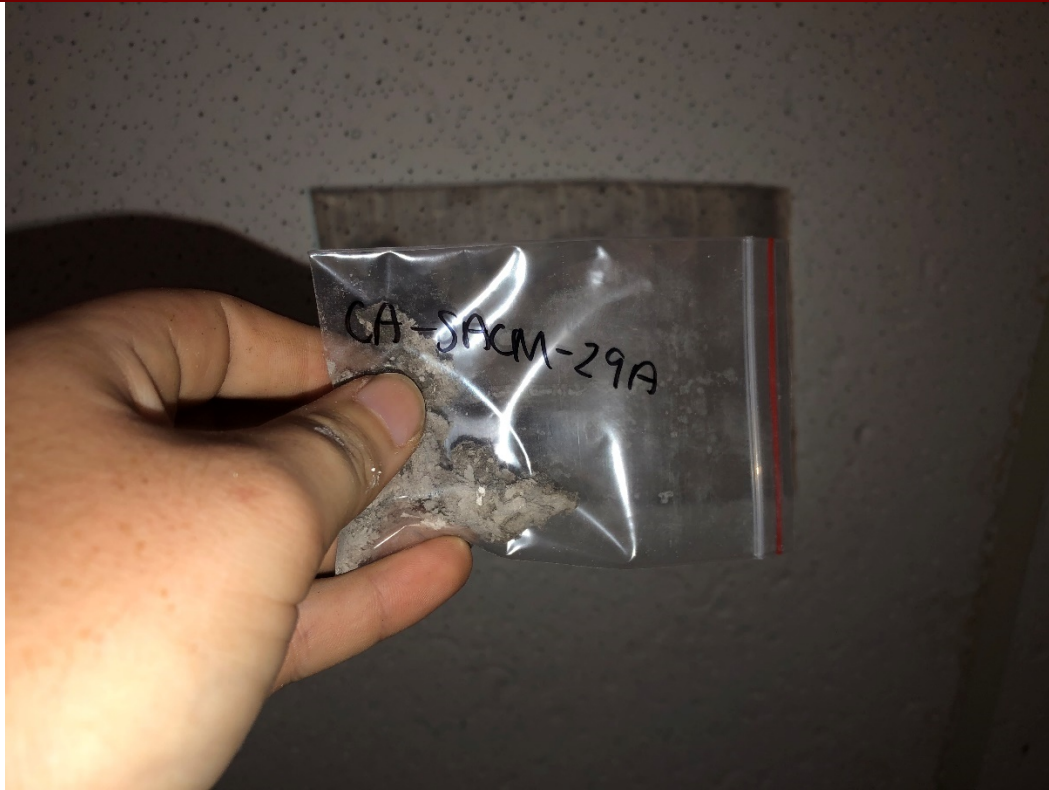
23. View of CA-SACM-29, 2x 3 ceiling tile with dents and dots (Rooms C1-1 and C2-3)

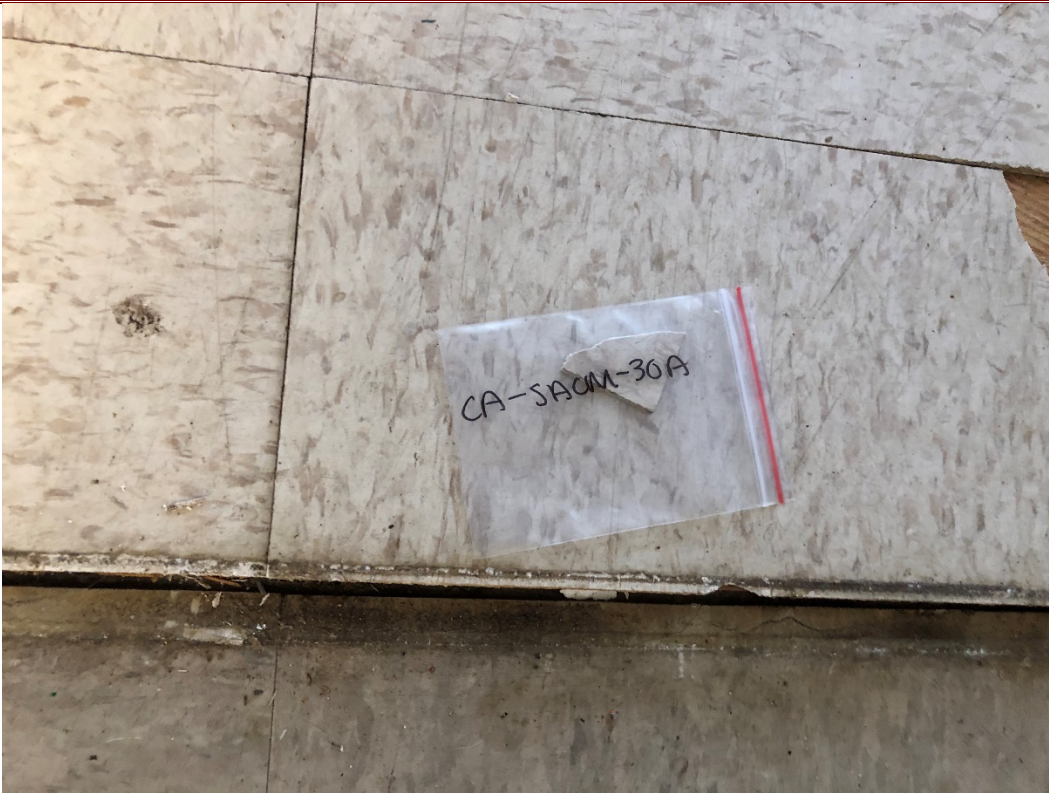
24. View of CA-SACM-30, 12" floor tile, cream (Rooms 24 and 36)

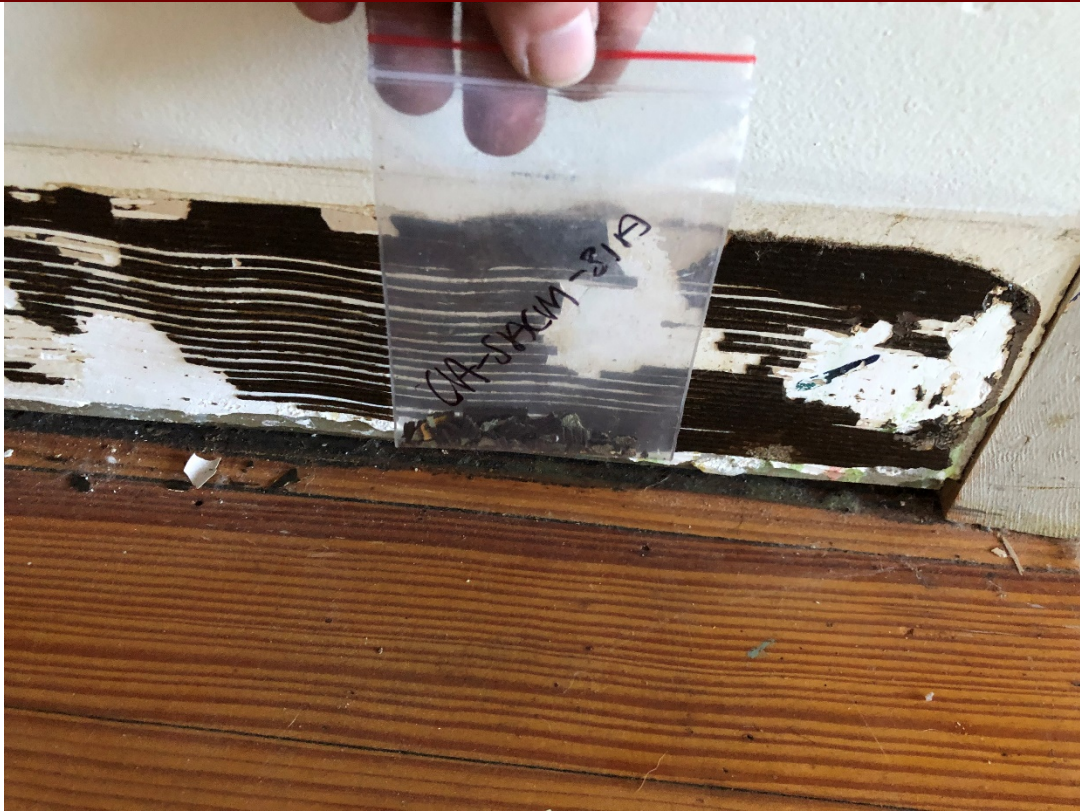
25. View of CA-SACM-31, base adhesive, black (Rooms 25 and 36)

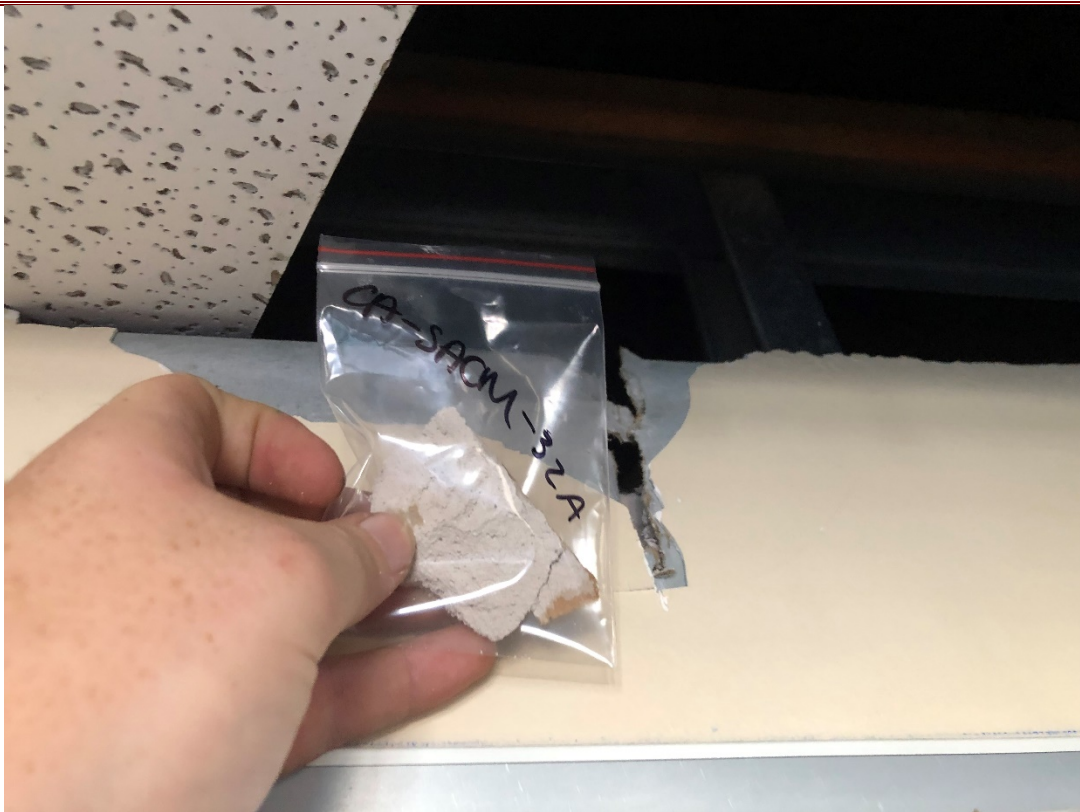
26. View of CA-SACM-32, sheetrock, light gray (Rooms L1-1 and 30)
