**Subject: Phase II Environmental Site Assessment, Rev 1  
Brown School - 42 Milk Street  
Newburyport, Massachusetts 01950**

# **Phase II Environmental Site Assessment, Rev 1**

**Brown School  
42 Milk Street  
Newburyport, Massachusetts**

**Appendix B – Photo Log**  
**Brown School**  
**42 Milk Street, Newburyport, Massachusetts**

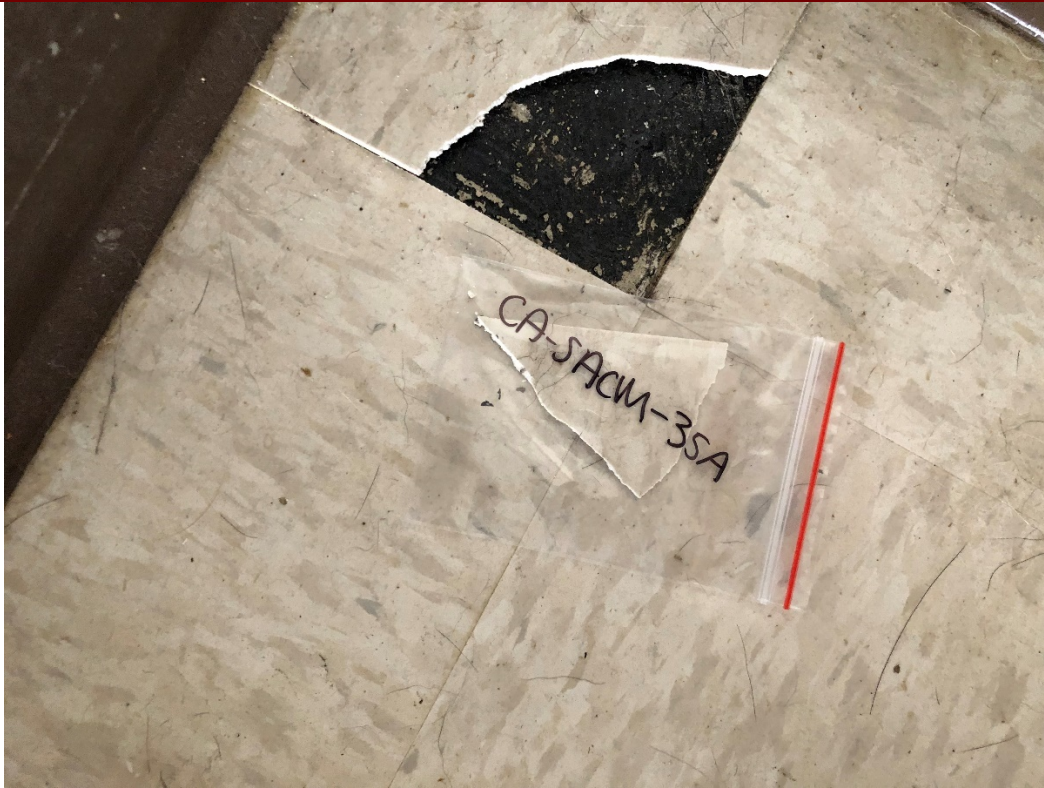
27. View of CA-SACM-34, 12" x 12" floor tile, white (sample mis-labelled in field)  
(Room M1-1)

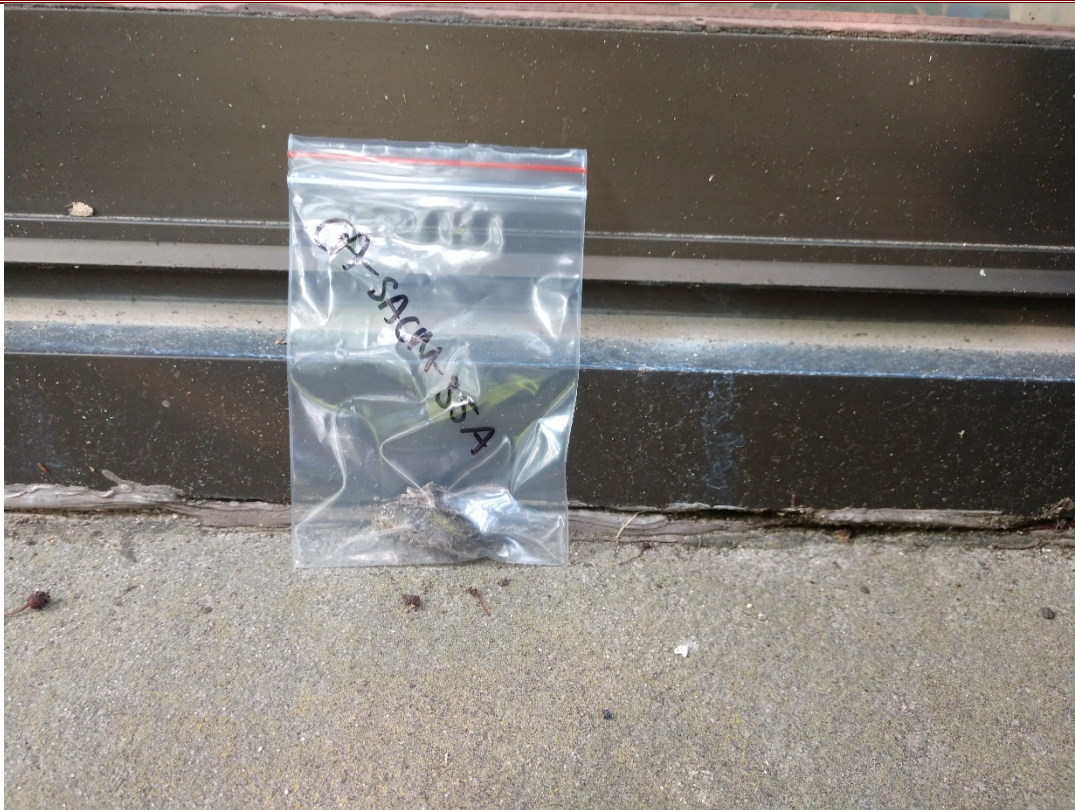
28. View of CA-SACM-35, caulk, dark gray – infill window to brick seam (eastern side  
A infill)

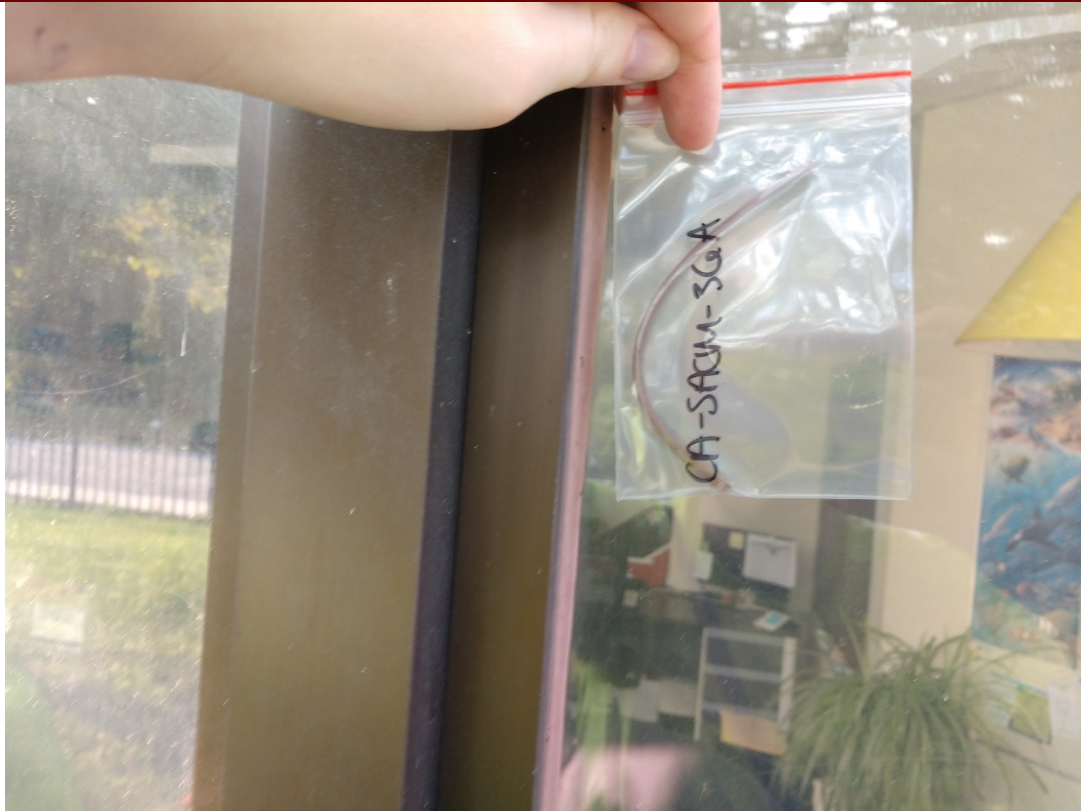
29. View of CA-SACM-36, caulk, brown/red, infill window repair (eastern side A infill)

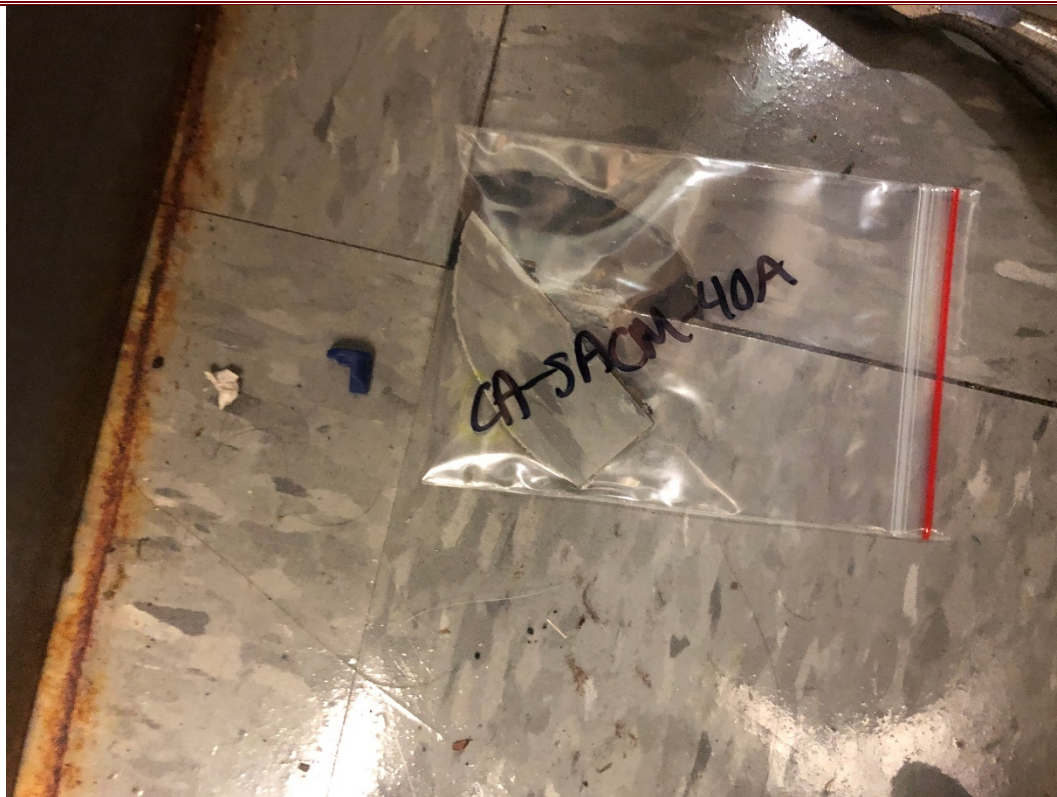
30. View of CA-SACM-40, 12" x 12" floor tile, light blue/gray and CA-SACM-41, mastic, black (Room G-1)

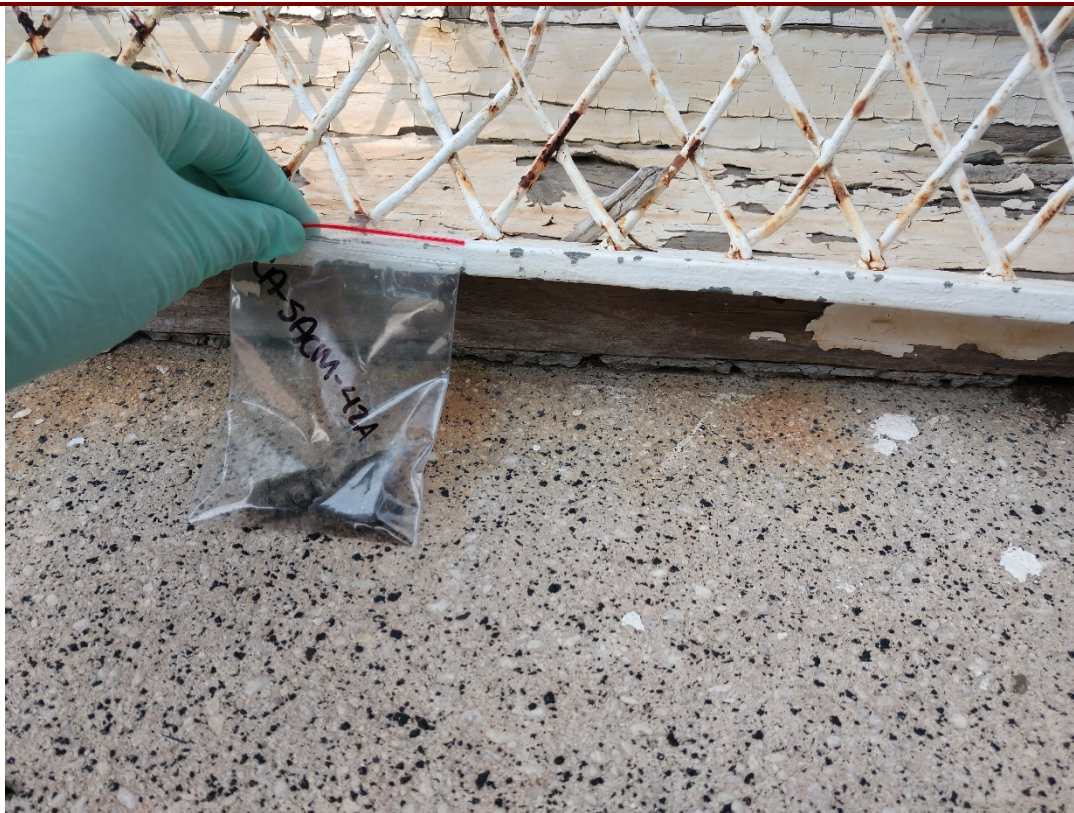
31. View of CA-SACM-42, caulk, light gray (B side exterior)

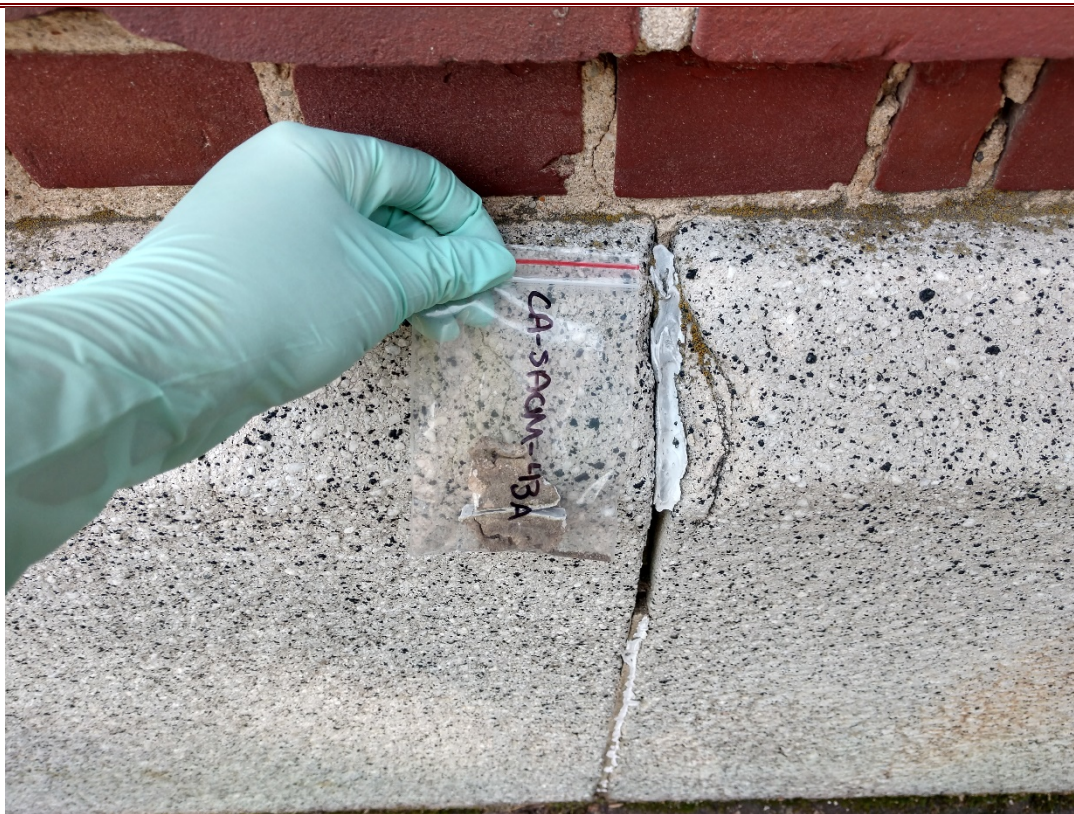
32. View of CA-SACM-43, caulk, white (B side exterior)

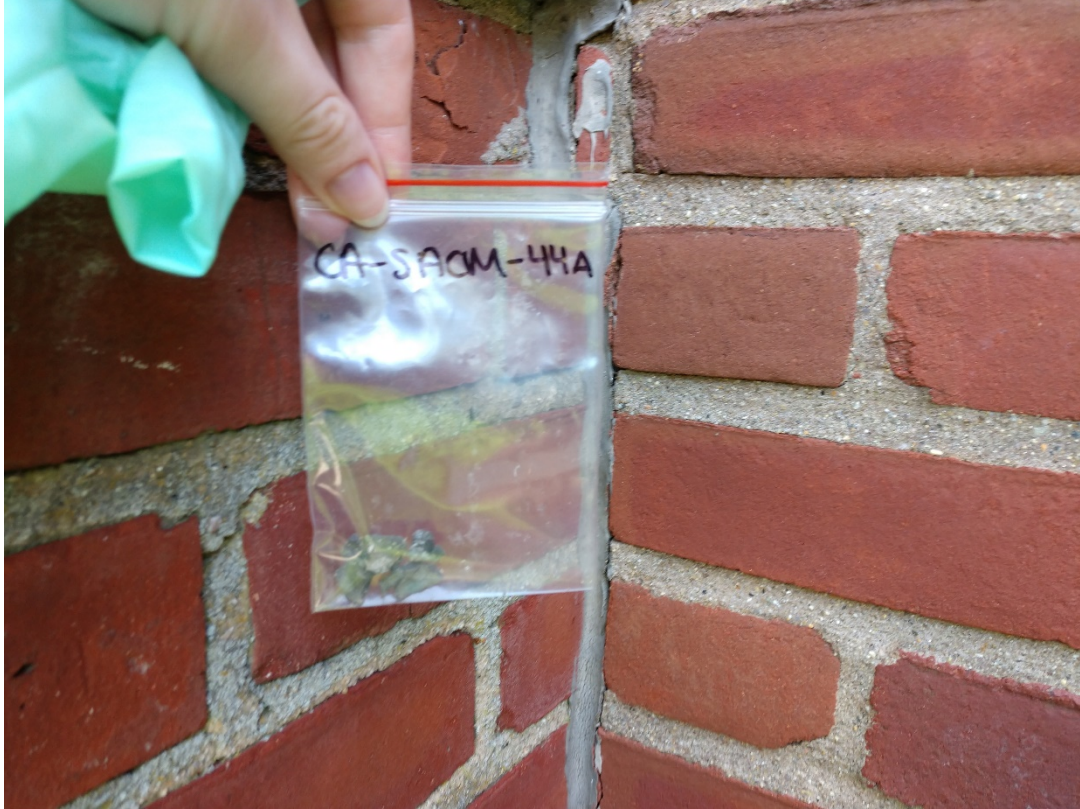
33. View of CA-SACM-44, caulk, gray – infill to original seam (A side exterior)

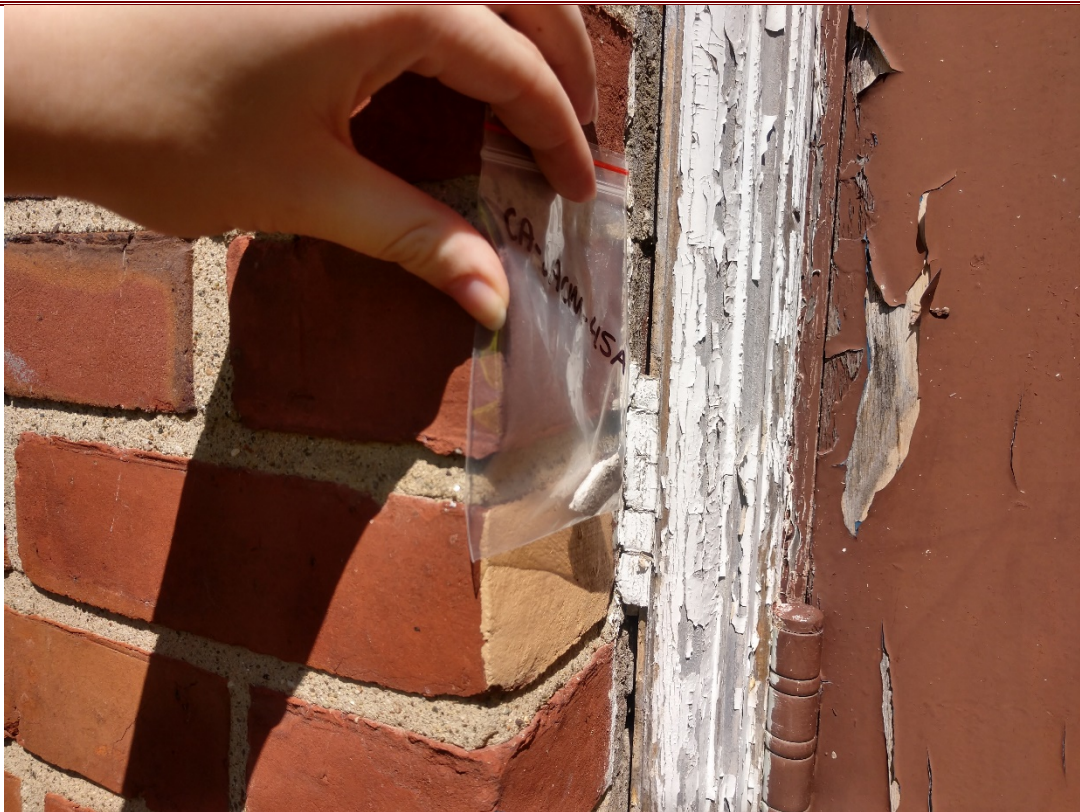
34. View of CA-SACM-45, caulk, white – gym addition doors (B side exterior)

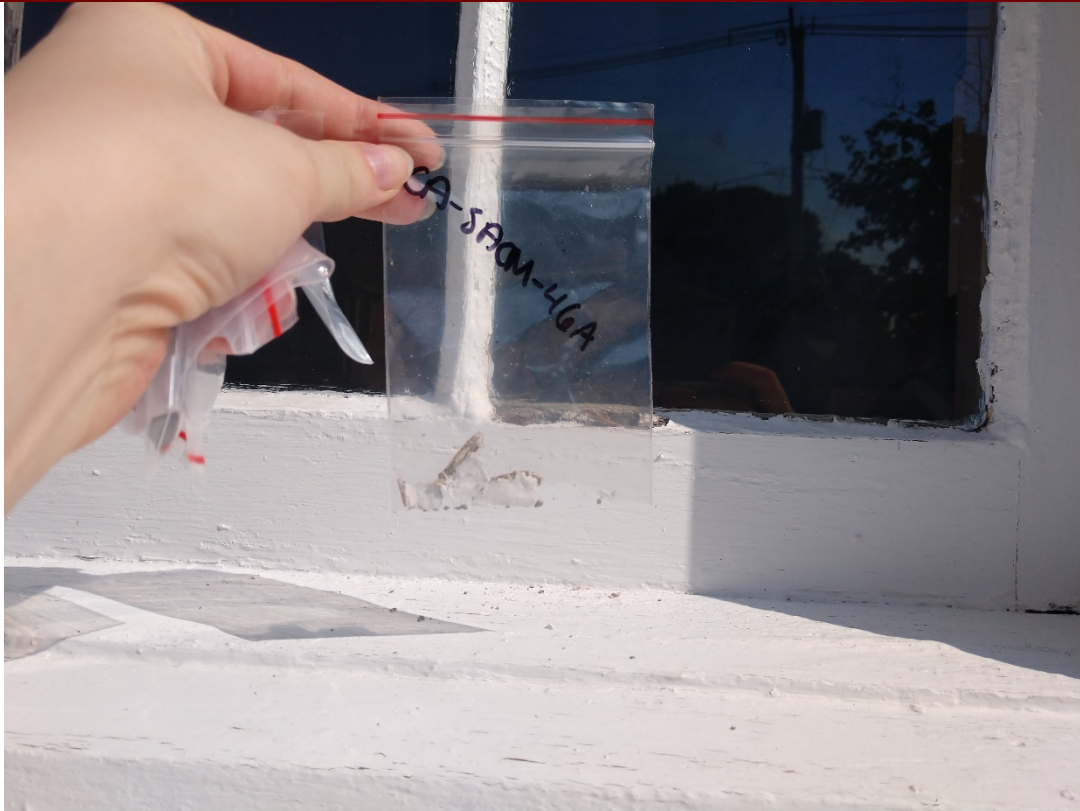
35. View of CA-SACM-46, caulk, white – gym addition windows (D side exterior)

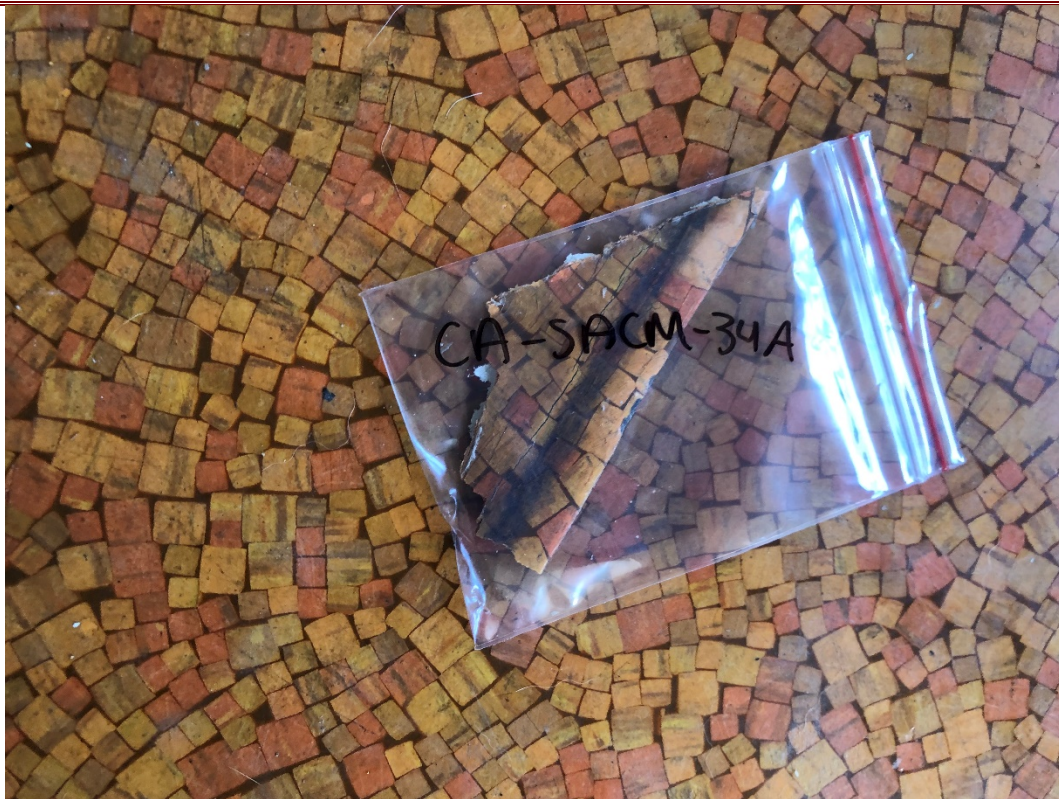
36. CA-SACM-48, linoleum, orange swirly square pattern (misabeled in field) (Room M1-1)

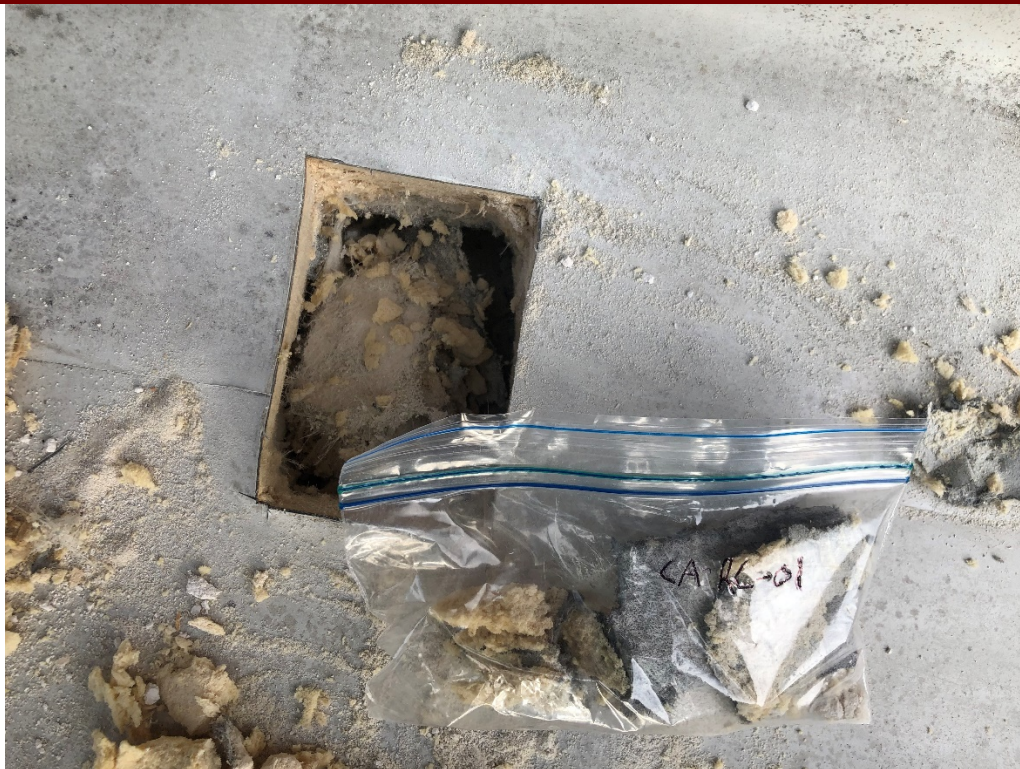
37. Representative view of roof cut

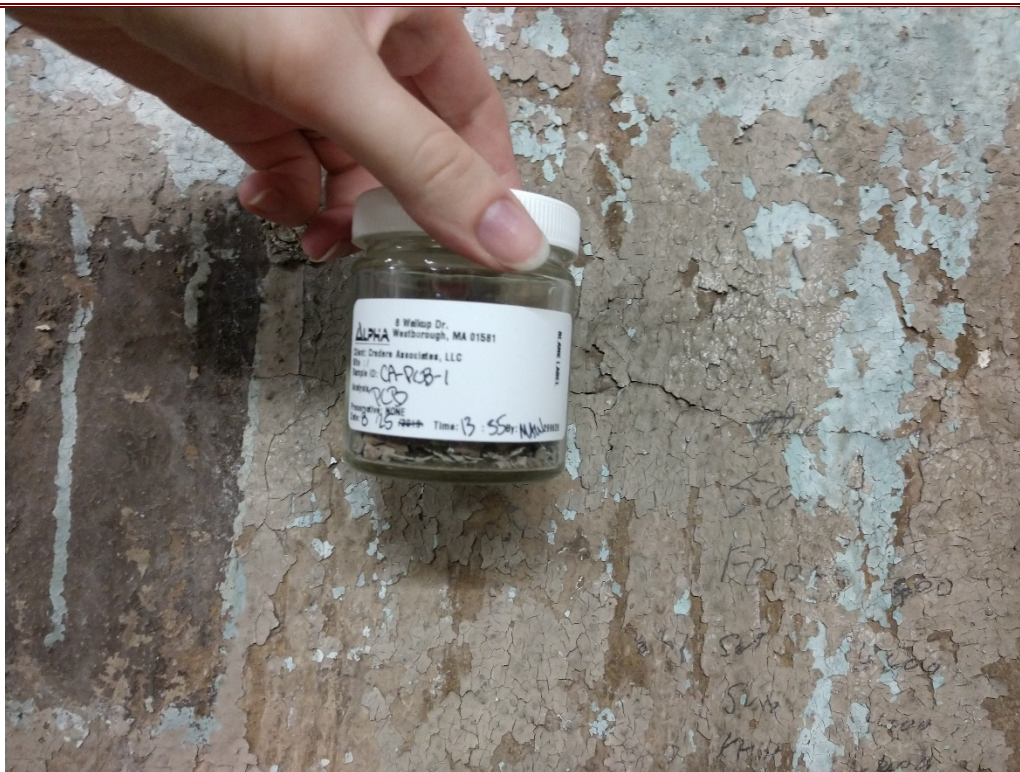
38. View of CA-PCB-1, paint, gray over light blue (boiler room)

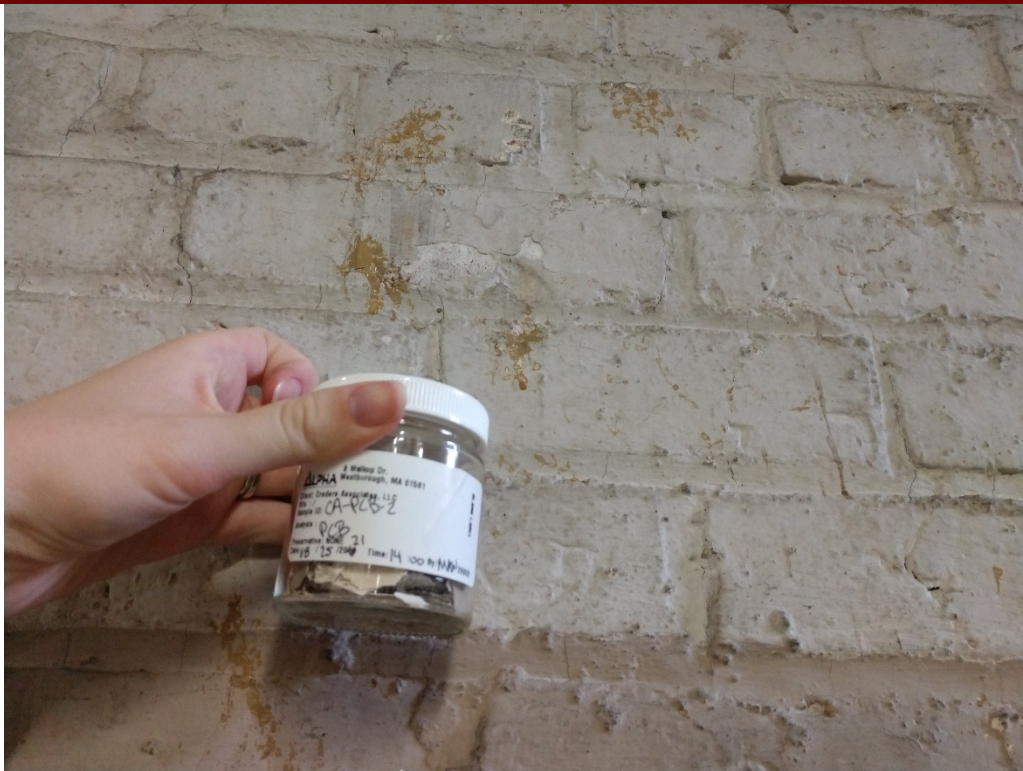
39. View of CA-PCB-2, paint, gray (boiler room)

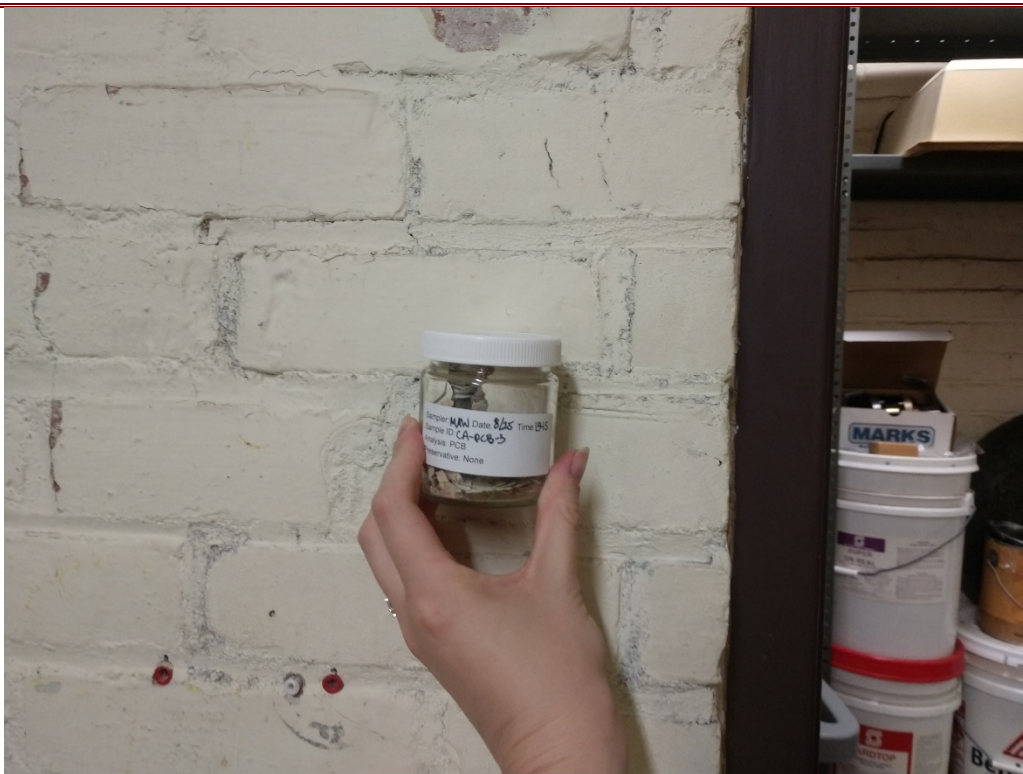
40. View of CA-PCB-3, paint, light yellow (Room J-3)

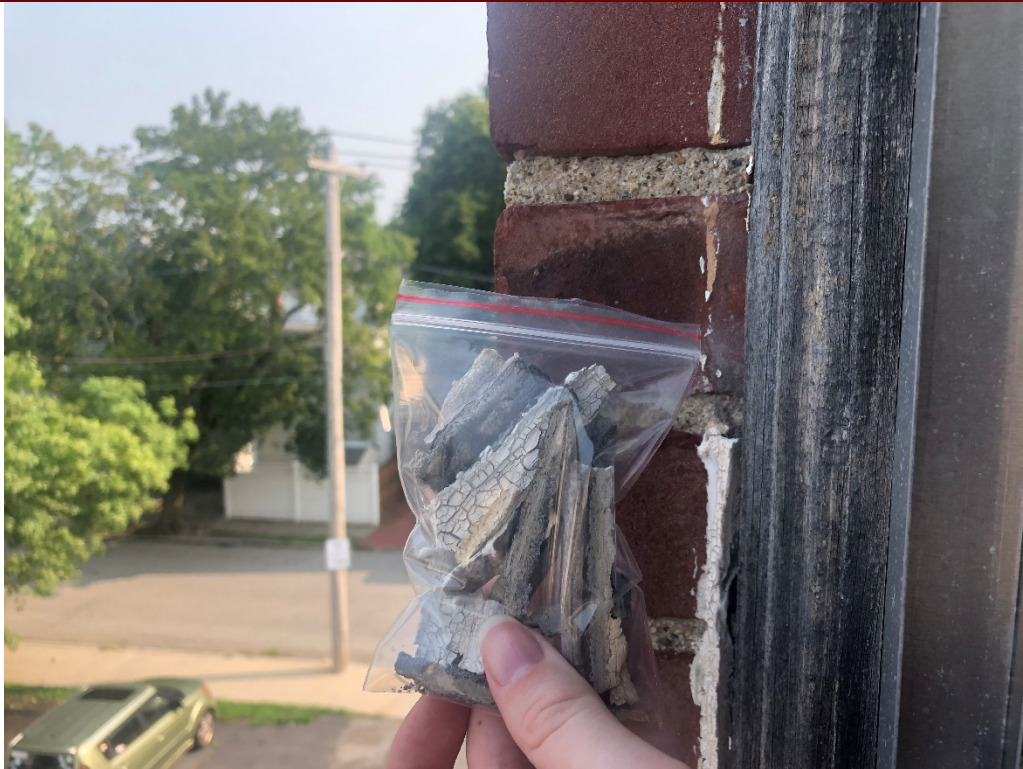
41. View of CA-PCB-7, caulk, white (original window exterior)

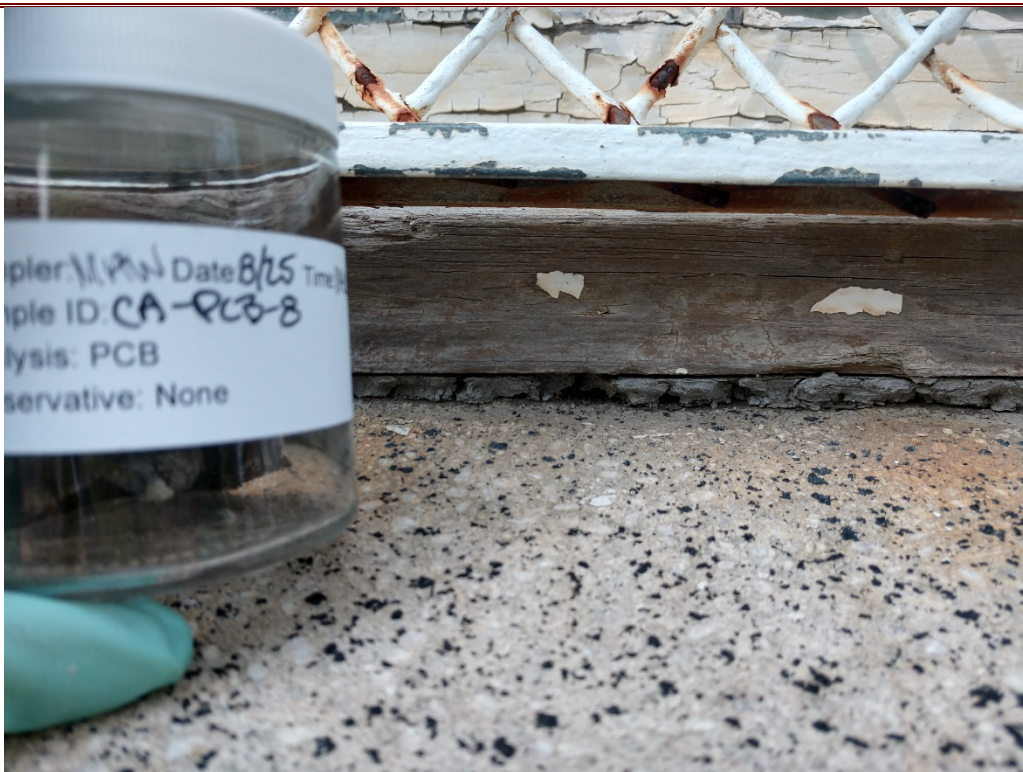
42. View of CA-PCB-8, caulk, light gray (B side exterior)

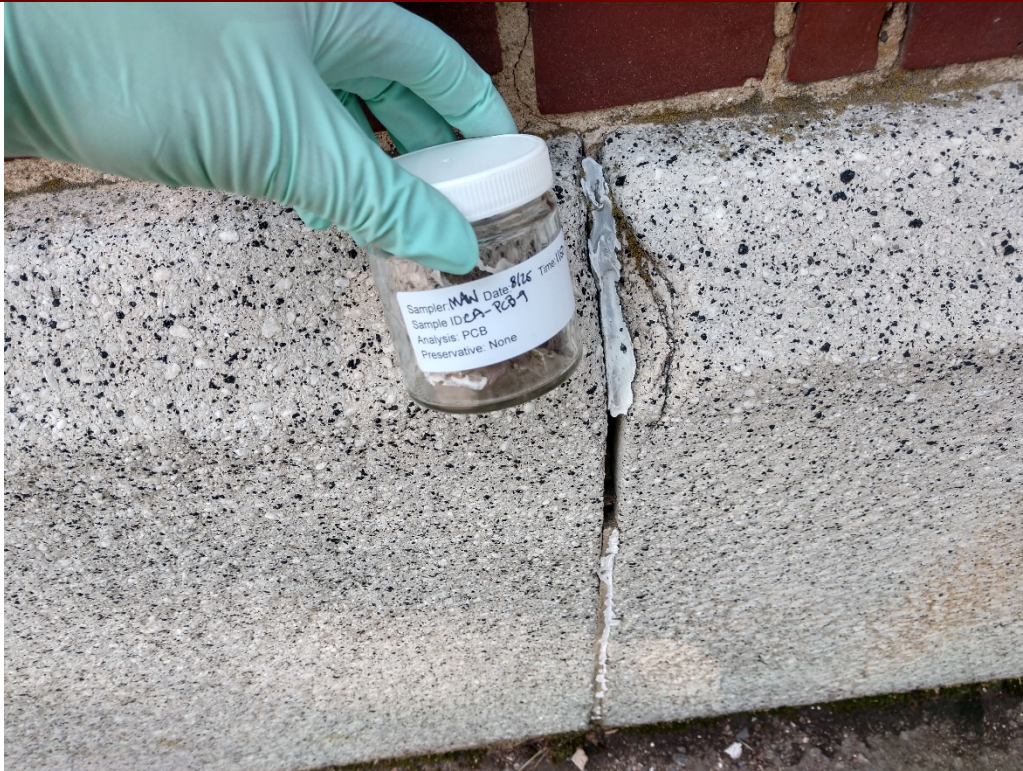
43. View of CA-PCB-9, caulk, white (B side exterior)

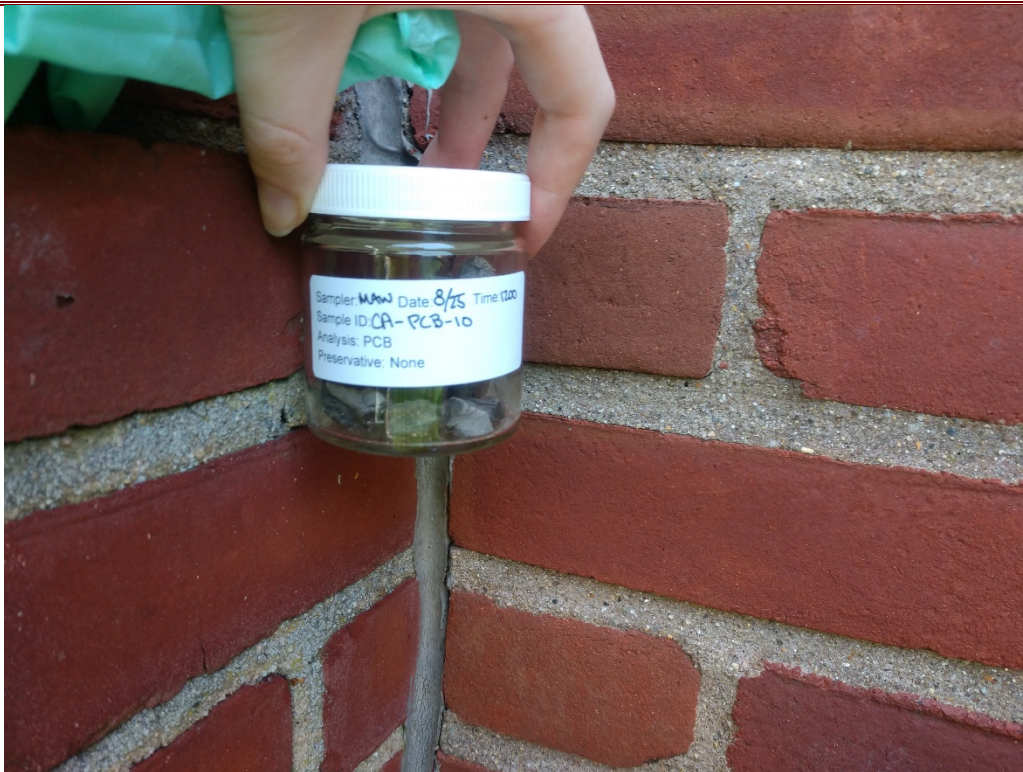
44. View of CA-PCB-10, caulk, gray (A side exterior)

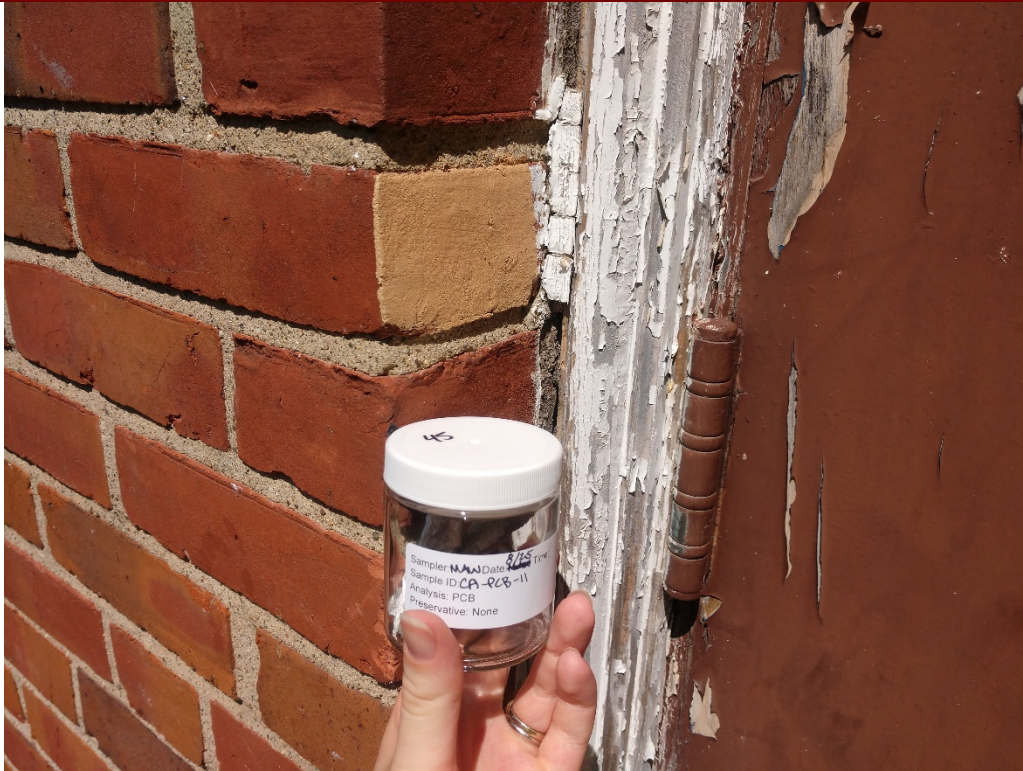
45. View of CA-PCB-11, caulk, white (Gym doors)

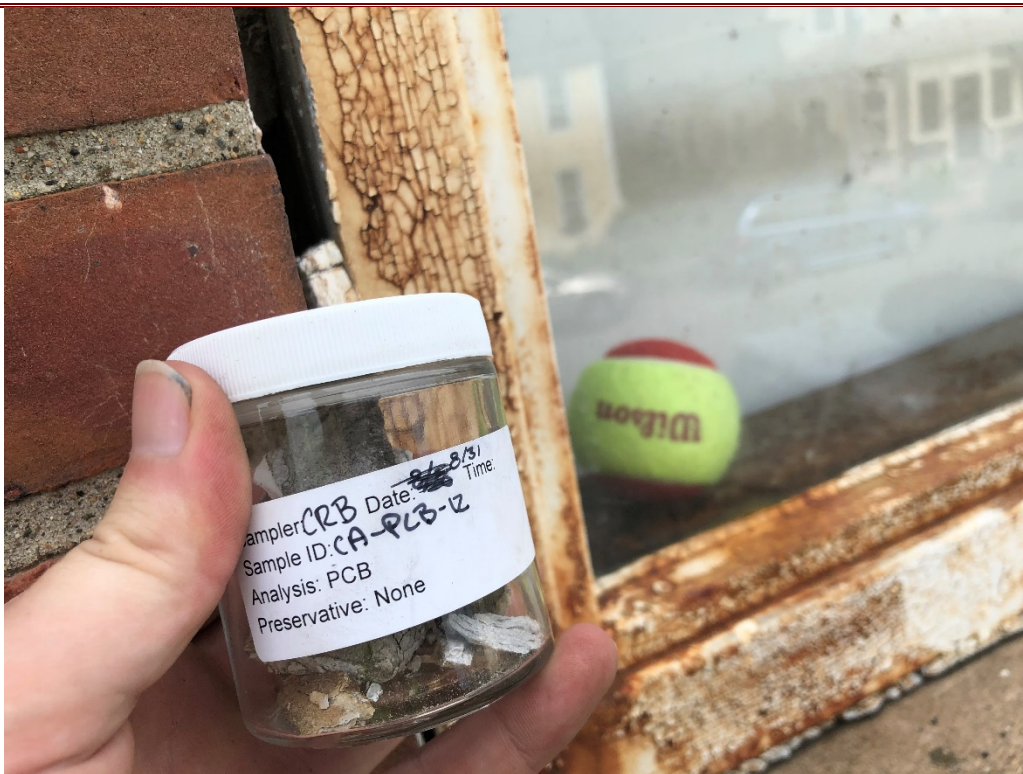
46. View of CA-PCB-12, caulk, white (Gym windows)

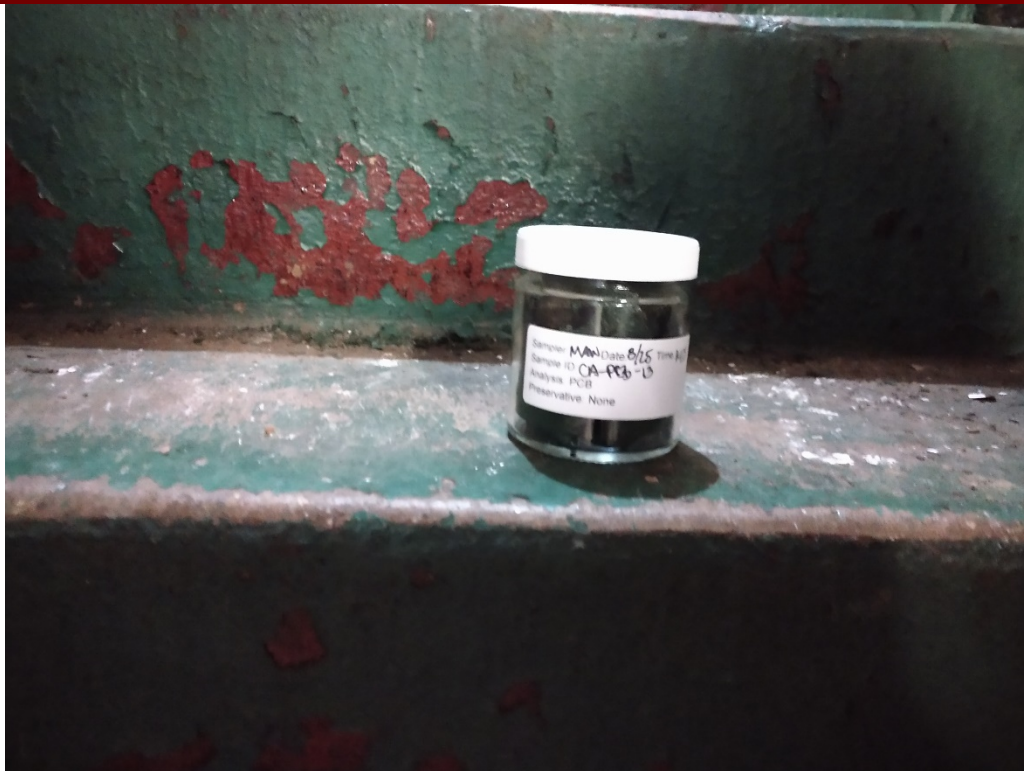
47. View of CA-PCB-13, paint, green (Boiler room)

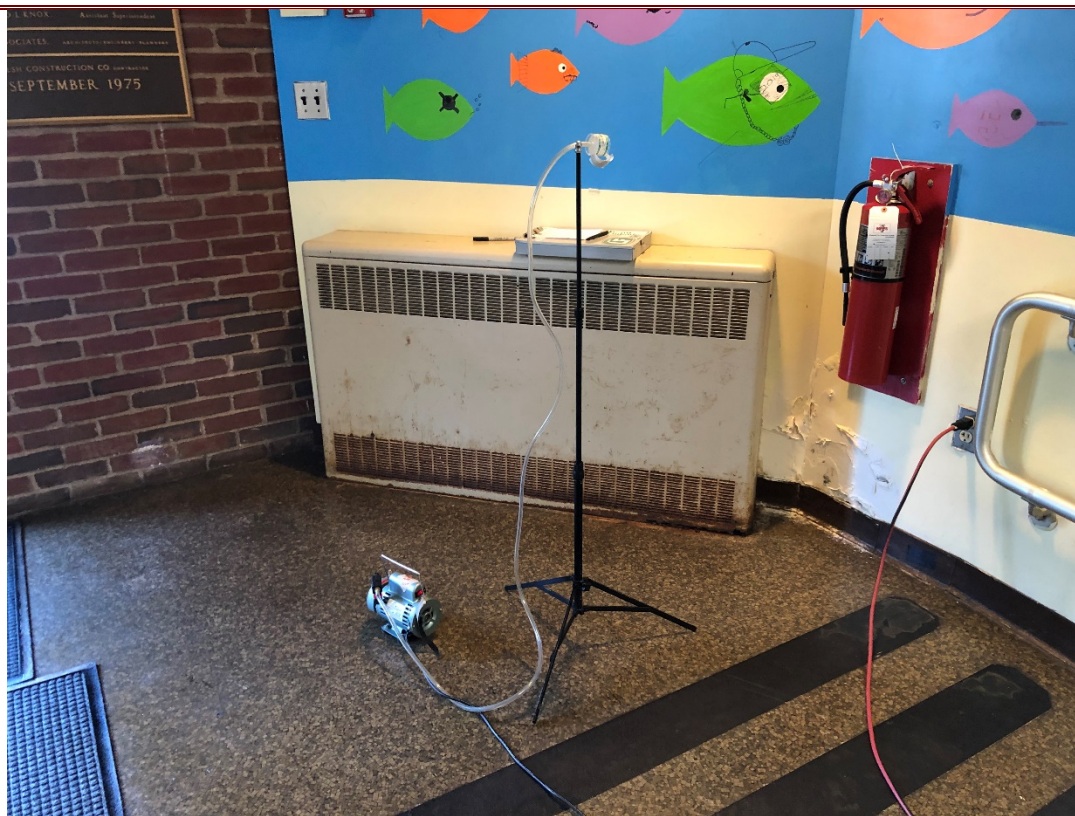
48. View of air sampling setup for mold sample collection

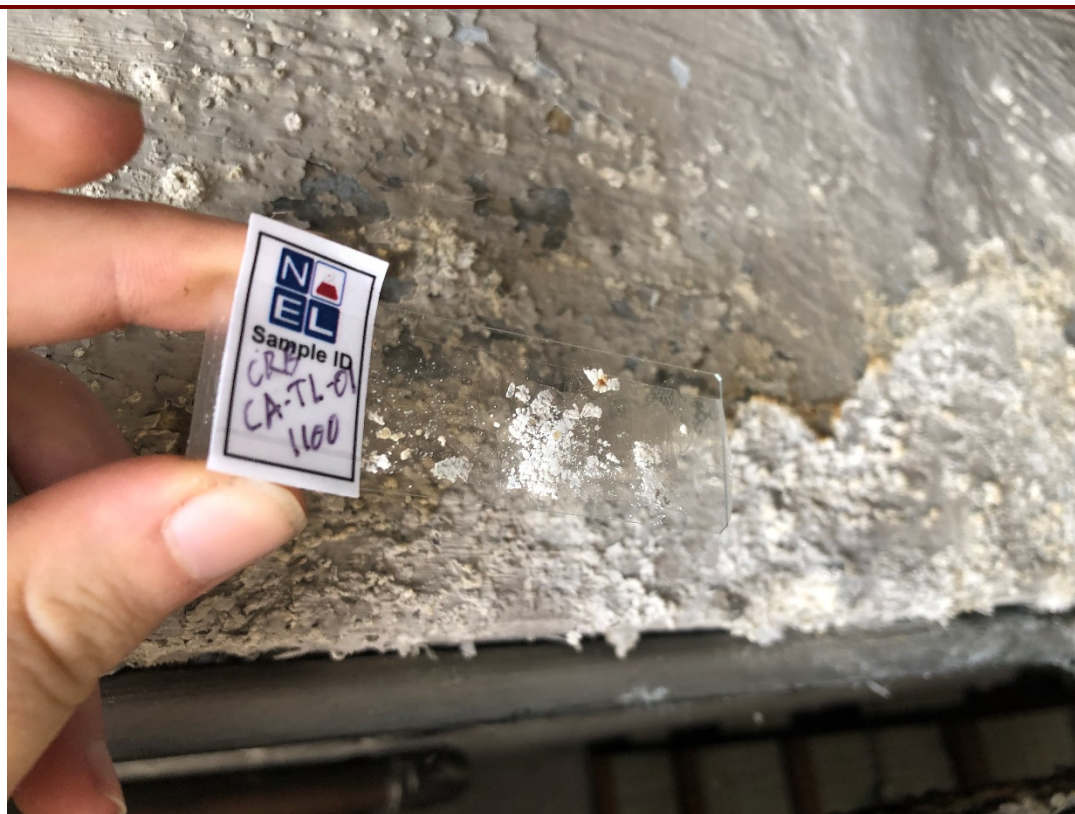
49. View of tape lift sample for mold
