NEWBURYPORT YOUTH SERVICES

FACILITY ASSESSMENT & PLANNING STUDY

EXISTING CONDITIONS REPORT, DESIGN CONCEPTS + COST ANALYSIS

NOVEMBER 2020

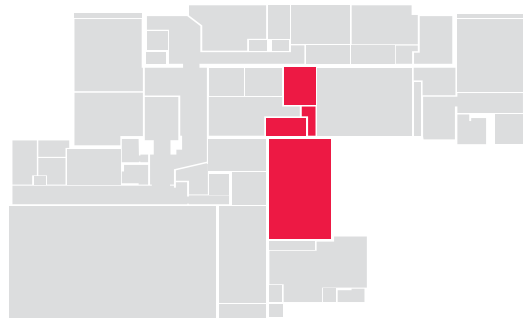
Clear signs of flooding problems are visible at here, due to the room being below ground level and relying on a sump pump system to remain dry. This system will have to be addressed with any upgrades to the mechanical equipment.

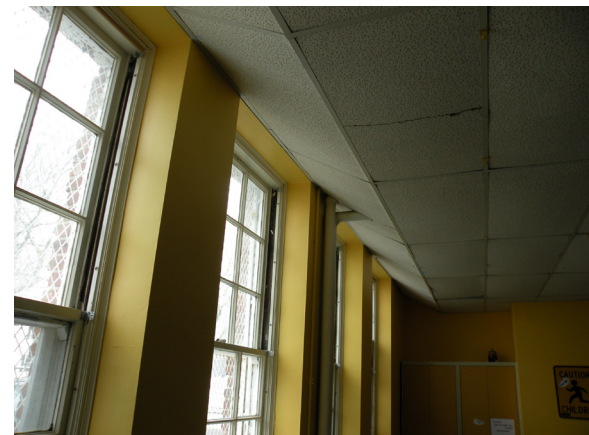
ACT ceiling and floors needs replacement

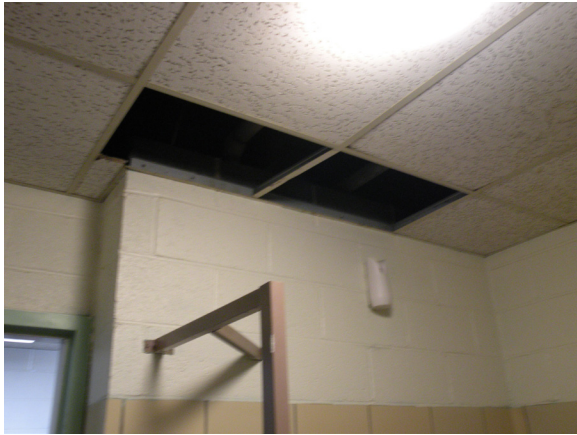
Ceiling tiles need replacement

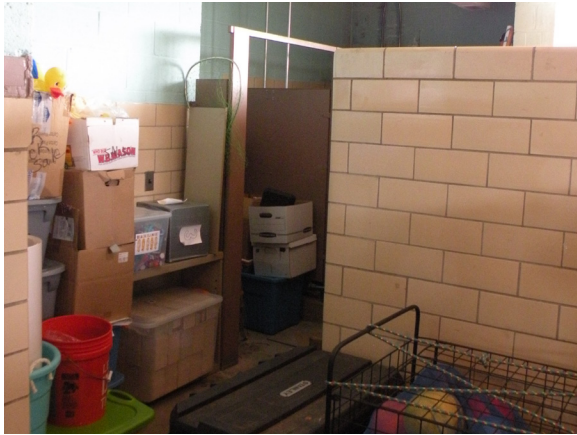
Restroom stalls are not used or accessible

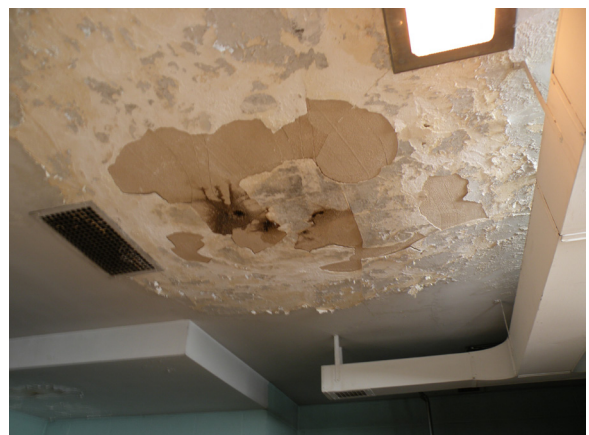
Moisture damage in the ceiling

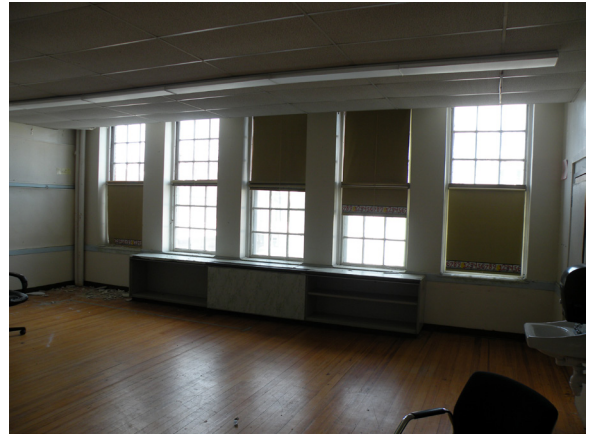
Damaged windows by balls in the play area

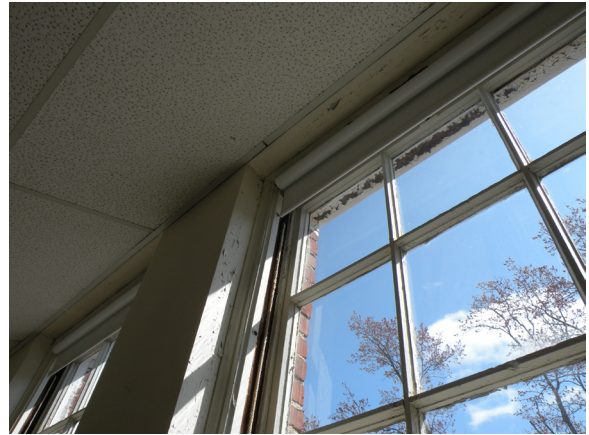
Condition at original building windows

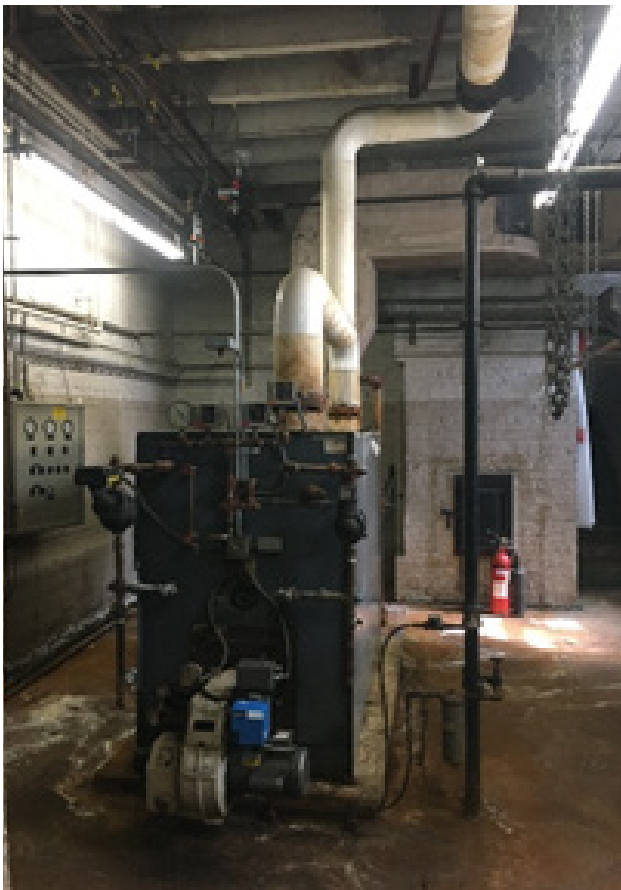
Existing Steam Boilers

Combustion air for the boiler room is provided through a combustion air louver. Breeching for the boiler is welded black steel construction and the breeching is insulated with what appears to be calcium silicate insulation with a canvas jacket. Some sections of the breeching are uninsulated which is non code compliant. The breeching discharges to a masonry chimney which appears to require some repairs. The condition of the chimney liner was not observed during this site visit as the boiler plant was in operation. However, given the age of the chimney, chimney liner repairs and/or replacement with a new internal liner are likely required. The boiler breeching shows signs of rust and corrosion,

and generally appears to be in poor physical condition.

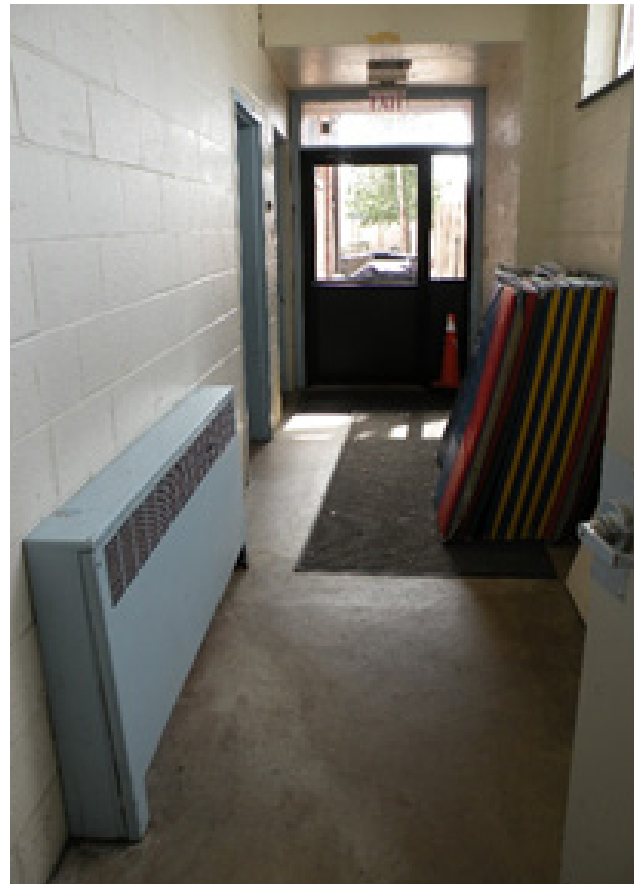
Ground Level Hallway Convactor

wall of each classroom. These units are provided with outside air drawn from a wall mounted louver and return air is drawn directly at the base of each unit. The ground floor classroom unit ventilators have outdoor air ducts that are extended to outdoor air louvers that are located at a slightly higher elevation than the floor mounted unit ventilators. Classrooms are provided with exhaust air registers that are connected to a sheetmetal exhaust ductwork system. In general, all classroom unit ventilators

and exhaust systems appear to be in poor condition, beyond their useful expected service life and are in need replacement.

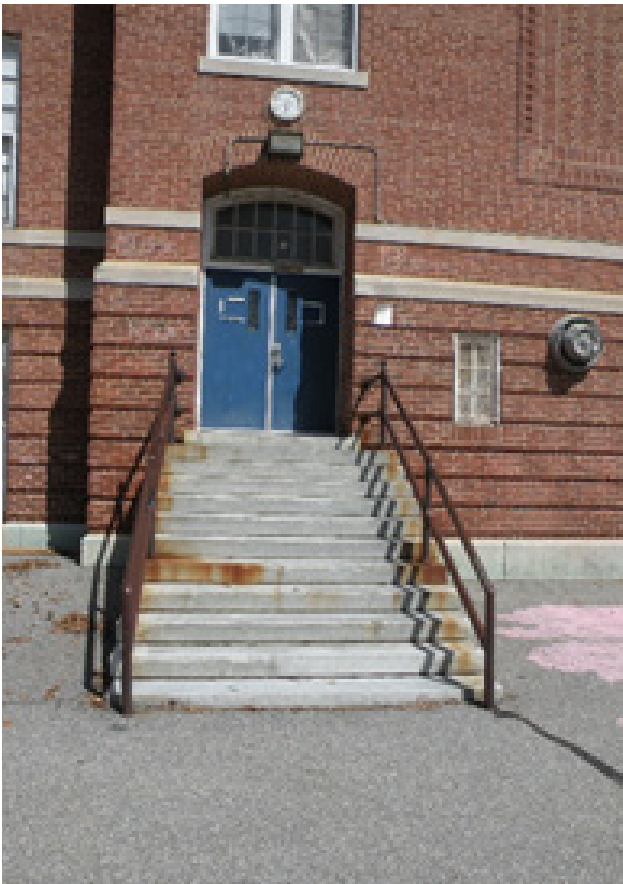
Ground Level - Damaged Sidewall Exhaust Fan

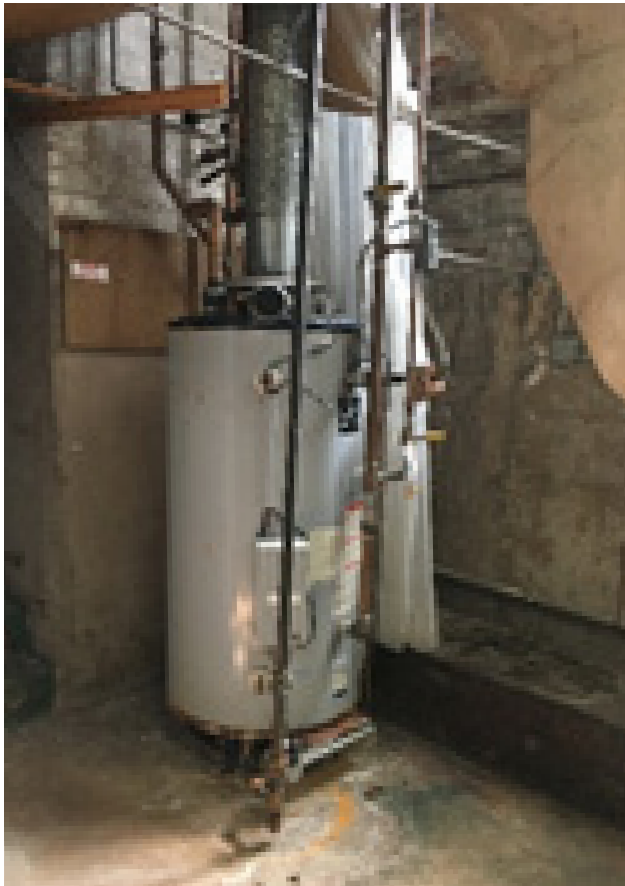
Domestic Water Heater

Domestic hot water is generated through a gas fired tank type water heater. The water heater has an input of 199,000 BTUH and 80 gallon storage. The hot water system is recirculated. There is no thermostatic mixing valve on the systems to prevent scalding. Water heater was manufactured in 2008 and is near the end of its

useful life and showing signs of corrosion.
