**CITY OF NEWBURYPORT  
BUILDING DEPARTMENT**

**Building Department Memo**

RE: 107 State Street

Date: September 24, 2021

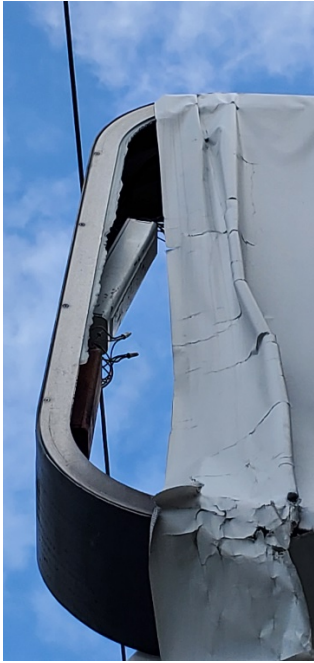
1. The pole mounted sign on State Street has an interior electrical ballast which is not secured properly and may become dislodged and fall to the pedestrian sidewalk below. (III. 1)  
The temporary protective fabric covering of the sign body has become unattached in multiple areas and may dislodge and become airborne. (III. 2)

**International Property Maintenance Code 2021, Chapter 1, Section 111.1.5.3**

*Any portion of a building, structure or appurtenance that has been damaged by fire, earthquake, wind, flood, deterioration, neglect, abandonment, vandalism or by any other cause to such an extent that it is likely to partially or completely collapse or to become detached or dislodged.*

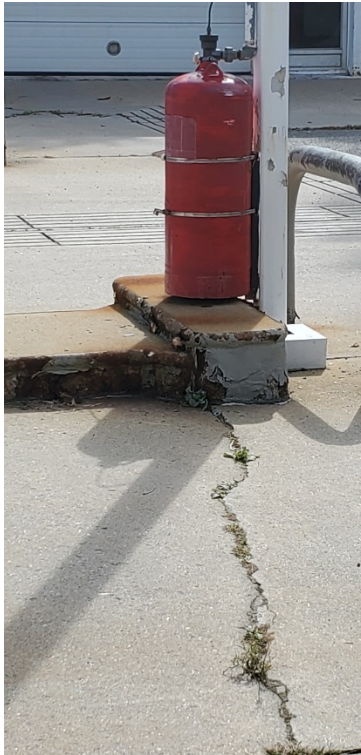
2. The concrete and steel fuel pump islands which are located in the middle of the paved lot have deteriorated to the point of exposing unattached metal and loosened concrete. (III 3 & 4)  
Red fire suppression tanks and accompanying pipes are attached to rusting supports with no preventive measures to discourage their mis-use. (III. 5 & 6)  
At the southeast corner of the lot is a wood retaining wall which shows evidence of failing. (III. 7)

**International Property Maintenance Code 2021, Chapter 1, Section 111.1.5.7**

*The building or structure is neglected, damaged, dilapidated, unsecured or abandoned so as to become an attractive nuisance to children who might play in the building or structure to their danger...or enables persons to resort to the building or structure for committing a nuisance or an unlawful act.*

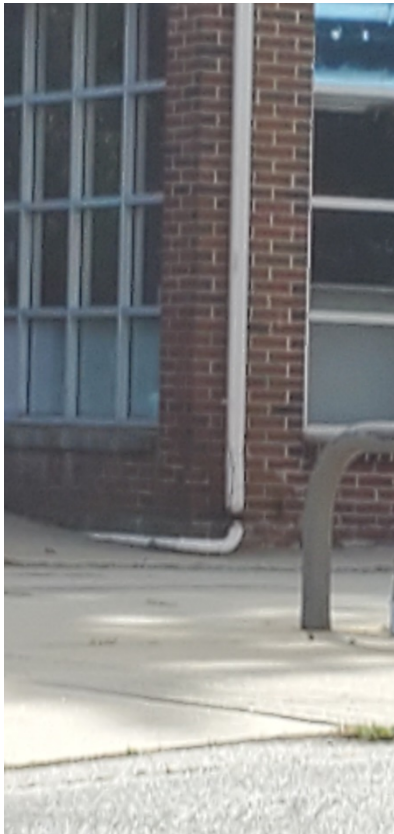
3. On the northwest corner of the building, a downspout is disconnected from the horizontal member potentially allowing rainwater to seep next to the building's foundation. (Ill. 8)

**International Plumbing Code 2015, Chapter 11, Section 1101.2**

*Rainwater from roofs and storm water from paved areas, yards, courts and courtyards shall drain to an approved place of disposal.*
