Brown School Feasibility Study - Draft

City of Newburyport
Newburyport, MA
October 1, 2014

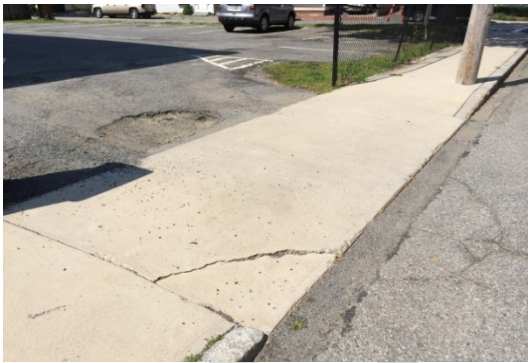
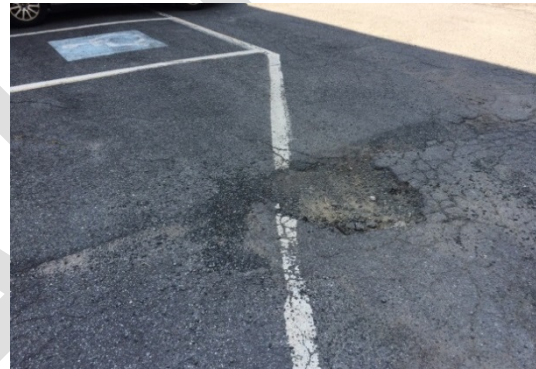
There are areas of significant pavement deterioration in the parking area in the northwest corner of the site, particularly near the Milk Street curb cut and along the accessible route from handicap parking space to Door 1. Plans for adaptive reuse should consider resurfacing the parking areas and repairing damaged concrete at the Milk Street curb cut.

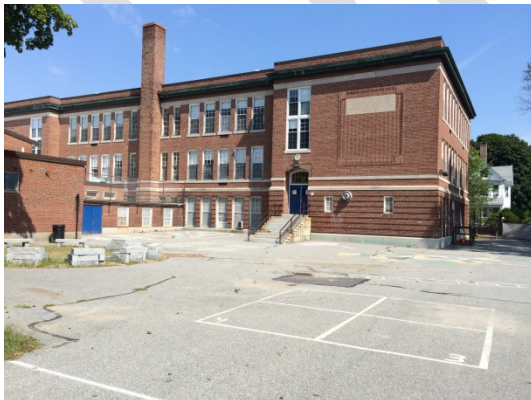
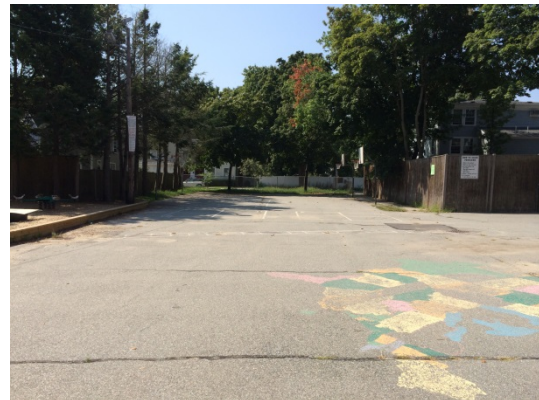
The pavement in the playground areas east and south of the building is in fair condition. There are visible cracks in some locations and patches from underground utility work. Future maintenance will be required for the surface to continue to be suitable for playground use.

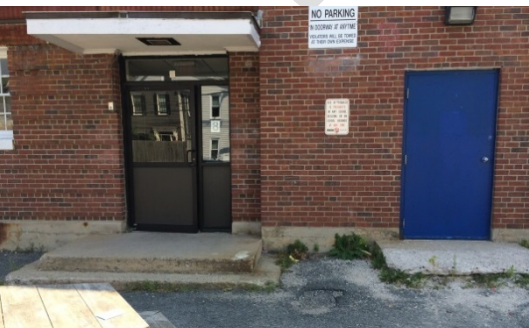
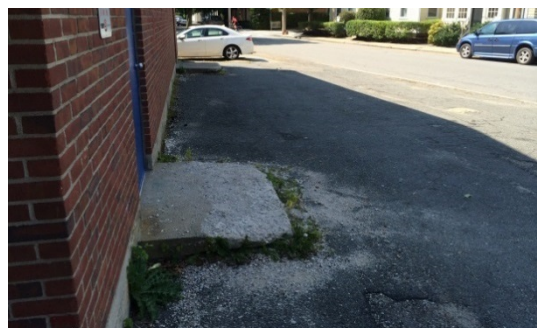
Doors 6 through 8 have concrete pads/steps that are in fair to poor condition. Most notably the concrete pad at Door 7 has fallen into disrepair and should be replaced.

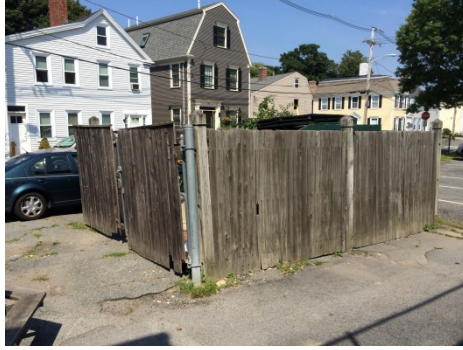
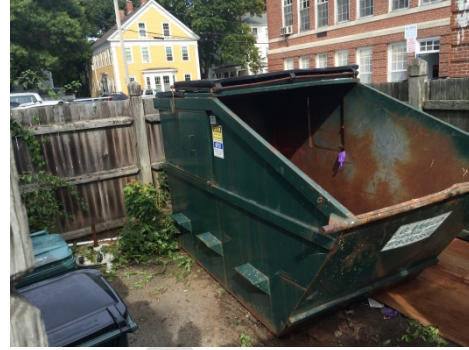
A dumpster for solid waste disposal is located along the Lime Street frontage. The dumpster is placed directly on an asphalt surface consistent with the adjacent parking areas and is surrounded by a wooden fence enclosure. The enclosure and underlying pavement are in poor conditions. Adaptive reuse plans should consider relocating the dumpster to improve the functionality and aesthetics of the parking areas in the northwest corner of the site. Regardless of the dumpster's final location, a new concrete pad and fence enclosure should be provided.

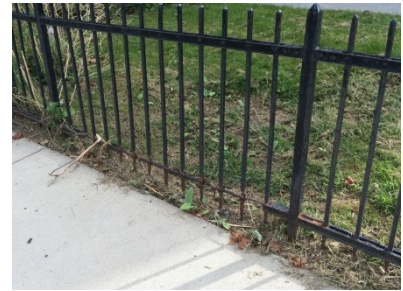
There are various fences located throughout the property. These fences include chain link fences and iron ornamental fencing near the front of the building. The ornamental fencing surrounds landscape areas and is in fair to poor condition with significant corrosion in certain locations. The chain link fence in the northeast corner of the site controlling access to the playground area from Milk Street is in good condition. A similar chain link fence controlling access from Prospect Street at the south end of the site is in fair condition and requires minor repairs.

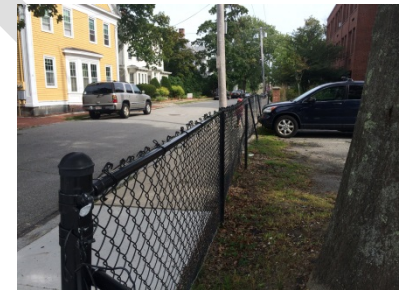
A chain link fence in the northwest corner of the site also requires minor repairs. This fence encloses only a portion of the parking area and does not provide security to the site or adequate protection to the sidewalk from vehicles on the site. The purpose of this fence should be considered with site planning for the adaptive reuse of the site and it should be replaced with guard rail, additional fencing and/or screening as appropriate.

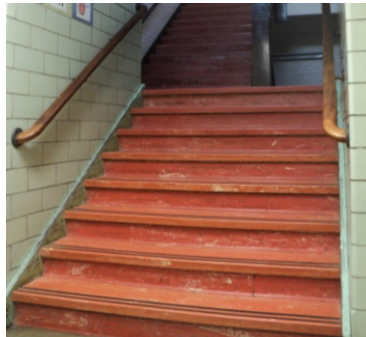
- Handrails – Compliant handrails have been added to one of the egress stairs but the other remains non-compliant. Handrails have been installed on the internal ramp but they are not continuous thereby rendering them non-compliant.

Non-compliant

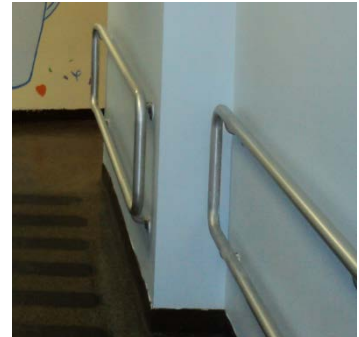
Non-compliant

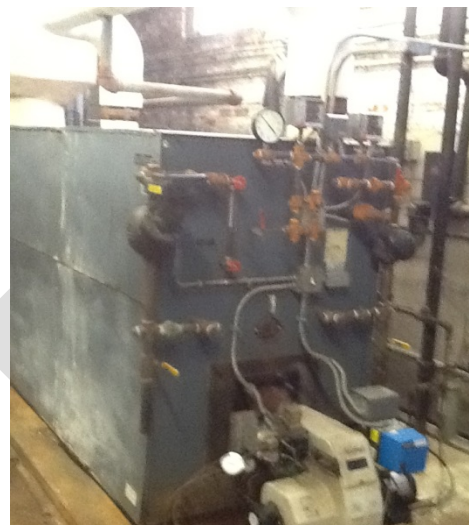
WEIL MCLAIN OIL FIRED BOILER

The heating for the building is provided from (2) low pressure steam boilers that run on No. 2 fuel oil. The boilers are piped to a common 8" steam header so that either boiler can run independent of the other and one can serve as a backup. These boilers are Weil McLean Model 88 and are rated at 3,392 MBH input/2,724 MBH output. Thus the total output capacity of the system with both boilers running is 5,448 MBH. However, one boiler should easily be able to handle the heating load for the building. The low pressure steam feeds a shell and tube heat exchanger which generates hot water. This hot water system heats the 3- story section of the building while the gym is heated with steam. The boilers are over 25 yrs old and in poor condition.

It is not recommend utilizing the existing heating and ventilation system in the new design because of its age and also due to the fact that there is no air conditioning component. A new system should be considered that would have both air conditioning and heating. A system under consideration is the The Mitsubishi Electric multi-unit system. It uses a variety of air handling units ranging from ductless ceiling units to traditional air handling units. This system uses the heat pump technology and could provide a high efficient heating and cooling system for the space and eliminate the need for the existing hot water heating system.

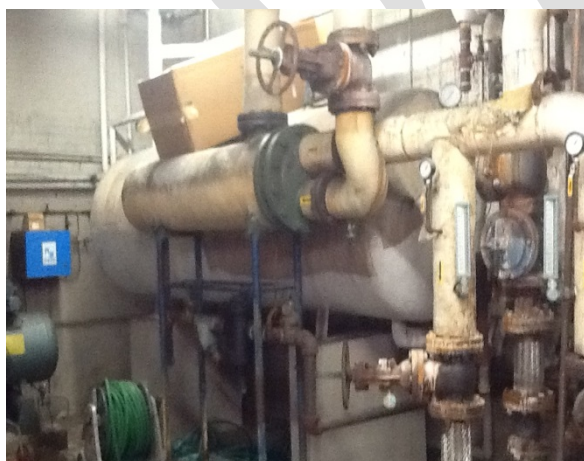
HOT WATER HEAT EXCHANGER

This hot water system was installed in 1975, thus making it almost 40 yrs old. The pumps, heat exchanger and piping are in poor condition. There have been several leaks in the hot water distribution piping recently due to age and deteriorating of the piping.

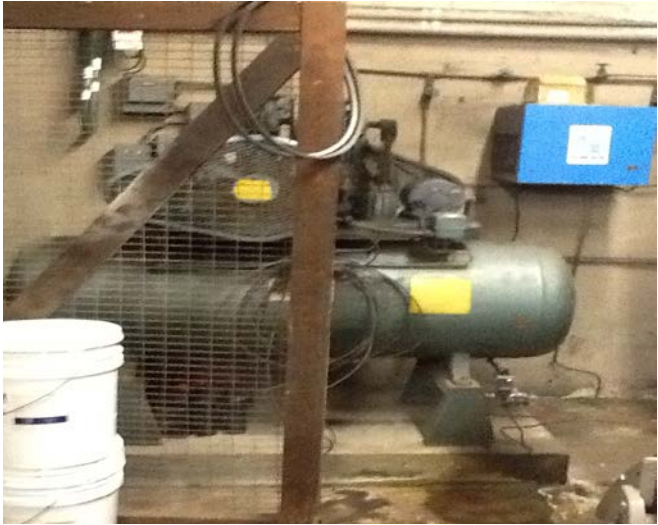
AIR COMPRESSOR FOR PNEUMATIC CONTROLS

All of the automatic temperature controls are pneumatic. The compressed air for this pneumatic system is provided by an air compressor located inside the boiler room. This control system was installed 40 years ago and is in poor condition. Pneumatic controls are no longer used except in special applications. These controls are in poor working order and if any of the existing mechanical equipment were to remain, these controls should be replaced with state of the art direct digital controls.

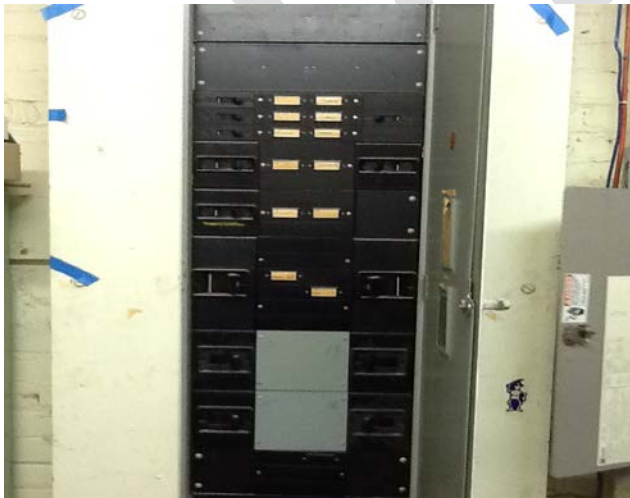
4400 AMP 120/208V-3P MAIN DISTRIBUTION PANEL MAIN SWITCH PUMPS

These subpanels provide the distribution to the lighting, mechanical equipment, and general outlets in the area it serves. Most of these panels are Westinghouse or Federal Pacific. Both of these panel types are obsolete and breakers and misc parts are no longer available. The electrical system is approximately 40 years old and in poor condition.

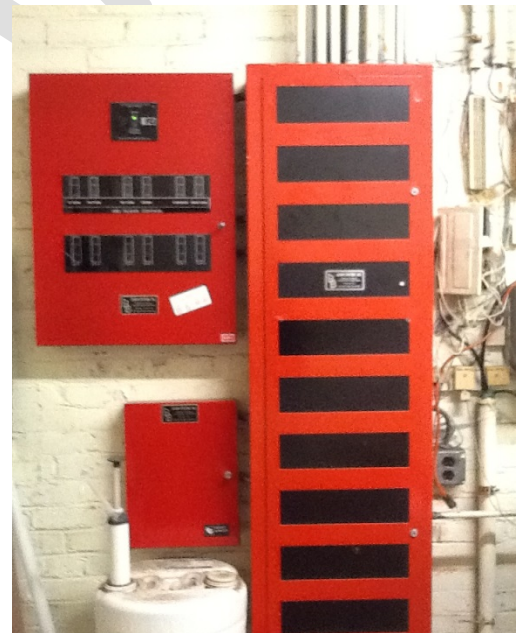
FCI MODEL FC-72 MAIN FIRE ALARM PANEL – LOCATED IN 1ST FL. ELECTRIC ROOM

Although this system may have been state of the art at the time of installation in 1998, it is now sixteen years old. This model of fire alarm system stopped production in 2005 and replacement parts are no longer available from the factory. Replacement parts maybe still available on the secondary markets or some service companies may still have inventory. Also, this system is a two wire Class B meaning it has two wires going to the devices with an end of line resistor.

This system should be replaced with a Class A 4-wire addressable system when the building is renovated. This type of system has 4 wires going to each device in which two wires are supervisory. Also, each device is identified on the fire alarm system so in the event of a fire, it is possible to pinpoint the location of the device in alarm. The Newburyport Fire Department will probably require this upgrade and even if not it is doubtful that expansion modules could be found for this system.

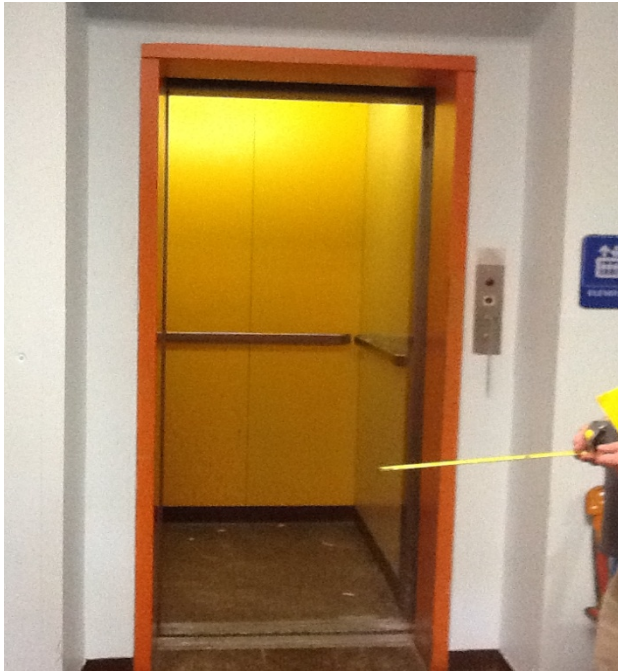
ELEVATOR WITH 32” DOOR OPENING

- Elevator is undersized. The shaft will have to be enlarged enough to accommodate a gurney.

This elevator is the hydraulic type and has a slow travel rate. It will be undersized for the building if offices and or residential uses are considered.

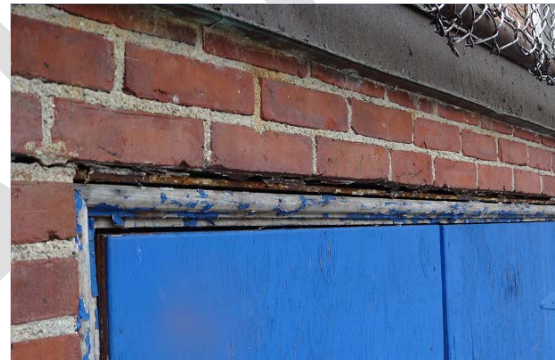
RUSTED JACK LINTELS AT BOILER HEAD HOUSE

Throughout the perimeter of the school, both in the original construction and in the 1975 addition, the steel lintels over masonry openings are not galvanized. In most cases, the lack of galvanizing the lintels has not caused a problem with damage due to rust expansion, but all steel lintels need new robust corrosion protection. The exception is the steel lintels of the boiler room head house at the rear of the building. These lintels have badly corroded and have rust jacked the masonry. We anticipate that those lintels will have to be removed and replaced with new galvanized lintels and the associated masonry work.

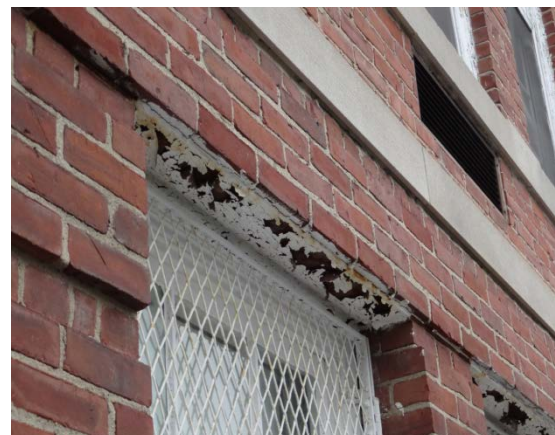
NO CORROSION PROTECTION AT LINTELS

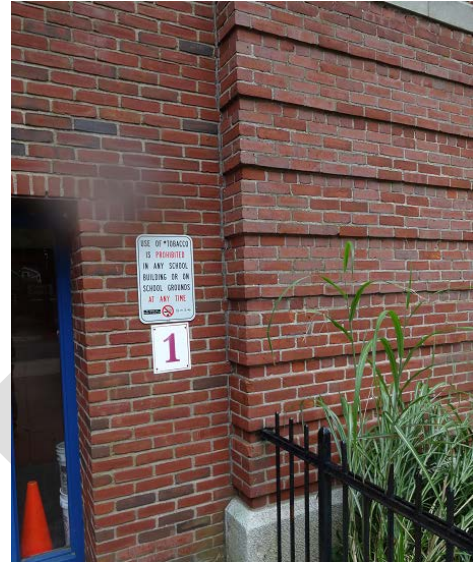
The sealant joint at the front of the building at the juncture of the original wings and the 1975 infill portion is deteriorated and should be cut out and replaced over the full height. This full height joint occurs in two places.

DETERIORATED SEALANT JOINTS AT BUILDING ADDITION

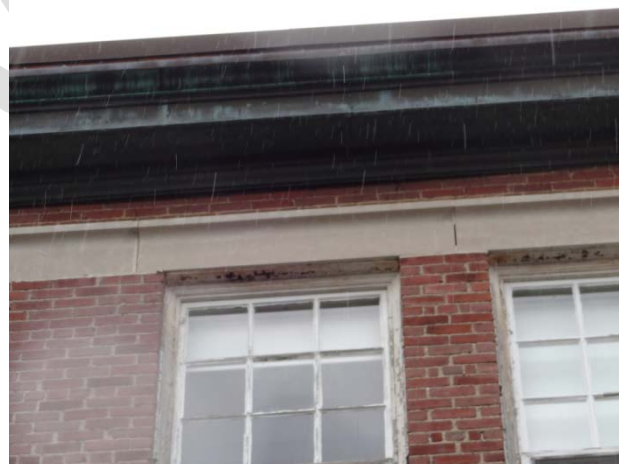
The condition of exterior masonry overall is good, and major repointing does not appear to be necessary. An exception to this is the stone belt course above the second floor windows. The head joints between stones are often completely missing the mortar. We recommend that his belt course be repointed throughout.

MISSING MORTAR AT HEAD JOINTS
