CREDERE ASSOCIATES, LLC

**SUBJECT: Project Peer Review - Former Circle Finishing
US Route 1 Traffic Circle
Newburyport, Massachusetts
MassDEP Release Tracking No. (RTN) 3-0392**

REMAINING UPLAND SOIL SAMPLES AND EXCAVATION LOCATIONS

FIGURE
3

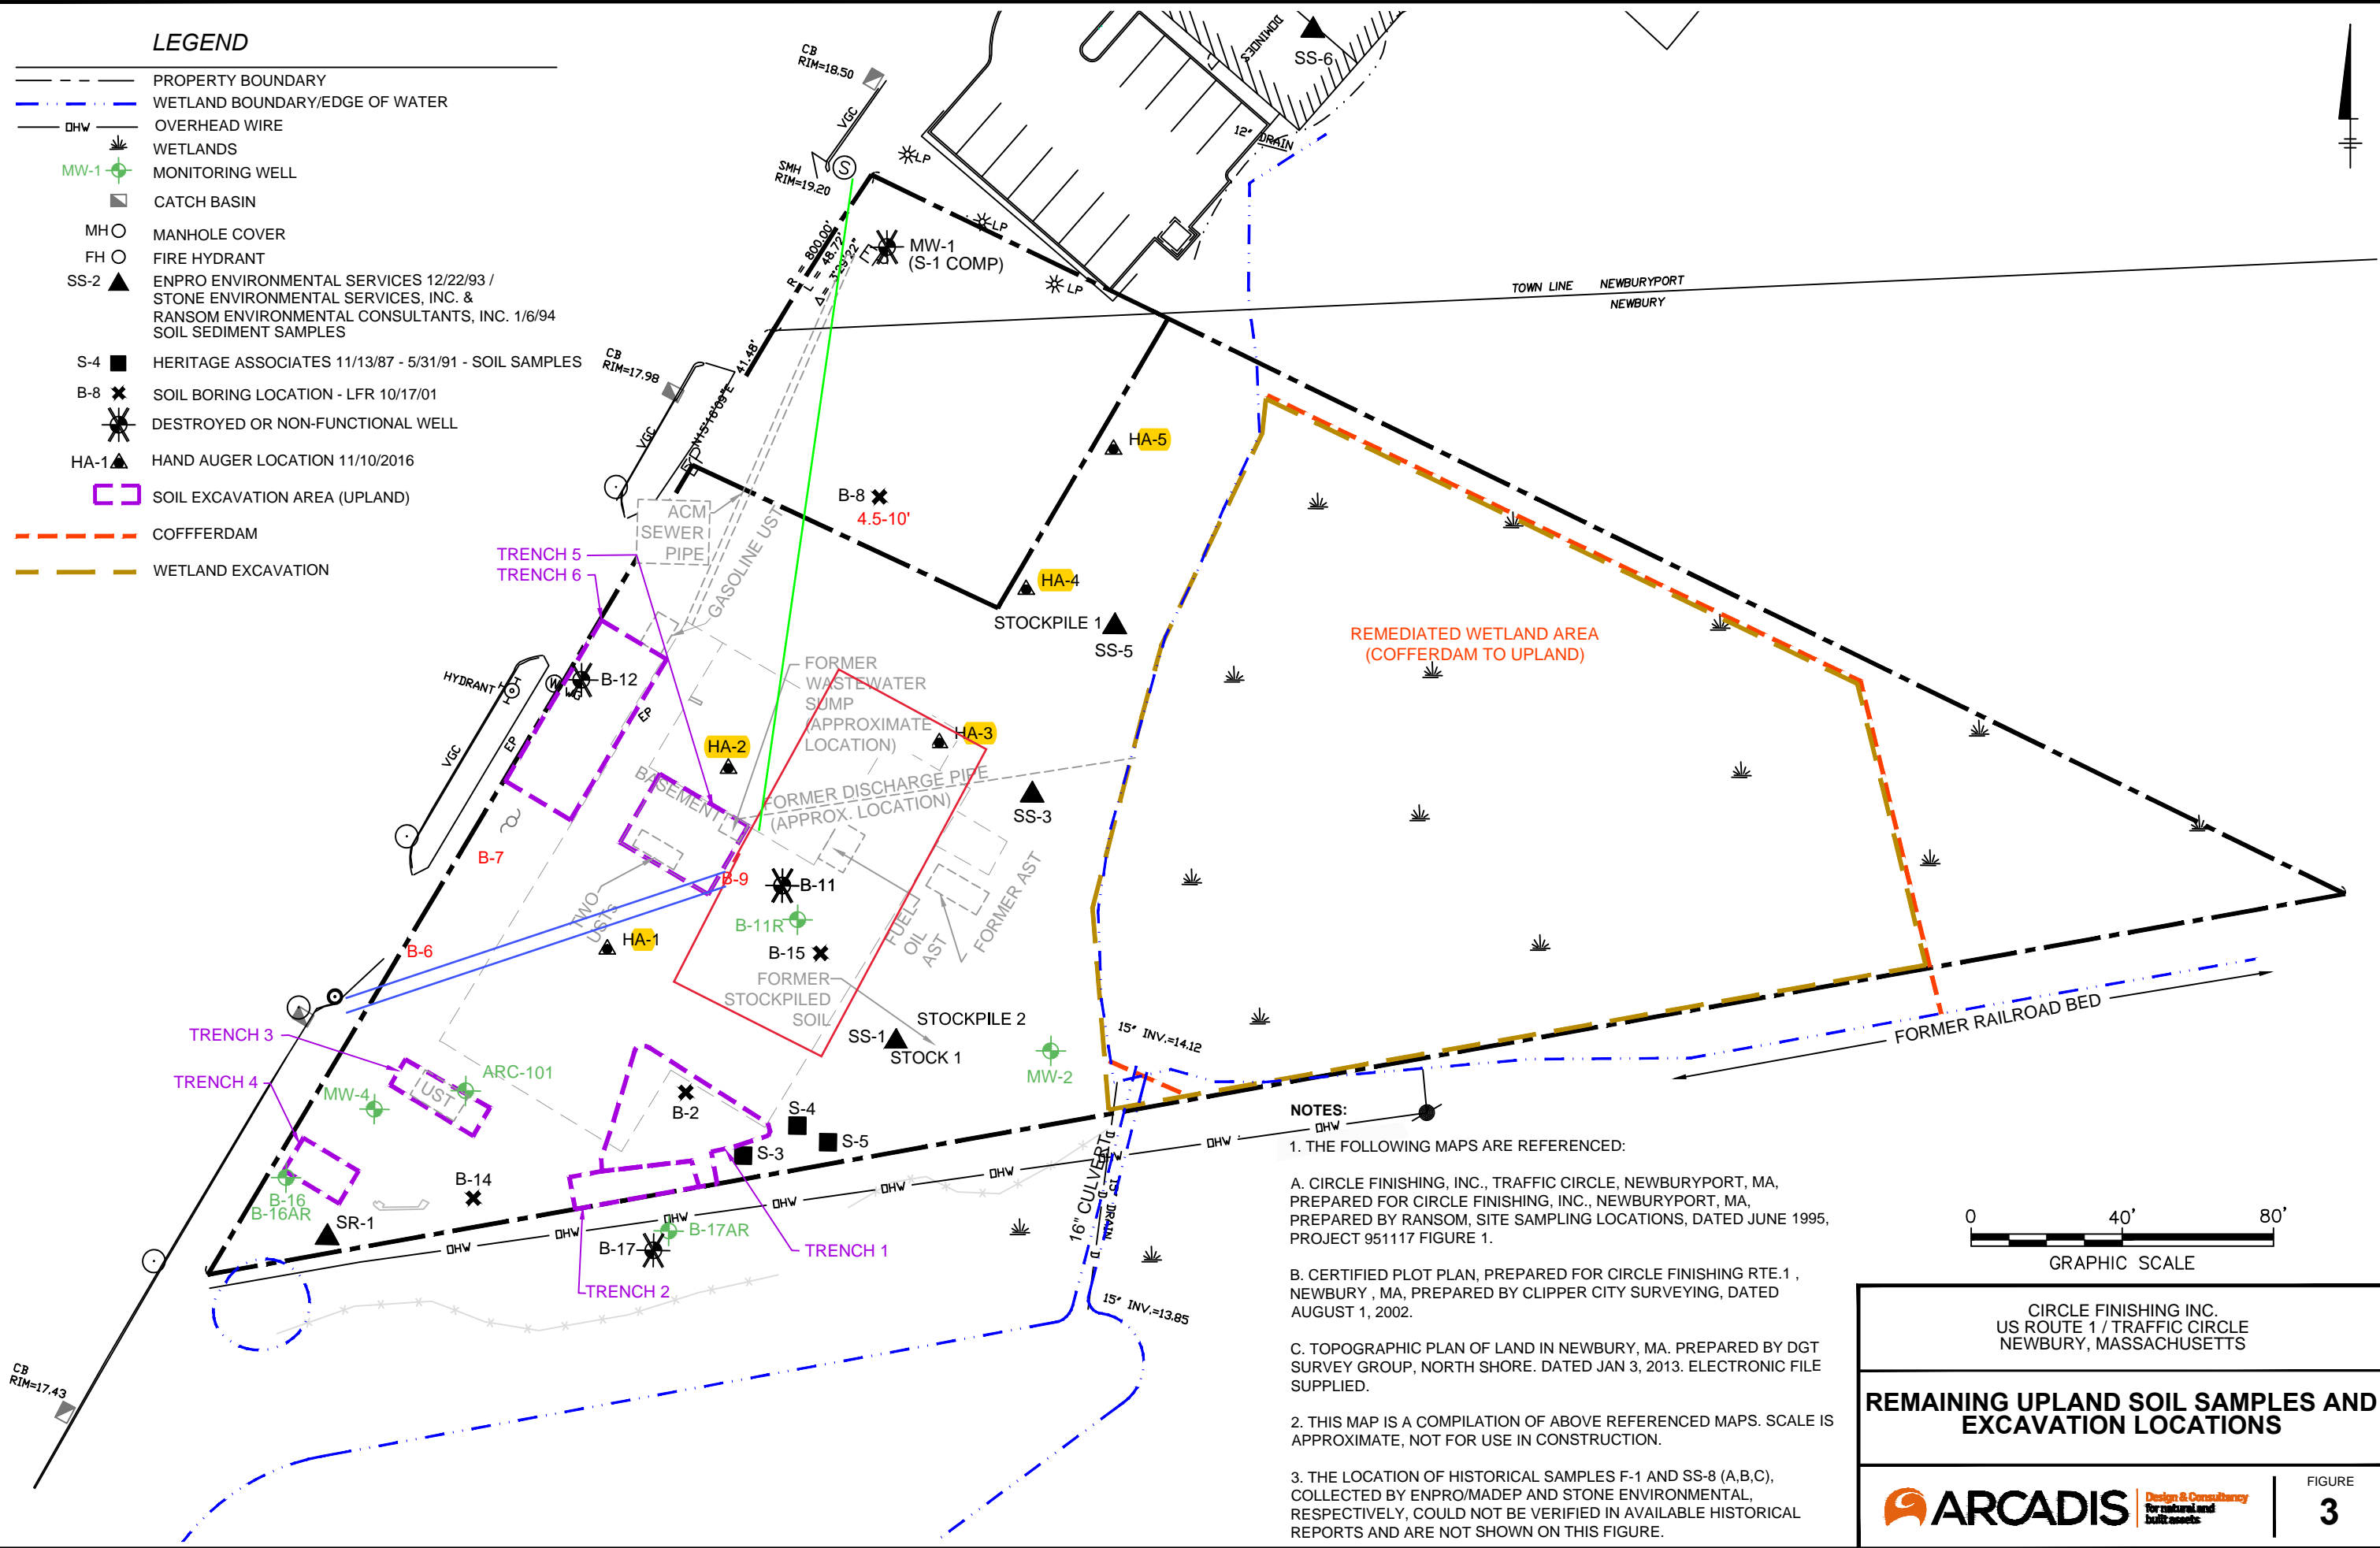
- B-5: VOC photoionization detector (PID) readings from this boring in 2001 ranged from less than 1 part per million (ppm) from 0 to 4 feet bgs, 413 ppm from 6 to 8 feet bgs and 65 ppm from 8 to 12 feet bgs. Analytical results were limited to a trace detection of ethylbenzene from 5 to 8 feet bgs. Despite the elevated PID result from 2001, the 2014 confirmatory samples from the southern side wall (0-13 feet) and the southern base of Trench 6 excavation were non-detect for EPH and VPH.

- B-6: Metals results from 2001 from 4.5 to 10 feet bgs were non-detect. The soil boring log indicated no evidence of VOCs by PID.
- B-7: Groundwater analytical results for VPH, VOCs, metals and EPH were non-detect in January 2003. This well is in the upgradient position of the water line. PID results indicate 51.6 ppm from 4 to 8 feet bgs and 1.9 ppm from 8 to 12 feet bgs.

- B-8: VOC PID readings from this boring in 2001 ranged from 3.2 from 0 to 4 feet bgs, 22.6 ppm from 4.5 to 8 feet bgs and 3.2 ppm from 8 to 10 feet bgs.

- B-9: VOC results from 2001 indicate 491 ppm from 1 to 8 feet bgs. This location is on the approximate eastern edge of the Trench 5 2014 excavation. Confirmatory samples from the Trench 5 excavation indicate low levels of VPH along the southern sidewall below the Method 1 Soil Standards.

- B-12 was the location of Trench 6 upland soil excavation in 2014. Confirmatory samples from the base of the excavation at 13 feet bgs and the north and northwest corner of the excavation sidewalls continued to detect VPH fractions in the north end of the trench excavation.

- MW-1 is in the upgradient position of the Site and was historically sampled only for metals in soil with concentrations below the Method 1 Soil Standards.

- HA-1: Elevated chromium above the Method 1 S-1 soil standards was documented at the surface from 0-1 foot in 2016.

Based on review of the above available data for the closest sample points, soil contamination within the vicinity of the water and forced main appears limited and below Massachusetts Method 1 Soil Standards. The exception is the soil along the water main immediately near the building (HA-1 and Trench 5 southern sidewall). Groundwater results for the one well B-7 suggests groundwater upgradient of the water main does not have evidence of significant groundwater contamination that could play a role in potentially impacting water within the water service. The proposed locations of the service lines do appear to be selectively routed where limited historical sources of contamination are present and thereby limited data is available. Lack of data cannot always be construed as indicative of lack of contamination, but in this case, there is limited evidence of sources of contamination in areas of proposed service line locations.

The available data does not indicate the presence of significant contaminants that could enter the water line in the event of water main break/low pressure event. However, based on limited data along these lines, best management practices (BMPs) such as lining the utility trench with a filter fabric and backfilling to the surface with clean material is recommended. This BMP will allow for a clean corridor in case of the need for repair as well as provides a barrier between a broken main and the water supply to minimize contaminants that could enter the lines. In addition, the use of single continuous run of pipe (like HDPE) through the area of contamination, will minimize any seams or connections that could be location of infiltration. Use of non-draining hydrants along the road will also minimize the potential for contamination entering the water supply from any residual contamination along the road.

1. Incorporation of elements of the BMP for a clean utility corridor/trench by the addition of a trench filter fabric liner and use of clean backfill within the proposed water utility trench(es). This change should be reflected on the applicants design plans in "Typical Trench Detail" and any associated specification.

2. Use of continuous HDPE piping for the water service and fire service lines to reduce the number of connections made in area containing residual soil contamination. This type of plastic piping is also considered acceptable for use high water table environments similar to the Site. This recommendation will necessitate a change to Note 2 on "Water Installation Notes" in the applicant plans to reflect continuous HDPE line for the water service from the main to the proposed building. Additionally, General Note No. 13 will have to be updated accordingly.
3. Use of a non-draining fire hydrant to eliminate the opportunity for a contaminant backflow scenario. This change should be reflected in the "Typical Fire Hydrant" specification and changed General Notes No. 12 in the applicant's design plans.
