**Project:** Custom House Maritime Museum  
25 Water Street  
Newburyport, MA 01950

**Subject:** Request for letter of support - Newburyport Custom House Masonry Repair Portico Roof  
CPA Application

2021 Architectural Conservation Assessment  
Newburyport Maritime Society, Inc. Custom House Maritime Museum

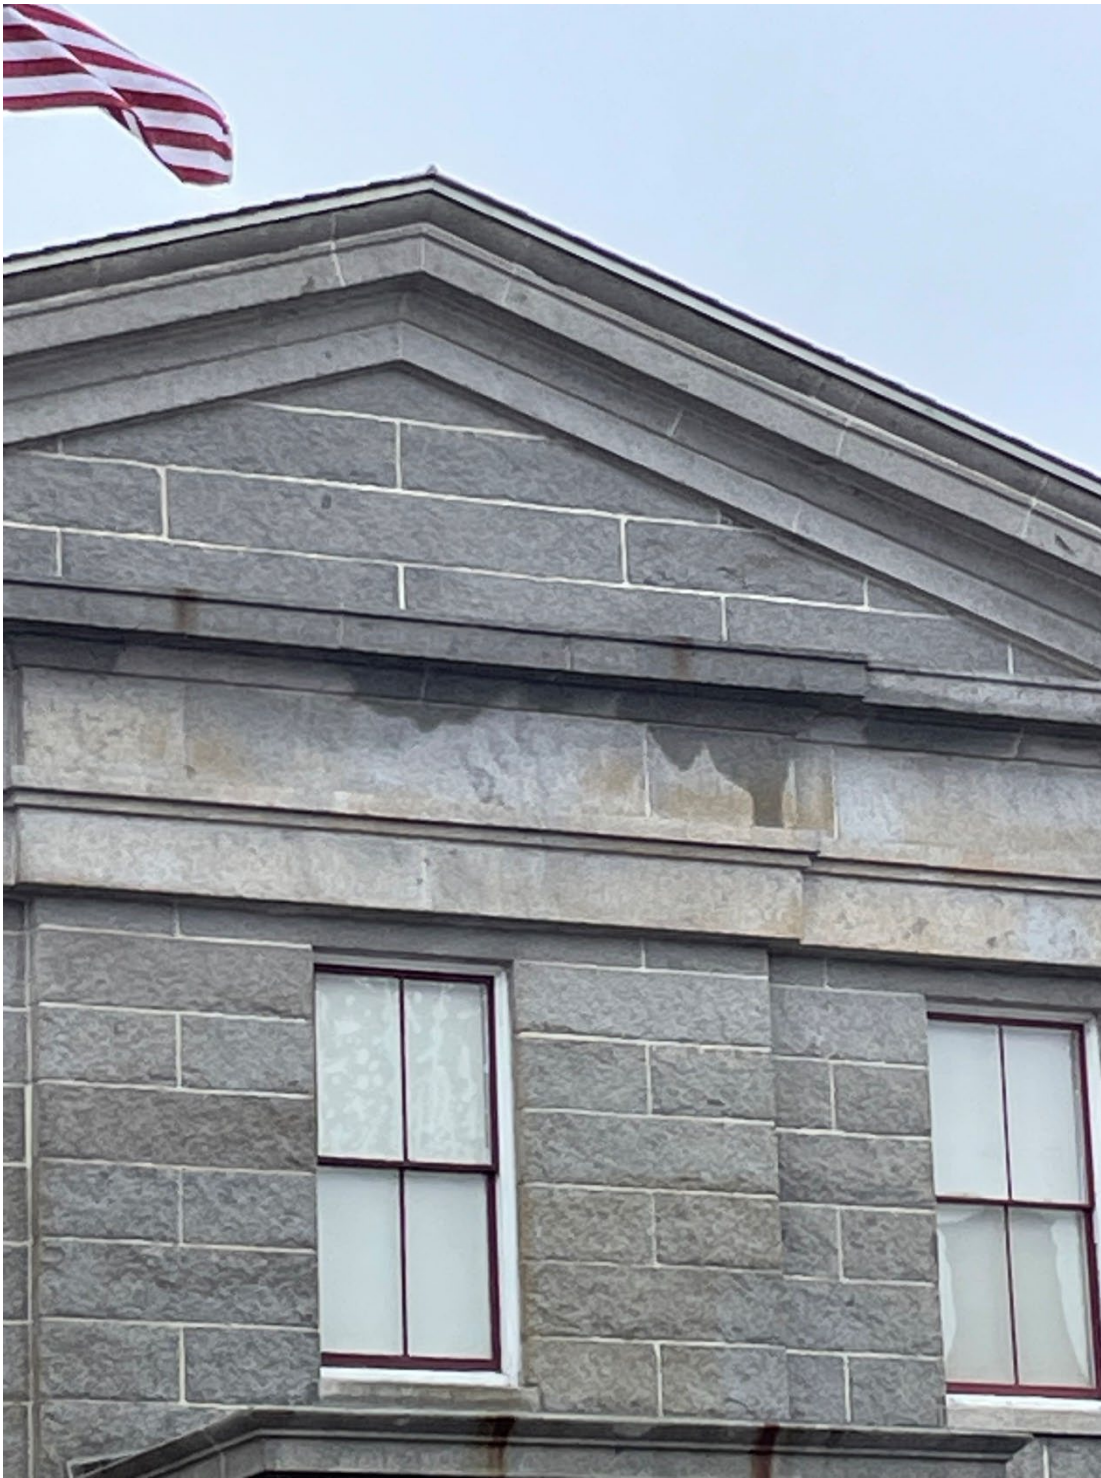
South façade gable bed joint failure 11/16/2022

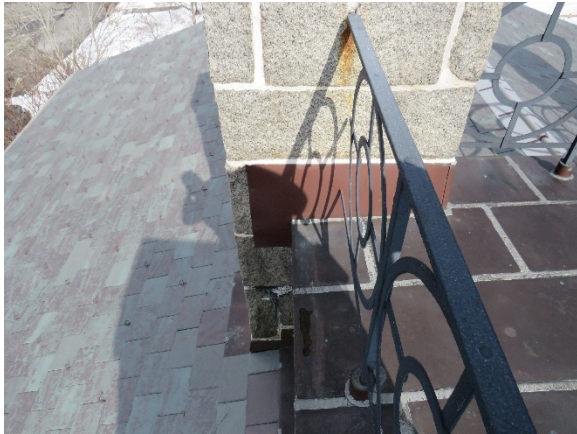
10. Observatory guardrail pitch pocket

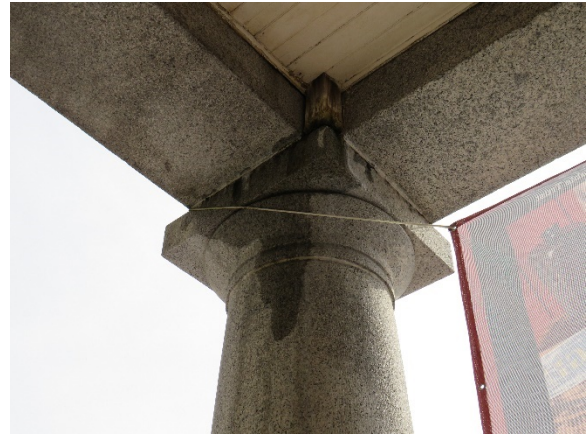
13. Portico southeast column capital with evidence of active water leaking through ceiling

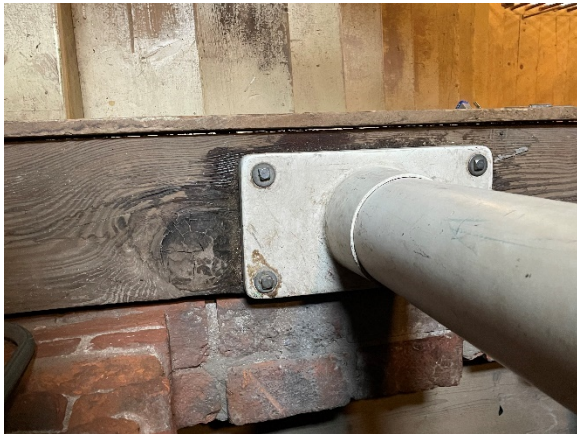
11. Flagpole base with evidence of wetting of the supporting structure. Photo by Joan Whitlow

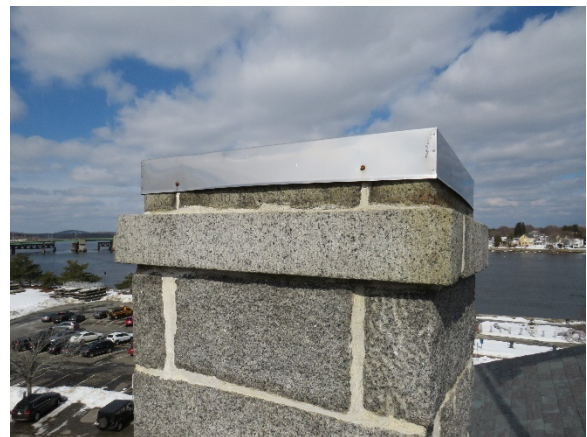
15. Northwest chimney cap – ferrous metal Tapcon screws

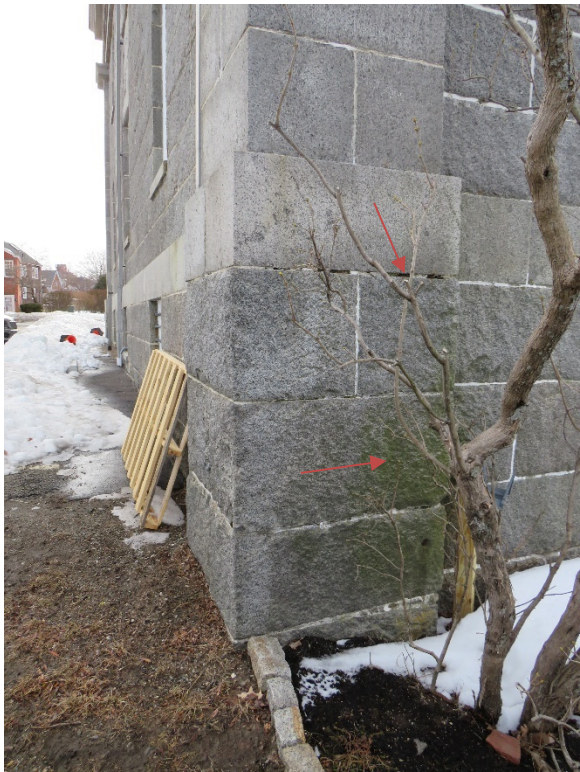
16. Northeast pilaster base – biological growth and mortar loss at ferrous metal setting wedges below watertable

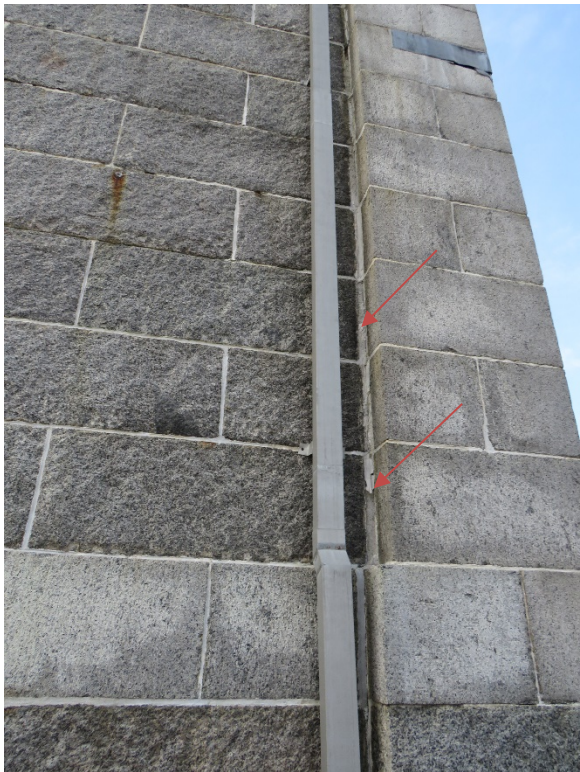
17. East façade, north pilaster – failing mortar joint

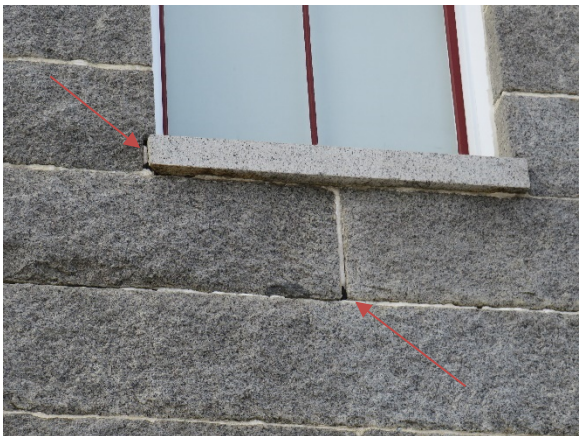
18. East façade window A3 – mortar loss at sill and vertical joint beneath

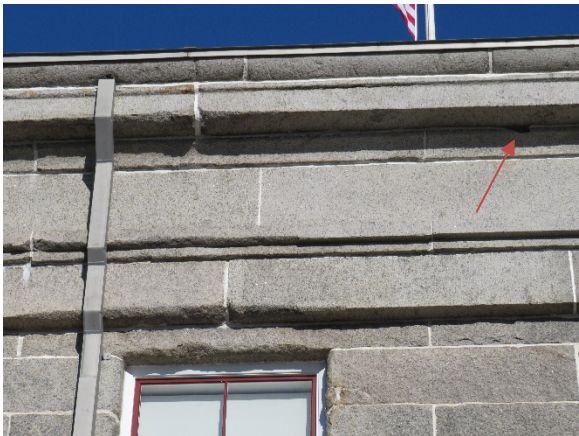
19. East façade, open bed joint above window B2

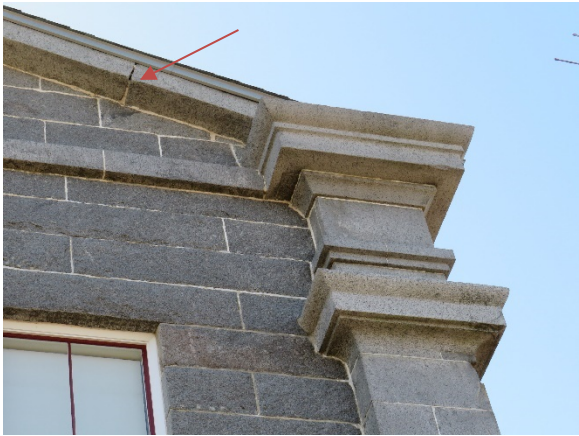
20. North façade, west rake – open mortar joint

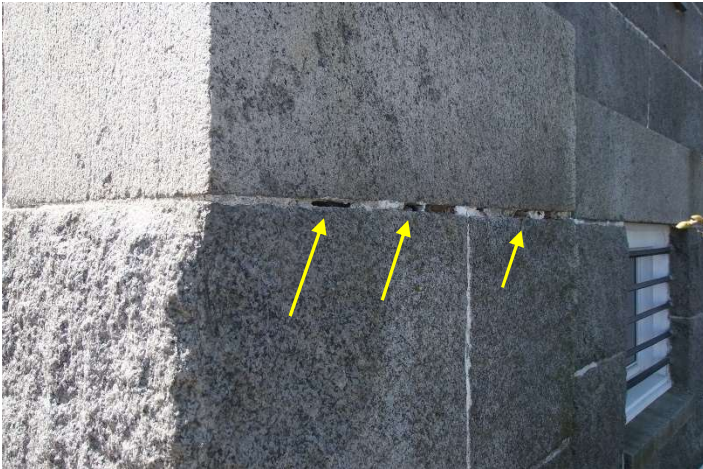
**PHOTOGRAPH 9**

Eroded bed joints at the northeast corner.

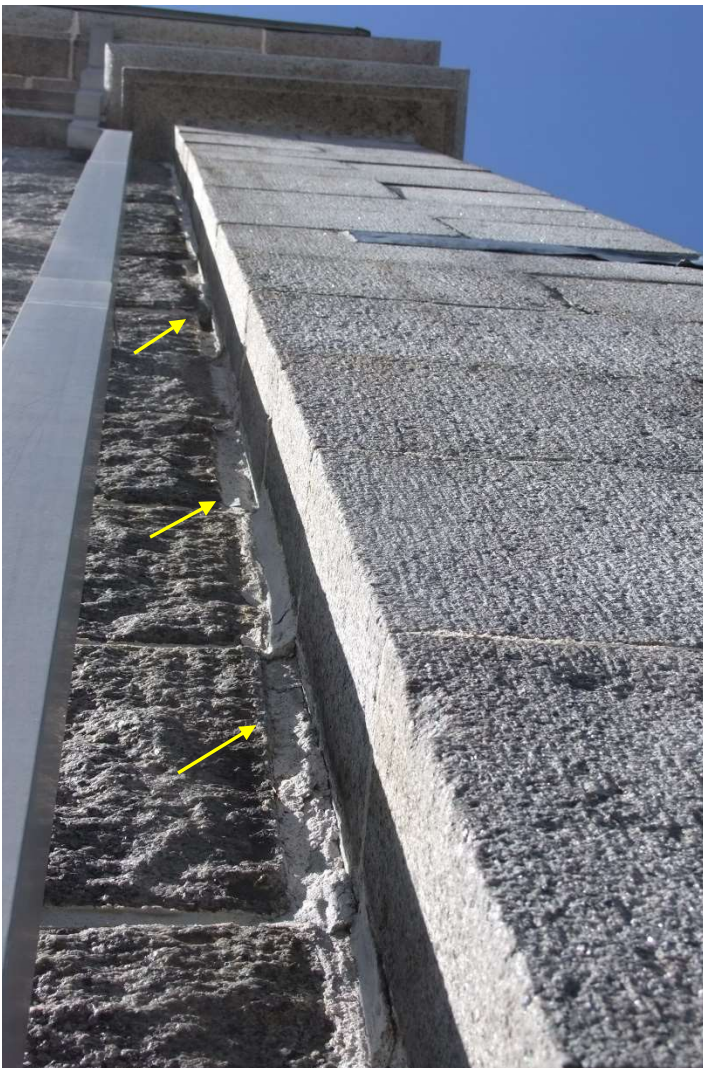
**PHOTOGRAPH 10**

Mortar in vertical joint is eroded and falling out (Northeast corner).

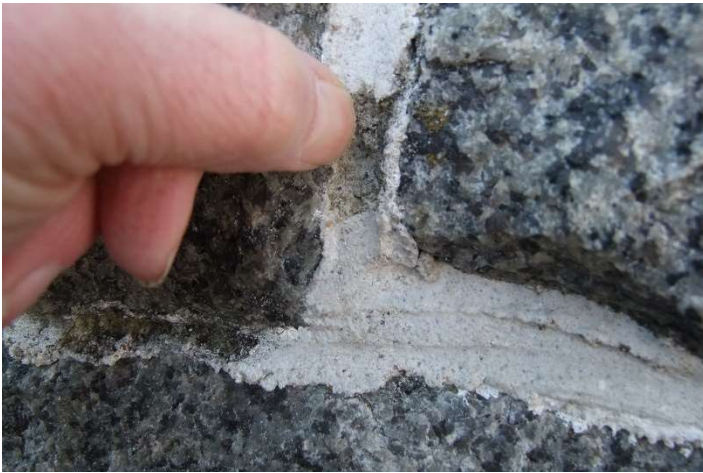
**PHOTOGRAPH 11**

Different mortar mixes have been applied to the joints on the East and North elevations.

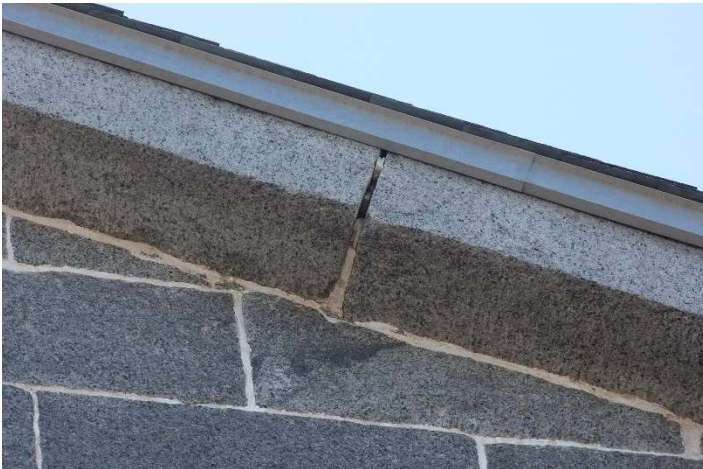
**PHOTOGRAPH 12**

Missing mortar in a head joint along the rake of the North gable.

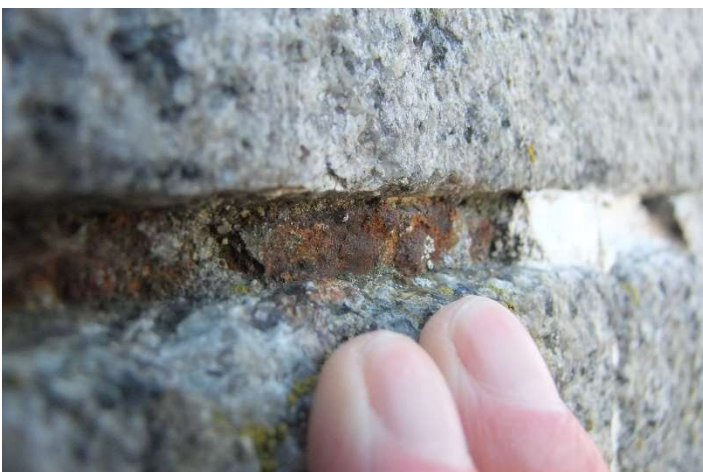
**PHOTOGRAPH 13**

Iron setting shims in bed joints are corroding and damaging the adjacent mortar and granite.
