PRESERVATION TIMBER FRAMING
P.O. Box 28
Berwick, ME 03901
www.preservationtimberframing.com

Delisle Barn
Brin Stevens and Stephen Delisle
195 High St
Newburyport, MA

09.25.2019
Issue 001
Jessica MilNeil

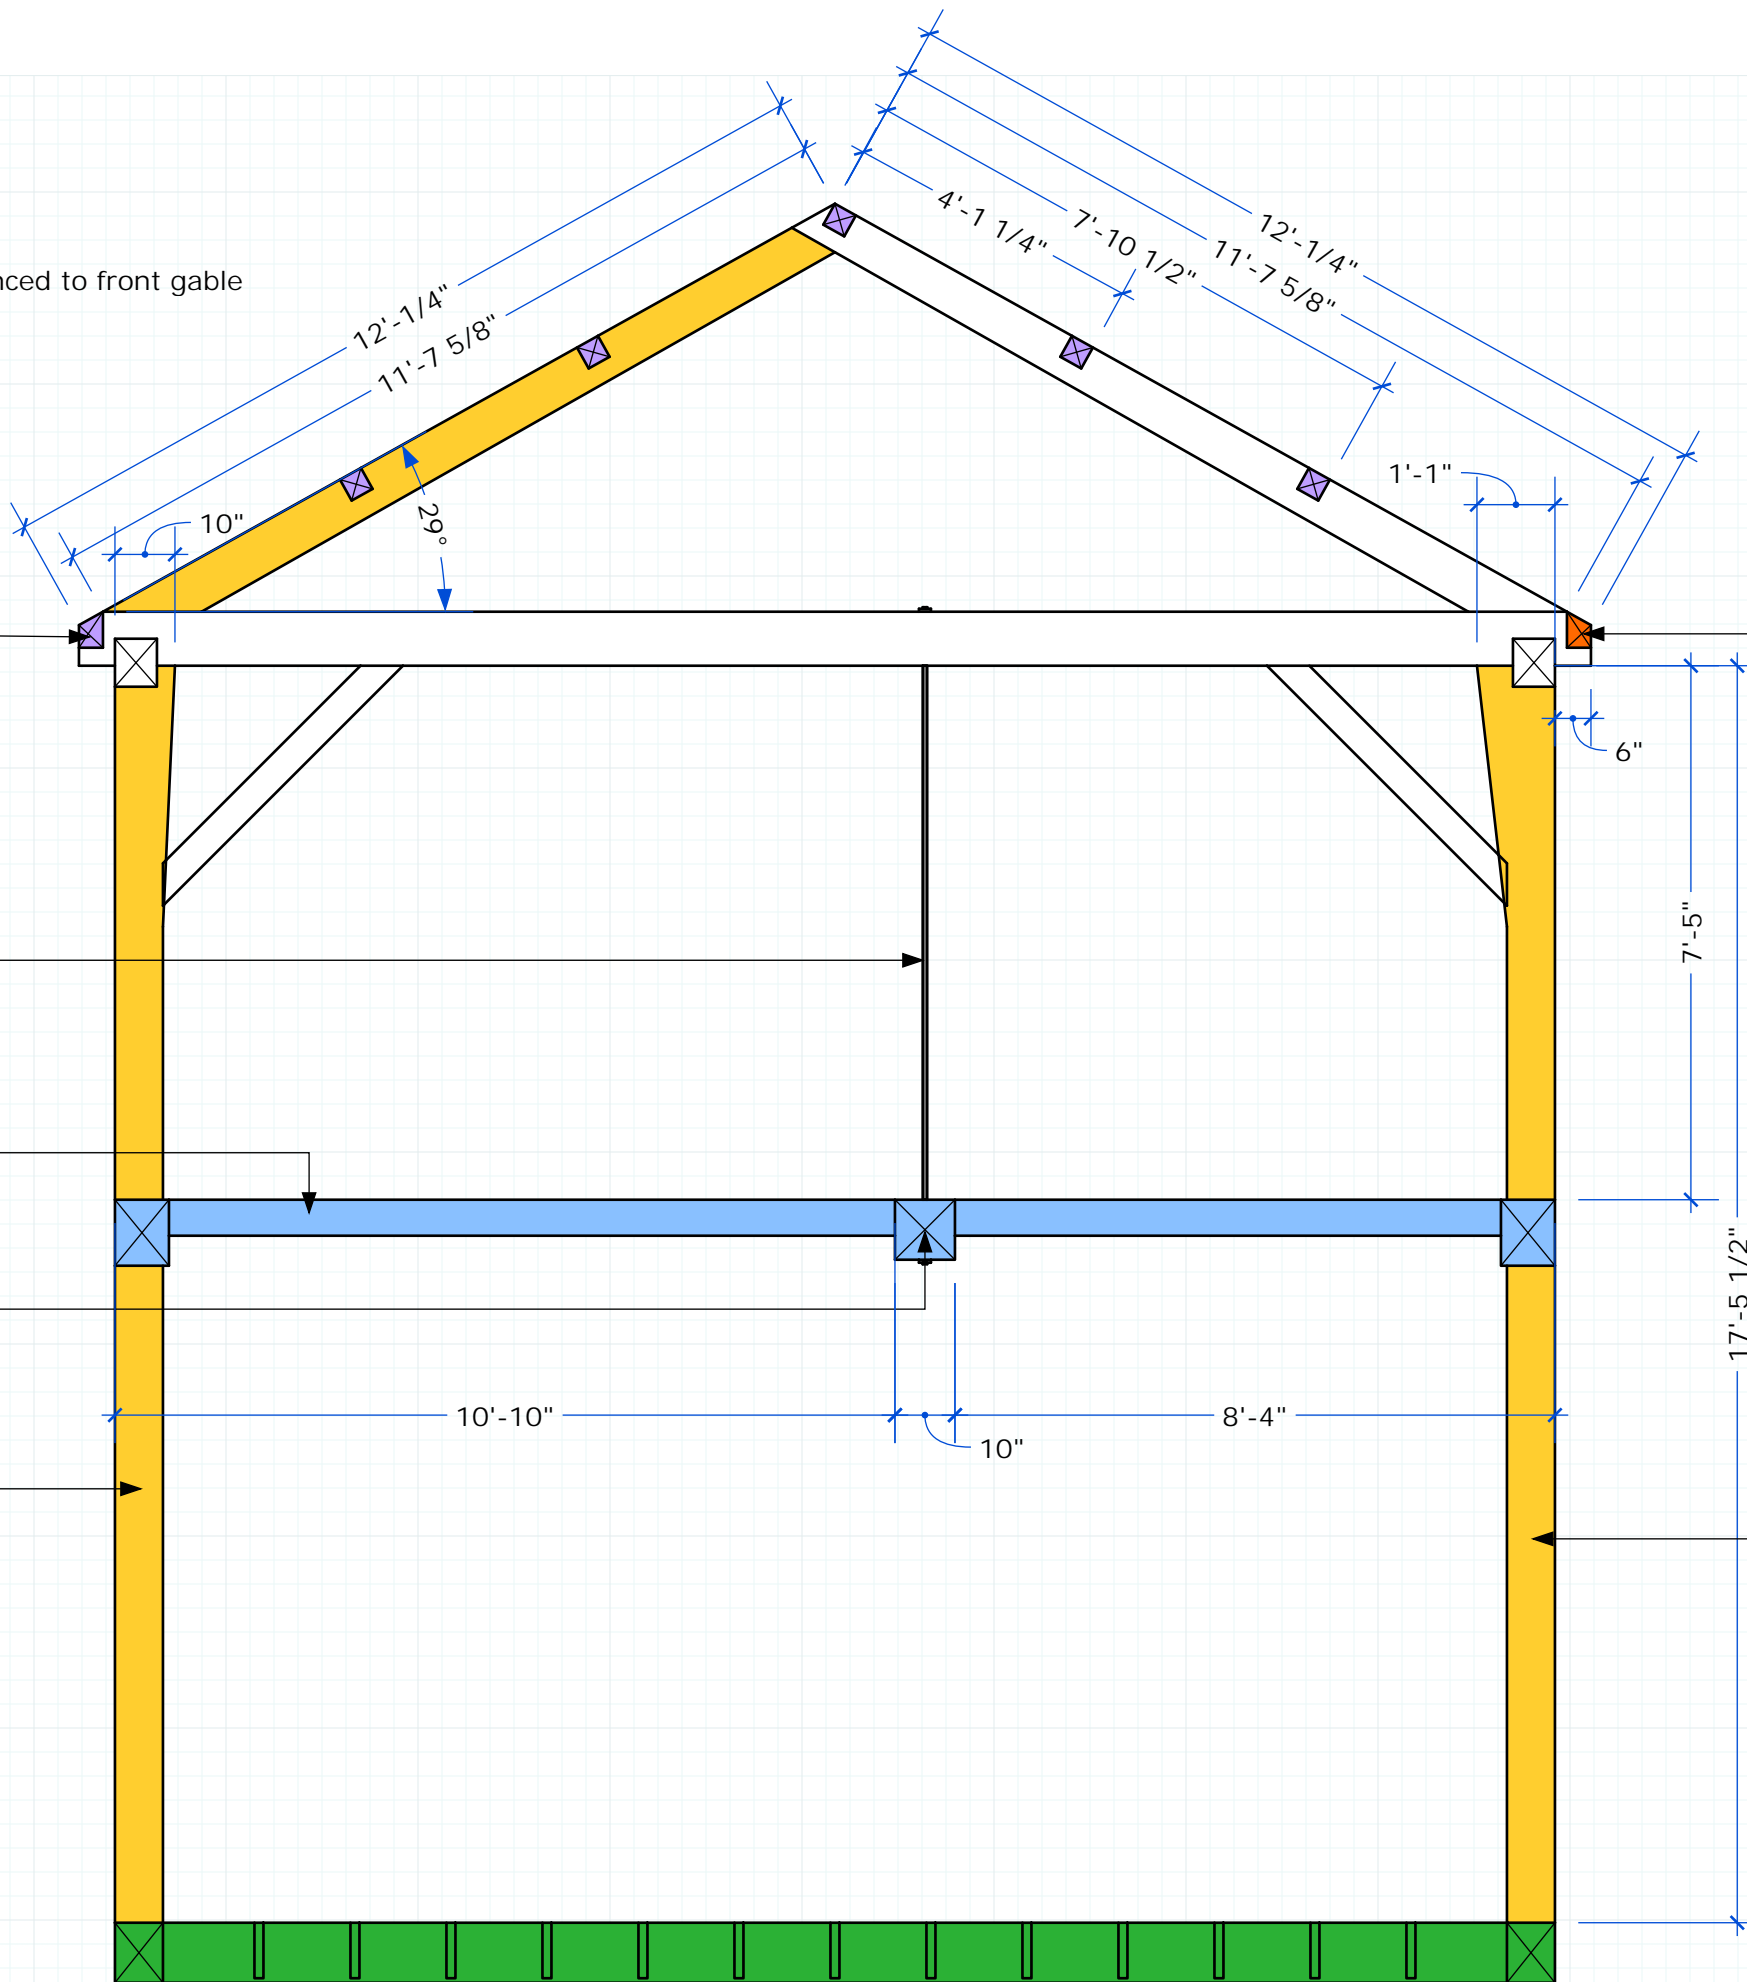
Bent 2

Reference face shown; bent 2 is referenced to front gable

Original flying purlin replaced with KD,
tie beam ends bolstered with KD

Tie beams run by plate,
joined by flying purlins

Tie rod hangs from tie beam,
supports summer beam

No girts or joists in line with bent.
Joists run next to posts

Loft joists land on eave girt and central
summer beam; dimensions approximate

Face fix, dutchman repair, possible scarf fix

Face fix, dutchman repair,
possible scarf repair

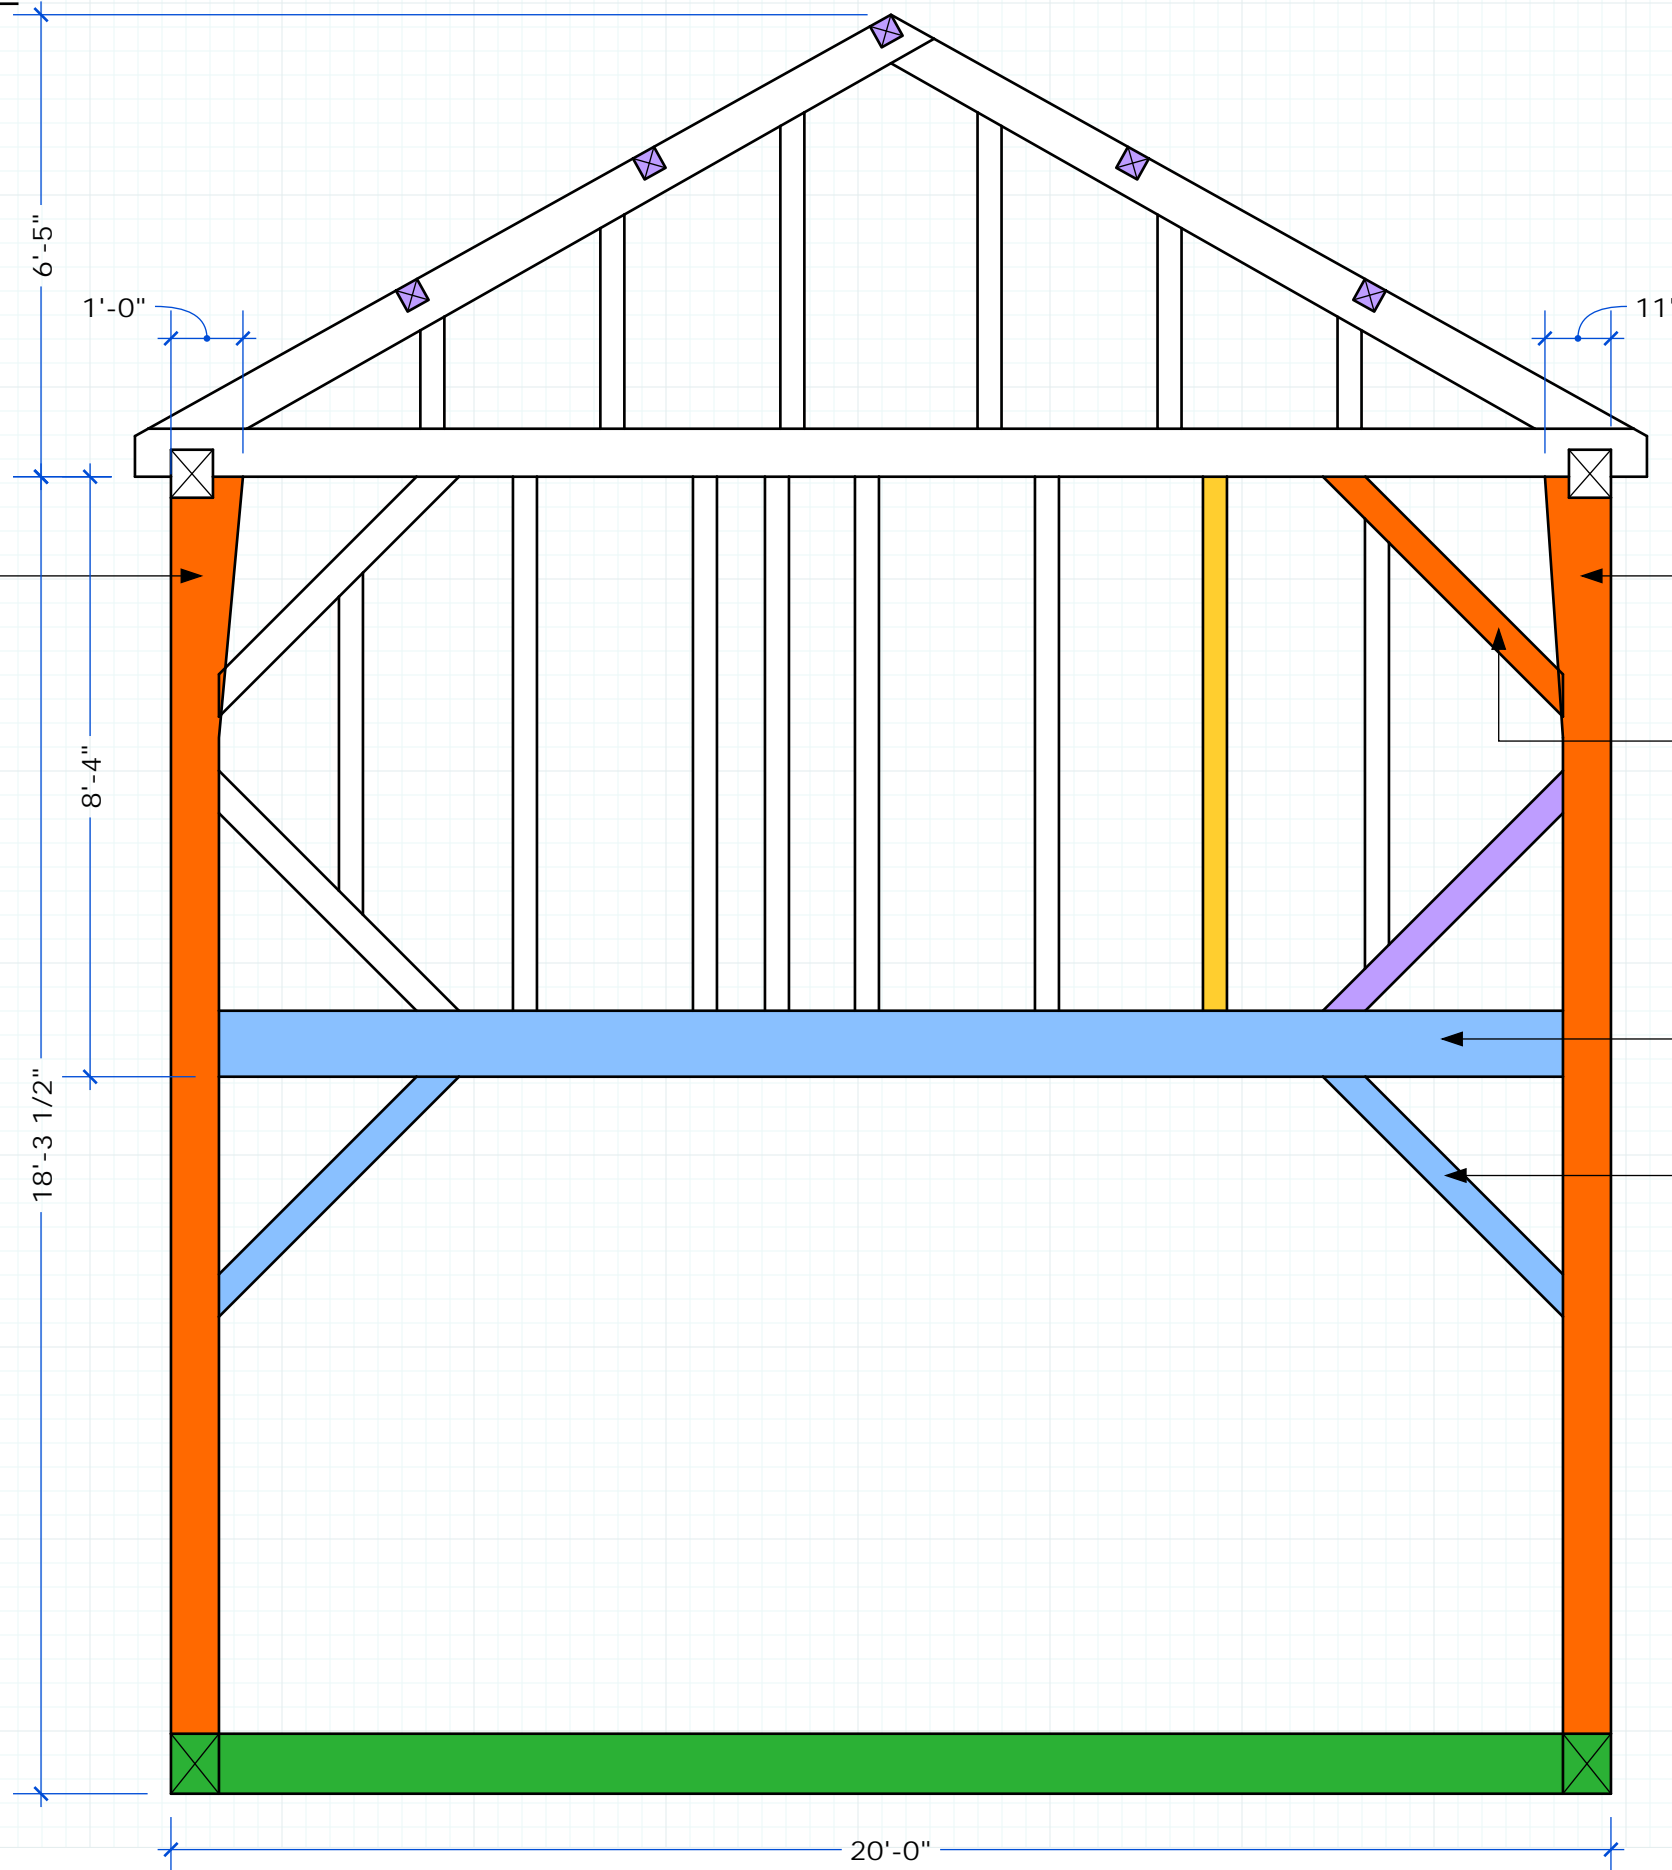
Bent 4

Post severely deteriorated and will likely need to be replaced

Post badly deteriorated, much of the material has already been removed. Post will likely need full replacement

Brace badly deteriorated and will likely need to be replaced

Loft girts hidden

Lower wall braces hidden

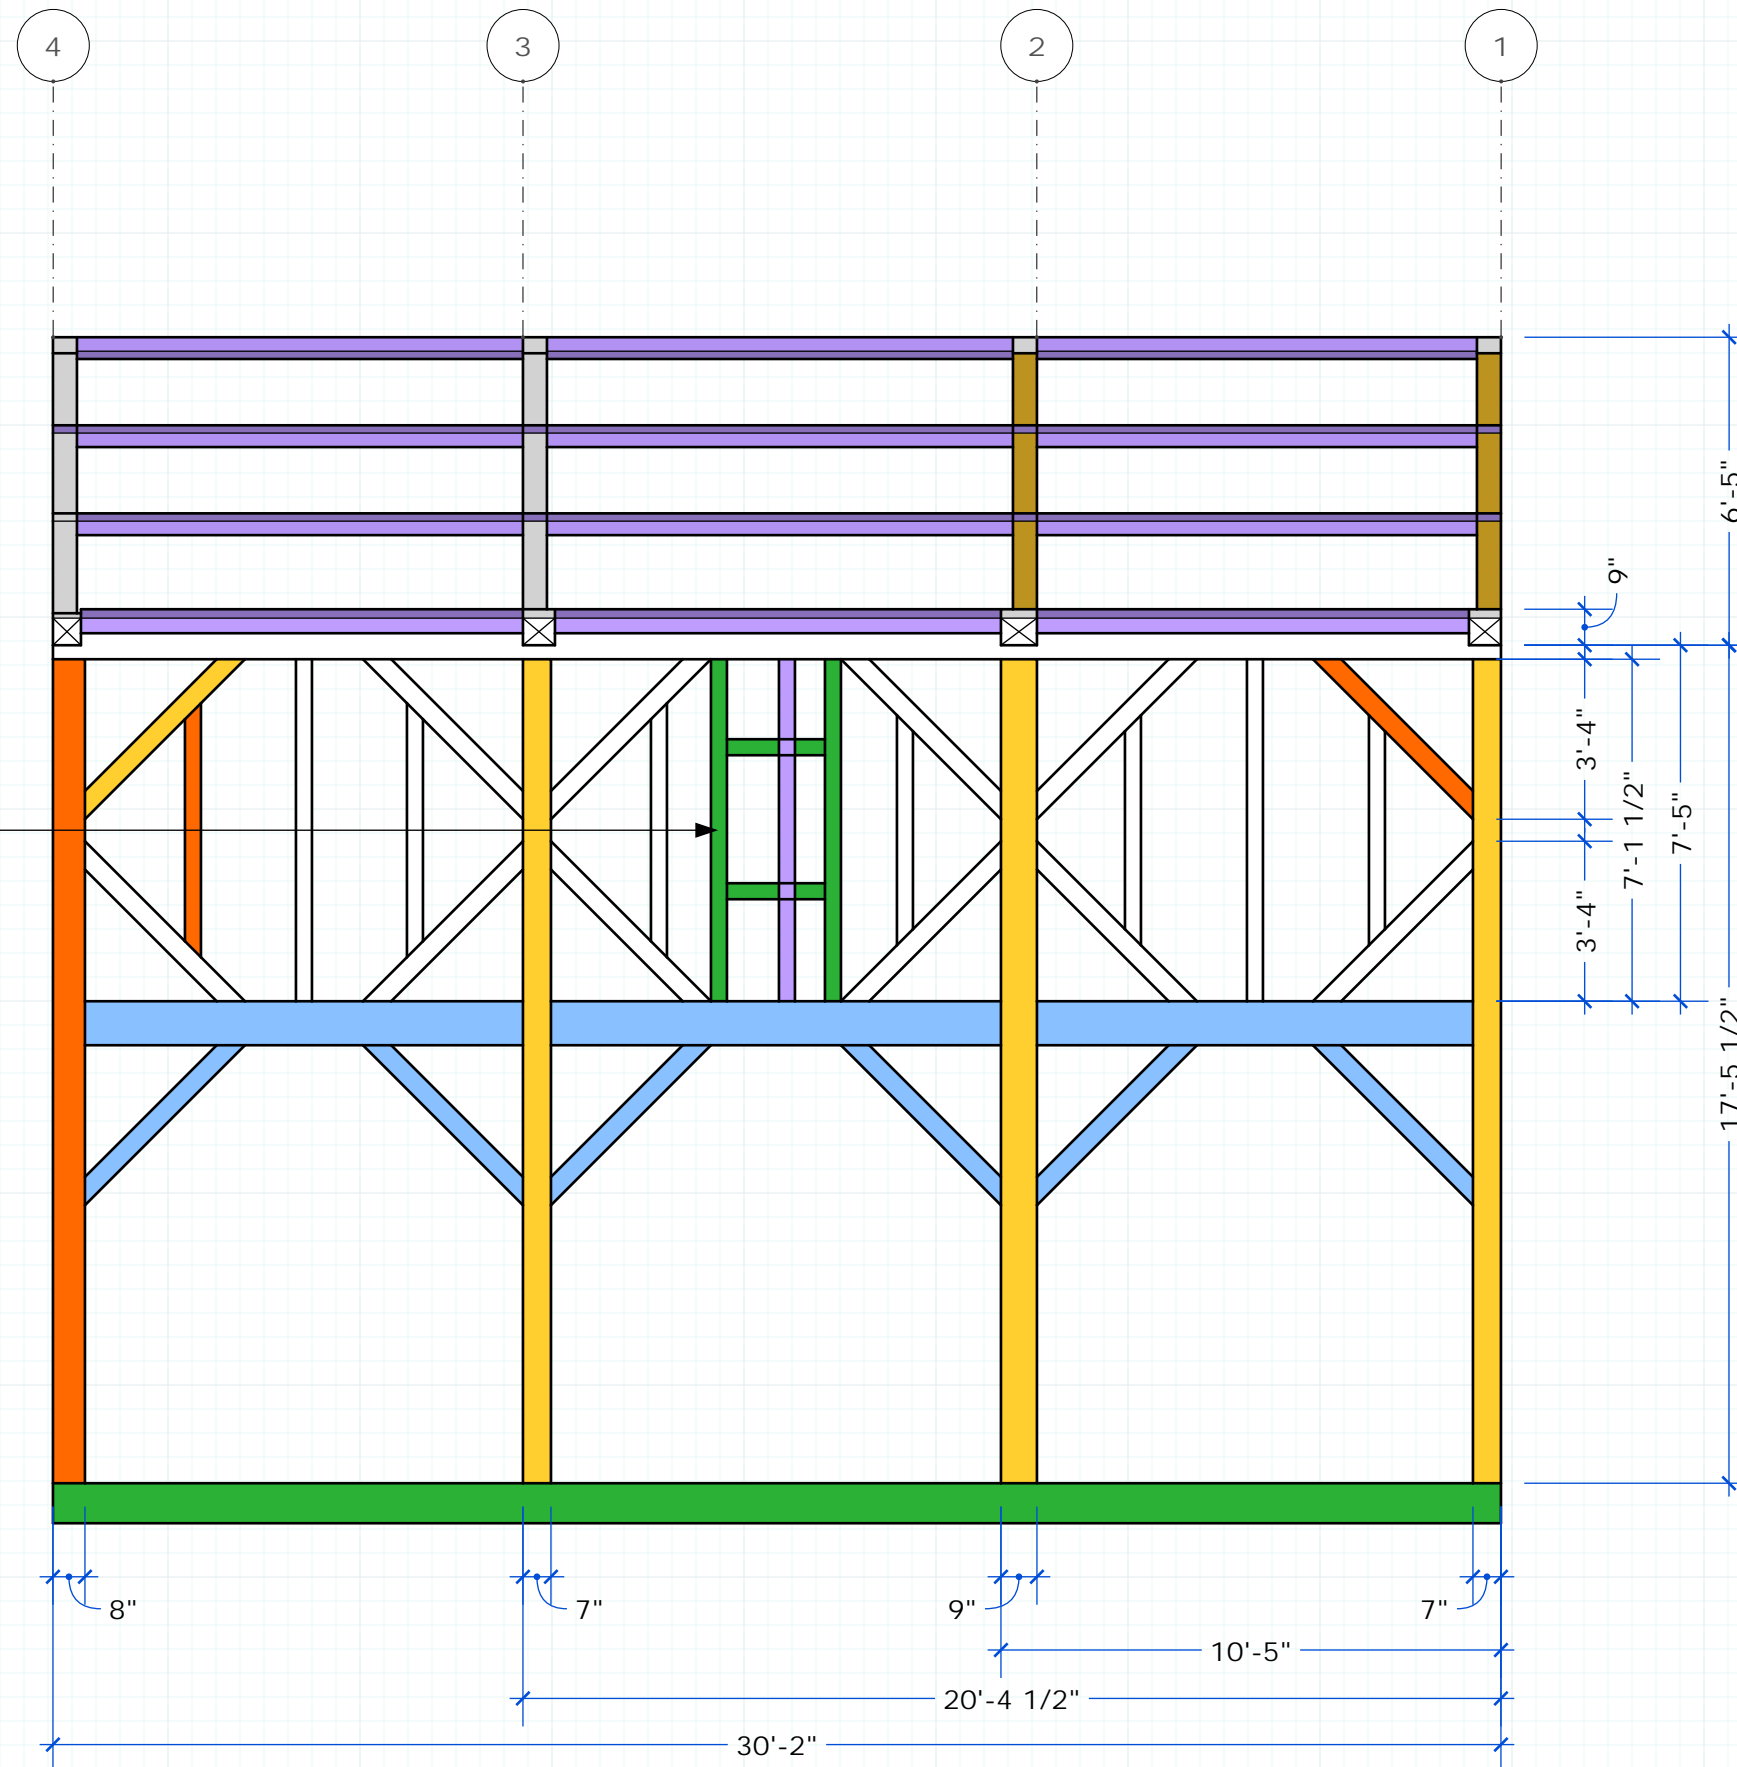
West (Left) Eave

Later window addition; original stud location indicated by mortise
