**Newburyport Historical Commission  
DEMOLITION PERMIT APPLICATION (Step 1)**

Property Address: 195 High Street

# DeLisle Barn

Existing Conditions Assessment Photo Documentation

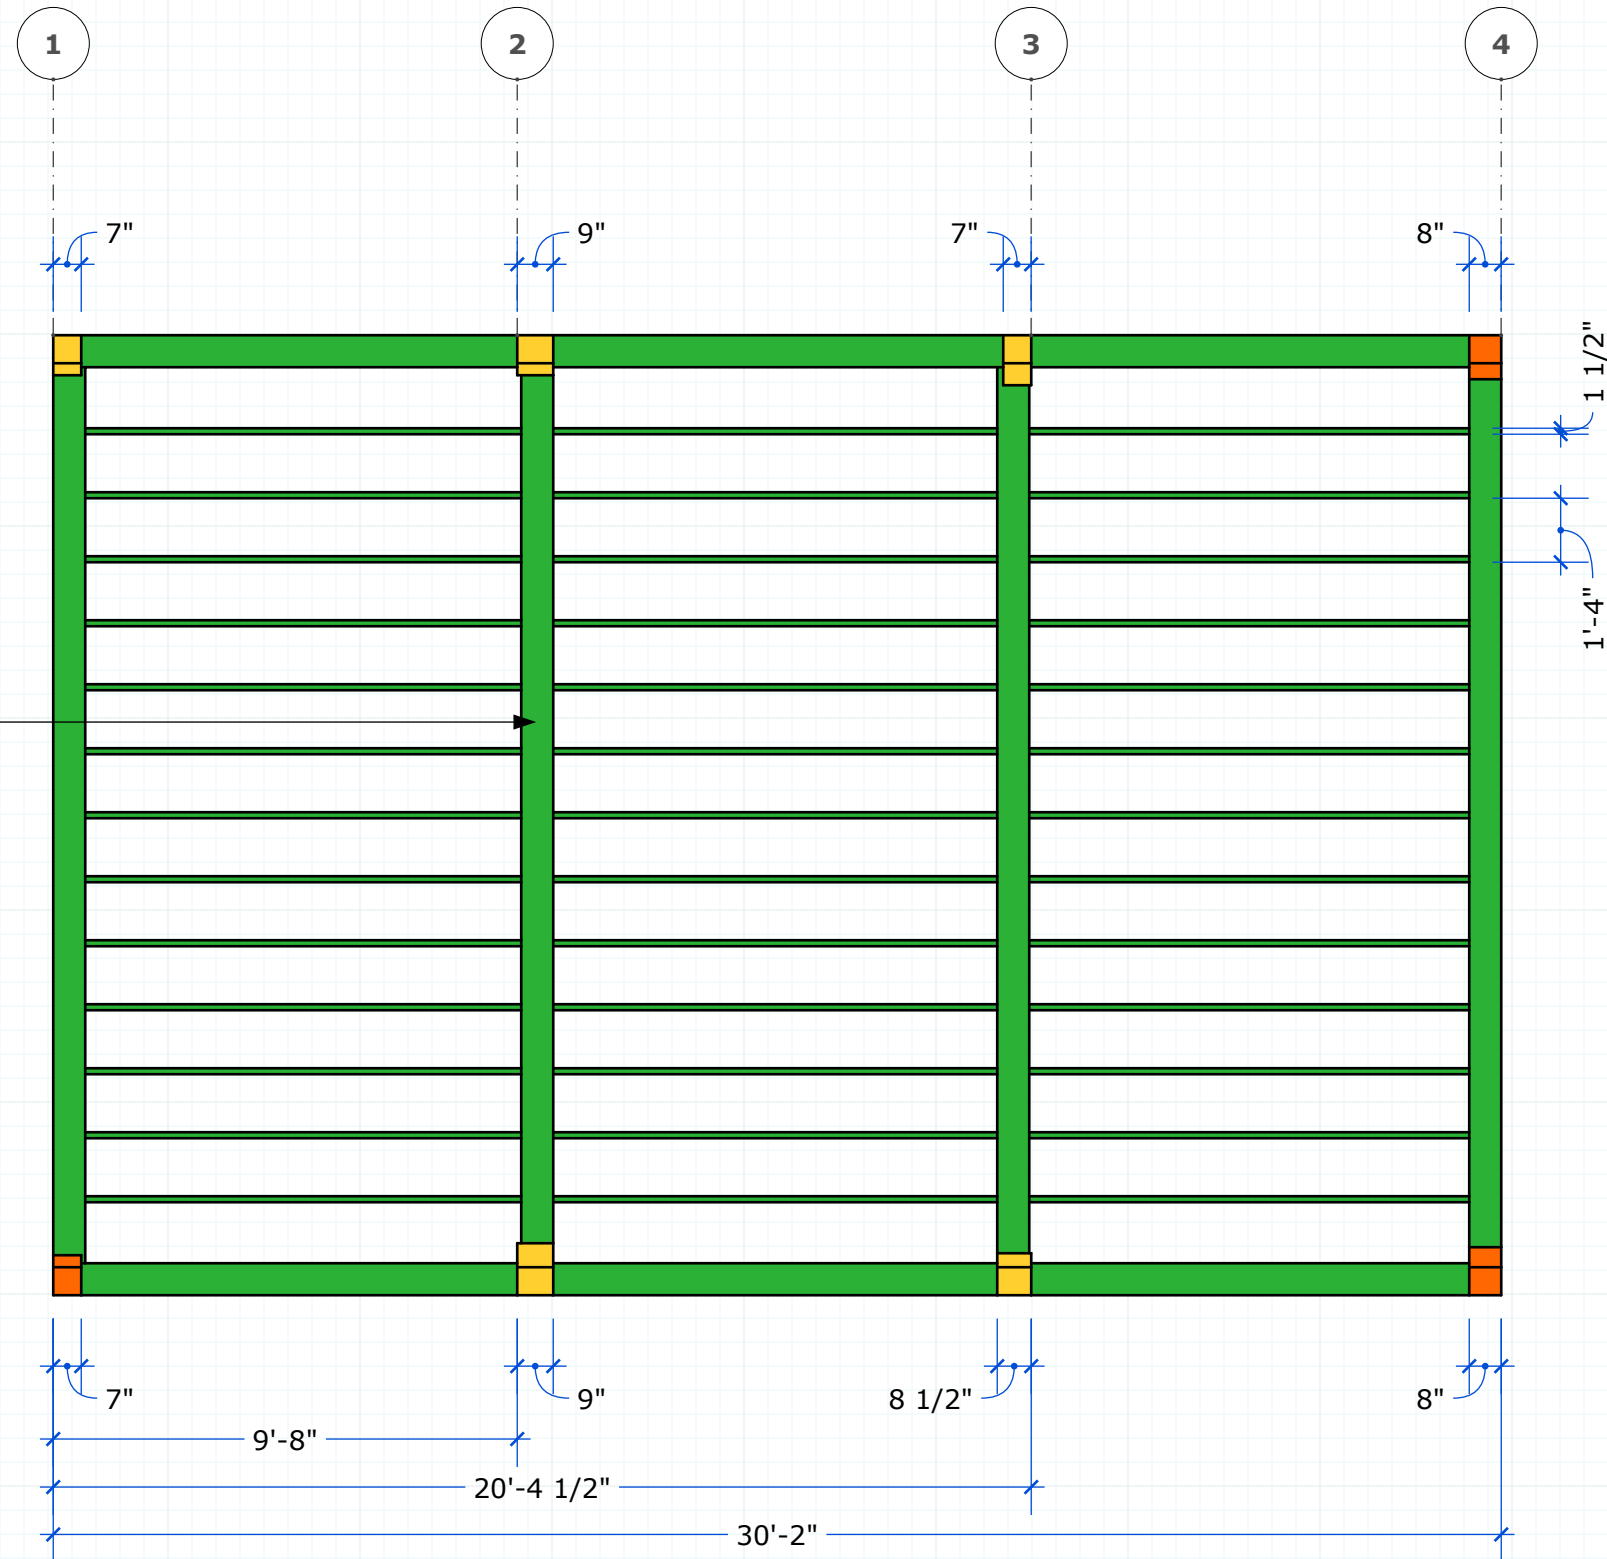
**Sill Level**

Undercarriage will need to be replaced. New concrete slab is one option. A combination timber/conventional floor is modeled: timber sills, timber girts aligned with bents, and KD joists on hangers

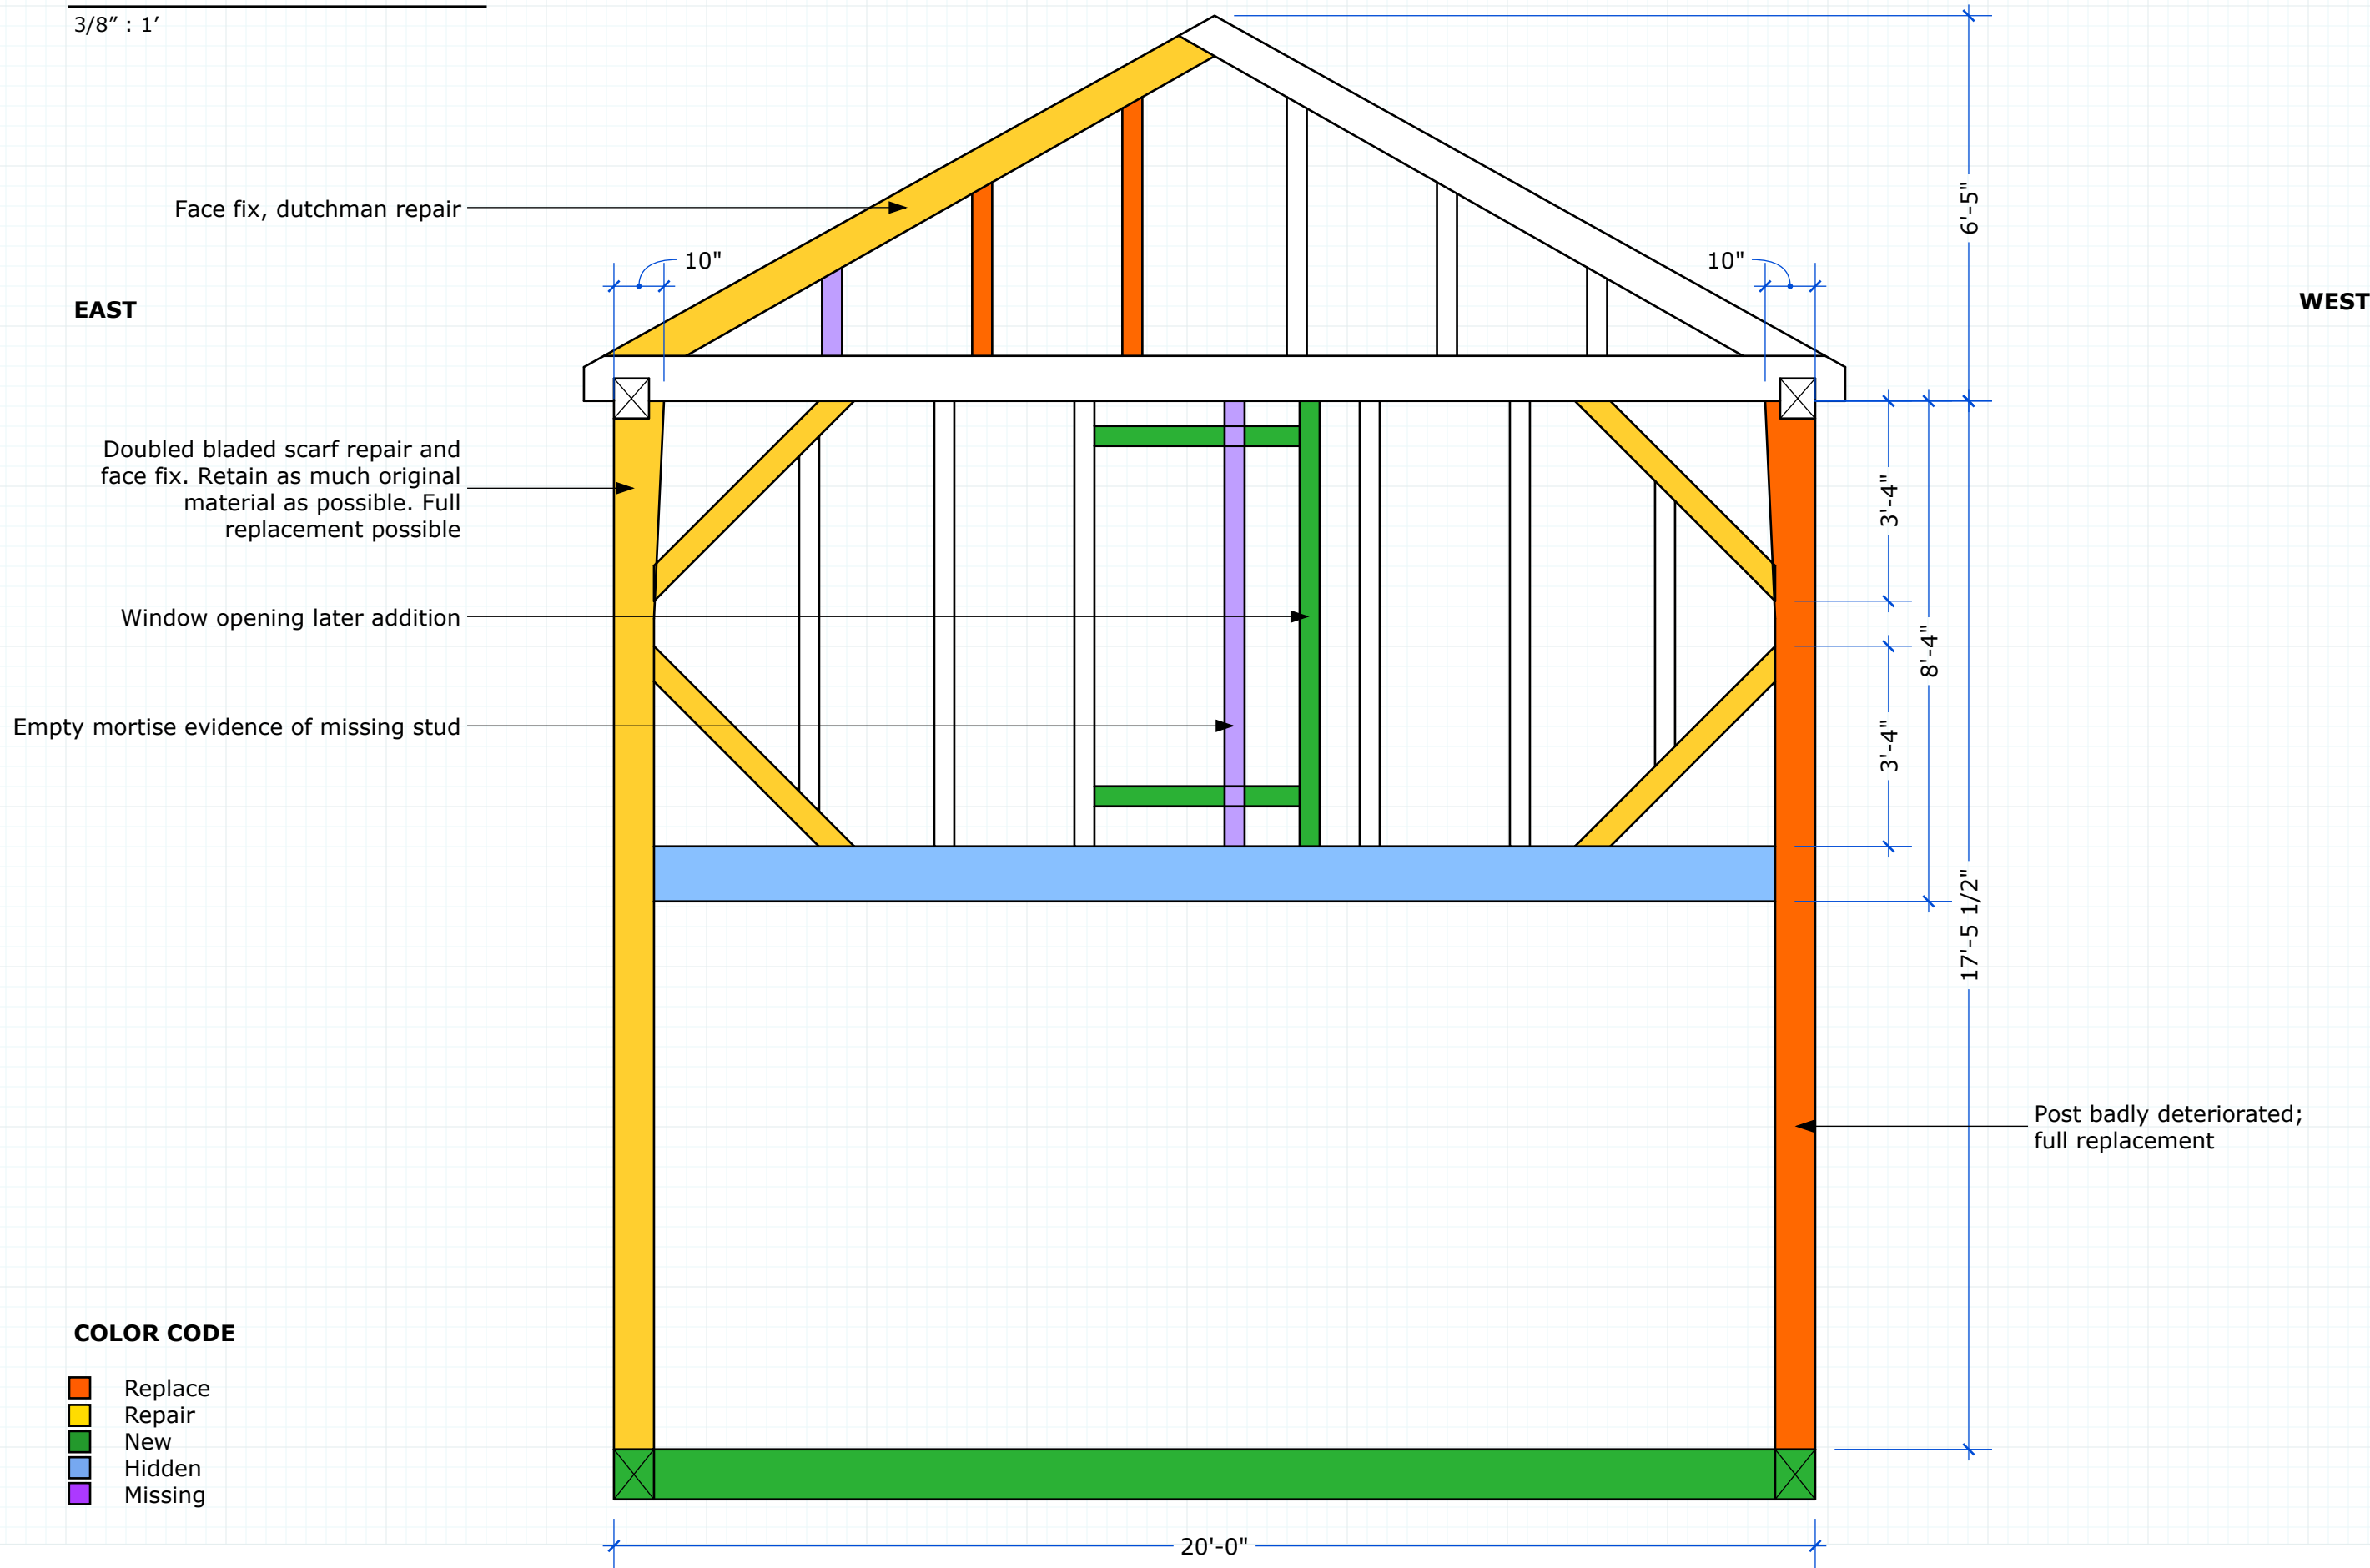
**Bent 1**

Original flying purlin replaced with KD,  
tie beam ends bolstered with KD

Face fix, dutchman repair, possible scarf fix

Face fix, dutchman repair,  
possible scarf repair

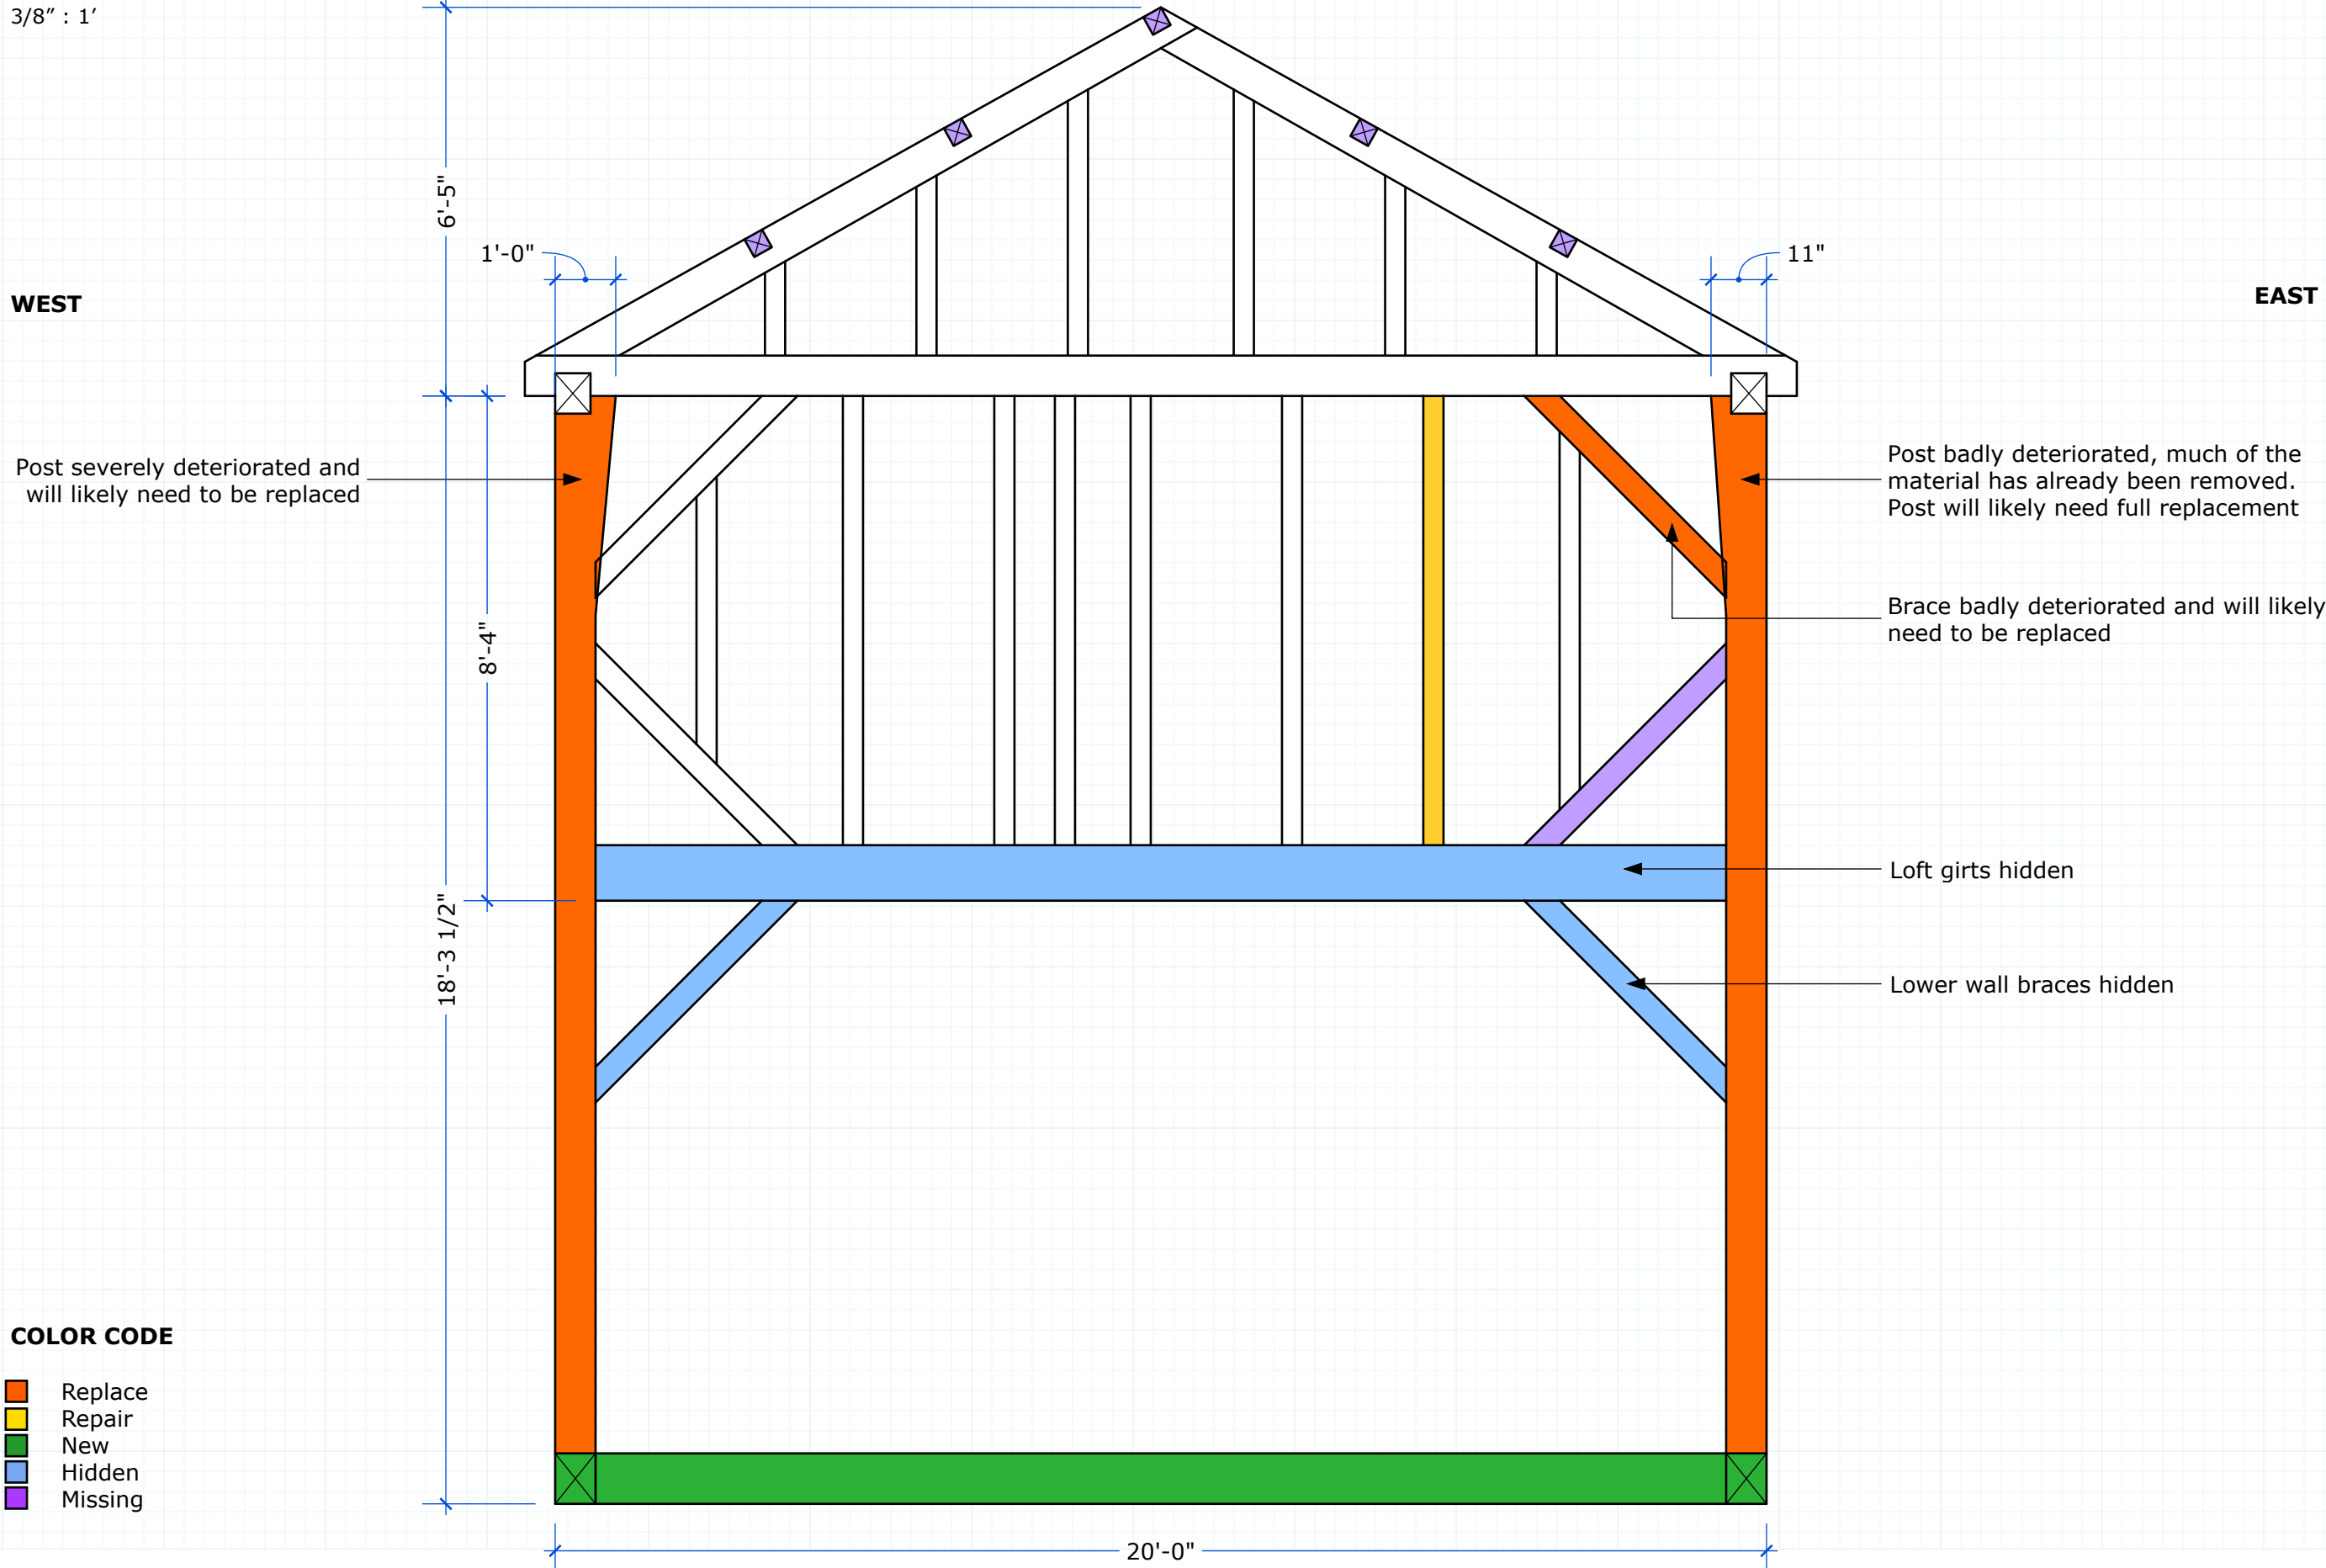
Post severely deteriorated and will likely need to be replaced

Post badly deteriorated, much of the material has already been removed. Post will likely need full replacement

Brace badly deteriorated and will likely need to be replaced

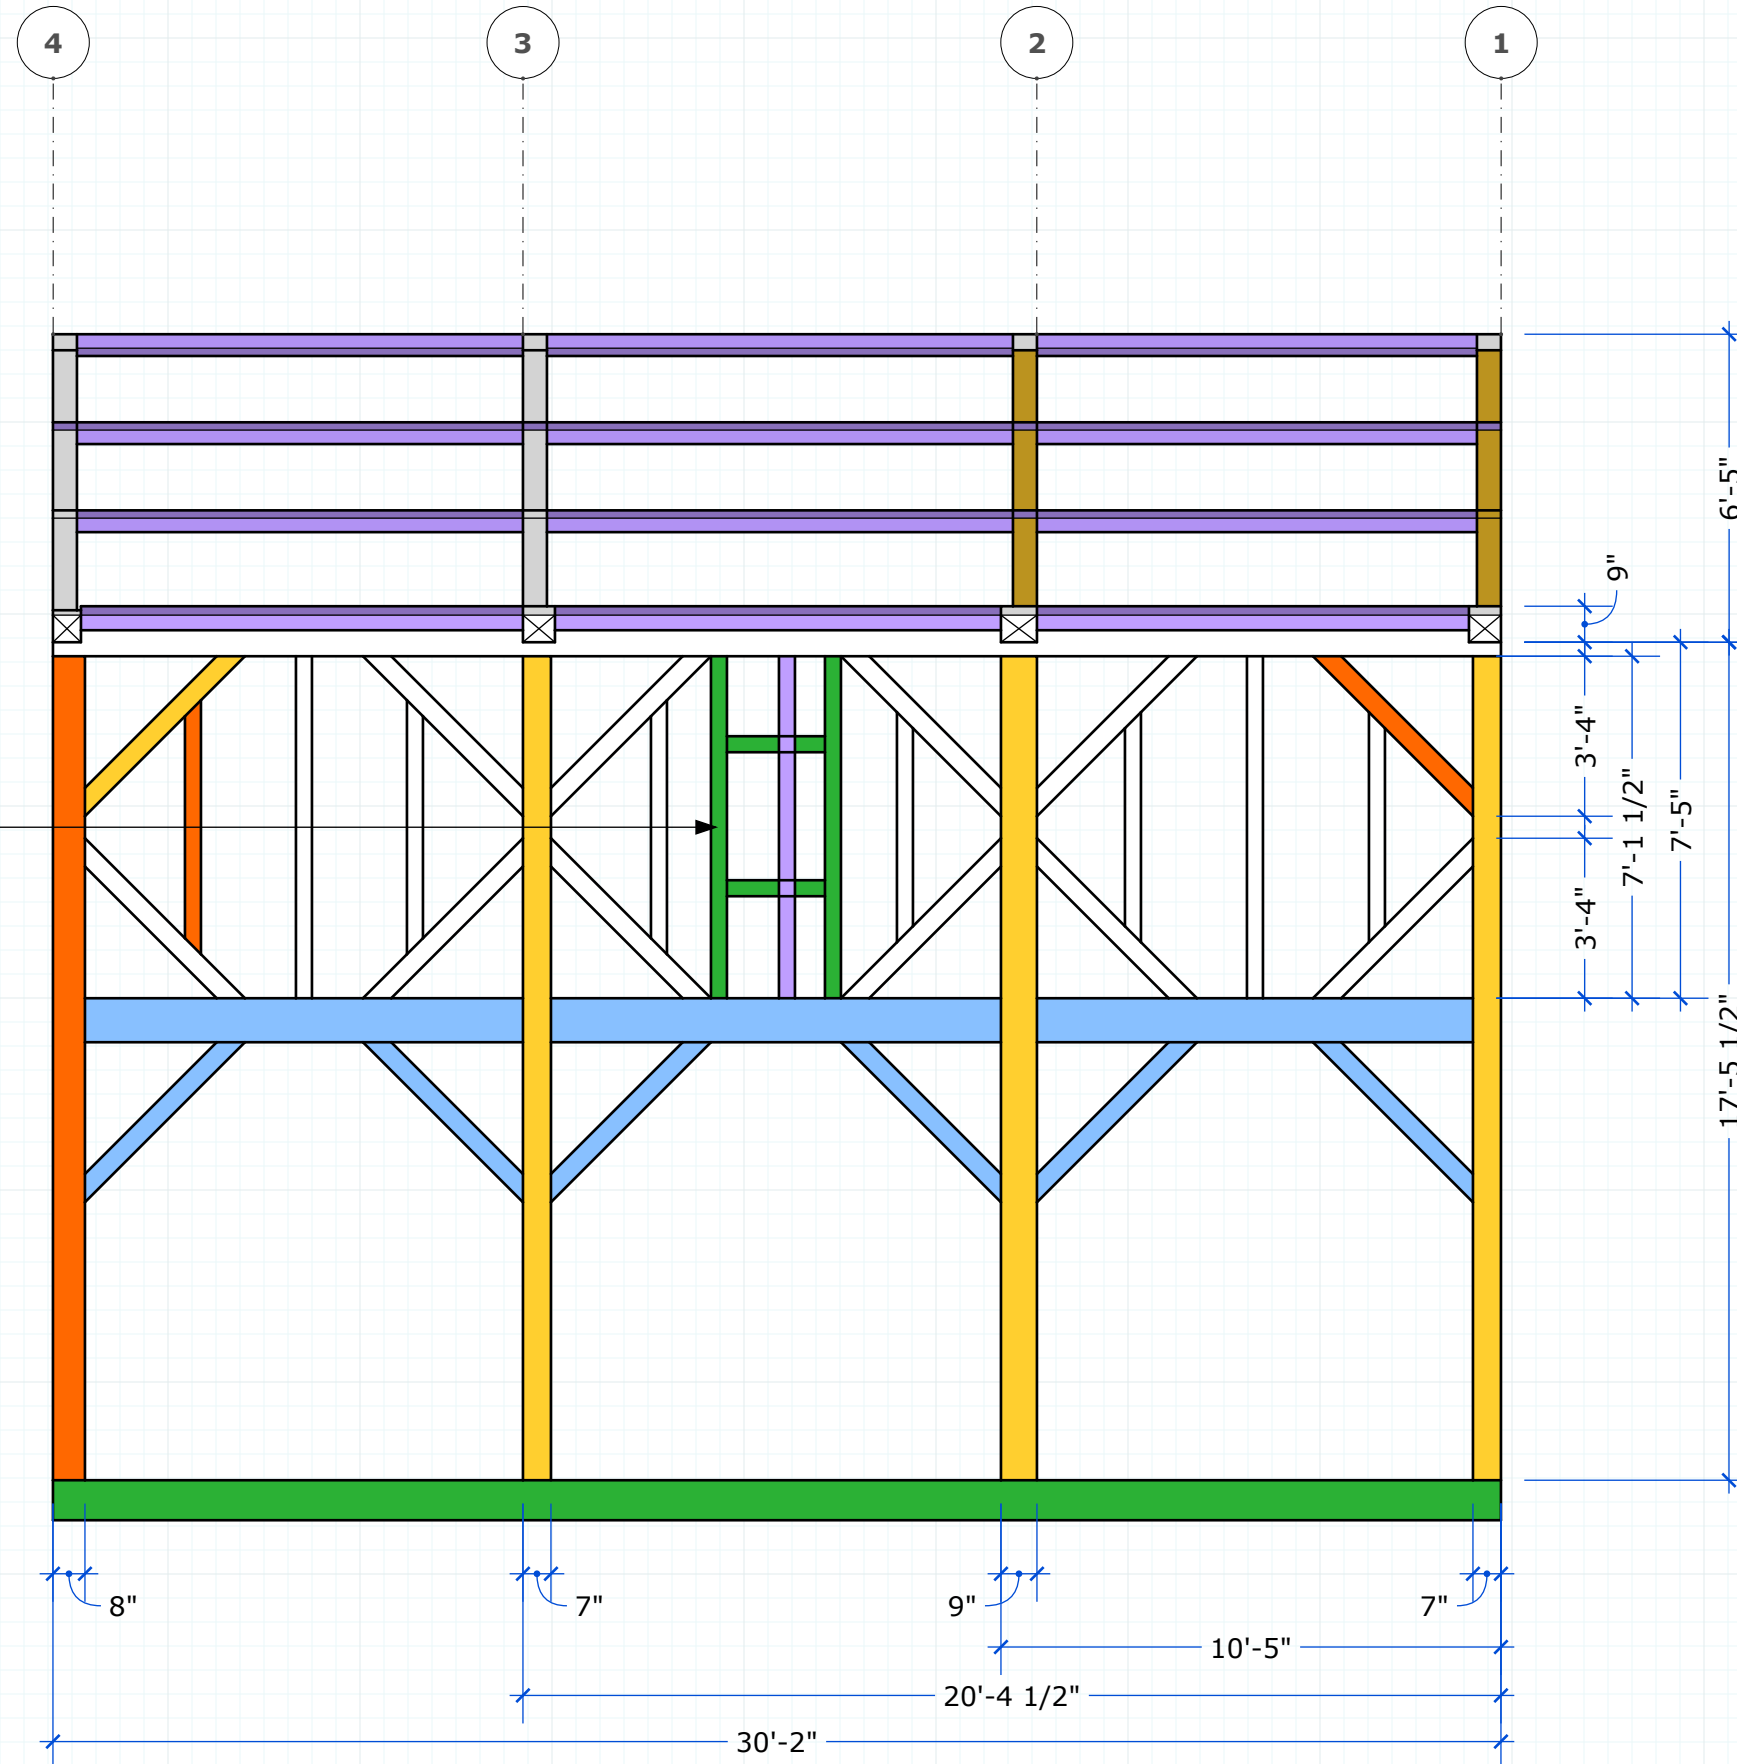
**West (Left) Eave**

Later window addition; original stud location indicated by mortise

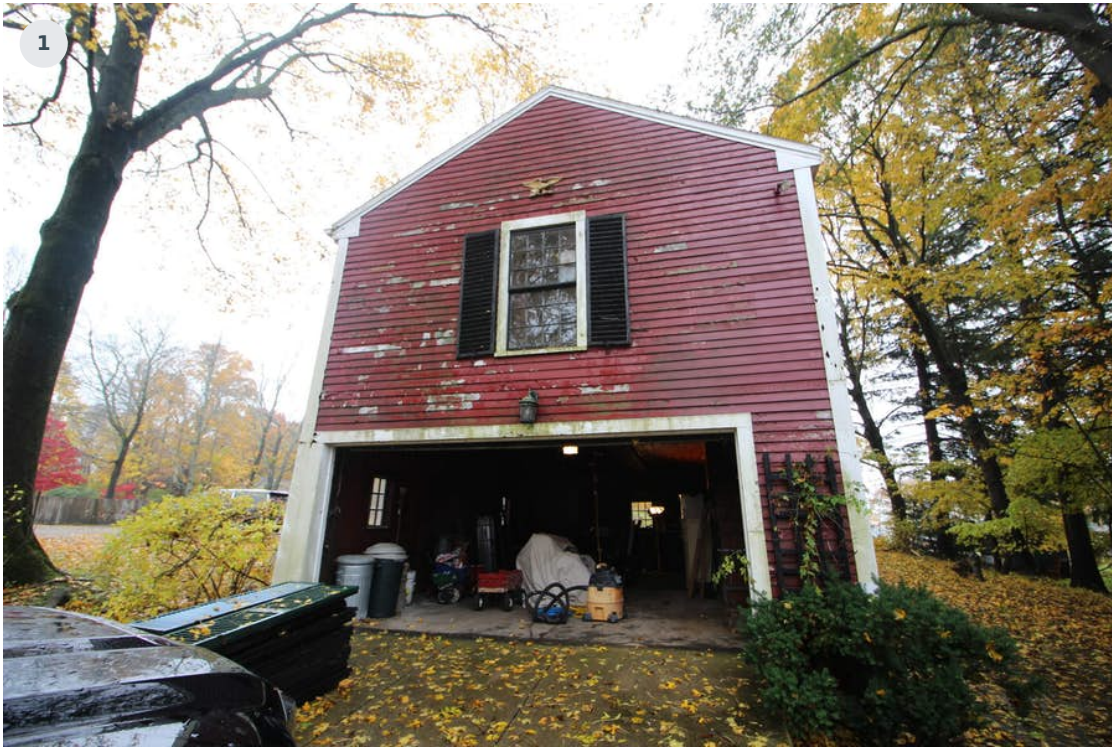
**Front Gable:**  
**Large entry door and concrete ramp is not original to the structure.**

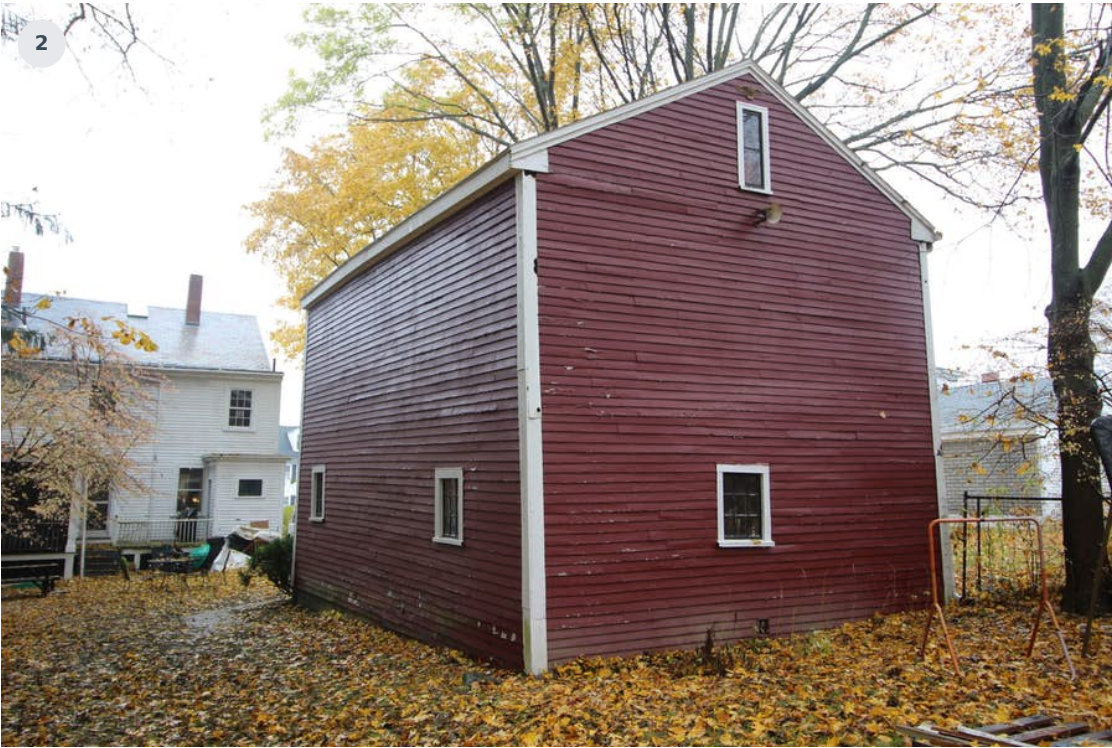
## **Rear Gable:**

**This two story carriage shed sits at grade. The clapboards and trim are not original.**

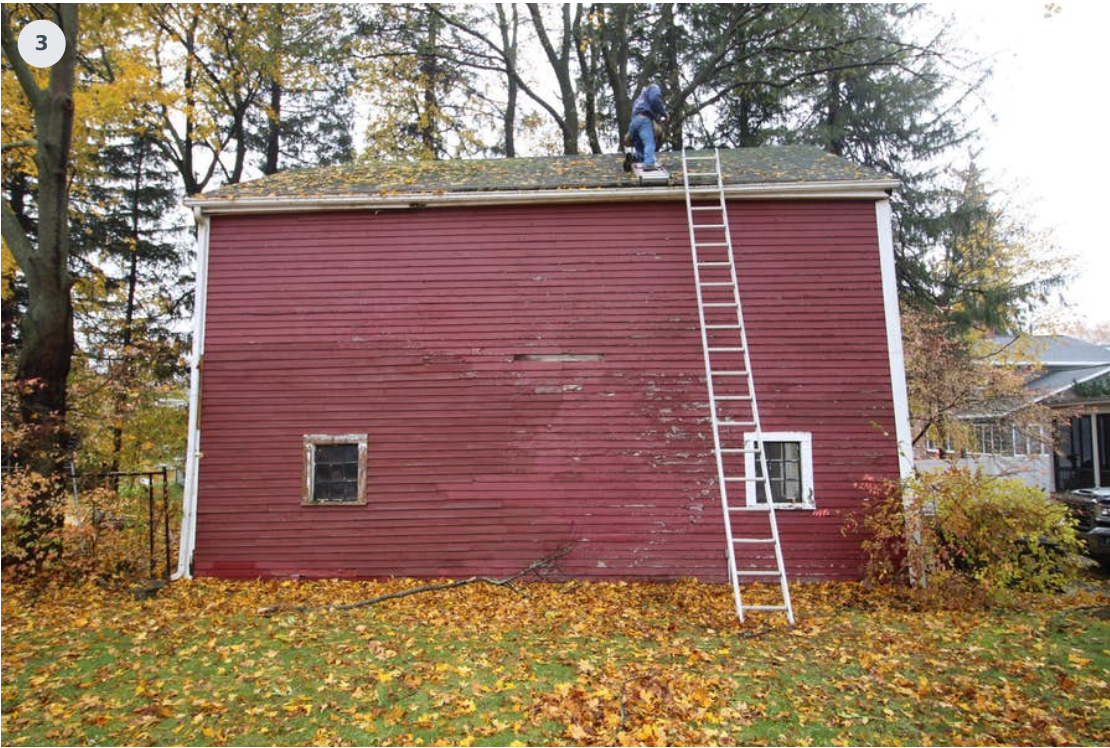
**Left Side Eave (as viewed from the driveway):  
The asphalt roof is near its end of life. Gutters  
are not functional. Clapboards are not original  
and covered in lead based paint. A beautiful  
timber frame is hidden beneath a much later  
exterior.**

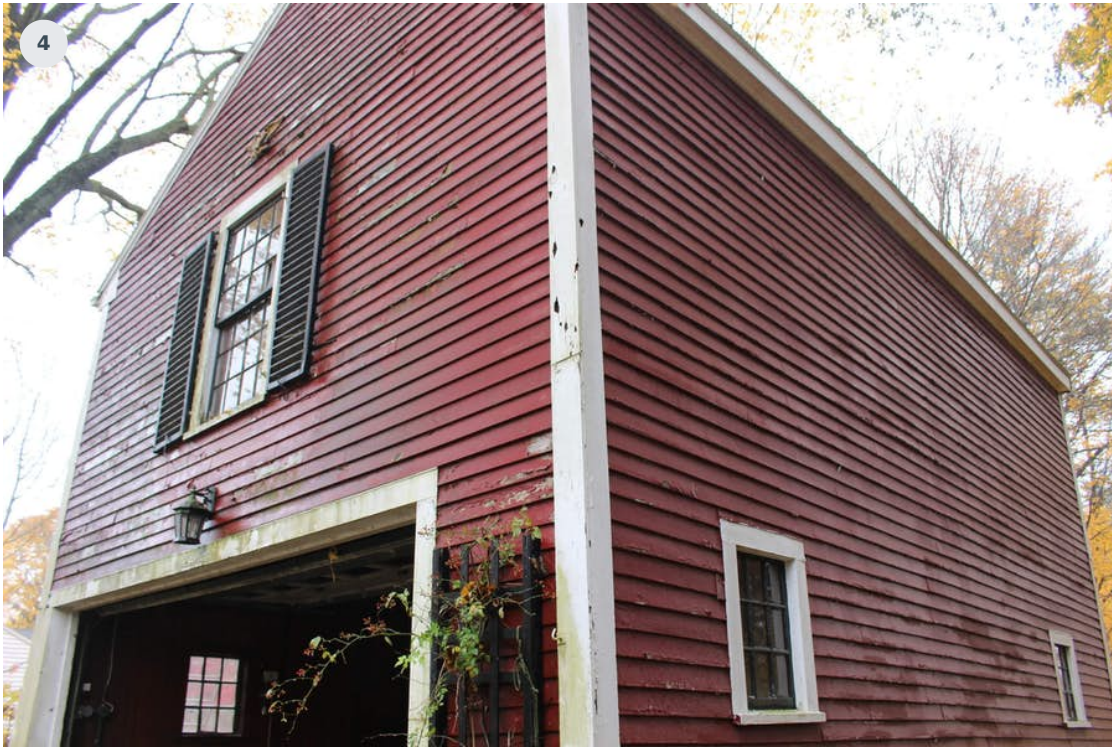
**Corner boards show signs of decay and animal damage. Water penetration is prevalent at the base of the barn where grade has built up over time and covered the sills. This has caused structural decay in the sills and post feet.**

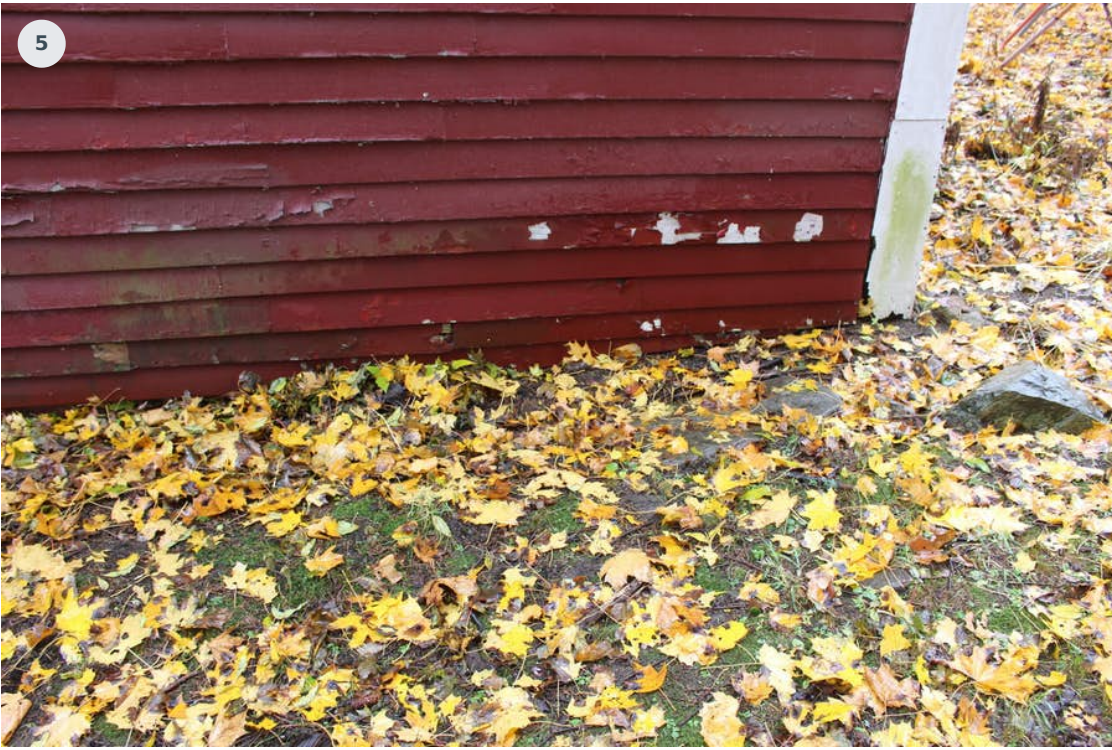
**Right rear corner of the barn is buried below the ground leaving it rotten and settled. The foundation along this side of the barn is minimal at best and does not adequately support the barn.**

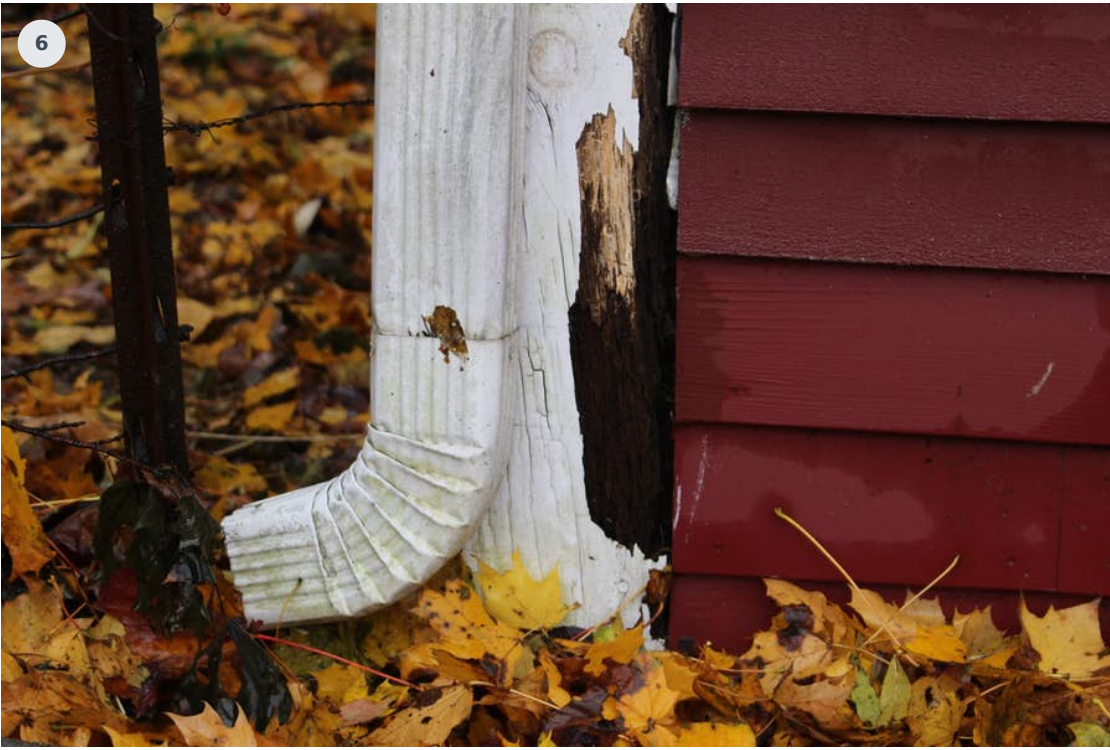
**Severe decay of much newer trim elements, including this corner board, indicate continued water penetration inside the building.**

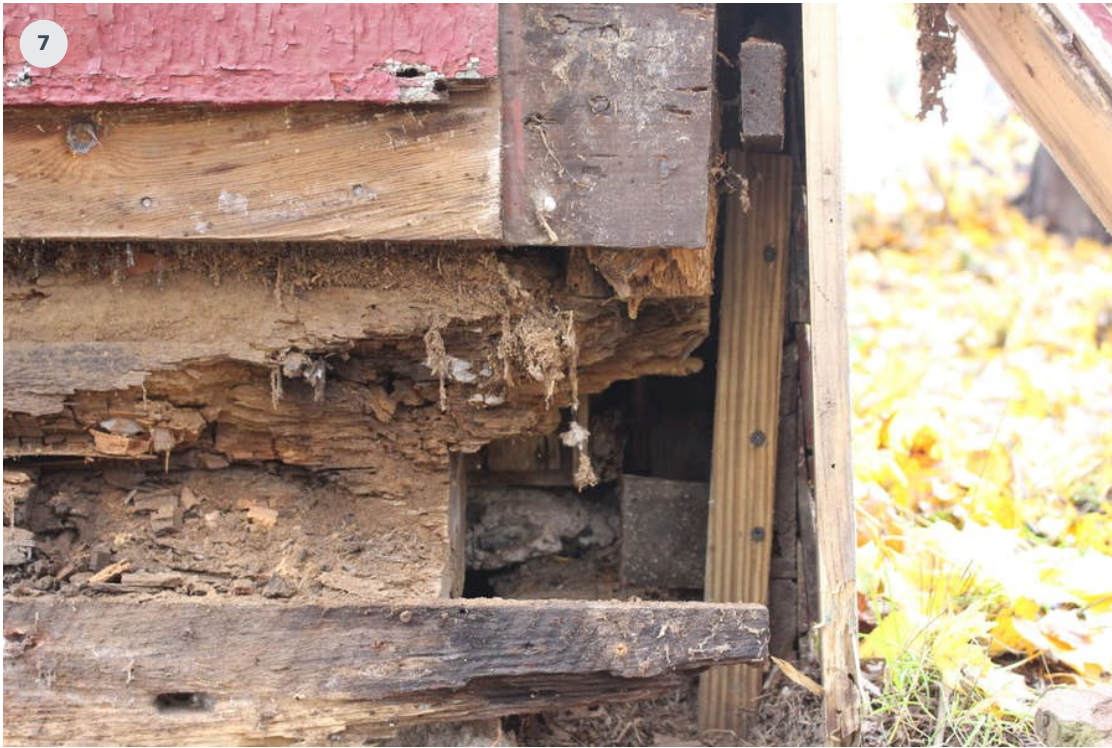
**Extensive sill damage and post foot damage is evident behind the decayed exterior siding and sheathing.**

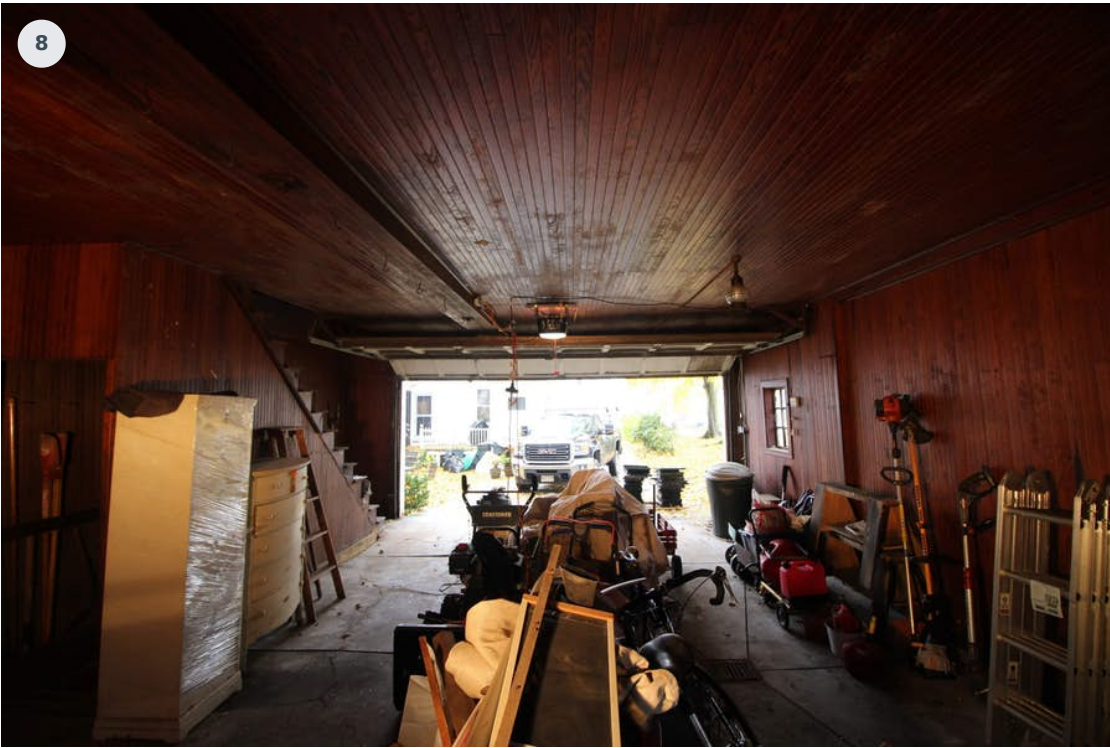
### **First Floor:**

**The bead board ceiling and walls hide a much earlier timber framed structure. This bead board was likely added in the first part of the 20th century. The barn frame is 18th century. This garage space is very functional for storage.**

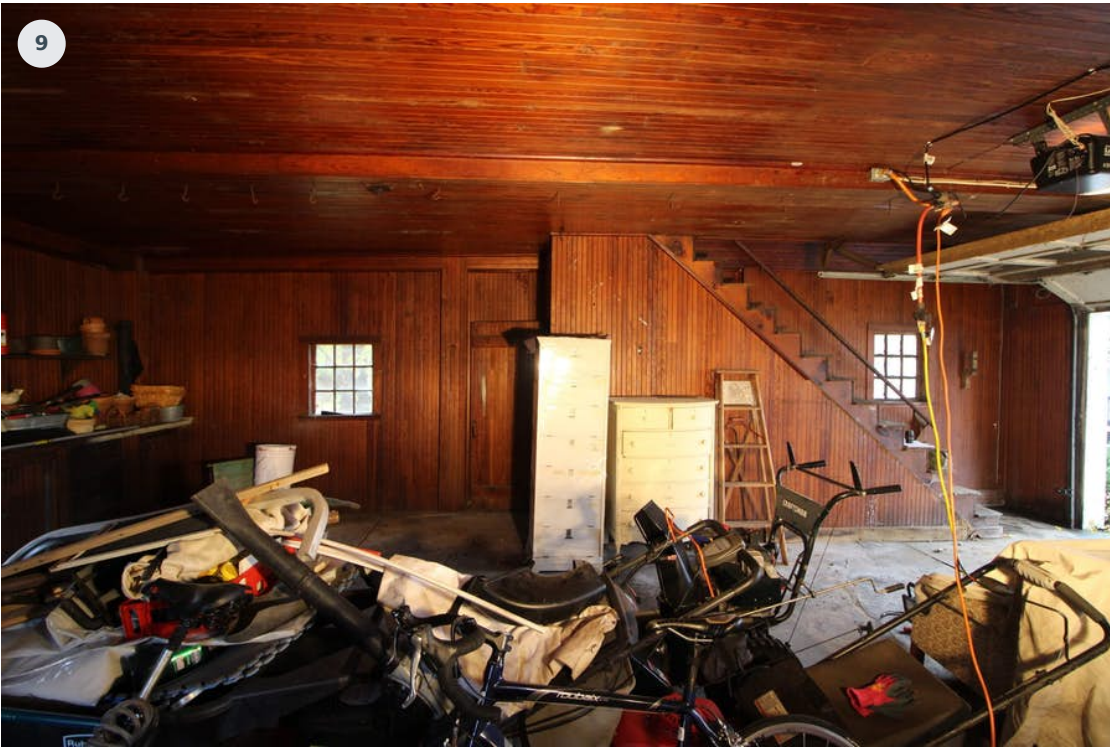
**A very nice staircase rises from the first floor to the loft space above. The ceiling is fully clad in bead board and hides original loft framing timbers. The garage door was added much later.**

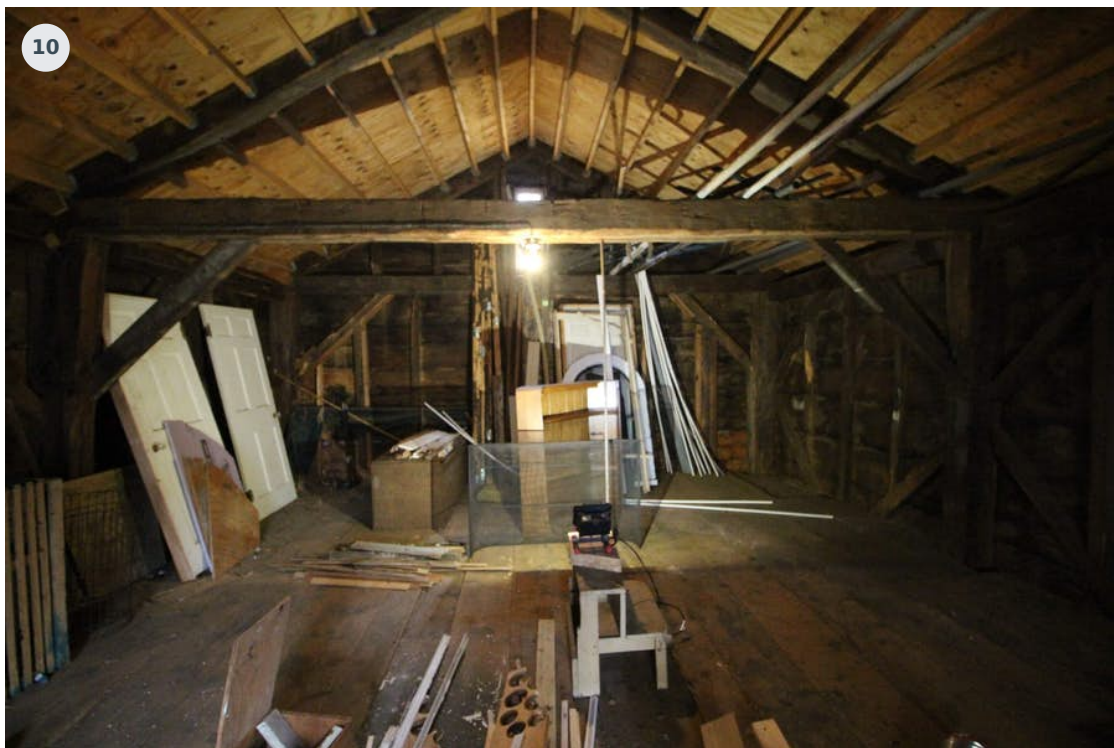
**The loft upstairs reveals the original timber frame complete with continuous tie beams and principal rafters. The tie beams are fully braced and cross over the continuous top plate and flared post at each bent. This english form of timber framing is prevalent during the 18th and early 19th century in New England. The barn is both authentic and very early. Very few of these structures have survived in Newburyport.**

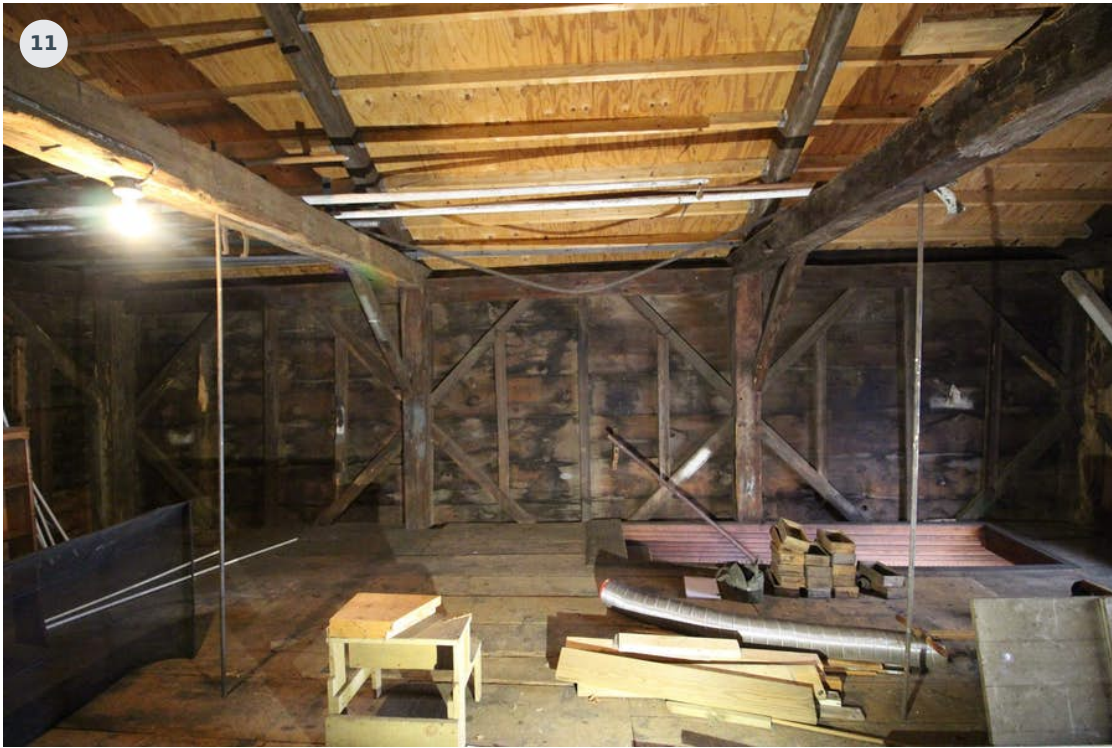
**This barn is very strong. It hosts ascending and descending braces which stiffen the frame tremendously. It also hosts both heavy timber posts with studs between in each bay. This is structural redundancy at its best. The top plate runs the full length of the barn eave wall. The tie beams are continuous. The entire frame is sheathed with wide pine boards that are beveled along both edges and fit together so tightly that they can shed water without exterior siding. Common purlins have been removed between principal rafters and plywood has replaced vertical sheathing boards.**
