**Newburyport Historical Commission  
DEMOLITION PERMIT APPLICATION (Step 1)**

Property Address: 195 High Street

# DeLisle Barn

Existing Conditions Assessment Photo Documentation

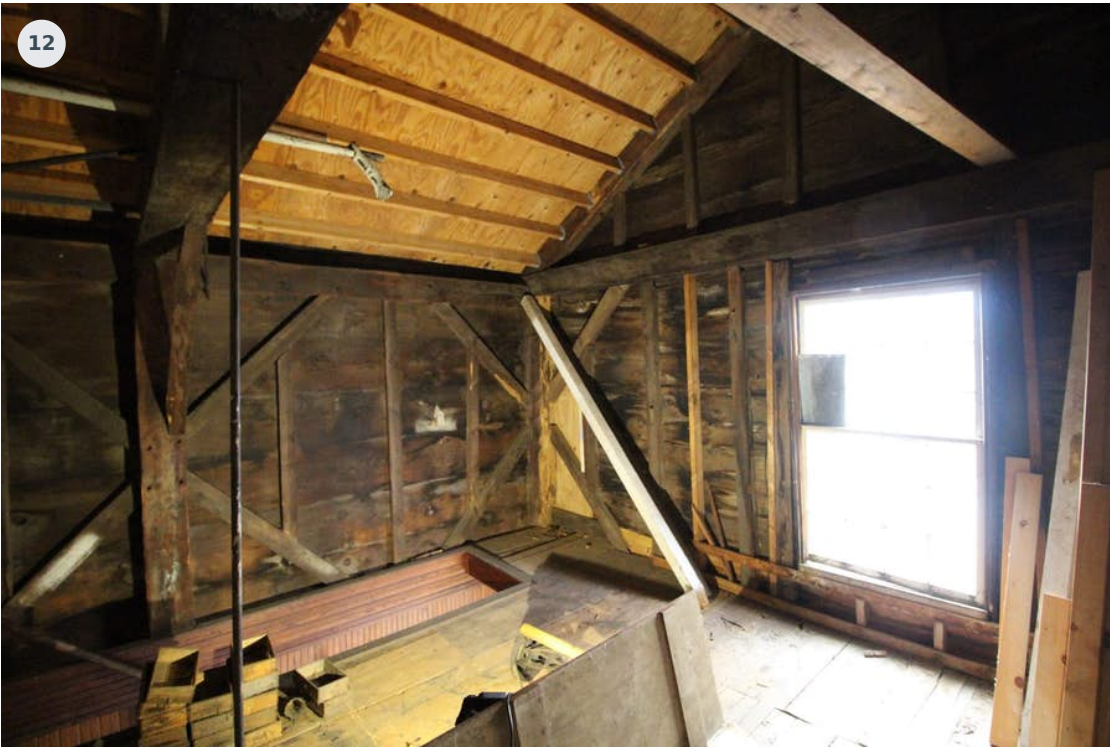
**Some powder post beetle damage is present in the frame, but it is not a structural issue. Water damage in the corner posts, however, will require their in kind replacement. As much of the original frame as possible will be saved and repaired as necessary.**

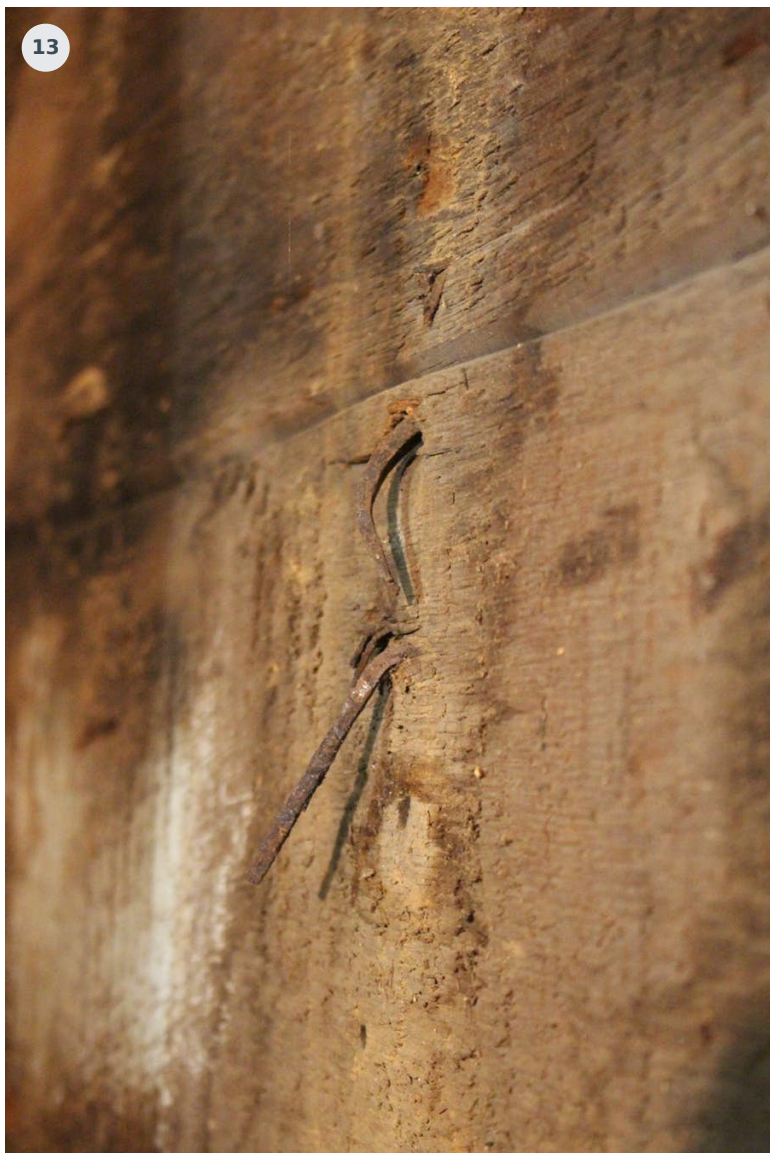
**This is a close up of the wonderful beveled sheathing that embraces the frame. In this photo, two original wrought nails penetrate through the sheathing and once fastened to an interior stud that has since decayed. The beveled sheathing remains viable despite the stud being rotten and missing.**

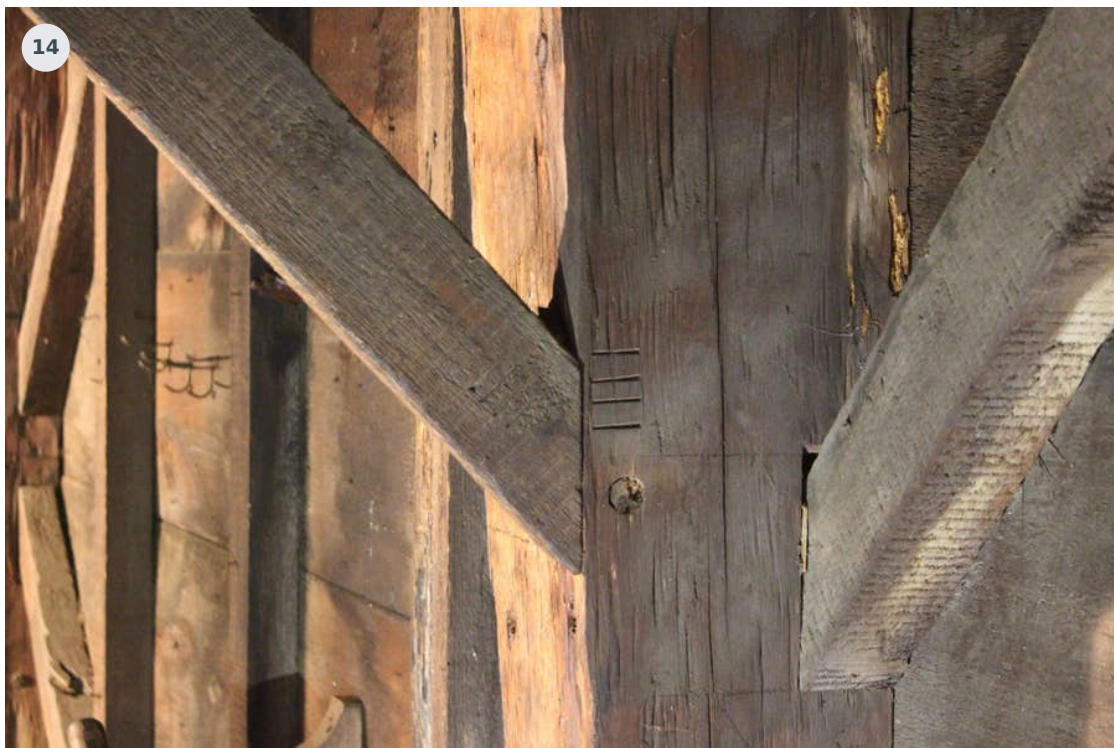
**So much of this frame is original and remains viable and beautiful. In this photo, one of the interior posts hosts the marriage marks and lay out lines placed there by the original builder. These marks indicate the position of framing parts in the overall timber structure. Posts are hand hewn while the braces are up and down sawn. Saw mills were available for the smaller timber elements very early on in Newburyport. It is common to see hewn and sawn timbers in the same structure.**

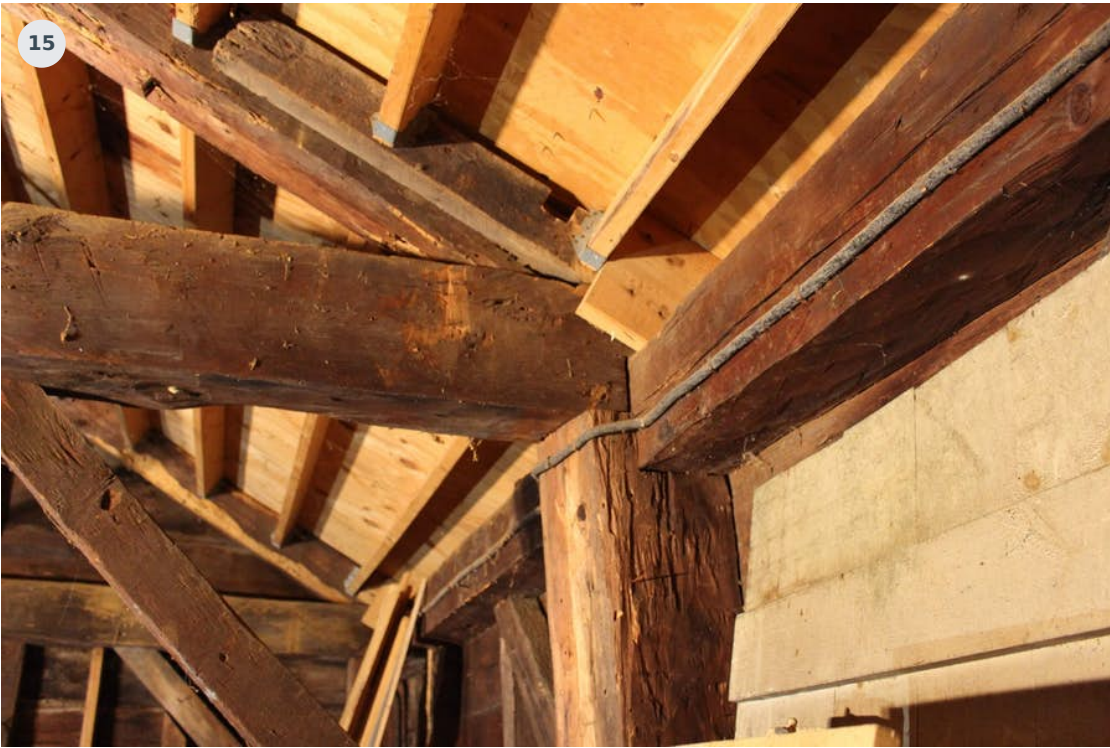
**A principal rafter engages the continuous tie beam. Close inspection reveals the original purlin pockets in the rafter since replaced with dimensional lumber and metal hangers. The tie beam crosses over the flared post and the dropped eave wall top plate creating the "English Tying Joint" so prevalent in the 18th century.**

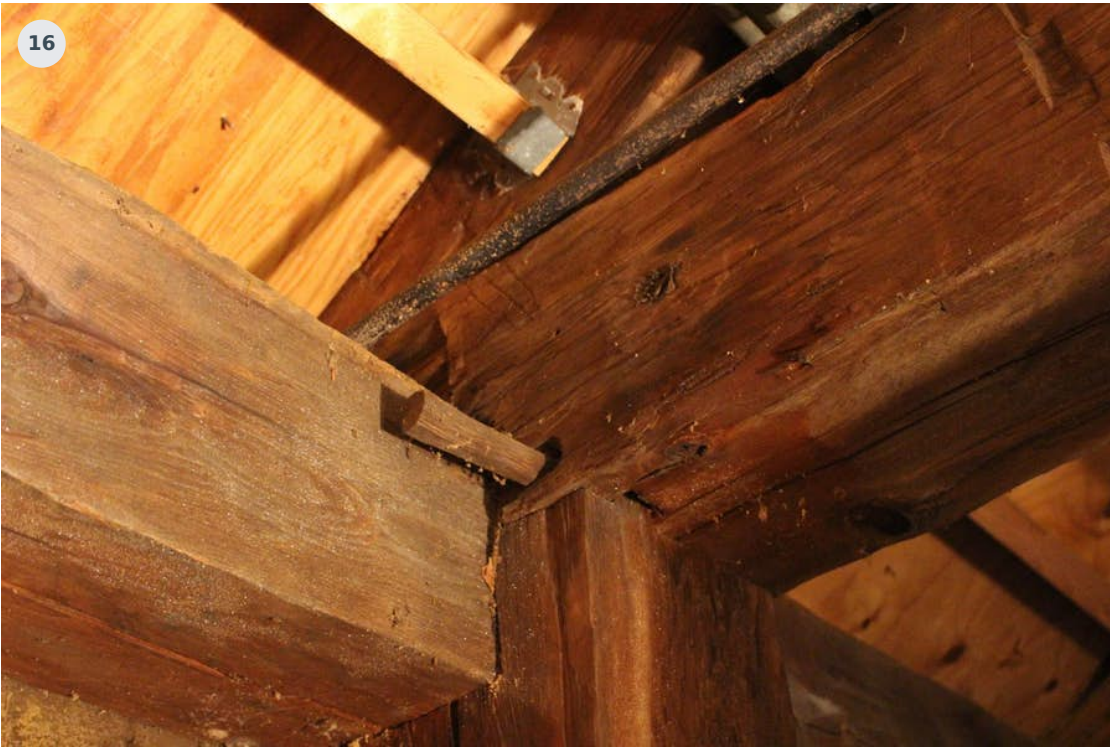
**A close up view of the English tying joinery including the post top, top plate, and tie beam. The rafter is also at the top of the photograph. A wooden peg secures the post top to the tie beam.**

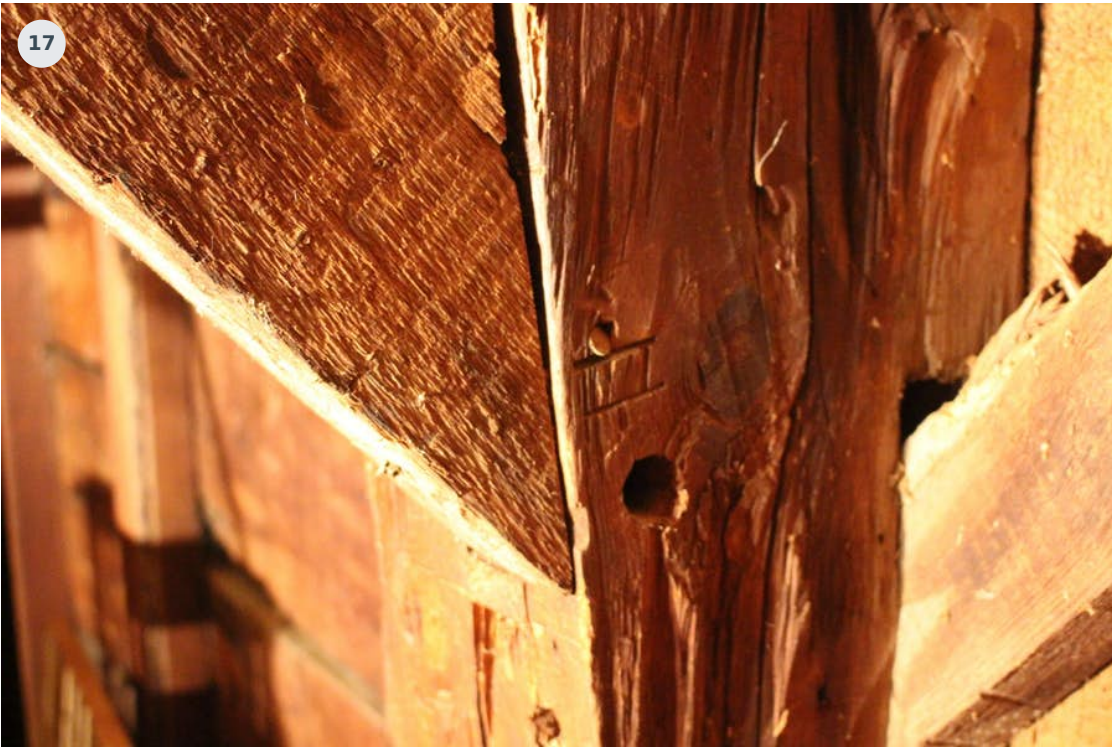
**A close up view of the hand hewn post with its marriage mark indicating the position of the sawn brace that engages it. The peg hole reveals a missing peg.**

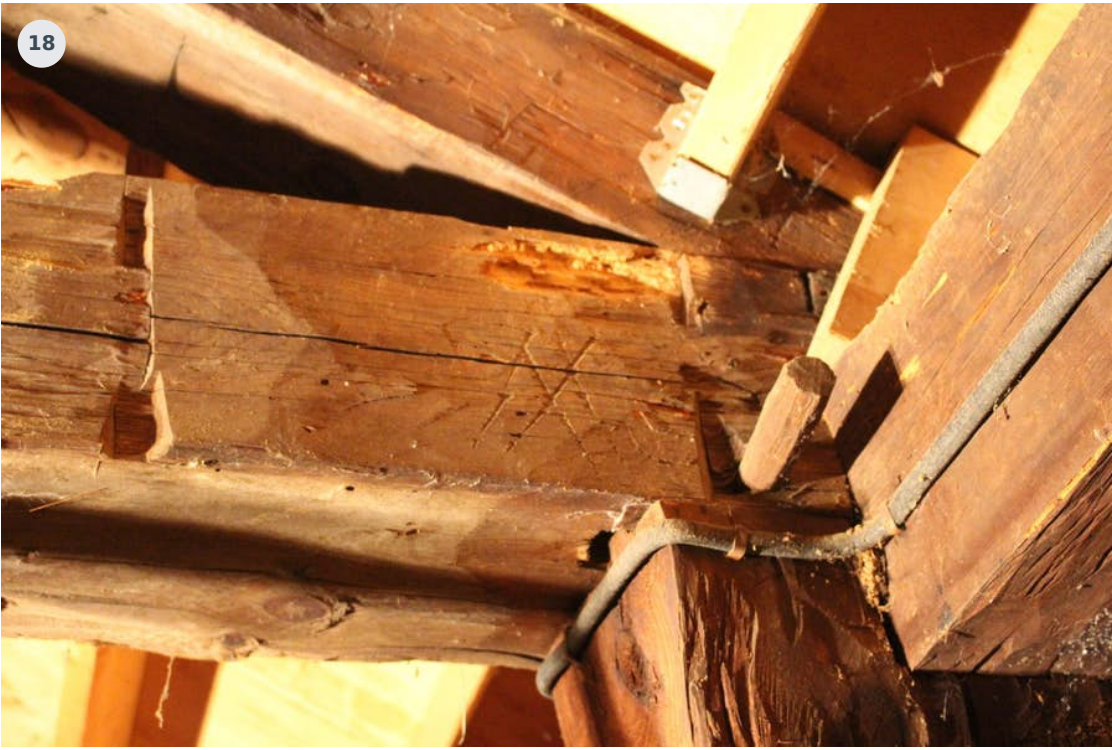
**Another close up of the English joinery in this wonderful barn. The hewing marks are very apparent and some tooling marks are visible in the tie beam.**

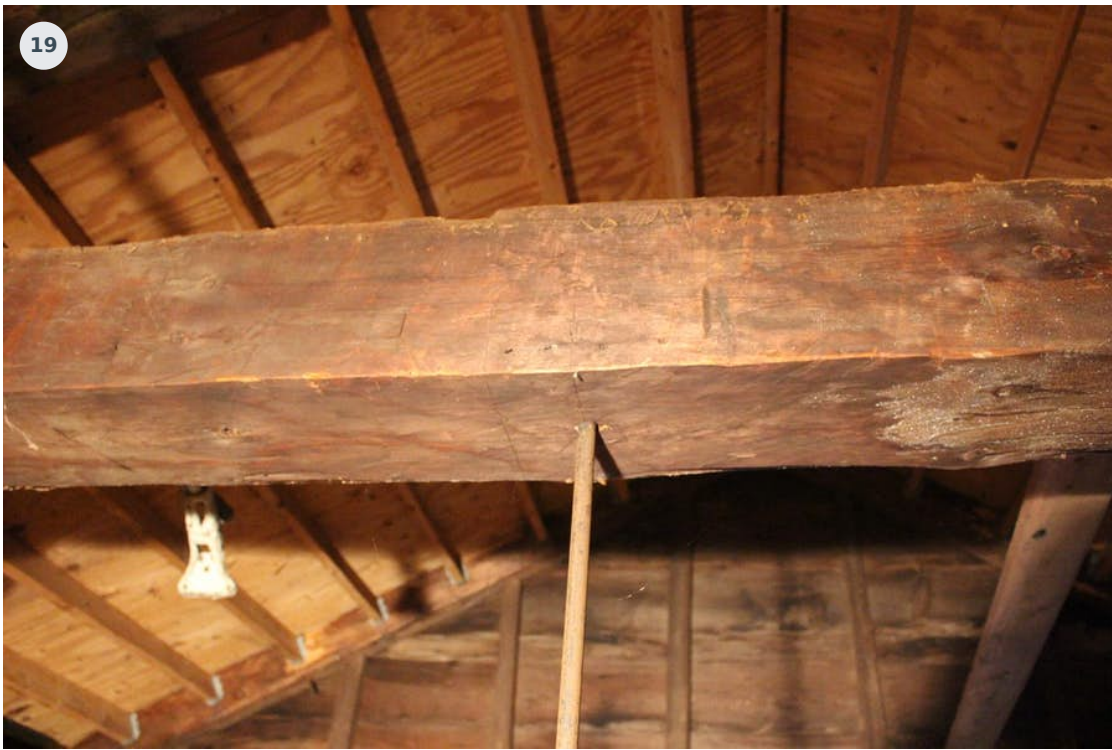
**The interior tie beams accept vertical rods that support the loft floor framing. This framing is hidden by bead board below. These rods are added later to this frame to allow for open space on the first floor level.**

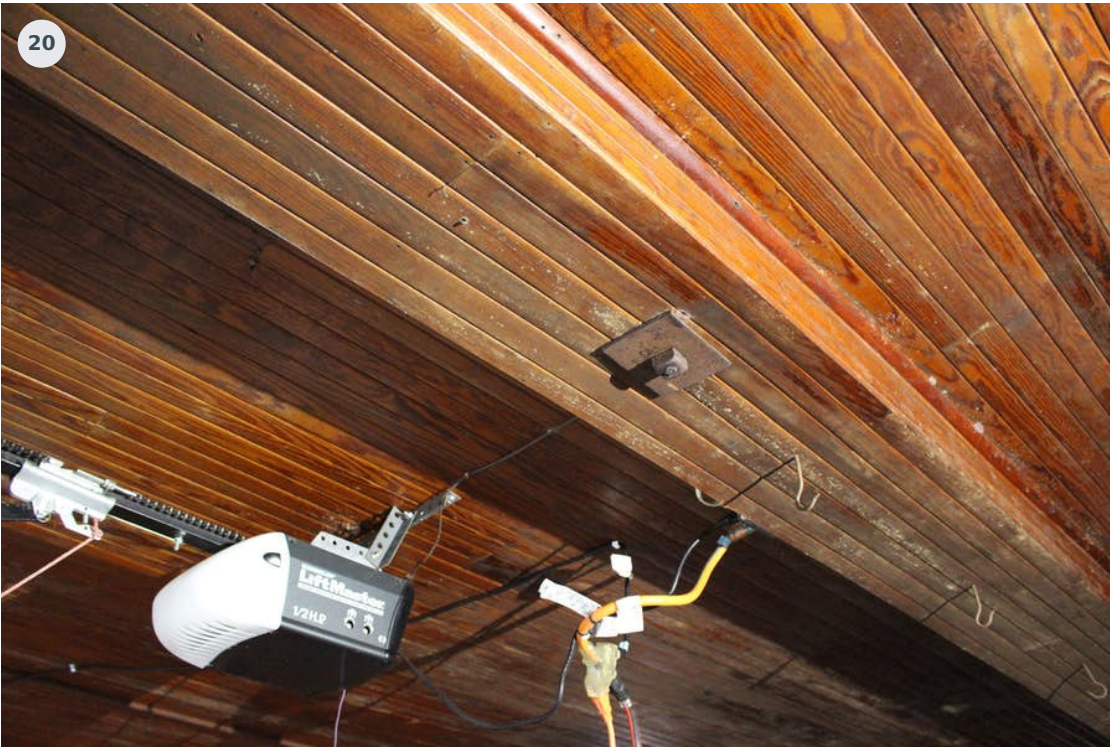
**The bead board ceiling and the beams they clad are supported with vertical rods from above.**

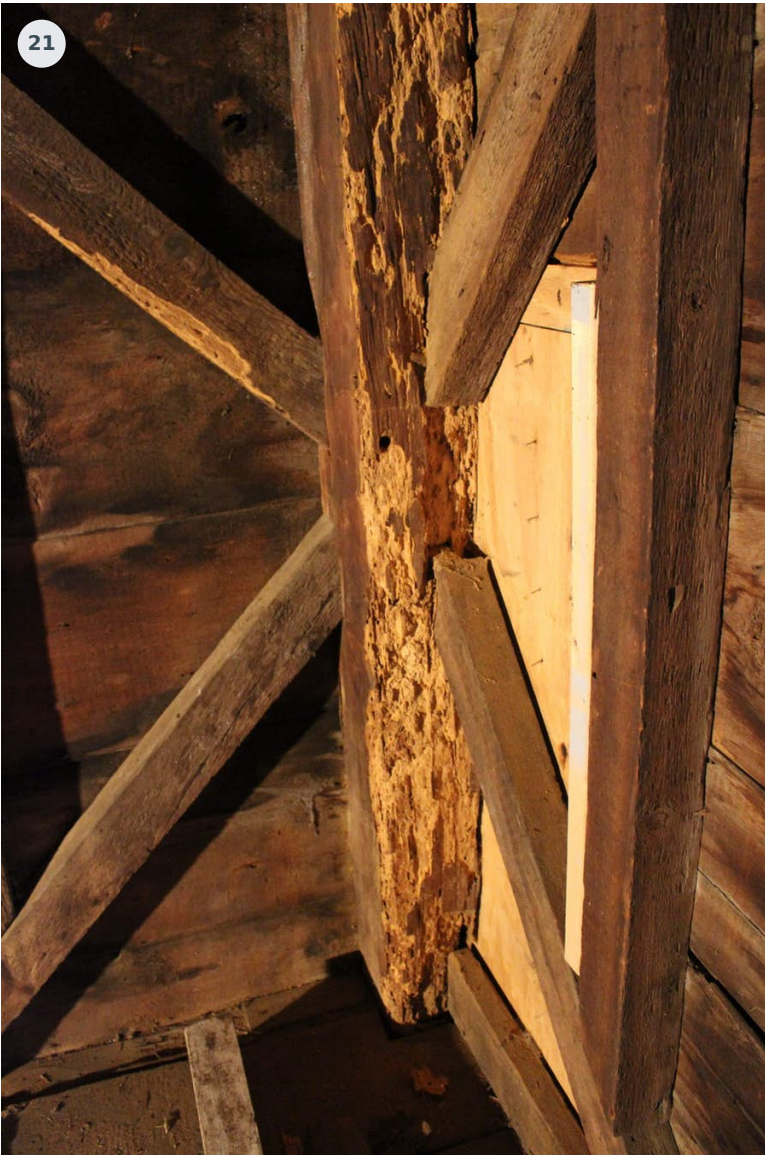
**The level of damage in the corner posts require in kind replacement. Sheathing and braces can be saved and repaired.**

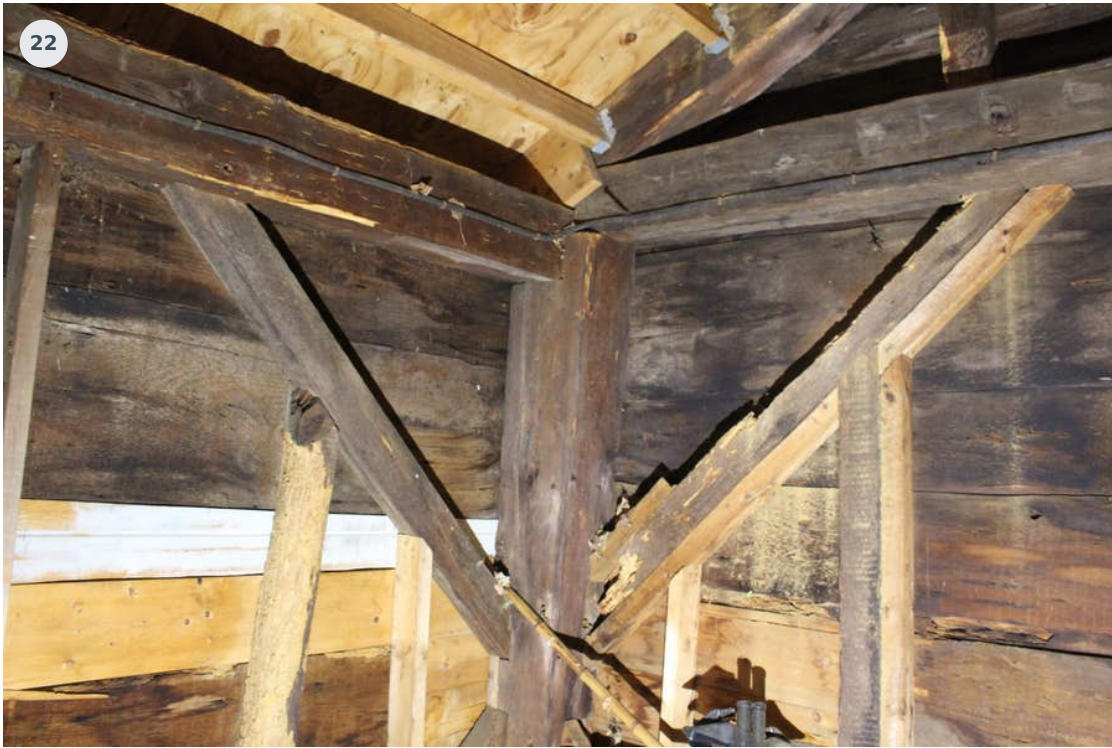
**New sheathing in this corner indicates long term water damage and the brace has rotted away from the corner post. Attempts were made to fill in the rot with new materials, but it is time to replace in kind and make the structure sound again.**
