Re: Additional Photos to Accompany Structural Engineer's Report;  
21-23 Walnut Street, Newburyport, MA (the "Property")  
Assessor's Map: 60 Lot: 25 A/B

Photos to accompany letter, dated August 10, 2020 from Fix Engineering to Newburyport Historical Commission

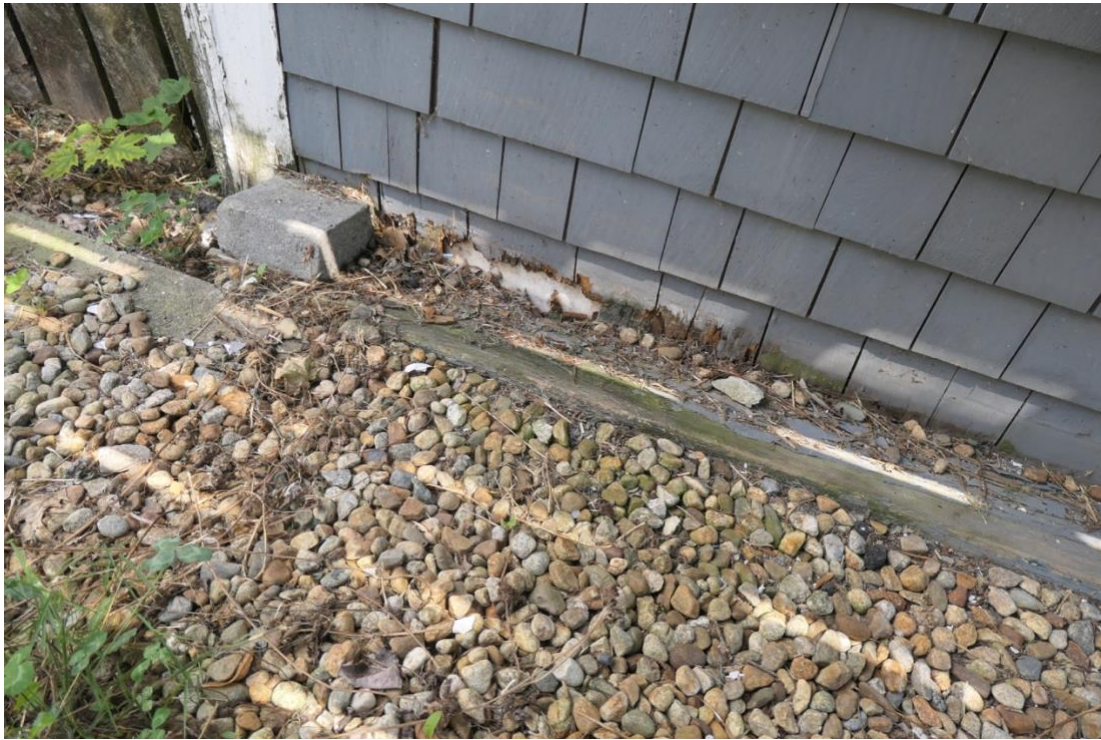
Rot of siding and sheathing at base of rear wall due to grade too high.

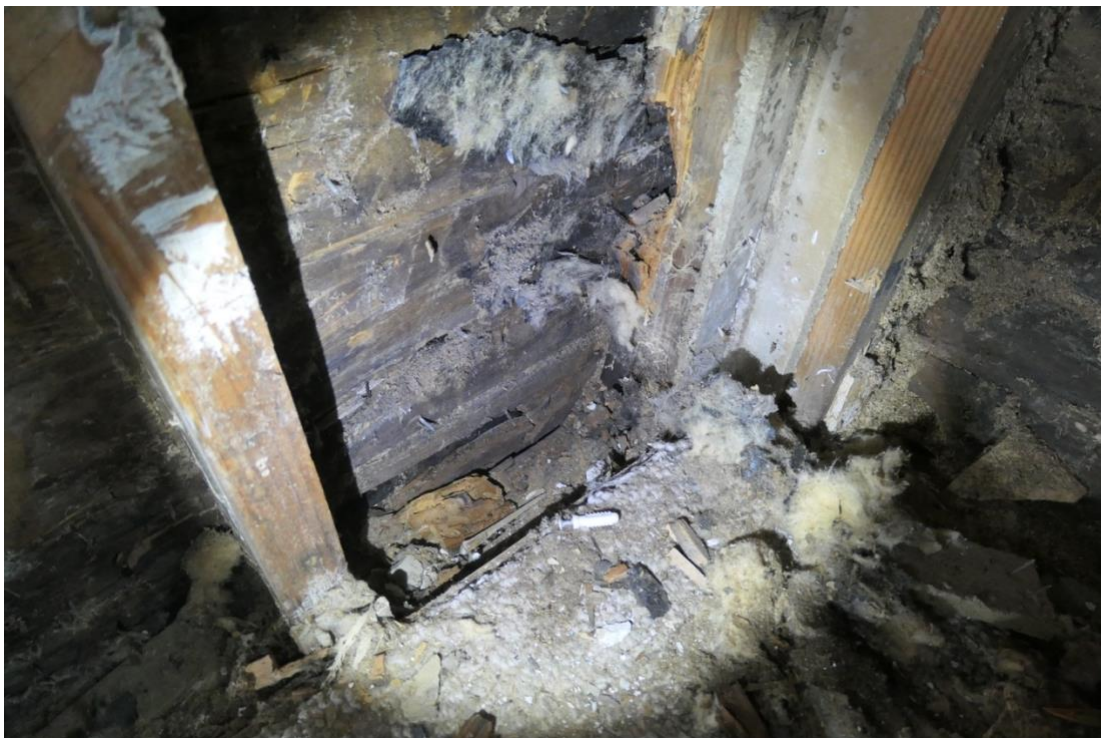
Interior view of rot and deterioration of rear wall.

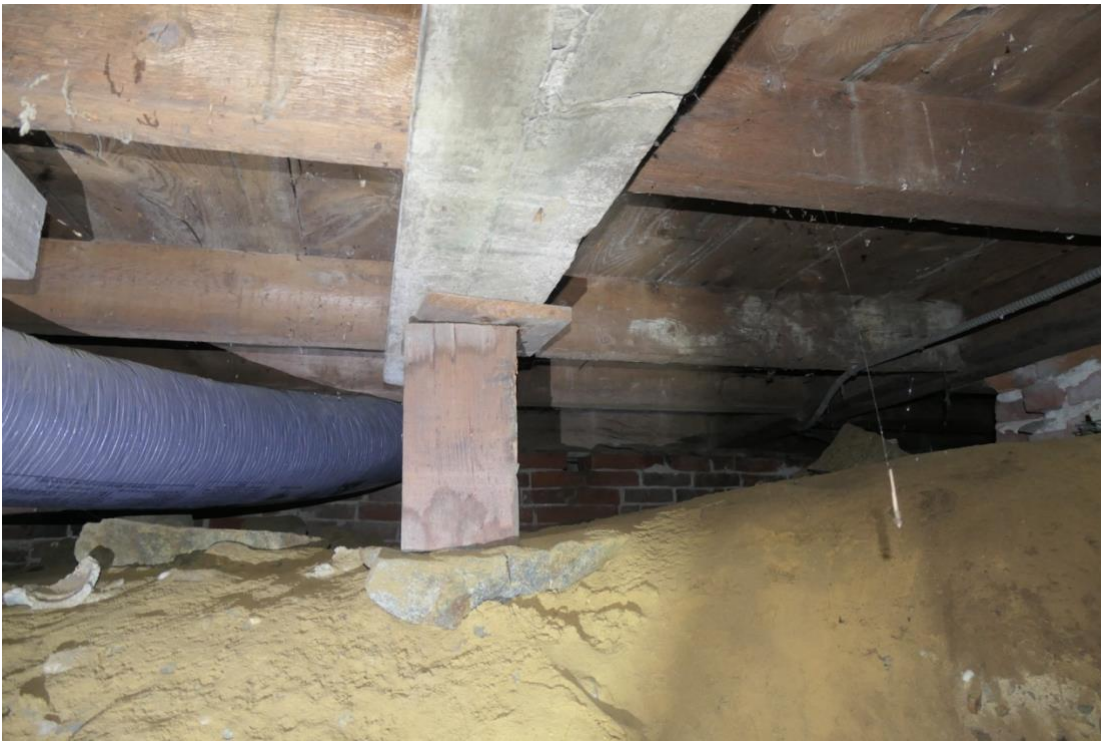
In crawl space: wood column set on unstable stone.

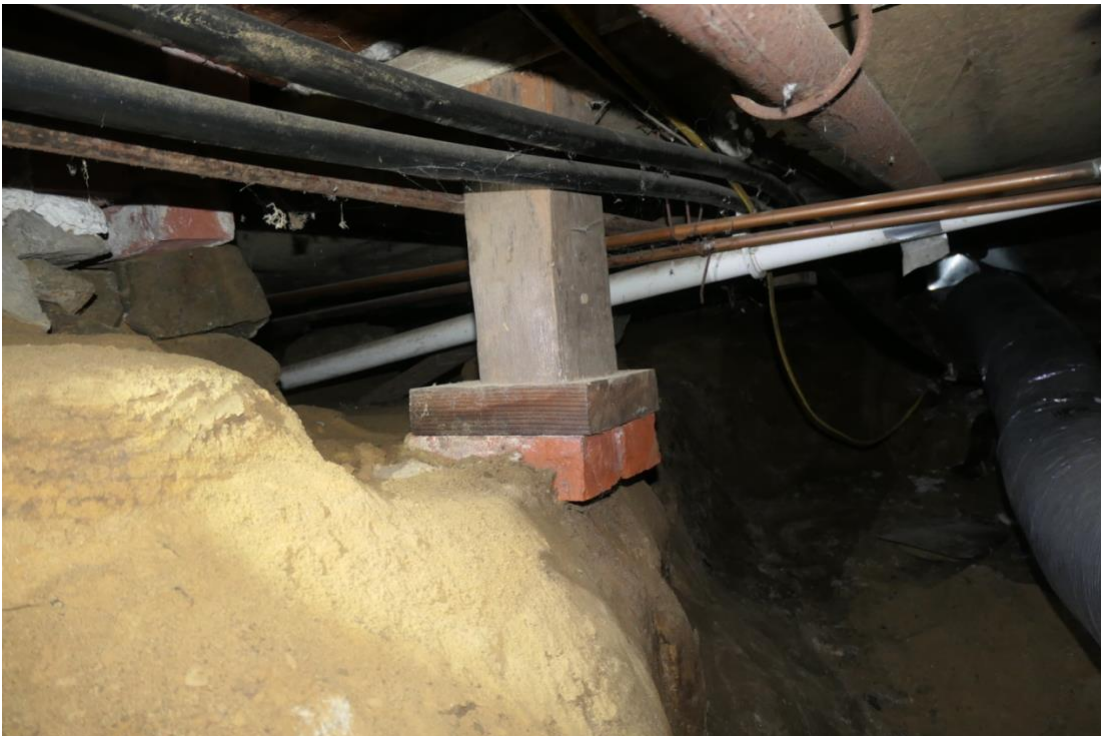
In crawl space: wood column set on unstable wood/ brick footing.

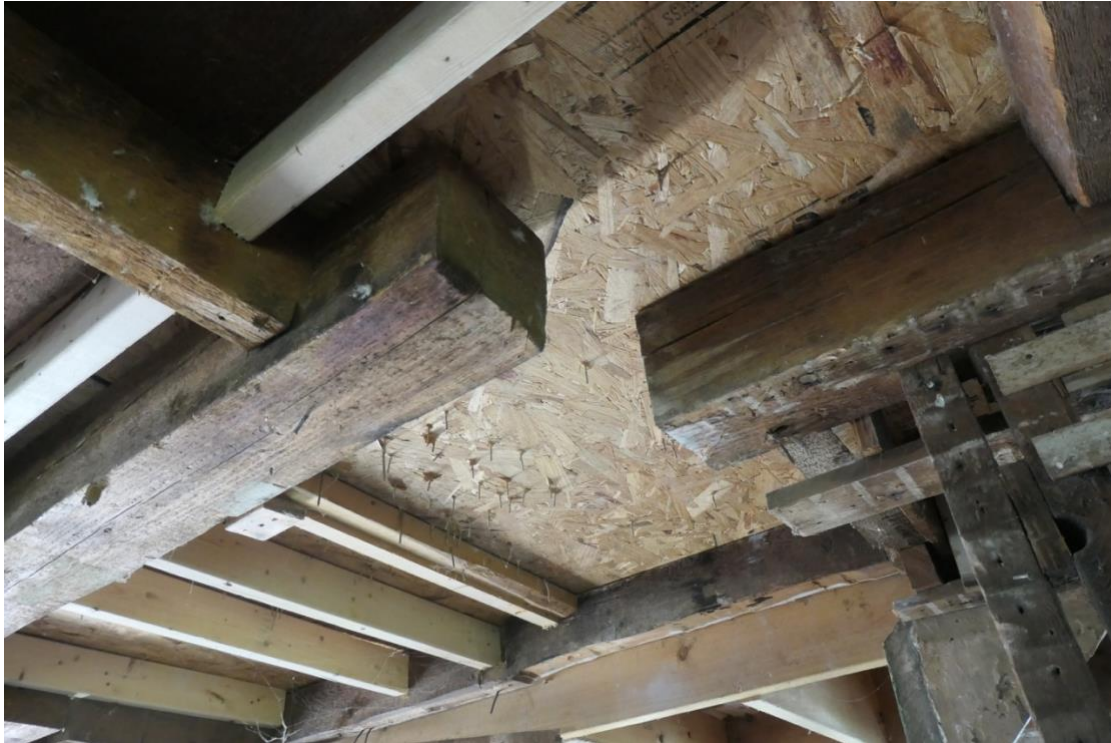
Second-floor framing: beams cut off, resulting in an unsafe condition.

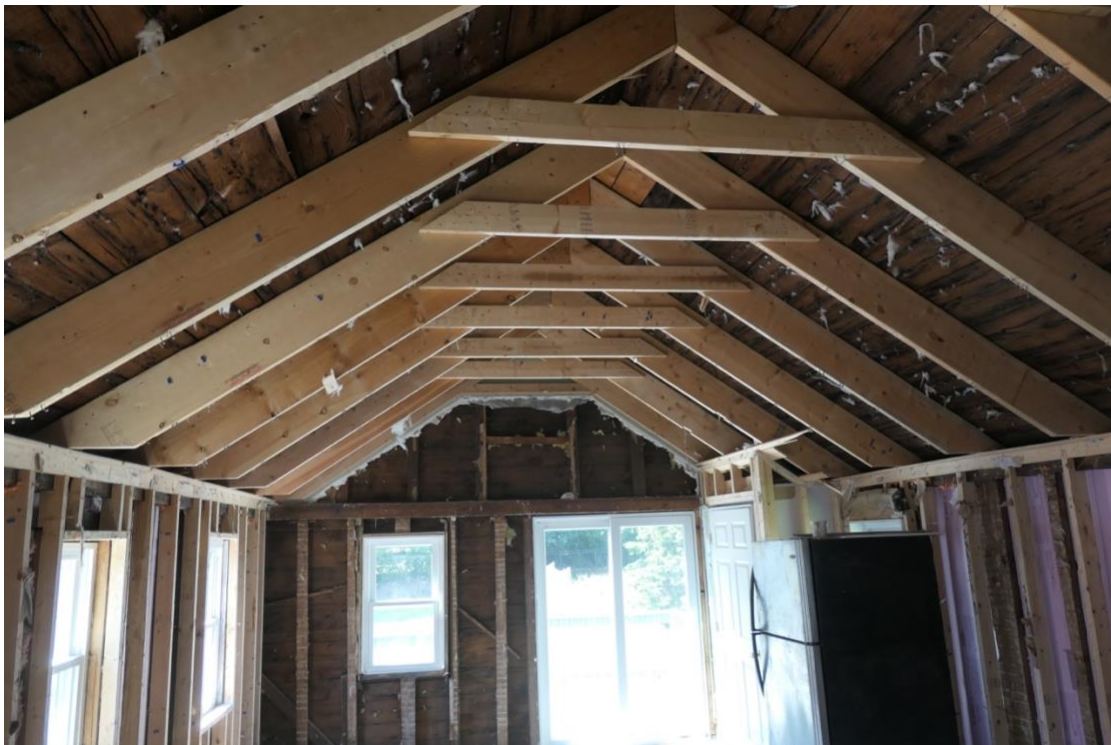
Collar ties set too high, which induces too much stress in rafters. Also, the rafter seat cuts at the wall plate are too severe, resulting in overstress in shear.
