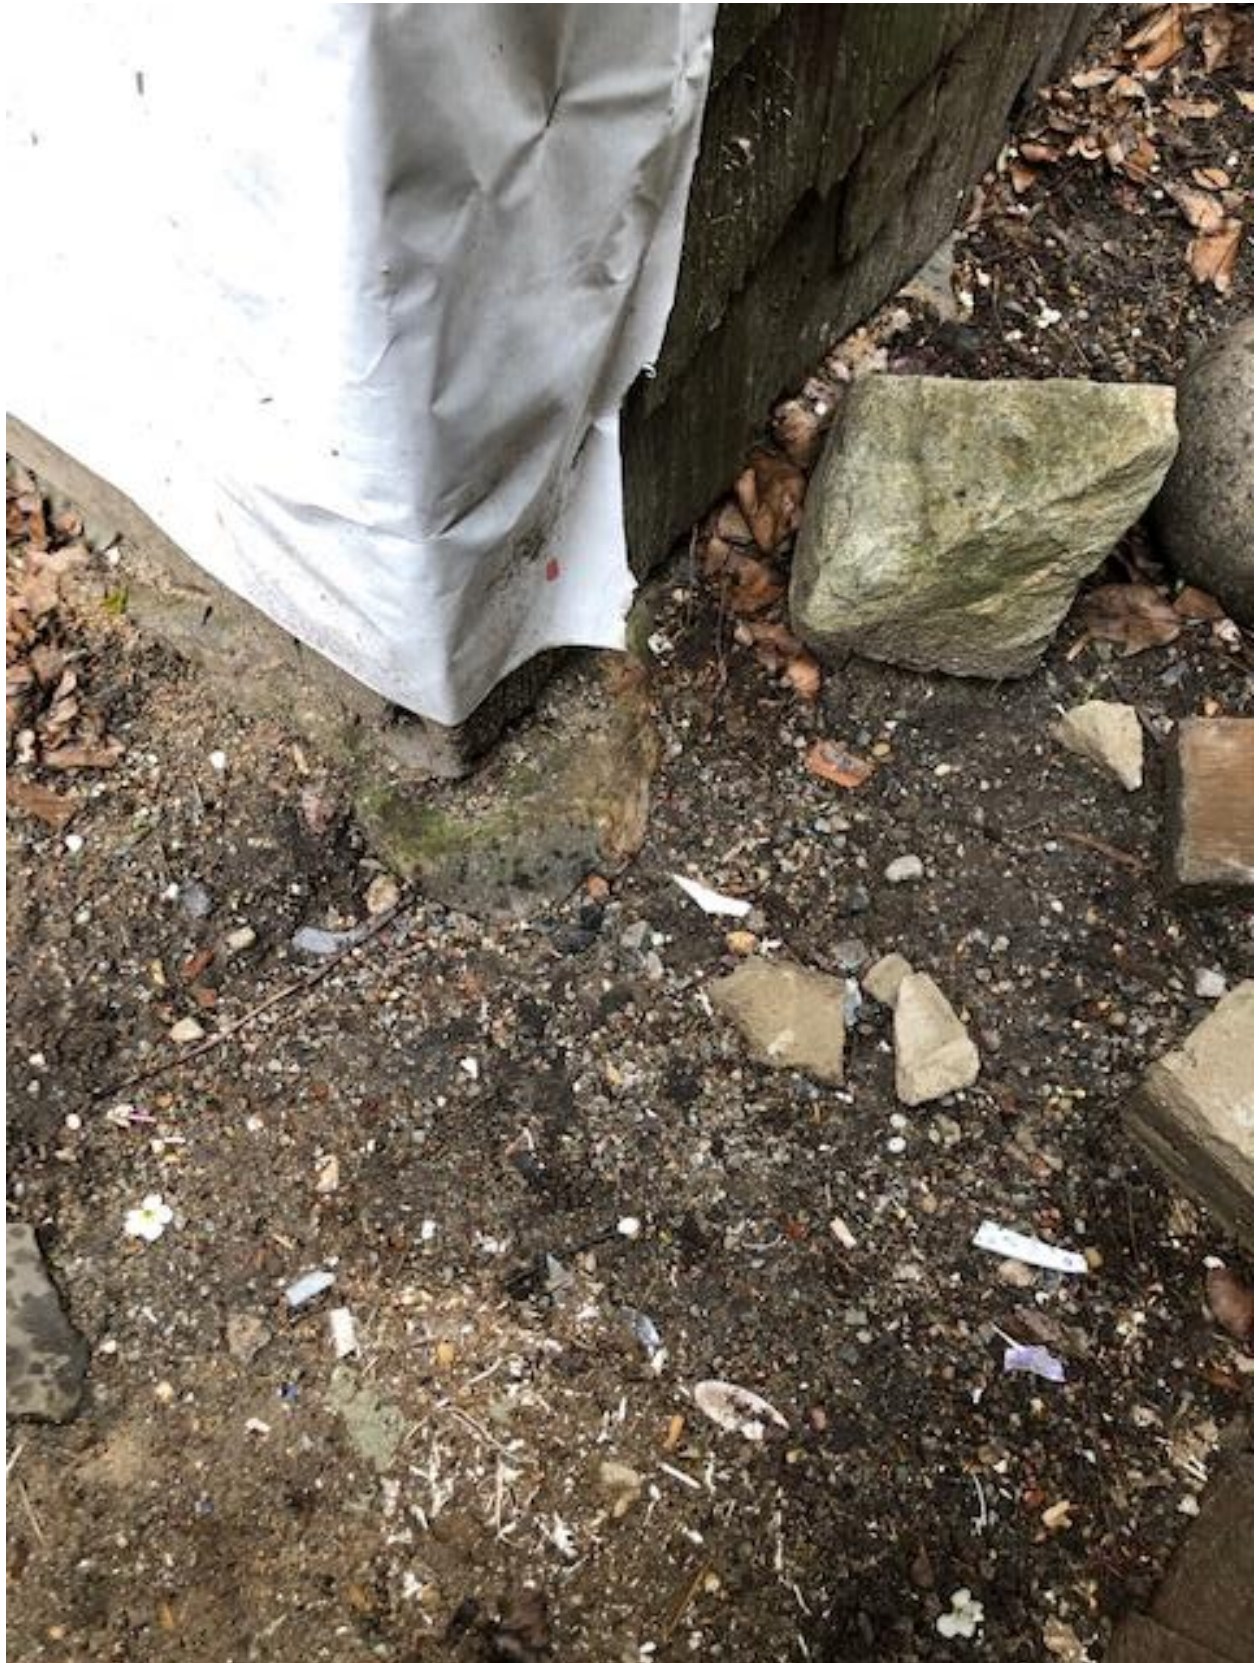
This is a corner stone under the north east corner

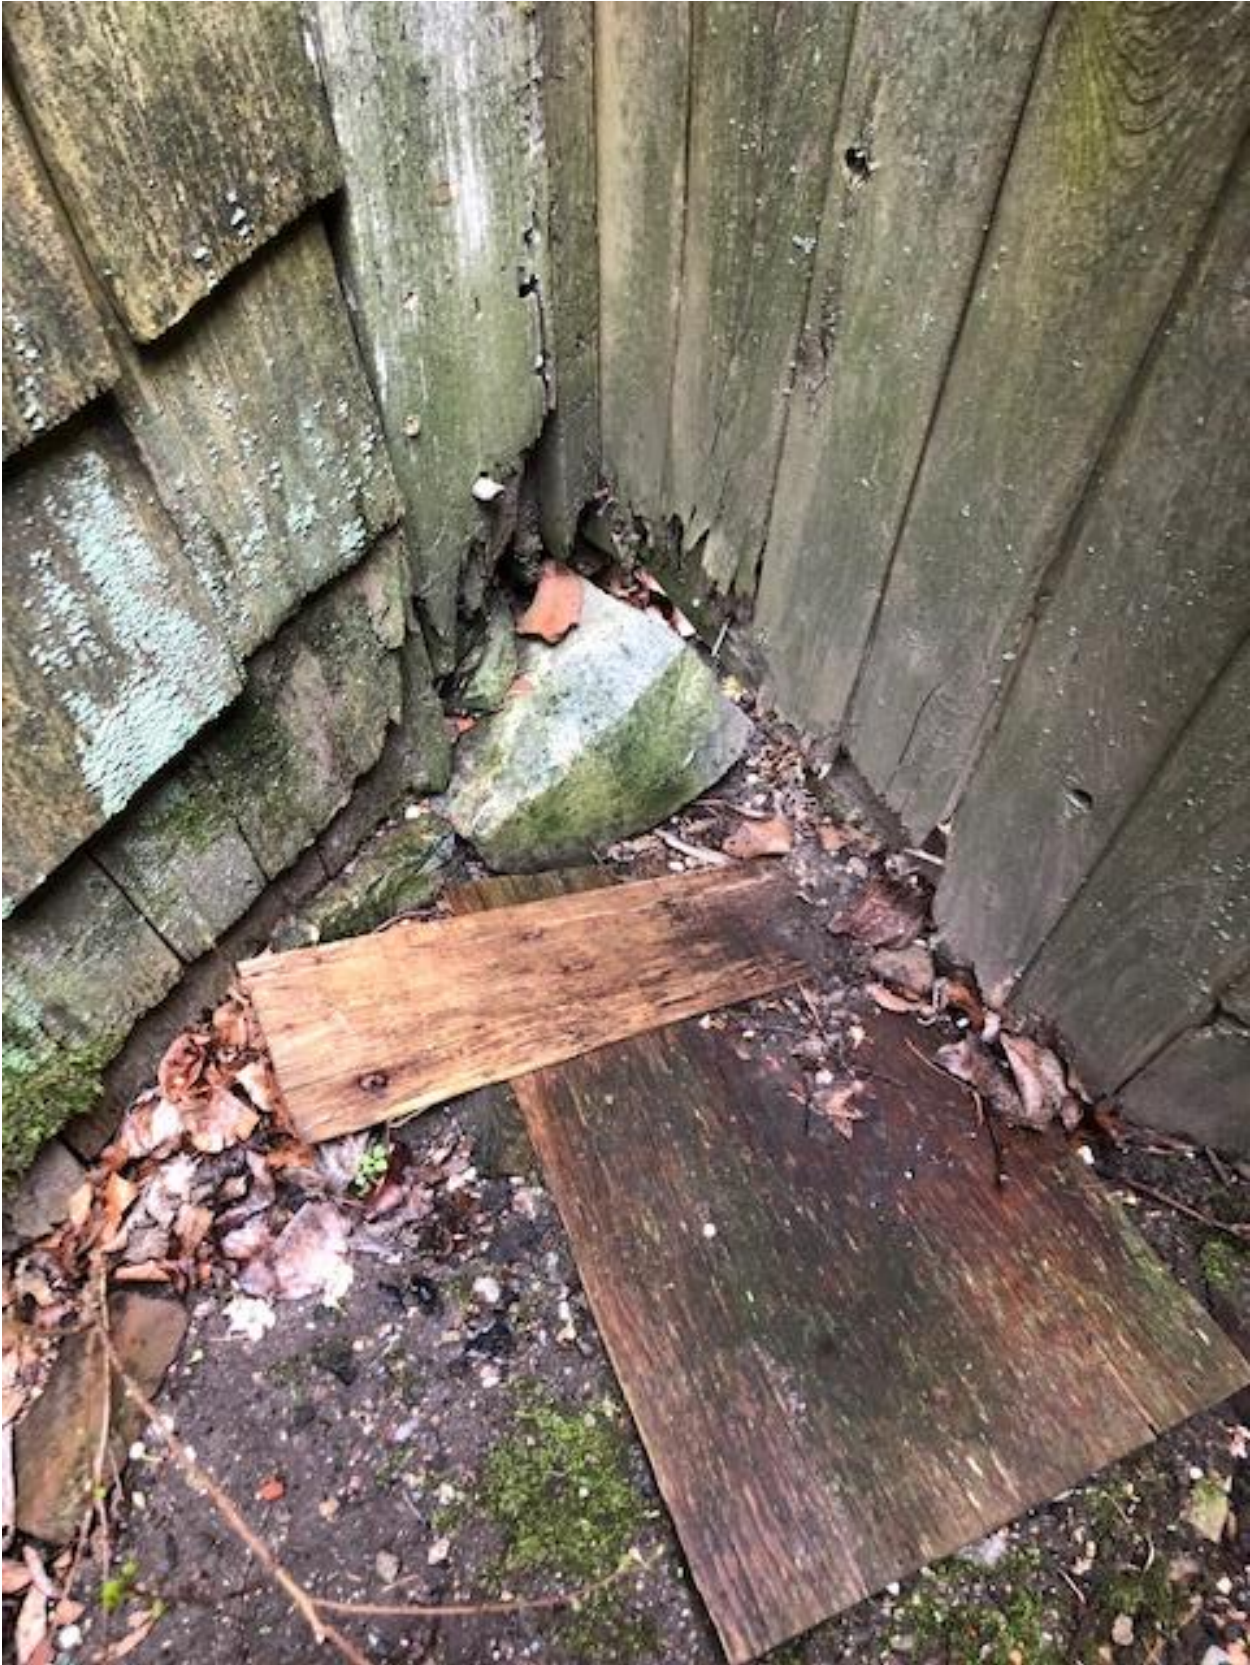
This is a corner stone under the north west corner

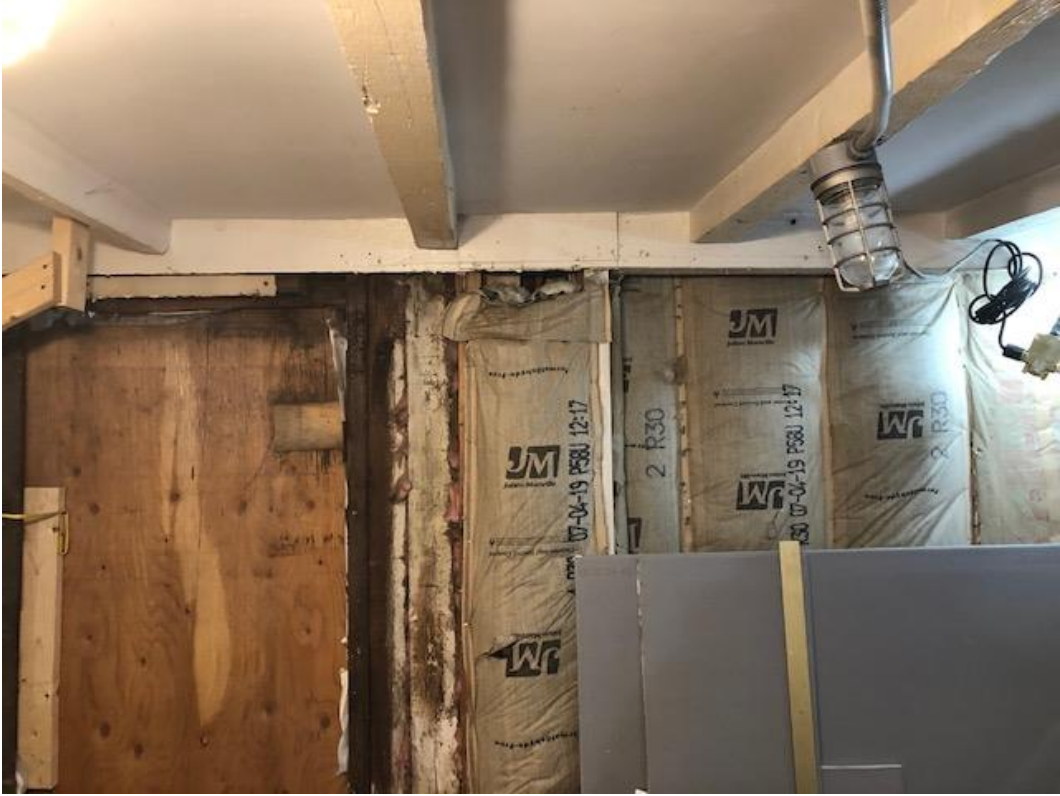
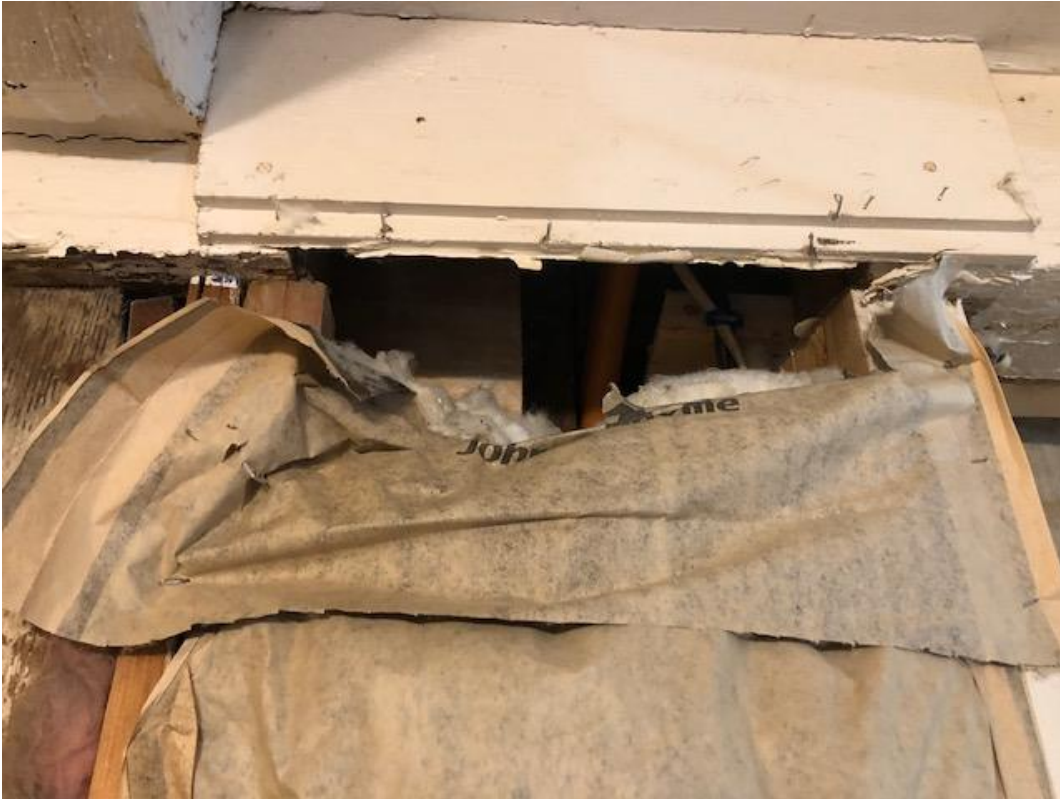
This is one of three beams that run left to right or north and south that have been altered and supported inside the house

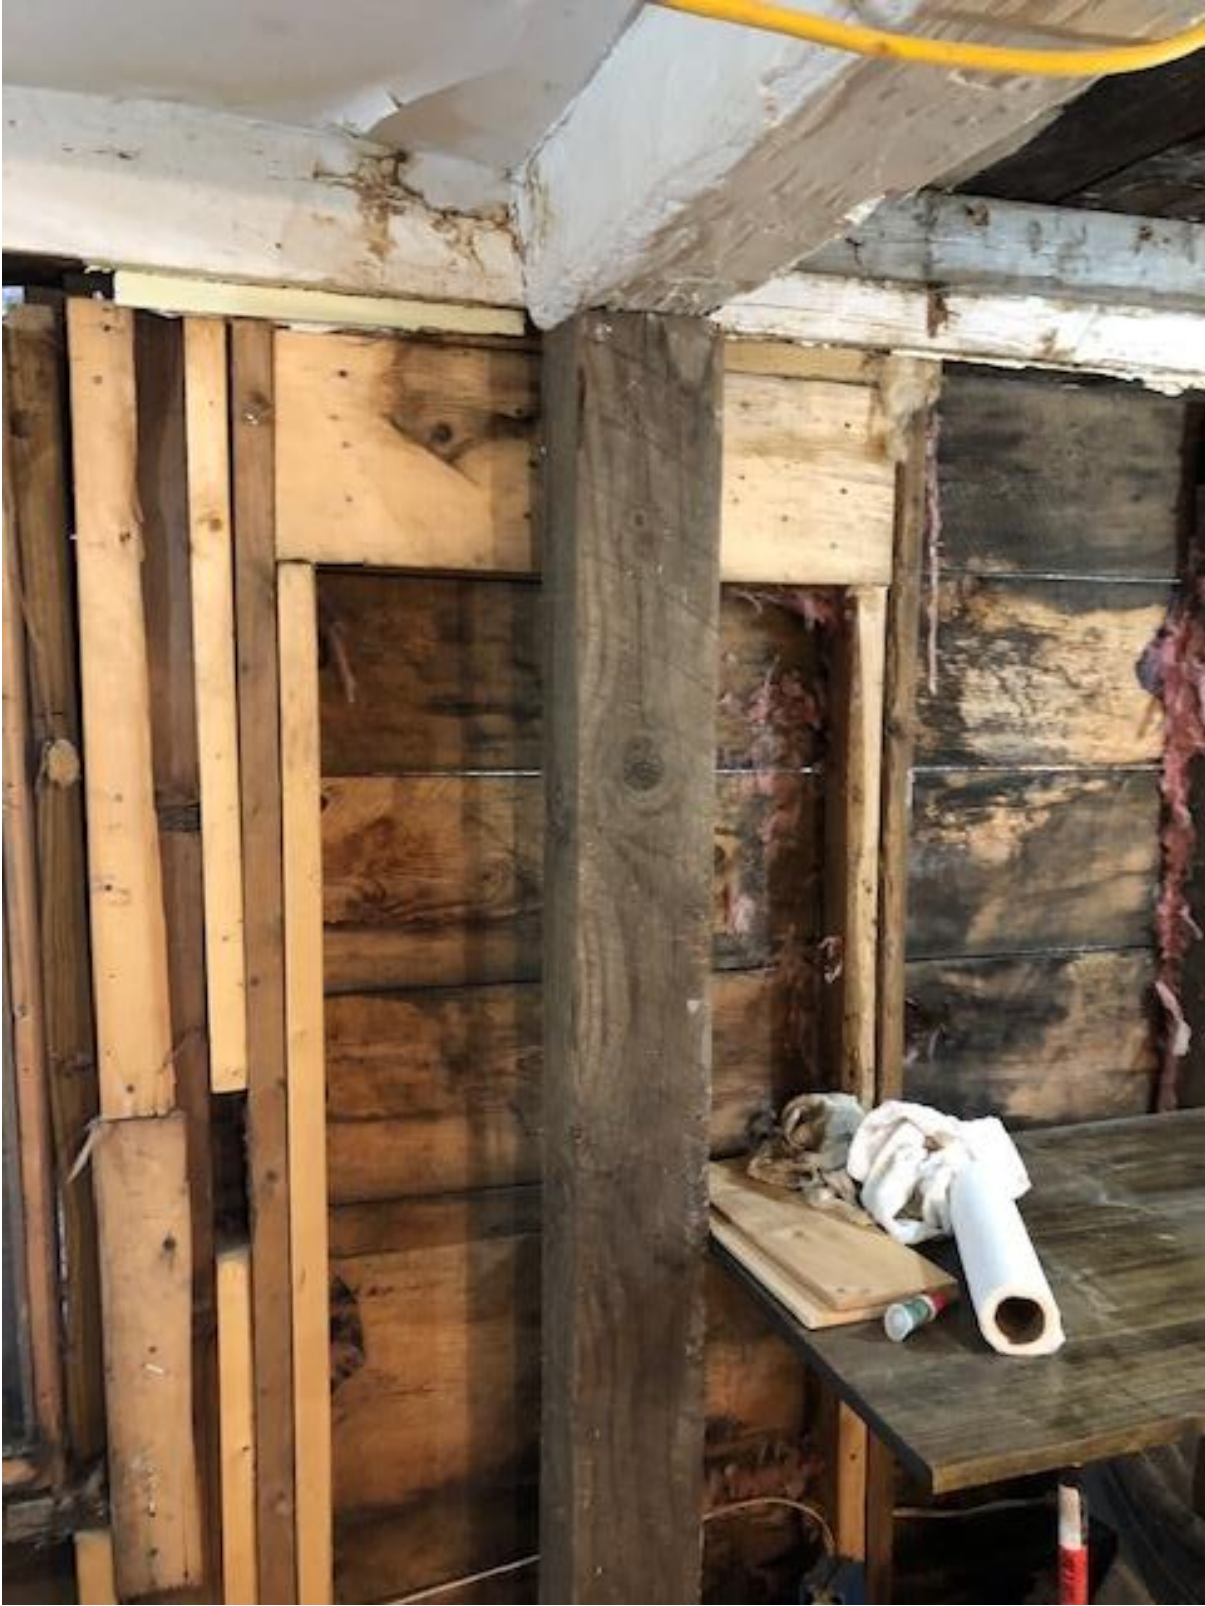
This is a center beam that was damaged by moisture penetrating through from the outside 25 years ago and had to have supports put in under the interior and exterior beams.

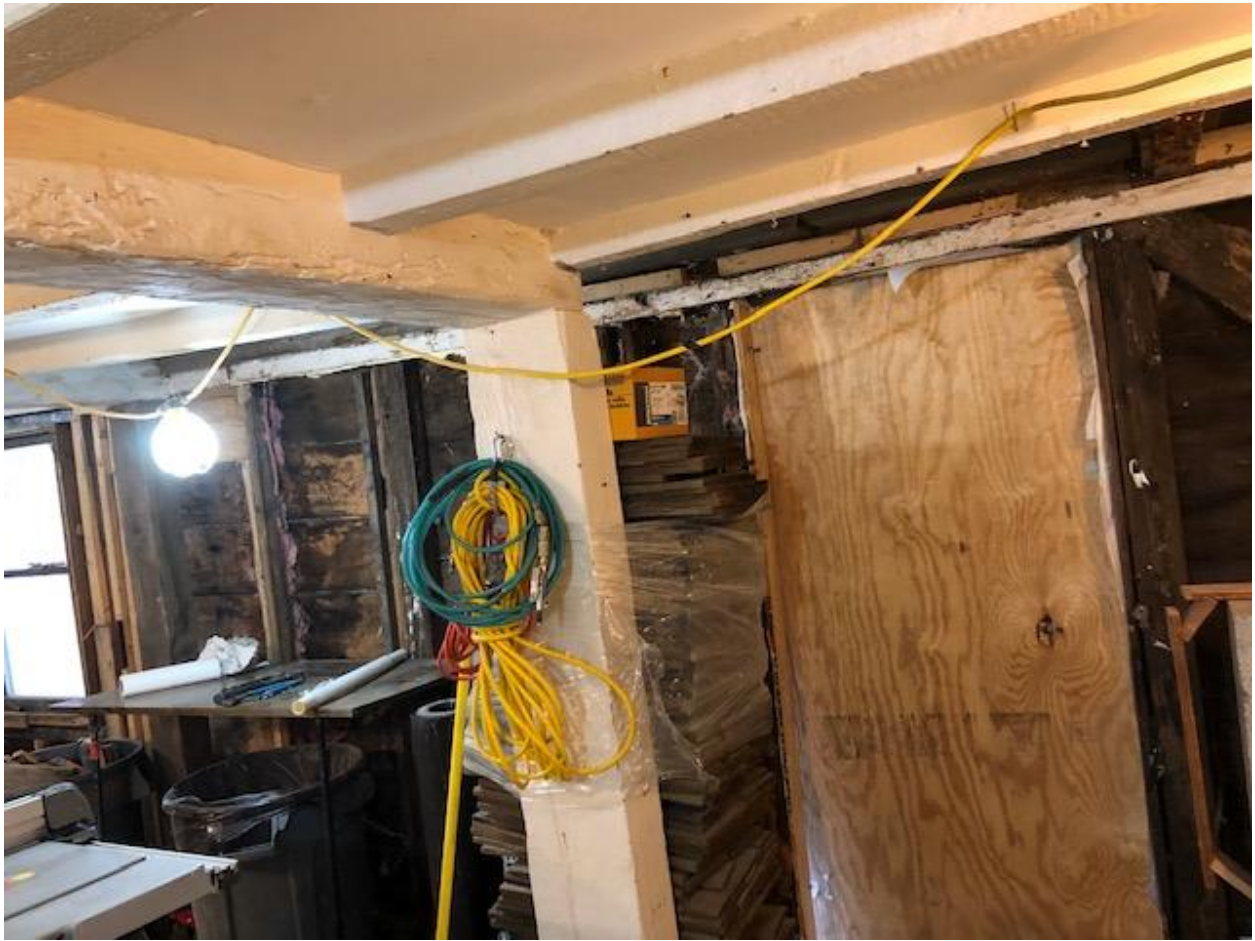
This is a center beam that was cut in order to put in a set of stairs 60 years ago.
