Re: Request for Determination of Historic Significance and Demolition 35 Munroe Street, Newburyport, MA (the "Property")
Assessor's Map: 53 Lot: 7

June 1, 2020

Re: Site Visit to 35 Munroe Street Newburyport, Massachusetts 01950

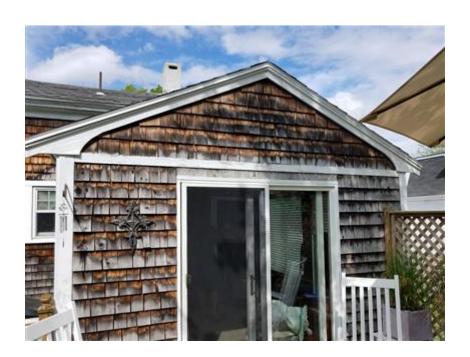
Image 1:

The existing sunroom is attached to the kitchen and was constructed during the 1980's according to the owner, Mr. Lingerman. The sunroom is sloping in the same direction as the kitchen [Image 1]. The floors are also sloping towards the rear of the lot. I observed some dry rot on the exterior wood support beams/joists of the sunporch.

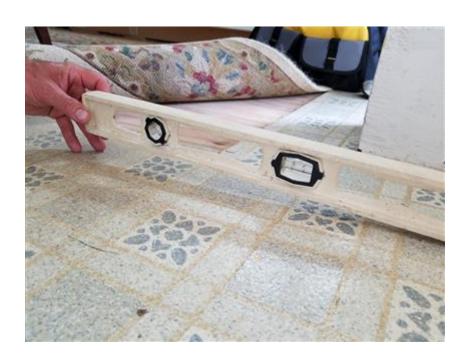
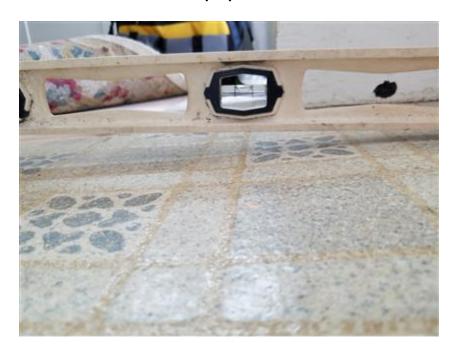
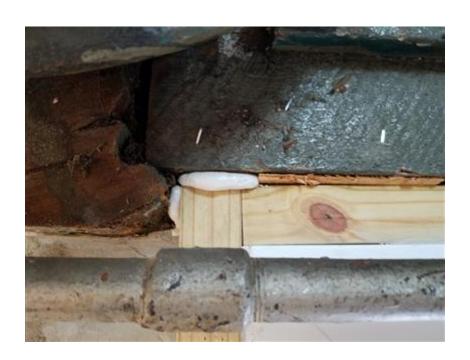
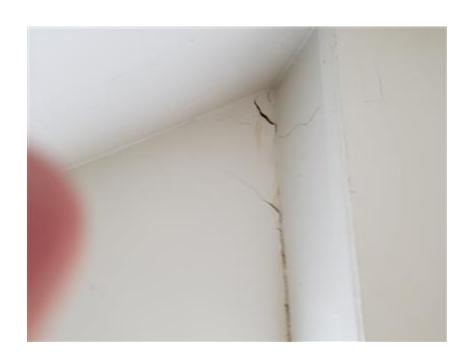
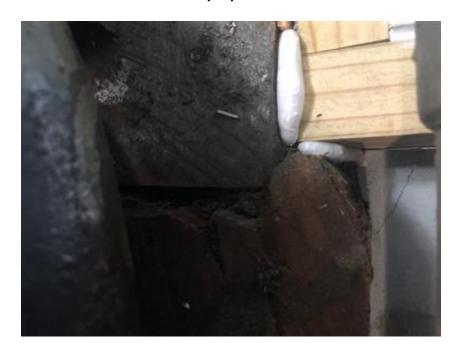
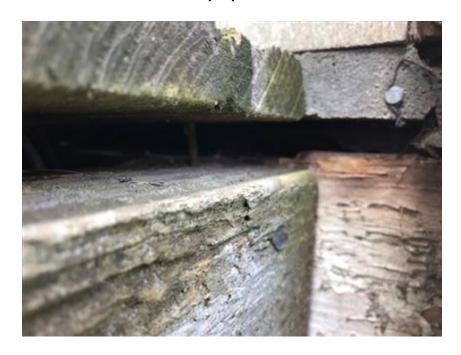
The floors throughout this part of the home are excessively out of level (greater than an inch per foot) [See Images 9-11, 24,26, 49,51]. The entire structure is sloping towards the rear of the lot. There are numerous cracks in the walls and ceilings throughout the kitchen and upstairs bedroom and bathroom [See Images xx].

Therefore, it is my opinion that attempting to salvage this portion of the house is not feasible nor cost effective and it is my recommendation that this portion of the house be demolished and reconstructed with new concrete foundations, footings and framing materials.

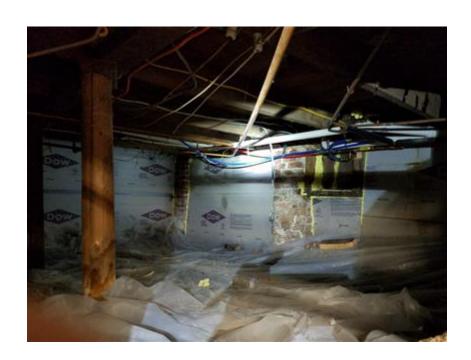
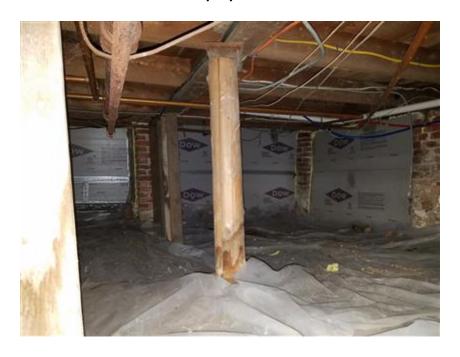
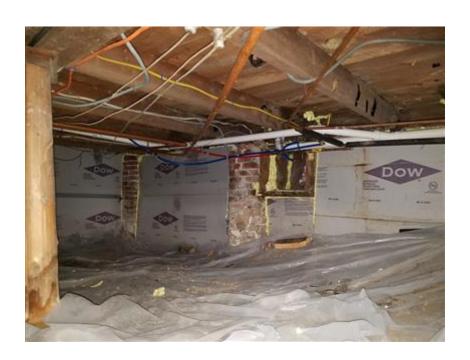
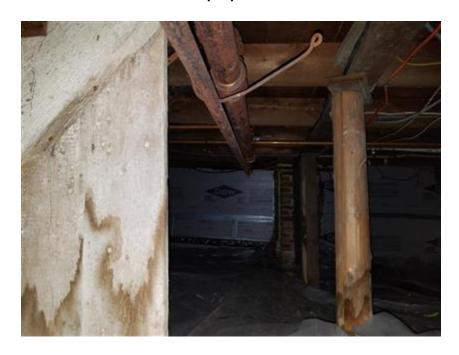
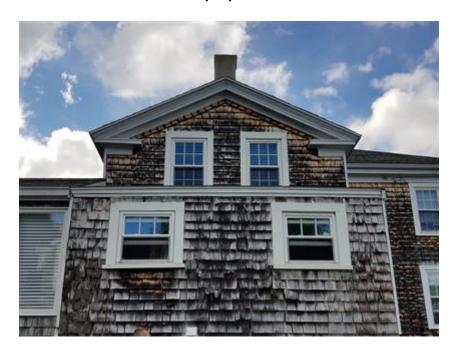
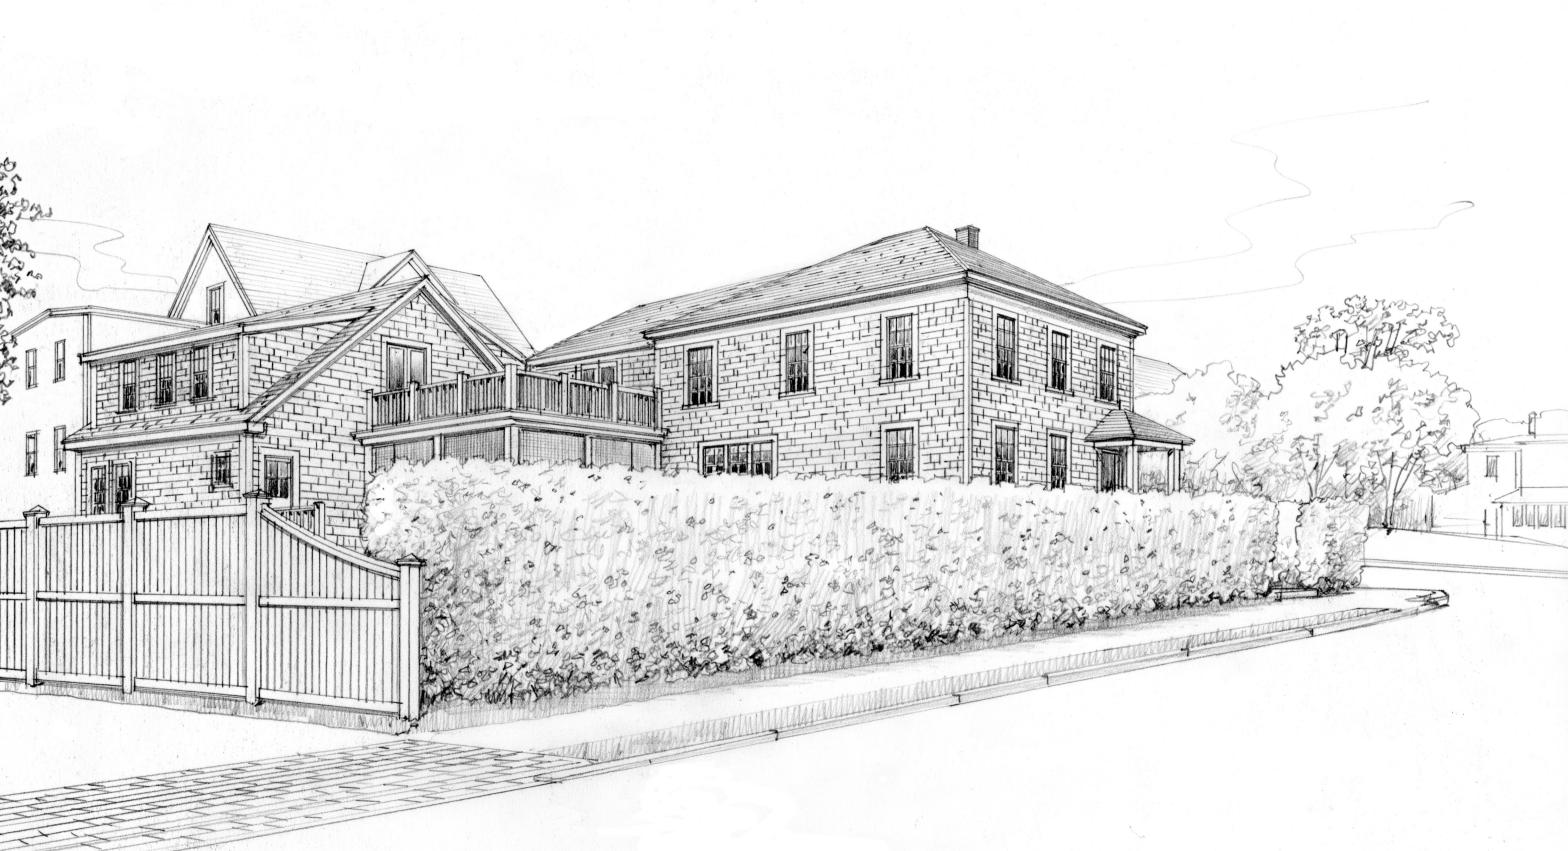
This portion of the home was not part of the original construction of the home but was constructed in the early 1900's according to the homeowner, Mr. Eric Lingerman. The foundation of this part of the home consists of tree trunks, wood framing and brick columns [See Image 17-21, 39, 56].

The kitchen/pantry/upstairs bedroom/bathroom portion of this home appears to have reached the end of its useful life. The existing foundation for this part of the home consists of various materials including brick, tree trunks and wood framing which have settled over time leading to the unlevel floors above. Repairing/rehabilitating this portion of the house would involve the jacking/ shoring of not only this structure but also the sunroom which is attached. Due to the age and shoddiness of the existing framing [See Images 47, 48], it is not clear that the structure could be sufficiently stabilized during the jacking process. This would lead to the structure shifting and collapsing under its own weight.
