Conservation Restriction Monitoring Report

Project Name	Port Place at Evergreen Commons
Date of Inspection	11/16/2021
Start Time/ End Time (optional)	
Inspector's Name(s)	Thomas G. Hughes
Inspector's Title(s)	Environmental Monitor
Inspector's Contact Information	
Hughes Environmental Consulting, 44 Merrimac Street, Newburyport, MA 01950 978-465-5400	
Others Present During Inspection	
Mike McDonald	
Type of Inspection	Baseline
Notes

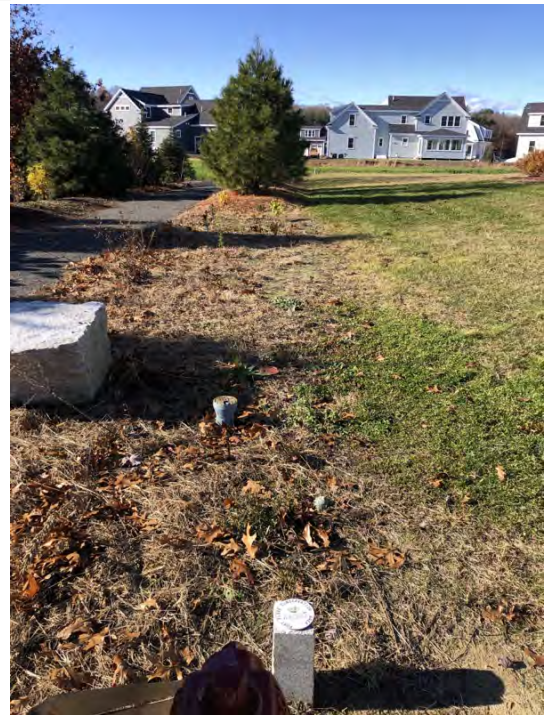
1 - Trail Entrance off Boyd Drive/Lot 3 Boundary

Minor plantings still needed in this area to help define lawn edge and per plan.

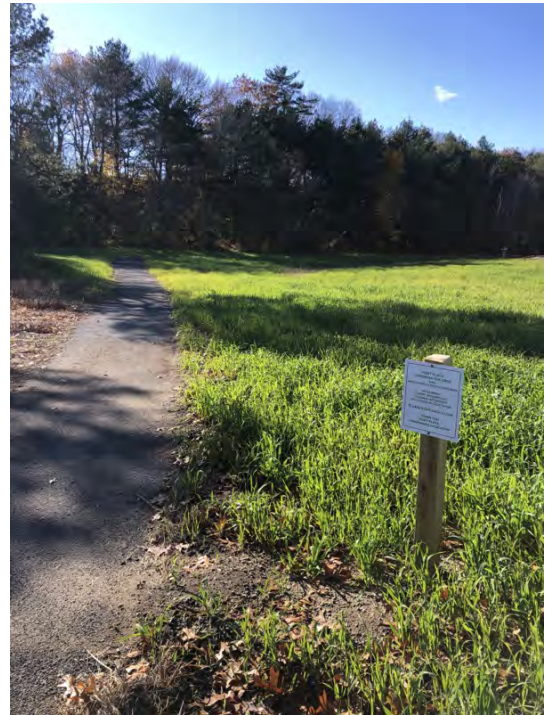
2 - Trail off Boyd Drive at Entry Sign

Pollinator meadow and trail in good shape. Oats are protecting pollinator seeds and seedlings

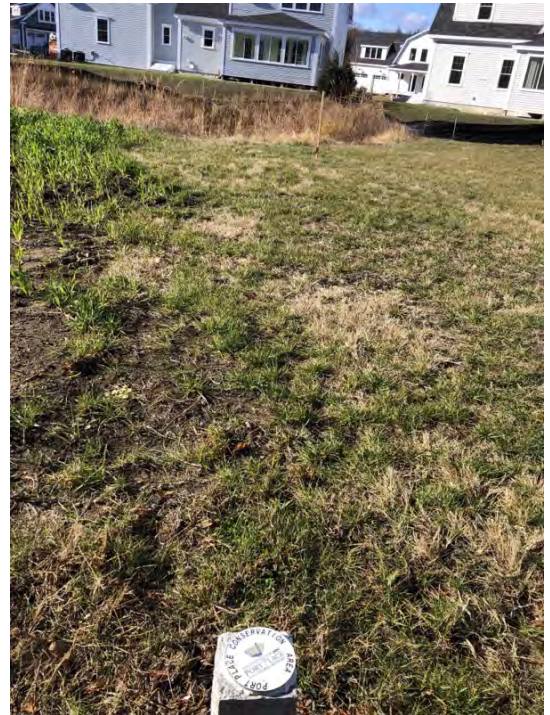
4 - Lot 7/8 Boundary

Sprinkler head in open space. meadow to be extended to line stakes at bound and midway

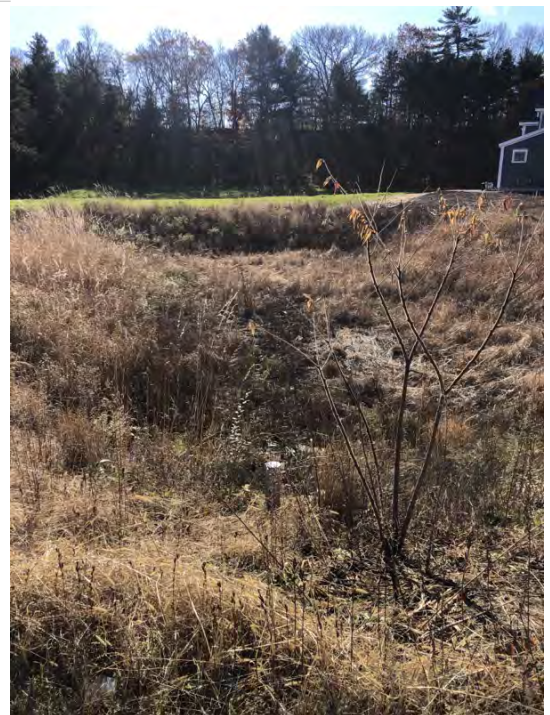
5 - Bioretention Area B

Bio retention area well vegetated and functions per design
New Photo

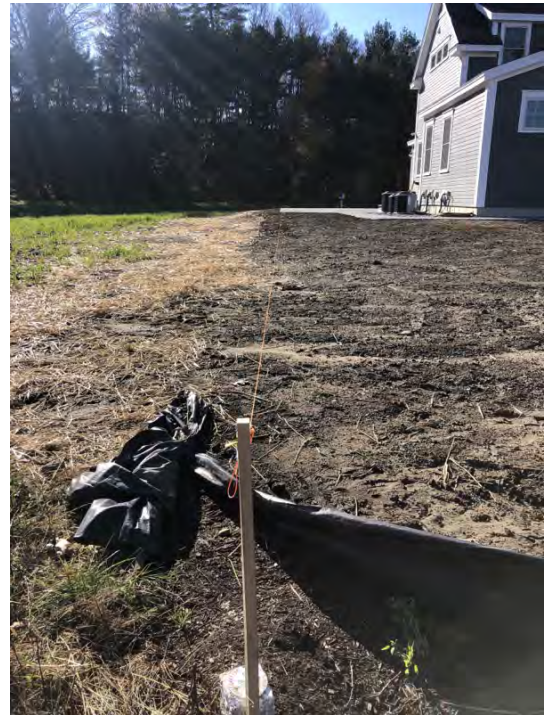
7 - Lot 10 Rear Boundary

Patio encroachment by inches. To be removed behind line and area seeded appropriately with pollinator mix

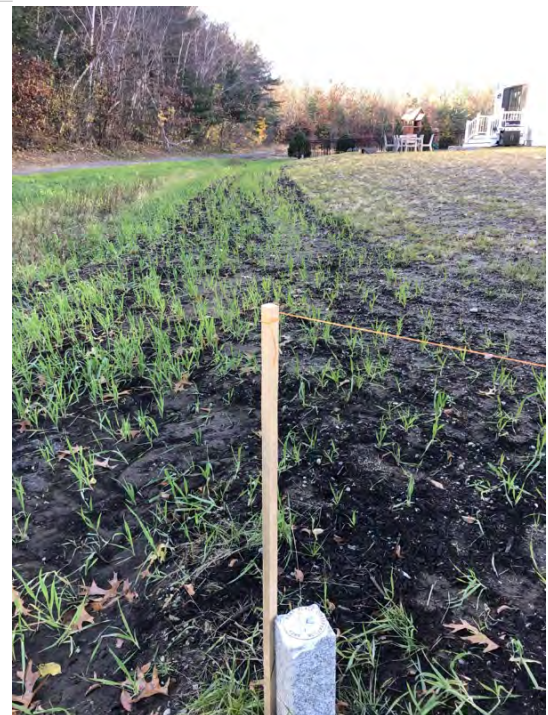
8 - Lot 11 Rear Boundary

Small area of lawn to be removed and seeded with pollinator
New Photo

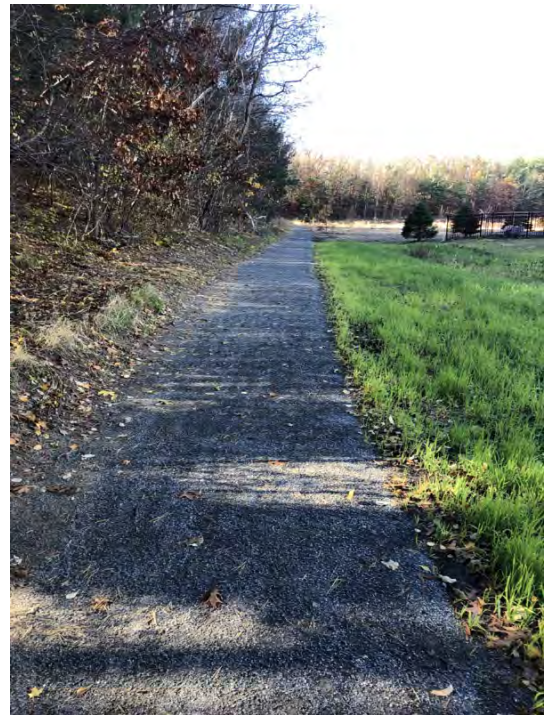
9 - Trail Behind Lot 11

Trail level and in good shape
New Photo

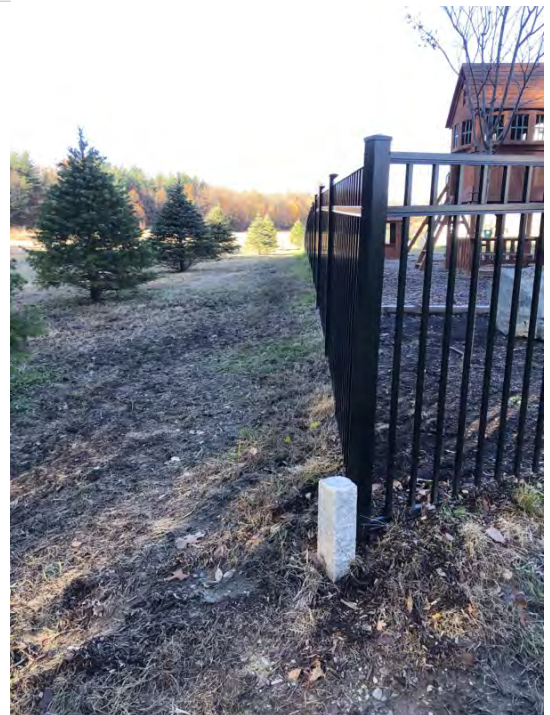
10 - Lot 12 Rear Boundary

Pollinator area to be adjusted to fence at 64 feet
New Photo

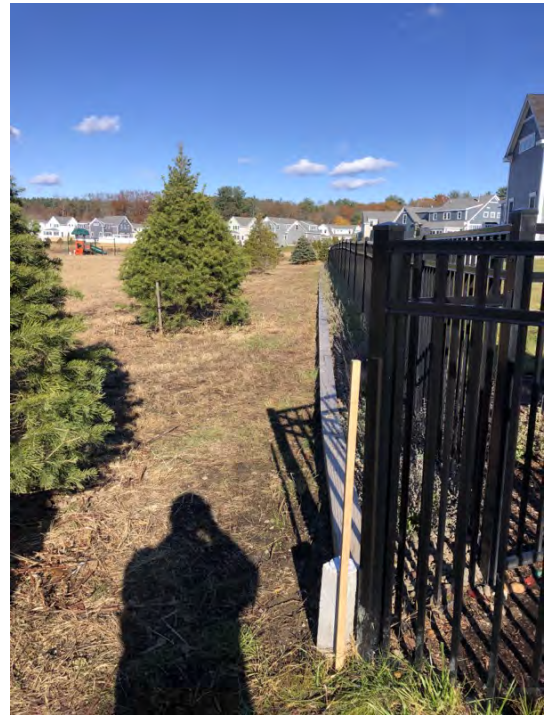
15 - Lot 13 Rear Boundary

Timber and landscape bed to be removed from open space - stake and string added to guide homeowners landscaper

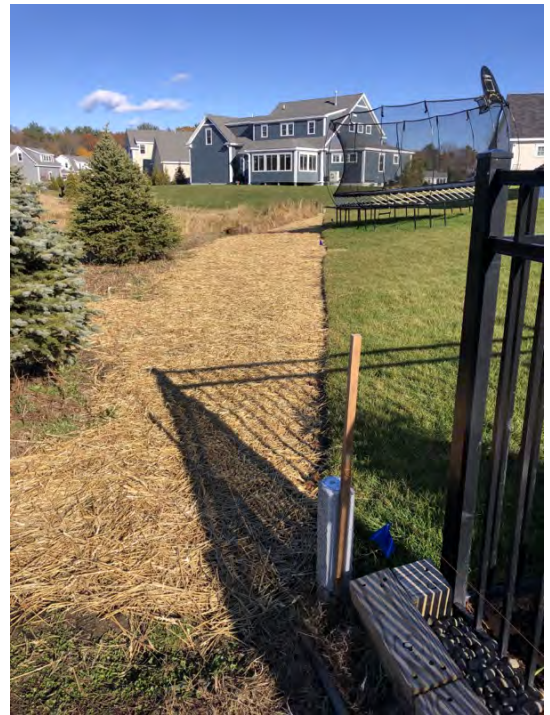
16 - Lot 14 Rear Boundary

Area seeded with fescue and mulched
New Photo

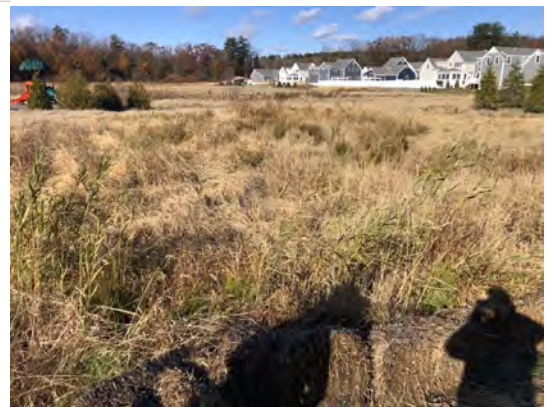
17 - Bioretention Area C

Phragmites to be pulled prior to mowing
New Photo

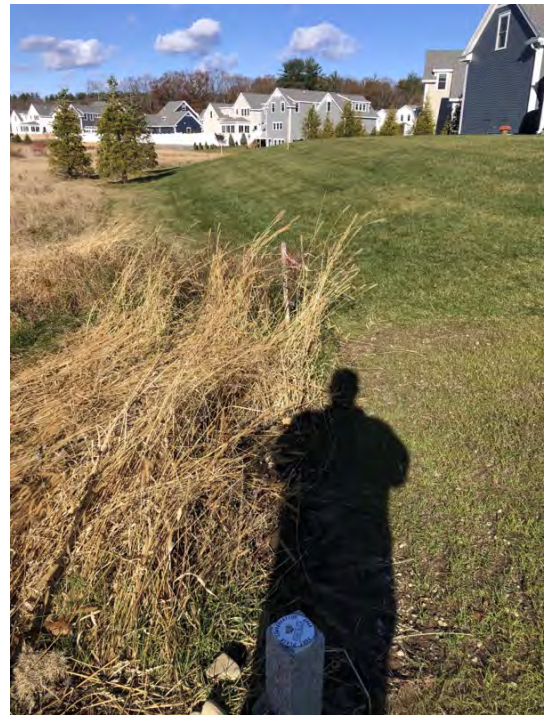
18 - Lots 16 and 17 Rear Boundary

Minor item - area was sodded for stabilization. Will be over seeded with fescue. HOA landscaper to be notified to maintain fescue meadow lawn area according to O&M. Stake set to assist in location

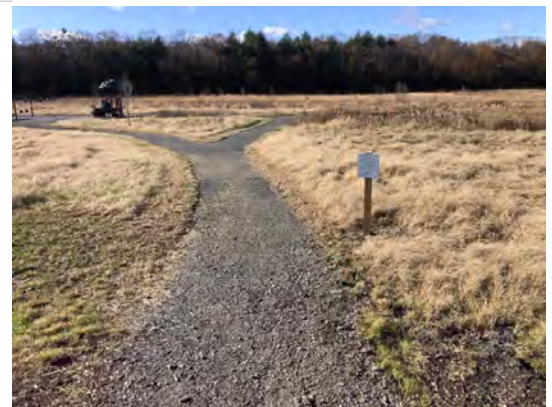
19 - Trail at Entry Sign between Lots 16 and 17

Trail in good shape
New Photo

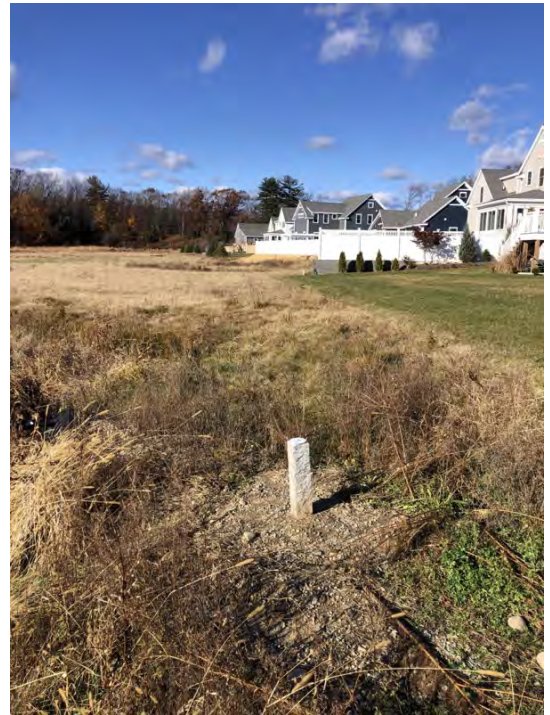
21 - Lots 19 and 20 Rear Boundary

Minor - pipe to be cut back to property boundary. Hangs over but is in ground on homeowner lot

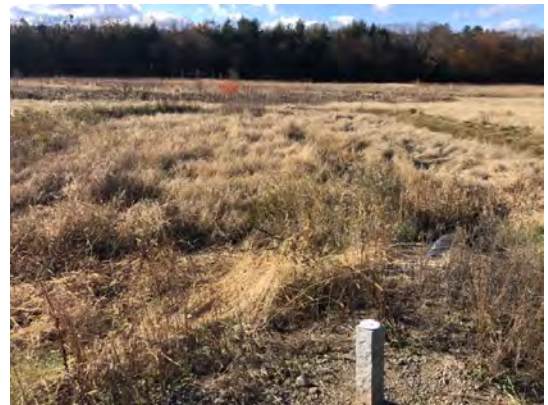
22 - Bioretention Area D

Pull phragmites before mowing
New Photo

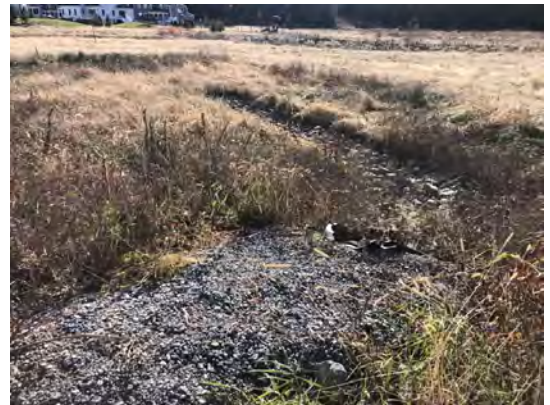
24 - Bioretention Area E

Pull out phragmites before mowing

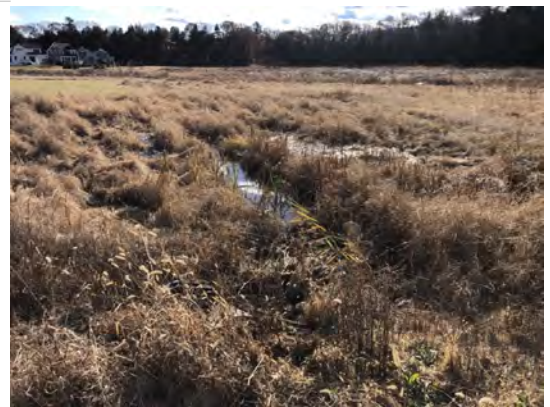
28 - Bioretention Area F

Pull phragmites before mowing
New Photo

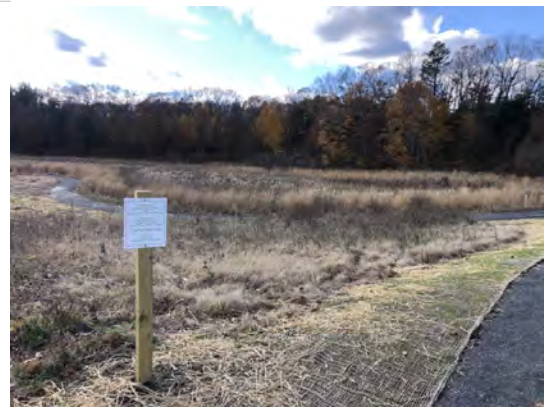
30 - From Northern Trail Entrance South Along Trail

Rills at bend need raking

raking of erosion rills of northern trail entry points. Minor touch up of landscape as noted

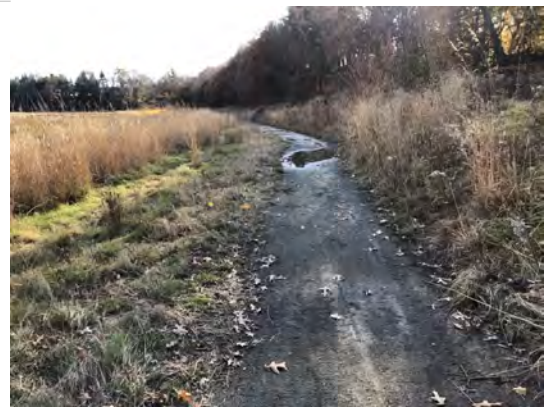
32 - Northwestern Trail Area
Looking South

Minor puddling due to recent heavy rainfall
New Photo

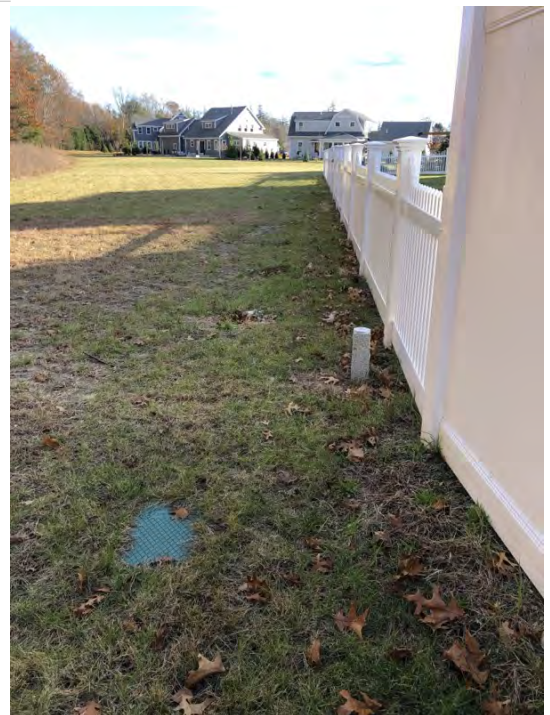
Control box in open space. Relocate or remove
New Photo

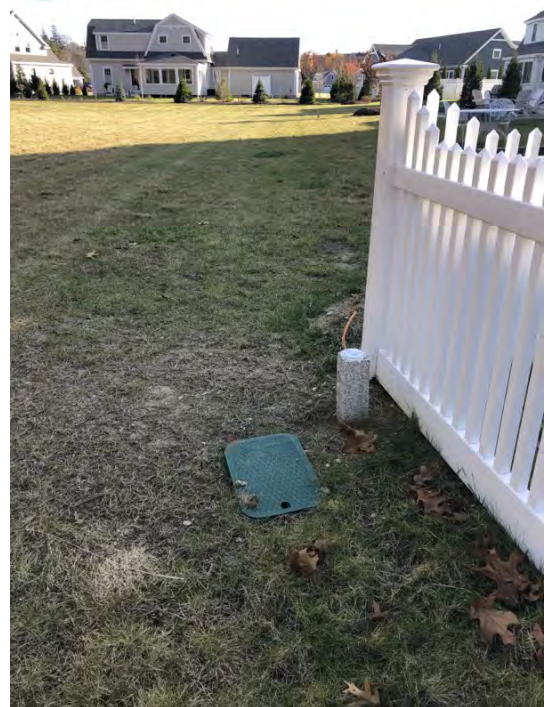
Control box in open space. Relocate or remove
New Photo

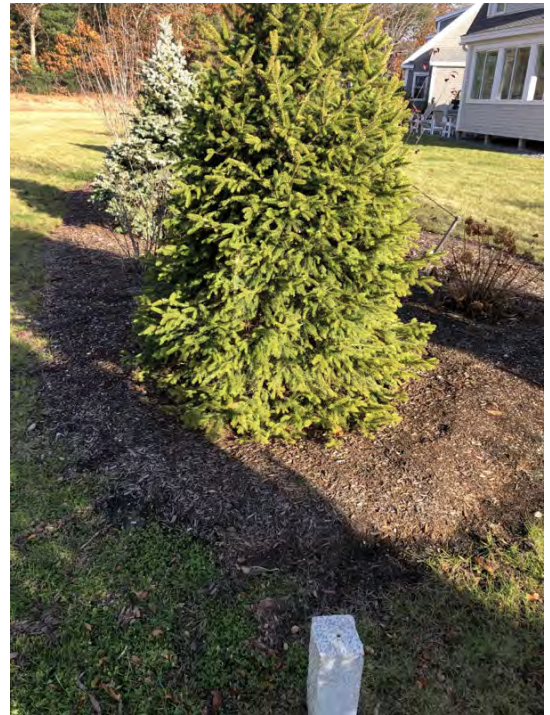
Landscape bed extends to open space. Relocate or stop maintenance as mulch bed

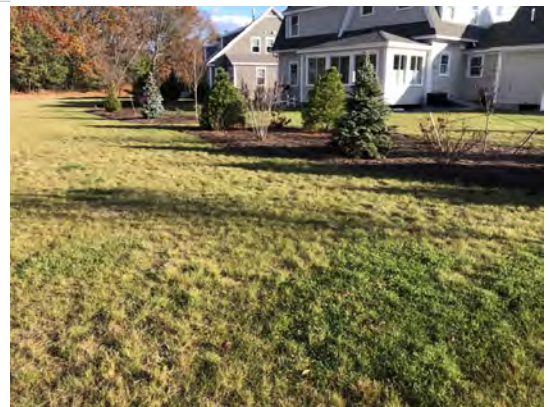
Lot 33. Better view of landscape area. Back half encroaches
New Photo

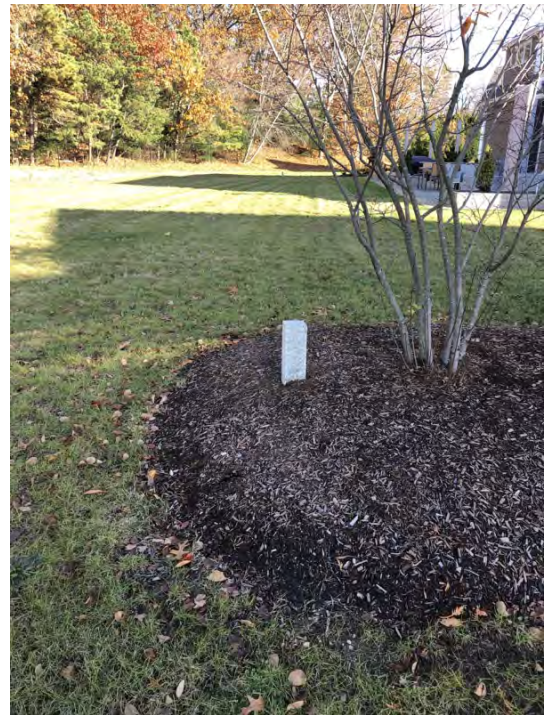
Remove end of boundary planting bed
New Photo

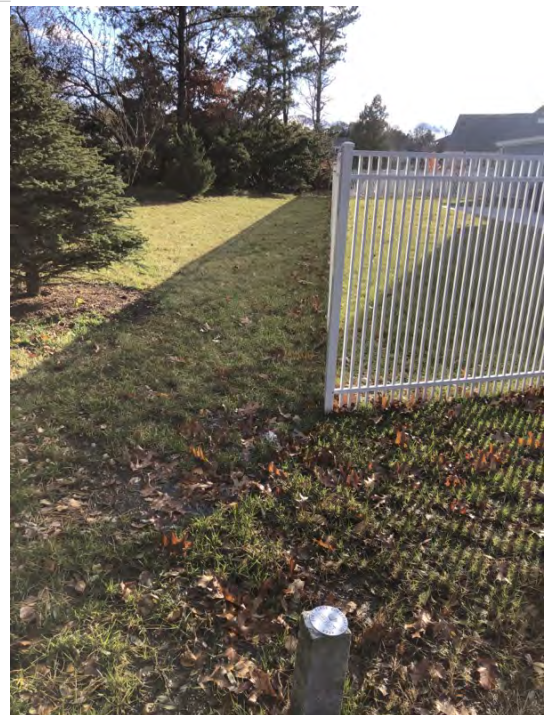
Final bound in woods. Fence well within property boundary
New Photo

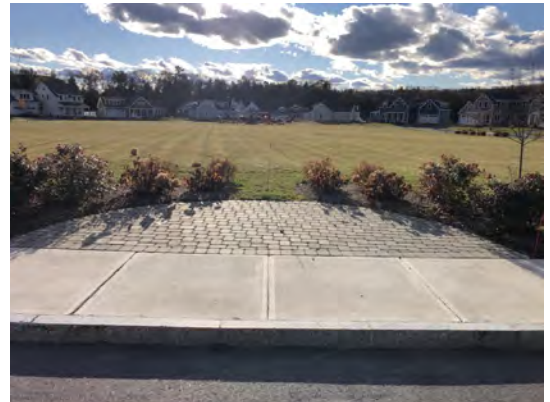
Note there are control boxes and irrigation within open space three. It is not currently hooked up.

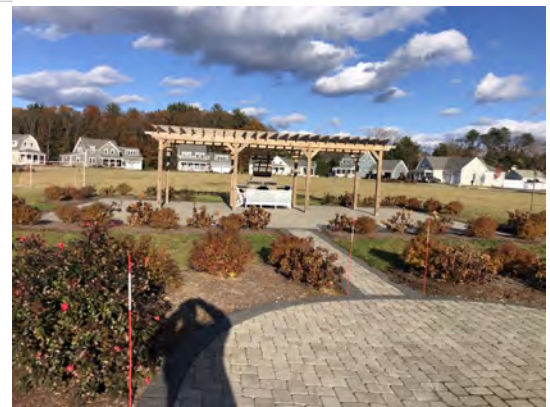
Other end of open space 3 - patio and fireplace
New Photo

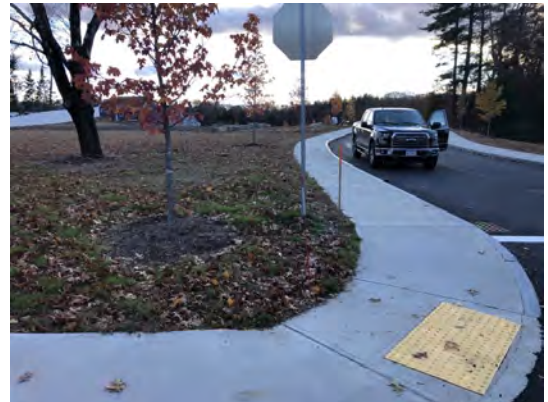
Open space 2 area near brown Ave. Minor area of construction materials being removed
