**A Landscape Preservation Plan
for the Laundry Yard and Courtyard
at the**

Caleb Cushing House

Newburyport, Massachusetts

November 2017

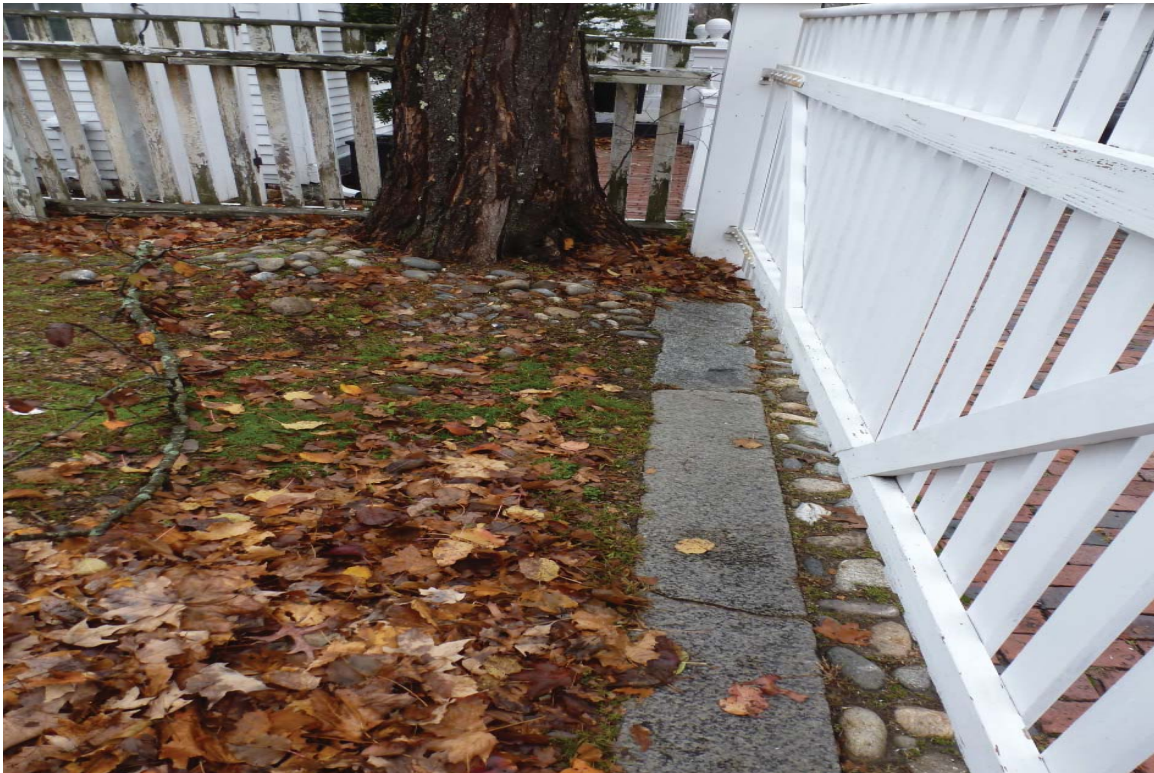
CA1: View looking towards Northeast of Alley

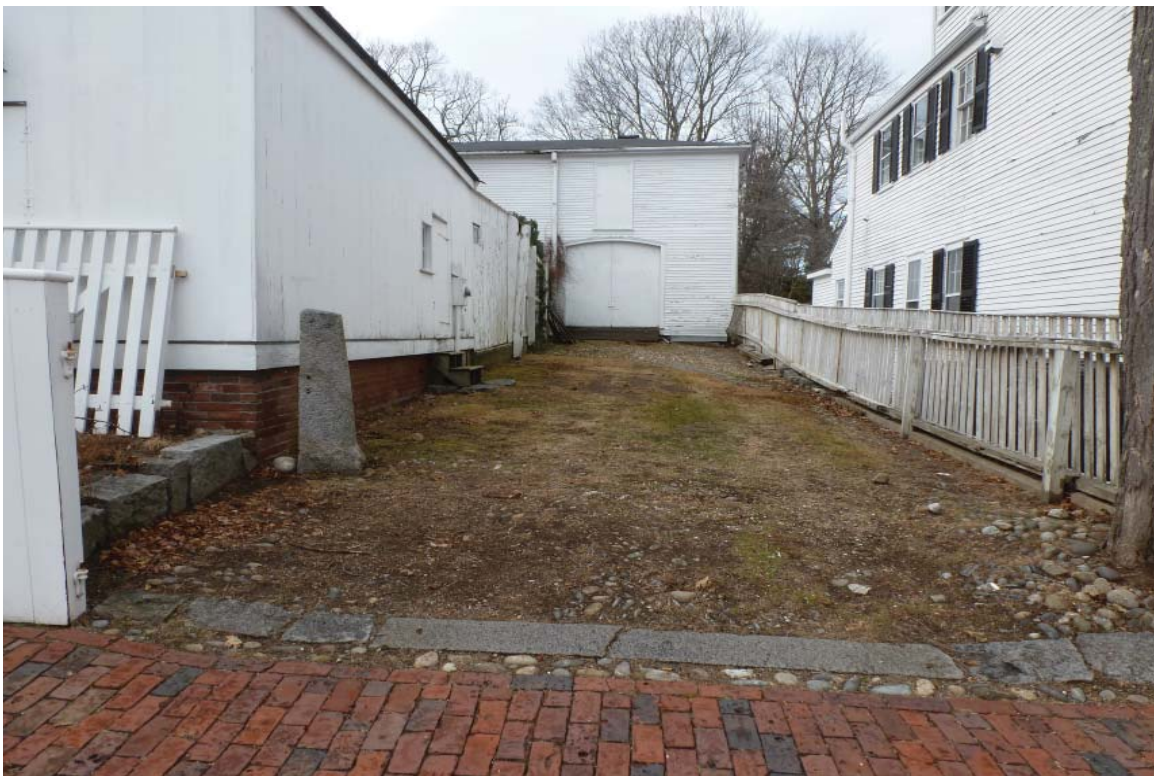
CA2: Northwest view down alley

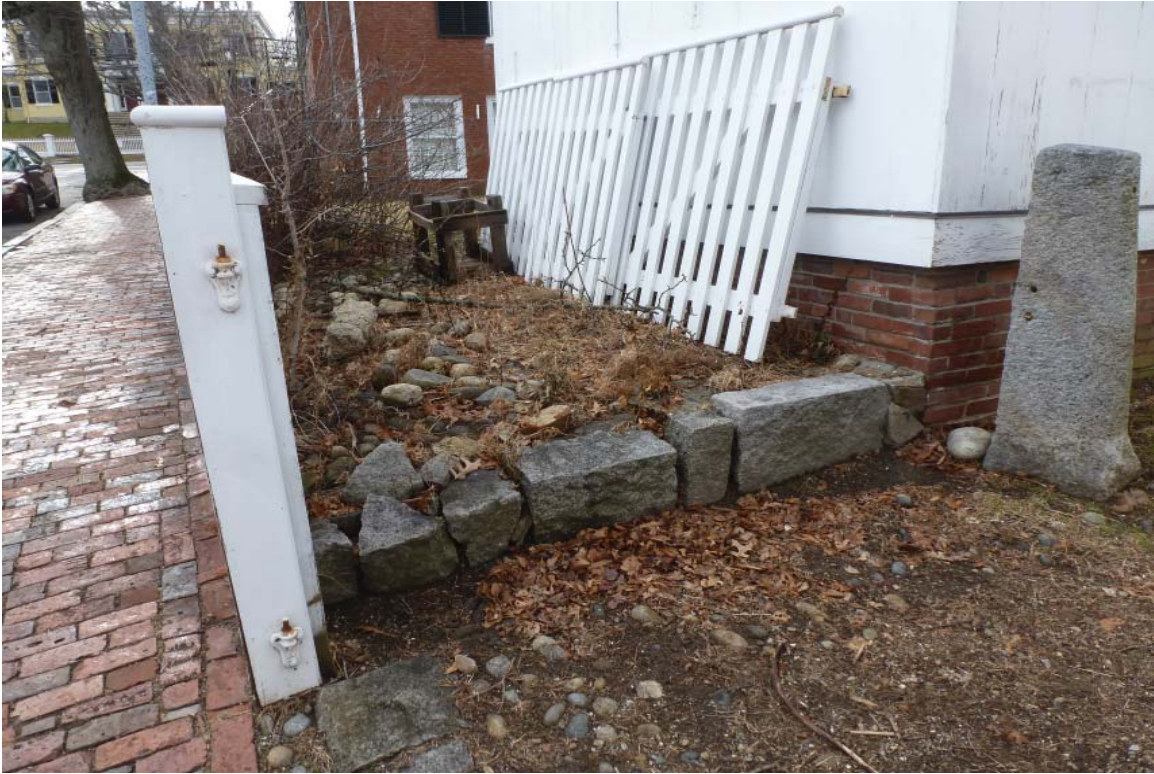
CA3: Granite edging behind Laundry Shed

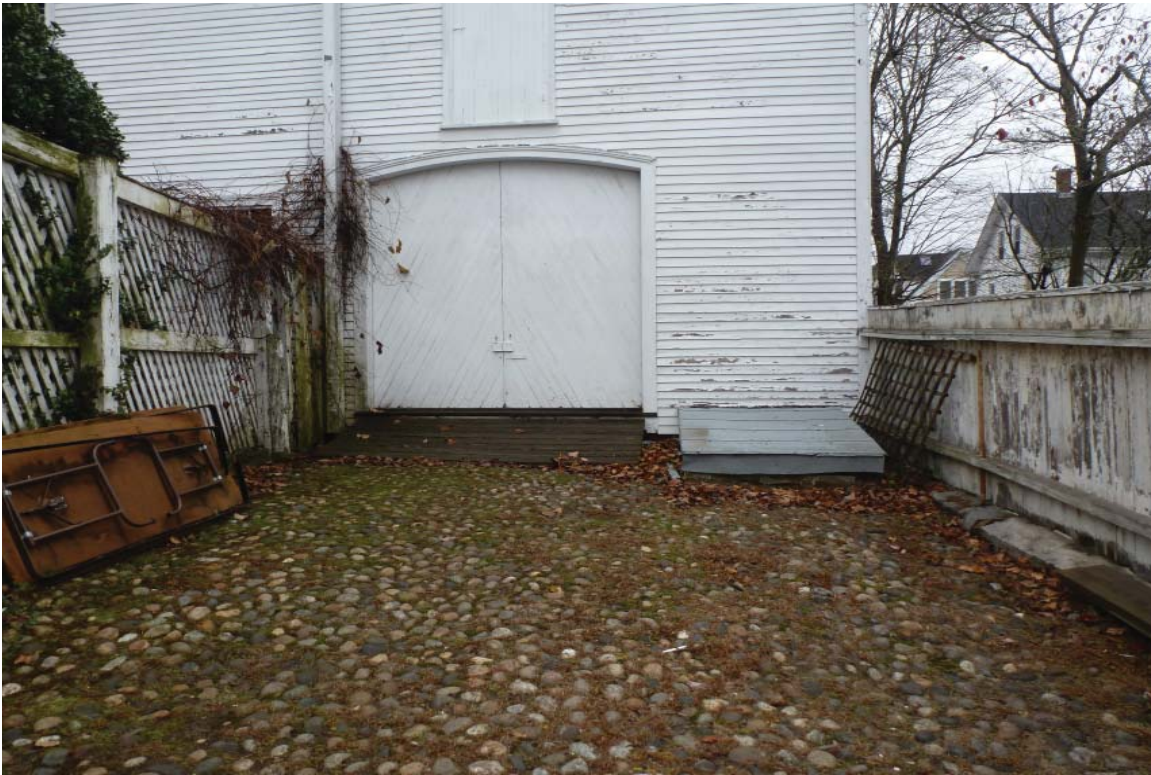
CA7: Close up of Barn threshold

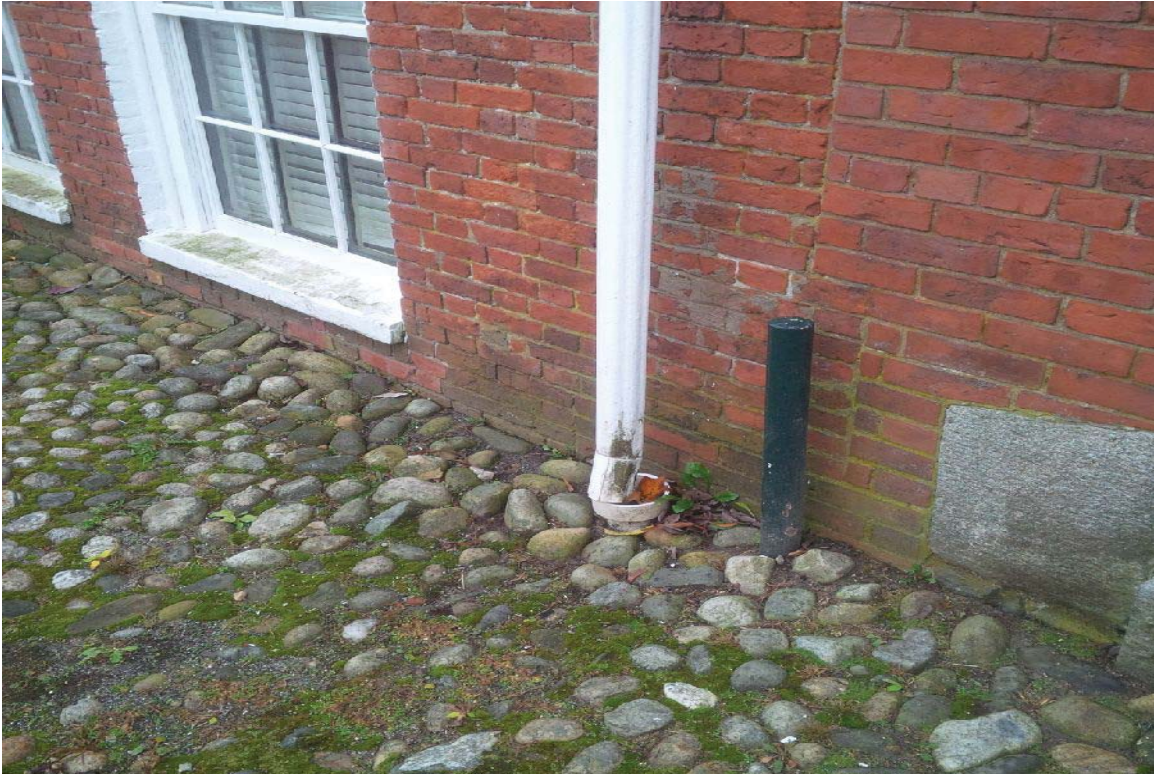
CY7: Closeup of cobblestone and gutter abutting Cushing House east side

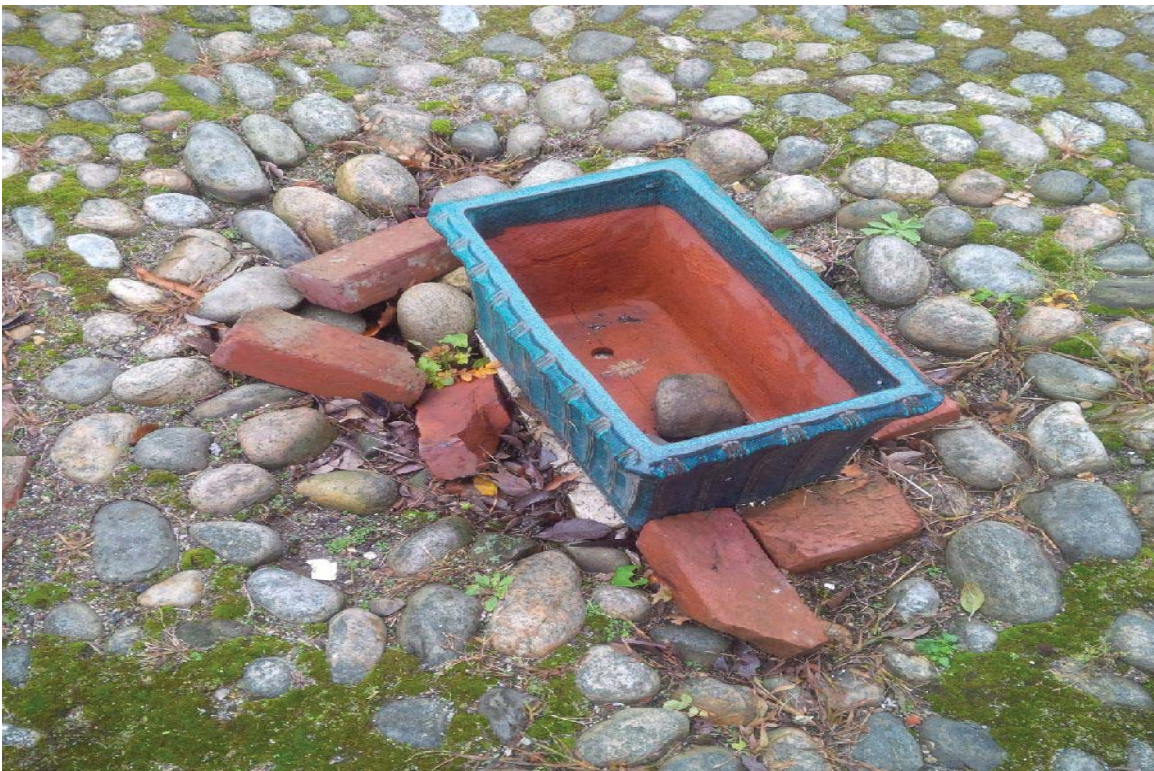
CY10: Close up of possible cistern location in Courtyard

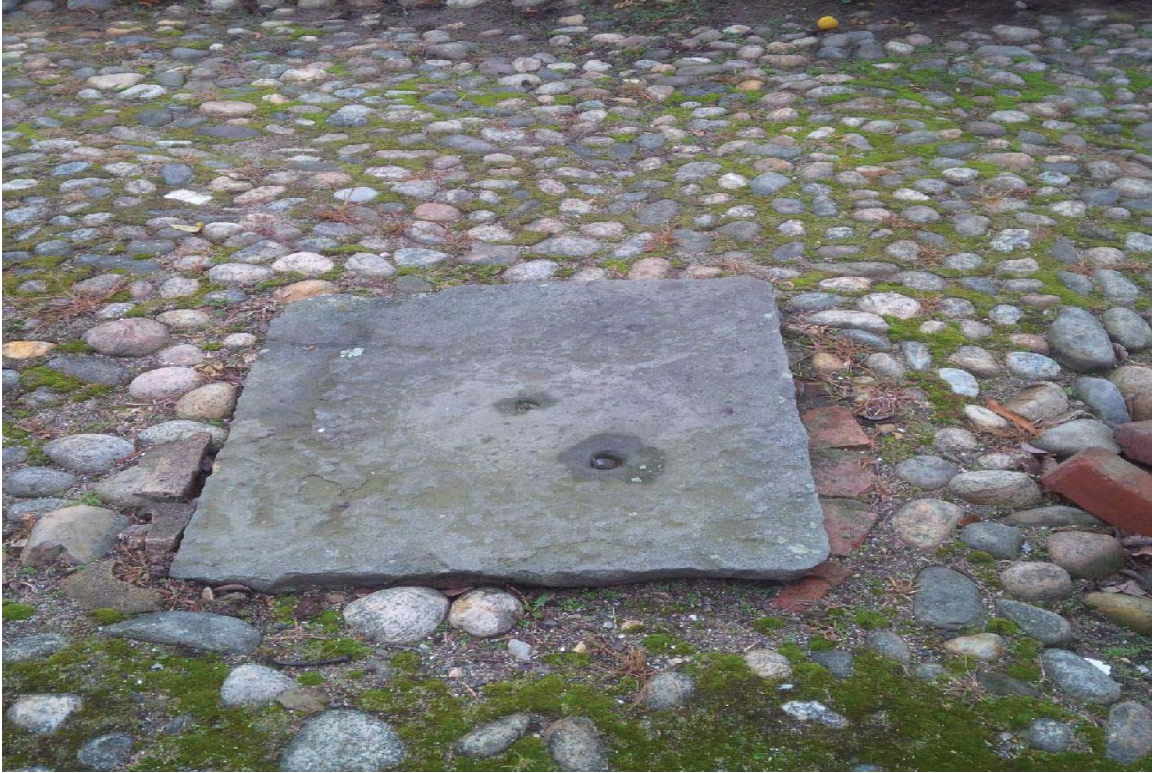
CY11: Close up view of possible Courtyard well

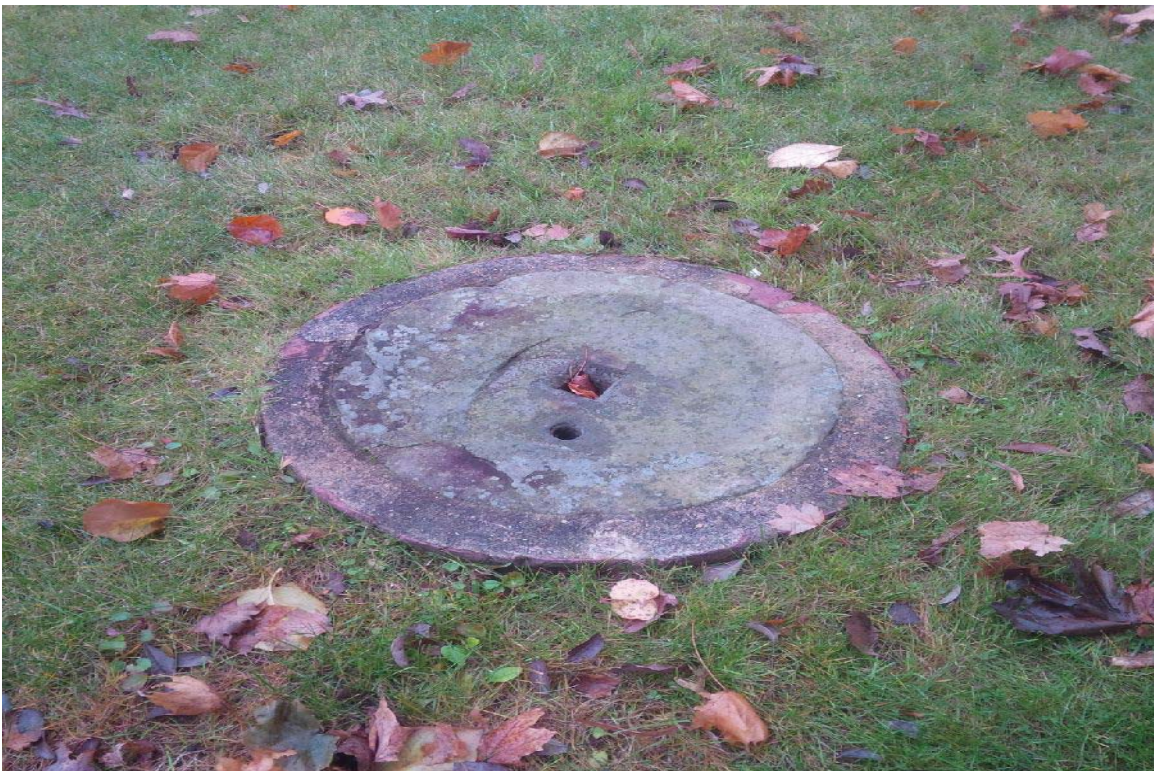
LY10: Detail view of manhole (well cover) at southeast side of Laundry Yard

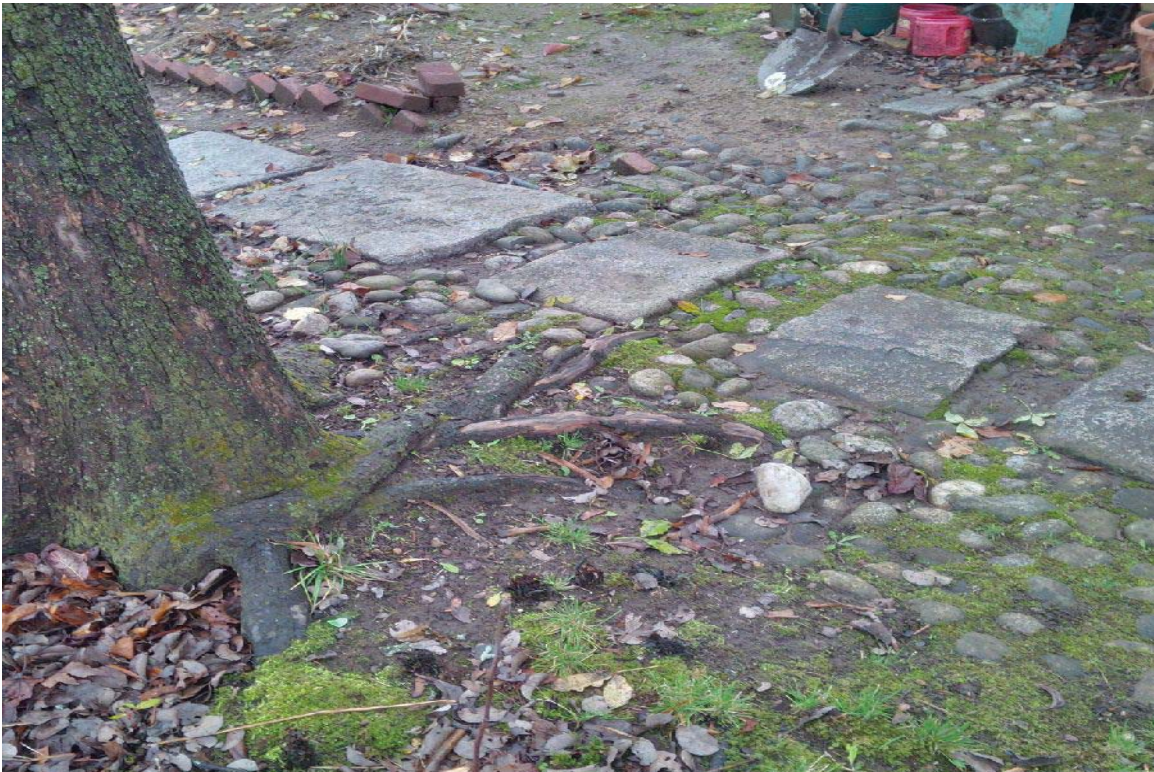
ON6: Detail photo of Orchard and Nursery path showing encroaching tree roots

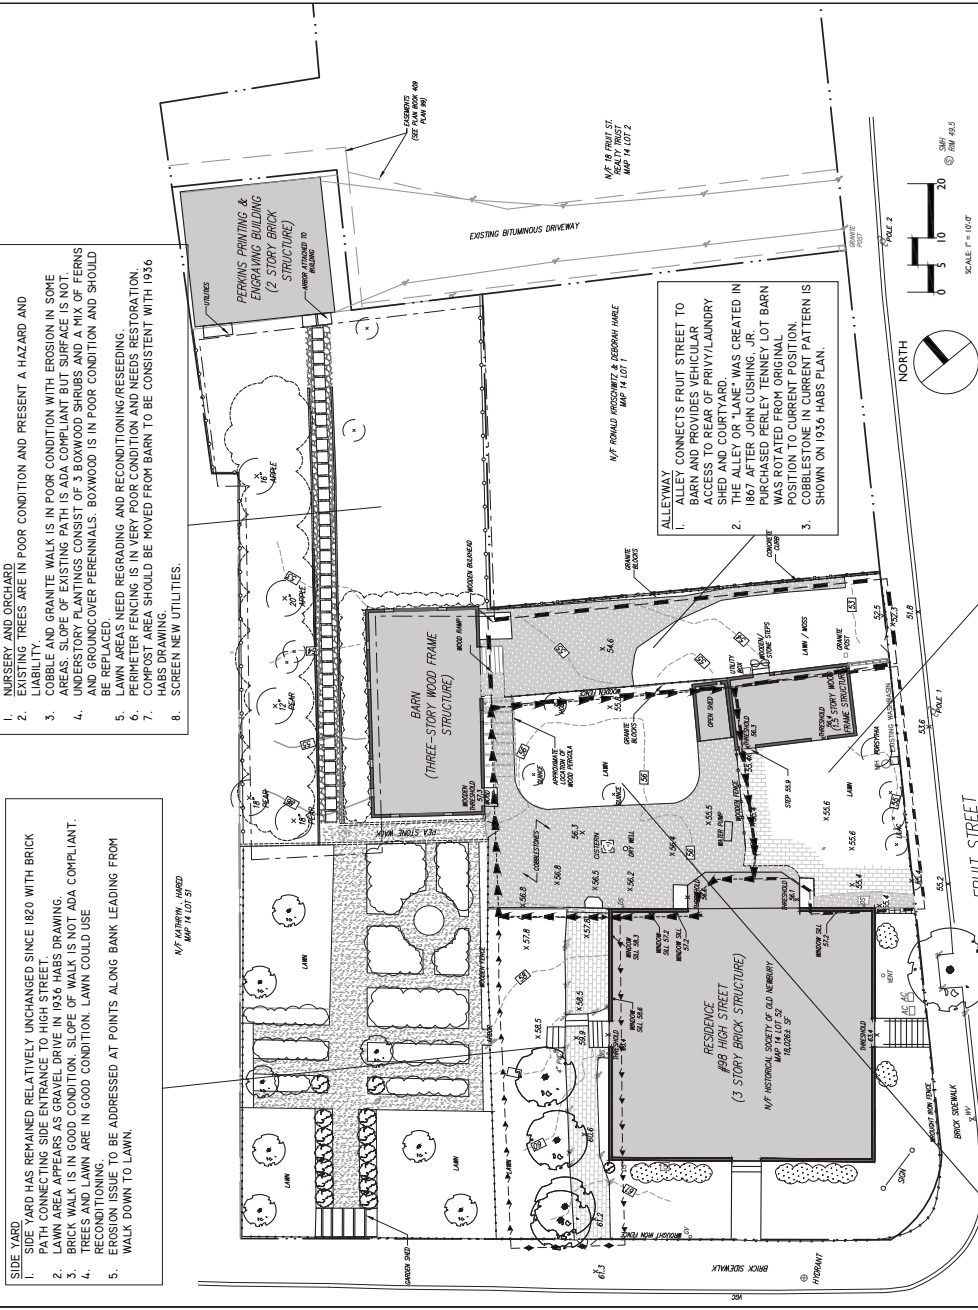
- SIDE YARD**
1. SIDE YARD HAS REMAINED RELATIVELY UNCHANGED SINCE 1820 WITH BRICK PATH CONNECTING SIDE ENTRANCE TO HIGH STREET.
 2. LAWN AREA APPEARS AS GRAVEL DRIVE IN 1936 HABS DRAWING.

3. BRICK WALK IS IN GOOD CONDITION. SLOPE OF WALK IS NOT ADA COMPLIANT.
 4. TREES AND LAWN ARE IN GOOD CONDITION. LAWN COULD USE EROSION ISSUE TO BE ADDRESSED AT POINTS ALONG BANK LEADING FROM WALK DOWN TO LAWN.

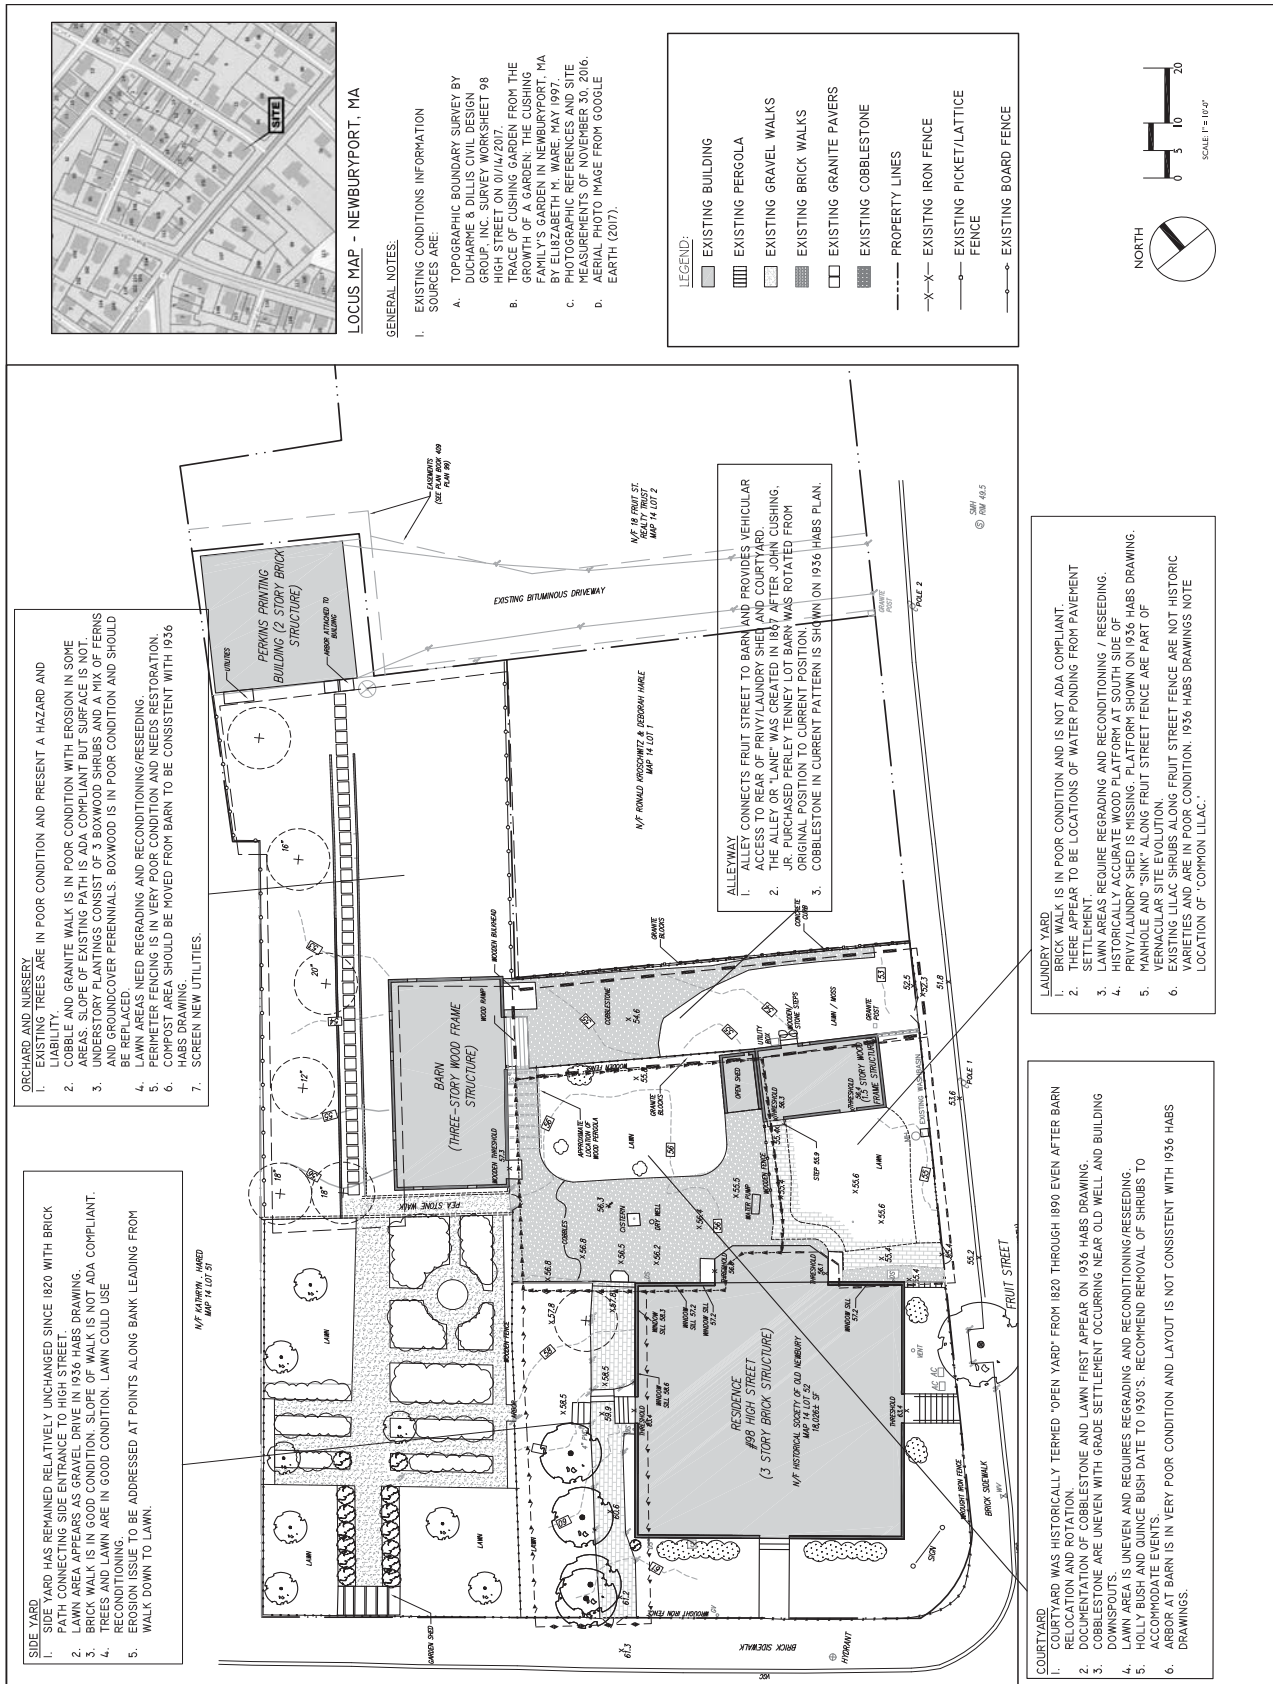
Landscape Site Analysis

1. The cobblestone surface has undulations making it unsafe and not ADA compliant. Some of the surface is covered in topsoil/lawn. As the cobblestone surface may be used largely for vehicular access, ADA compliance may not be necessary in this alley. Further investigation is recommended to determine the full extent of cobblestone under the topsoil and grass.
2. Wood picket fence along property line is in poor condition. We recommend that it be reconstructed.
3. Further structural investigation will be required to determine the appropriate treatment for the bulkhead at carriage barn.
4. The wood ramp to carriage barn is in fair condition. We are recommending reconstruction as a two-piece structure that can be partially removed for better access to the Courtyard area through the arbor in the lattice fence.

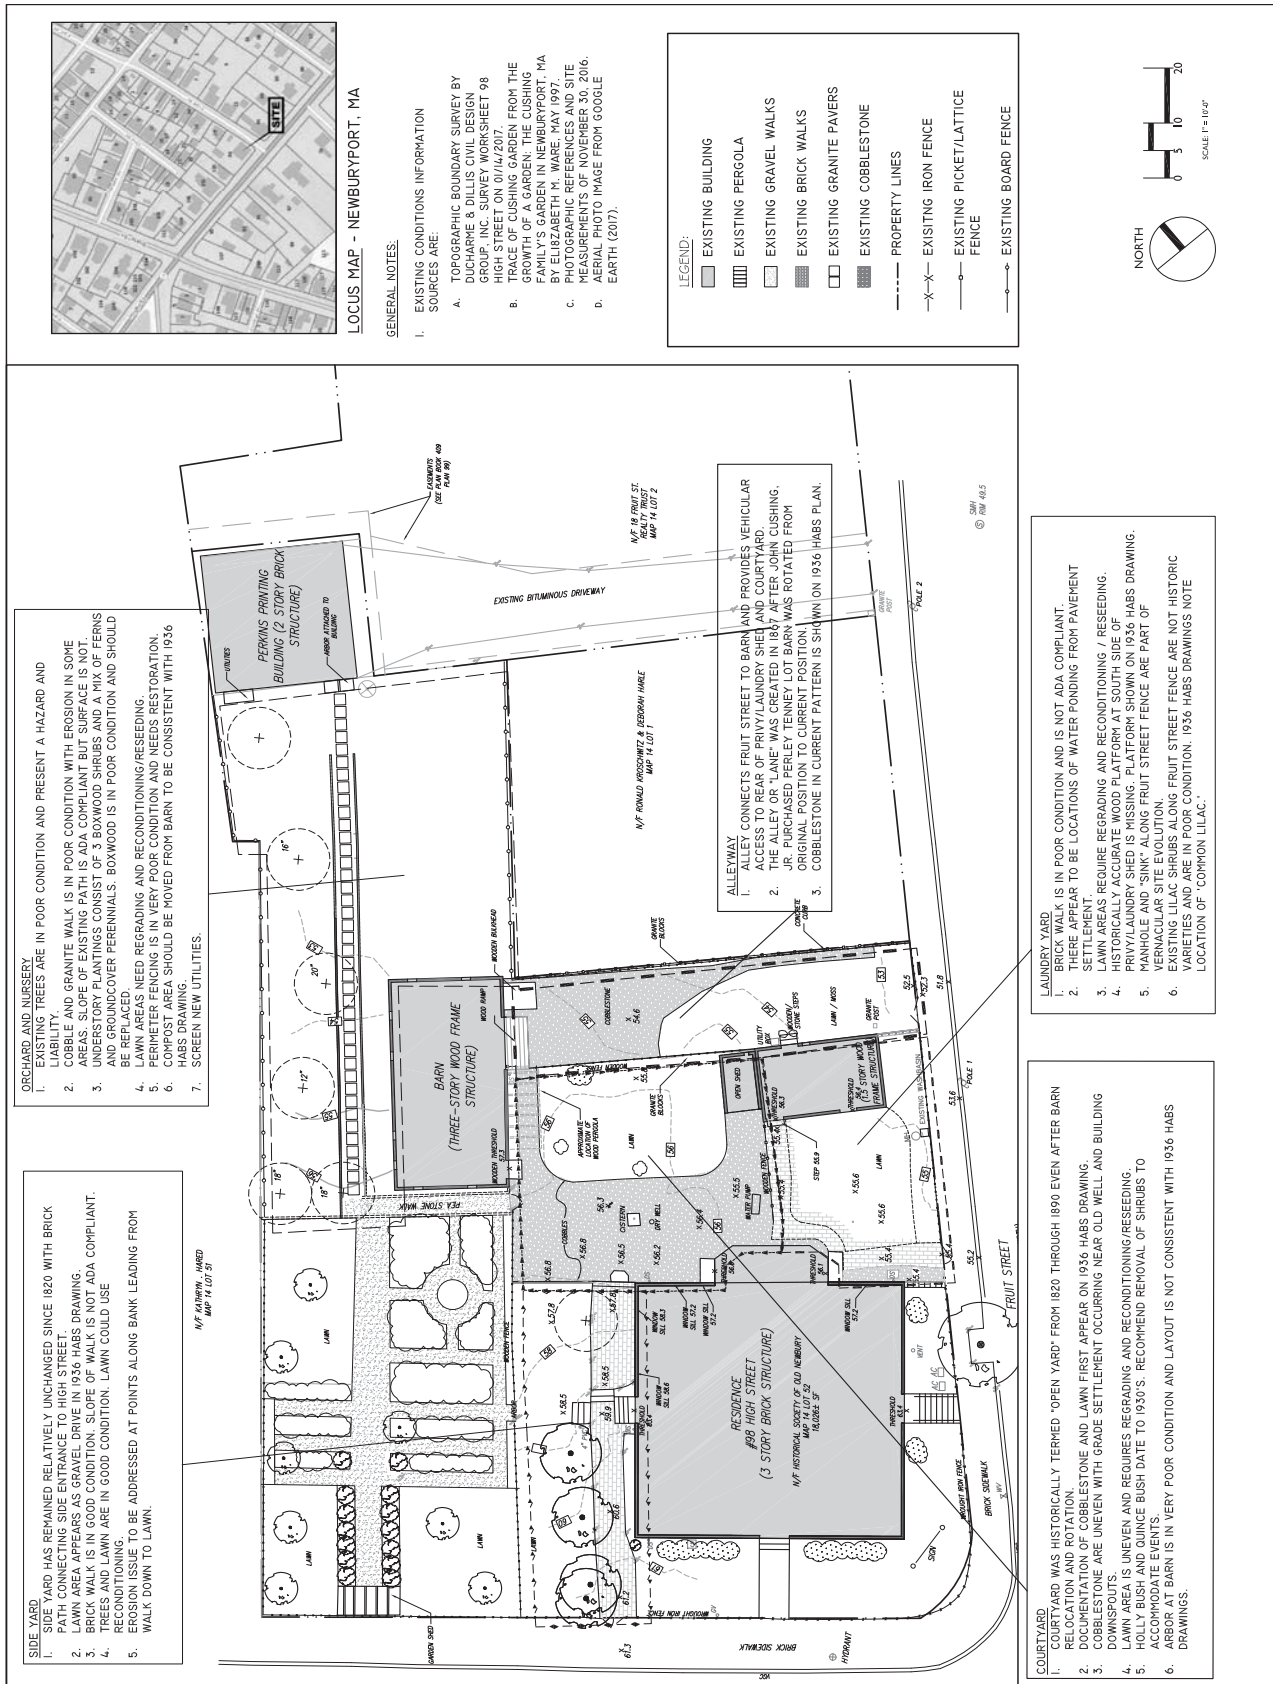
Landscape Site Analysis

1. The walk is in fair condition and should be reconstructed. If reconstructed as granite sets surrounded by cobblestone, it could be made more level and safer for able individuals, however, it will still not be ADA compliant.
2. Wood board fence along property lines is in poor condition and should be reconstructed.
3. The Alcove seat structure is in poor condition and we recommend that it be reconstructed.
4. The lawn area should be reconditioned.
5. The planting beds for perennials as shown on the 1936 HABS drawings could be restored.
6. All of trees are all in poor condition and present a hazard. We recommend removal of all trees and replanting of new fruit trees to restore the character of the Orchard.

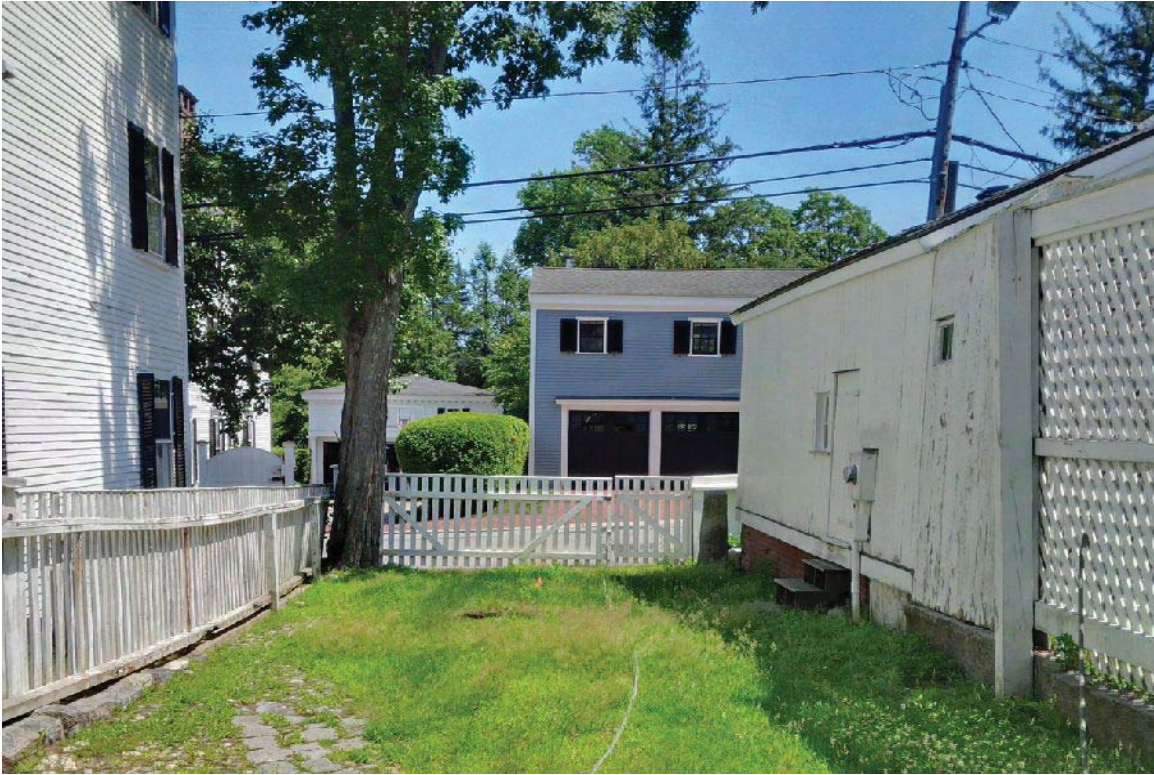
Alley leading to Fruit Street. Shows grass surface over cobblestone. Elm Tree on left

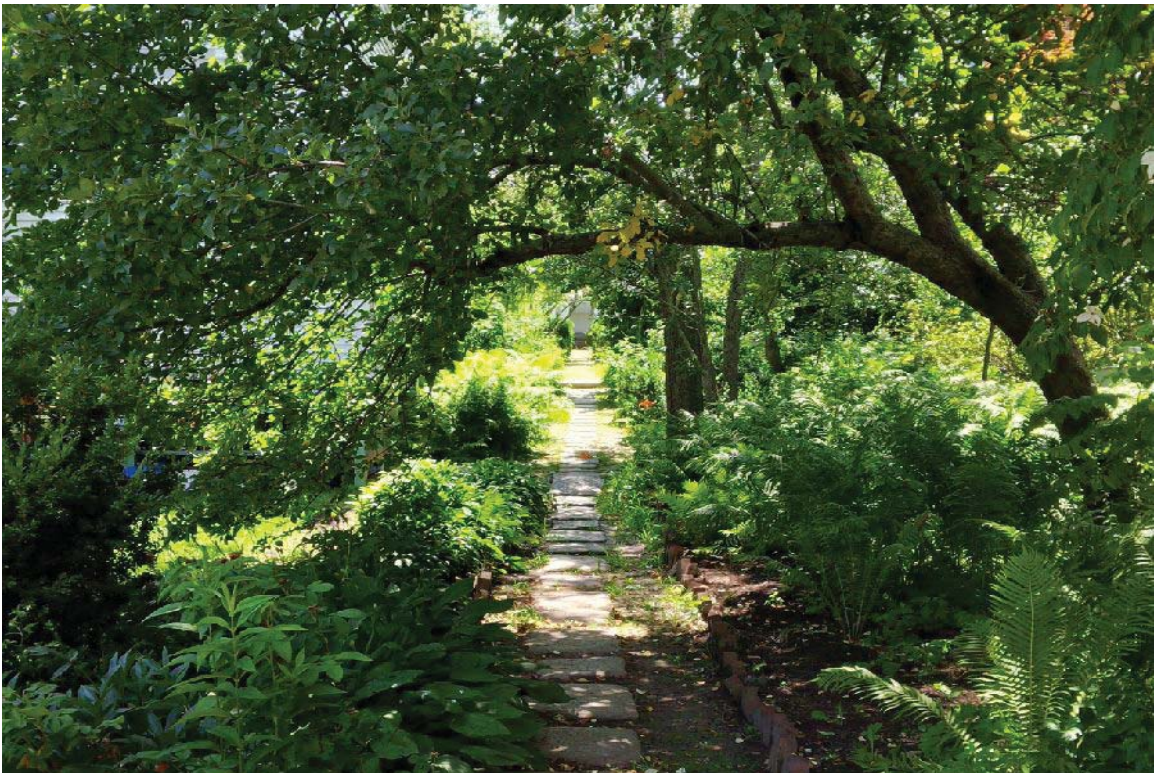
Nursery-Orchard Area: View south towards formal garden. Shows overgrowth.
