# Armory Garage

57 Low Street  
Phase II ESA

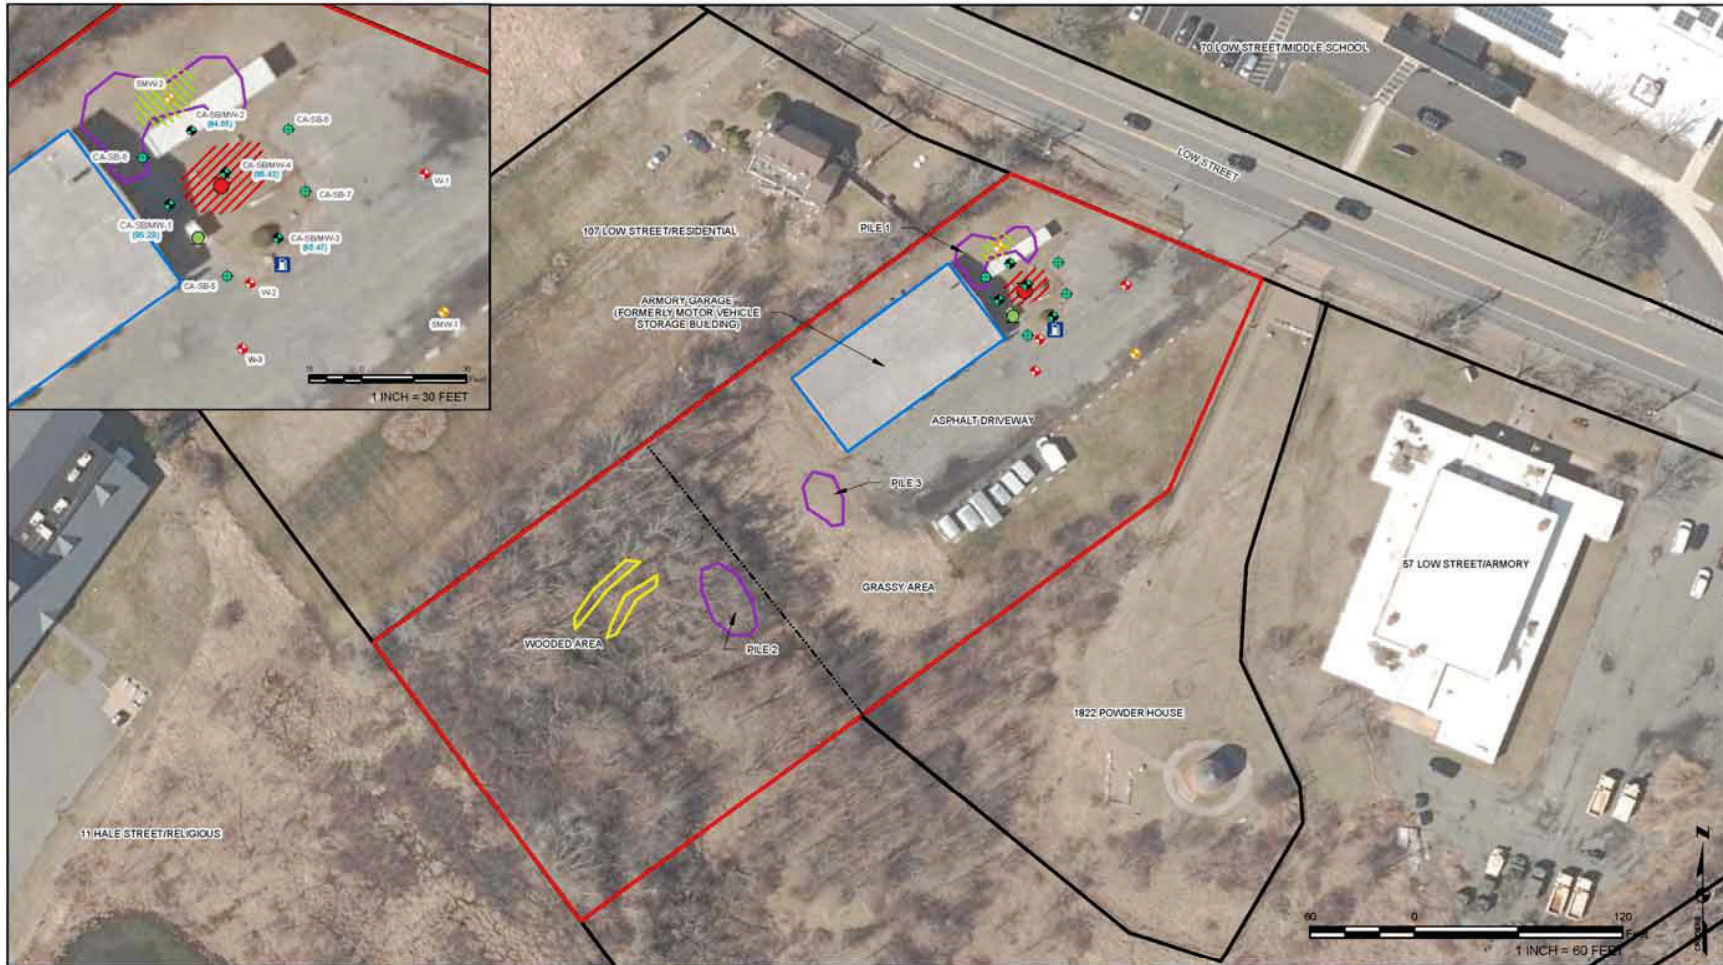
**FIGURE 2**  
**DETAILED SITE PLAN**  
 ARMORY GARAGE  
 57 LOW STREET  
 NEWBURYPORT, MASSACHUSETTS

- ▶ **Soil**: Two Samples (CA-SB-4 & CA-SB-8) contained low concentrations of both VPH and EPH compounds below the Massachusetts applicable standards
- ▶ **Groundwater**: Methyl-tert-butyl ether (MTBE) is present in one well(CA-MW-2) but below applicable Massachusetts applicable standards. No EPH compounds were detected above laboratory reporting limits

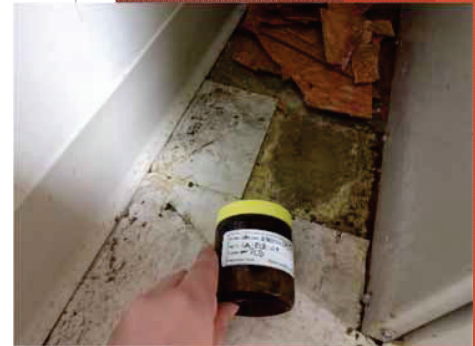
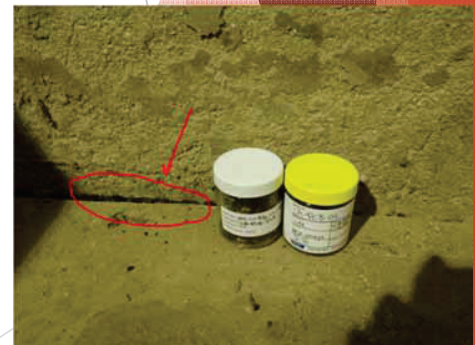
- ▶ **PCBs:** Two materials were identified containing PCBs >1 mg/kg and <50 mg/kg
  - ▶ CA-PCB-2: expansion gasket, black (foundation)
  - ▶ CA-PCB-4: mastic, black (below boiler in boiler room)
- ▶ **Mold:** None of the detected mold spore counts in the air samples exceeded any of the Calculated Reference Standards
- ▶ **Mold:** Pithomyces were identified at a “high” level in the tape lift samples from the Men’s Bathroom

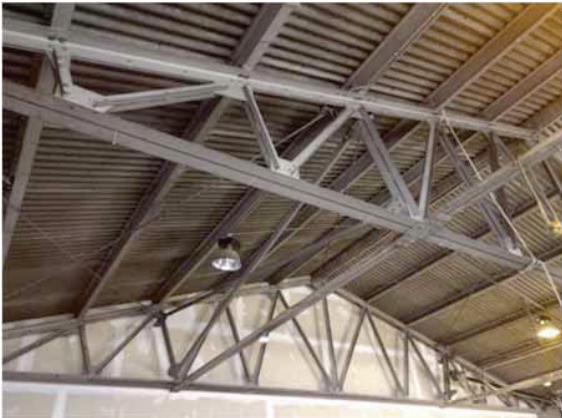
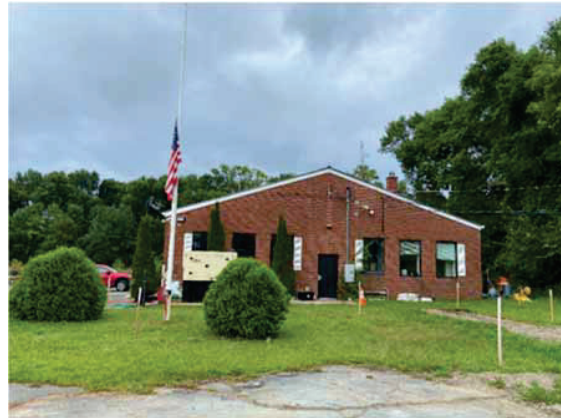
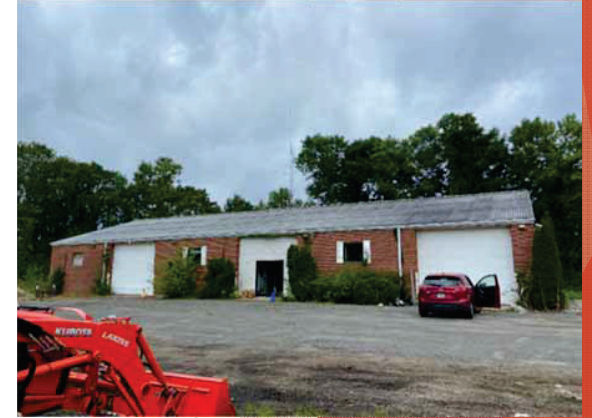
- ▶ Lead-containing paint present throughout the building
- ▶ Lead-based paint outside on flag point and adjacent to garage doors
- ▶ Asbestos is present in/on the building
