Brown School

42 Milk Street
Phase I ESA

Armory Garage

57 Low Street
Phase II ESA

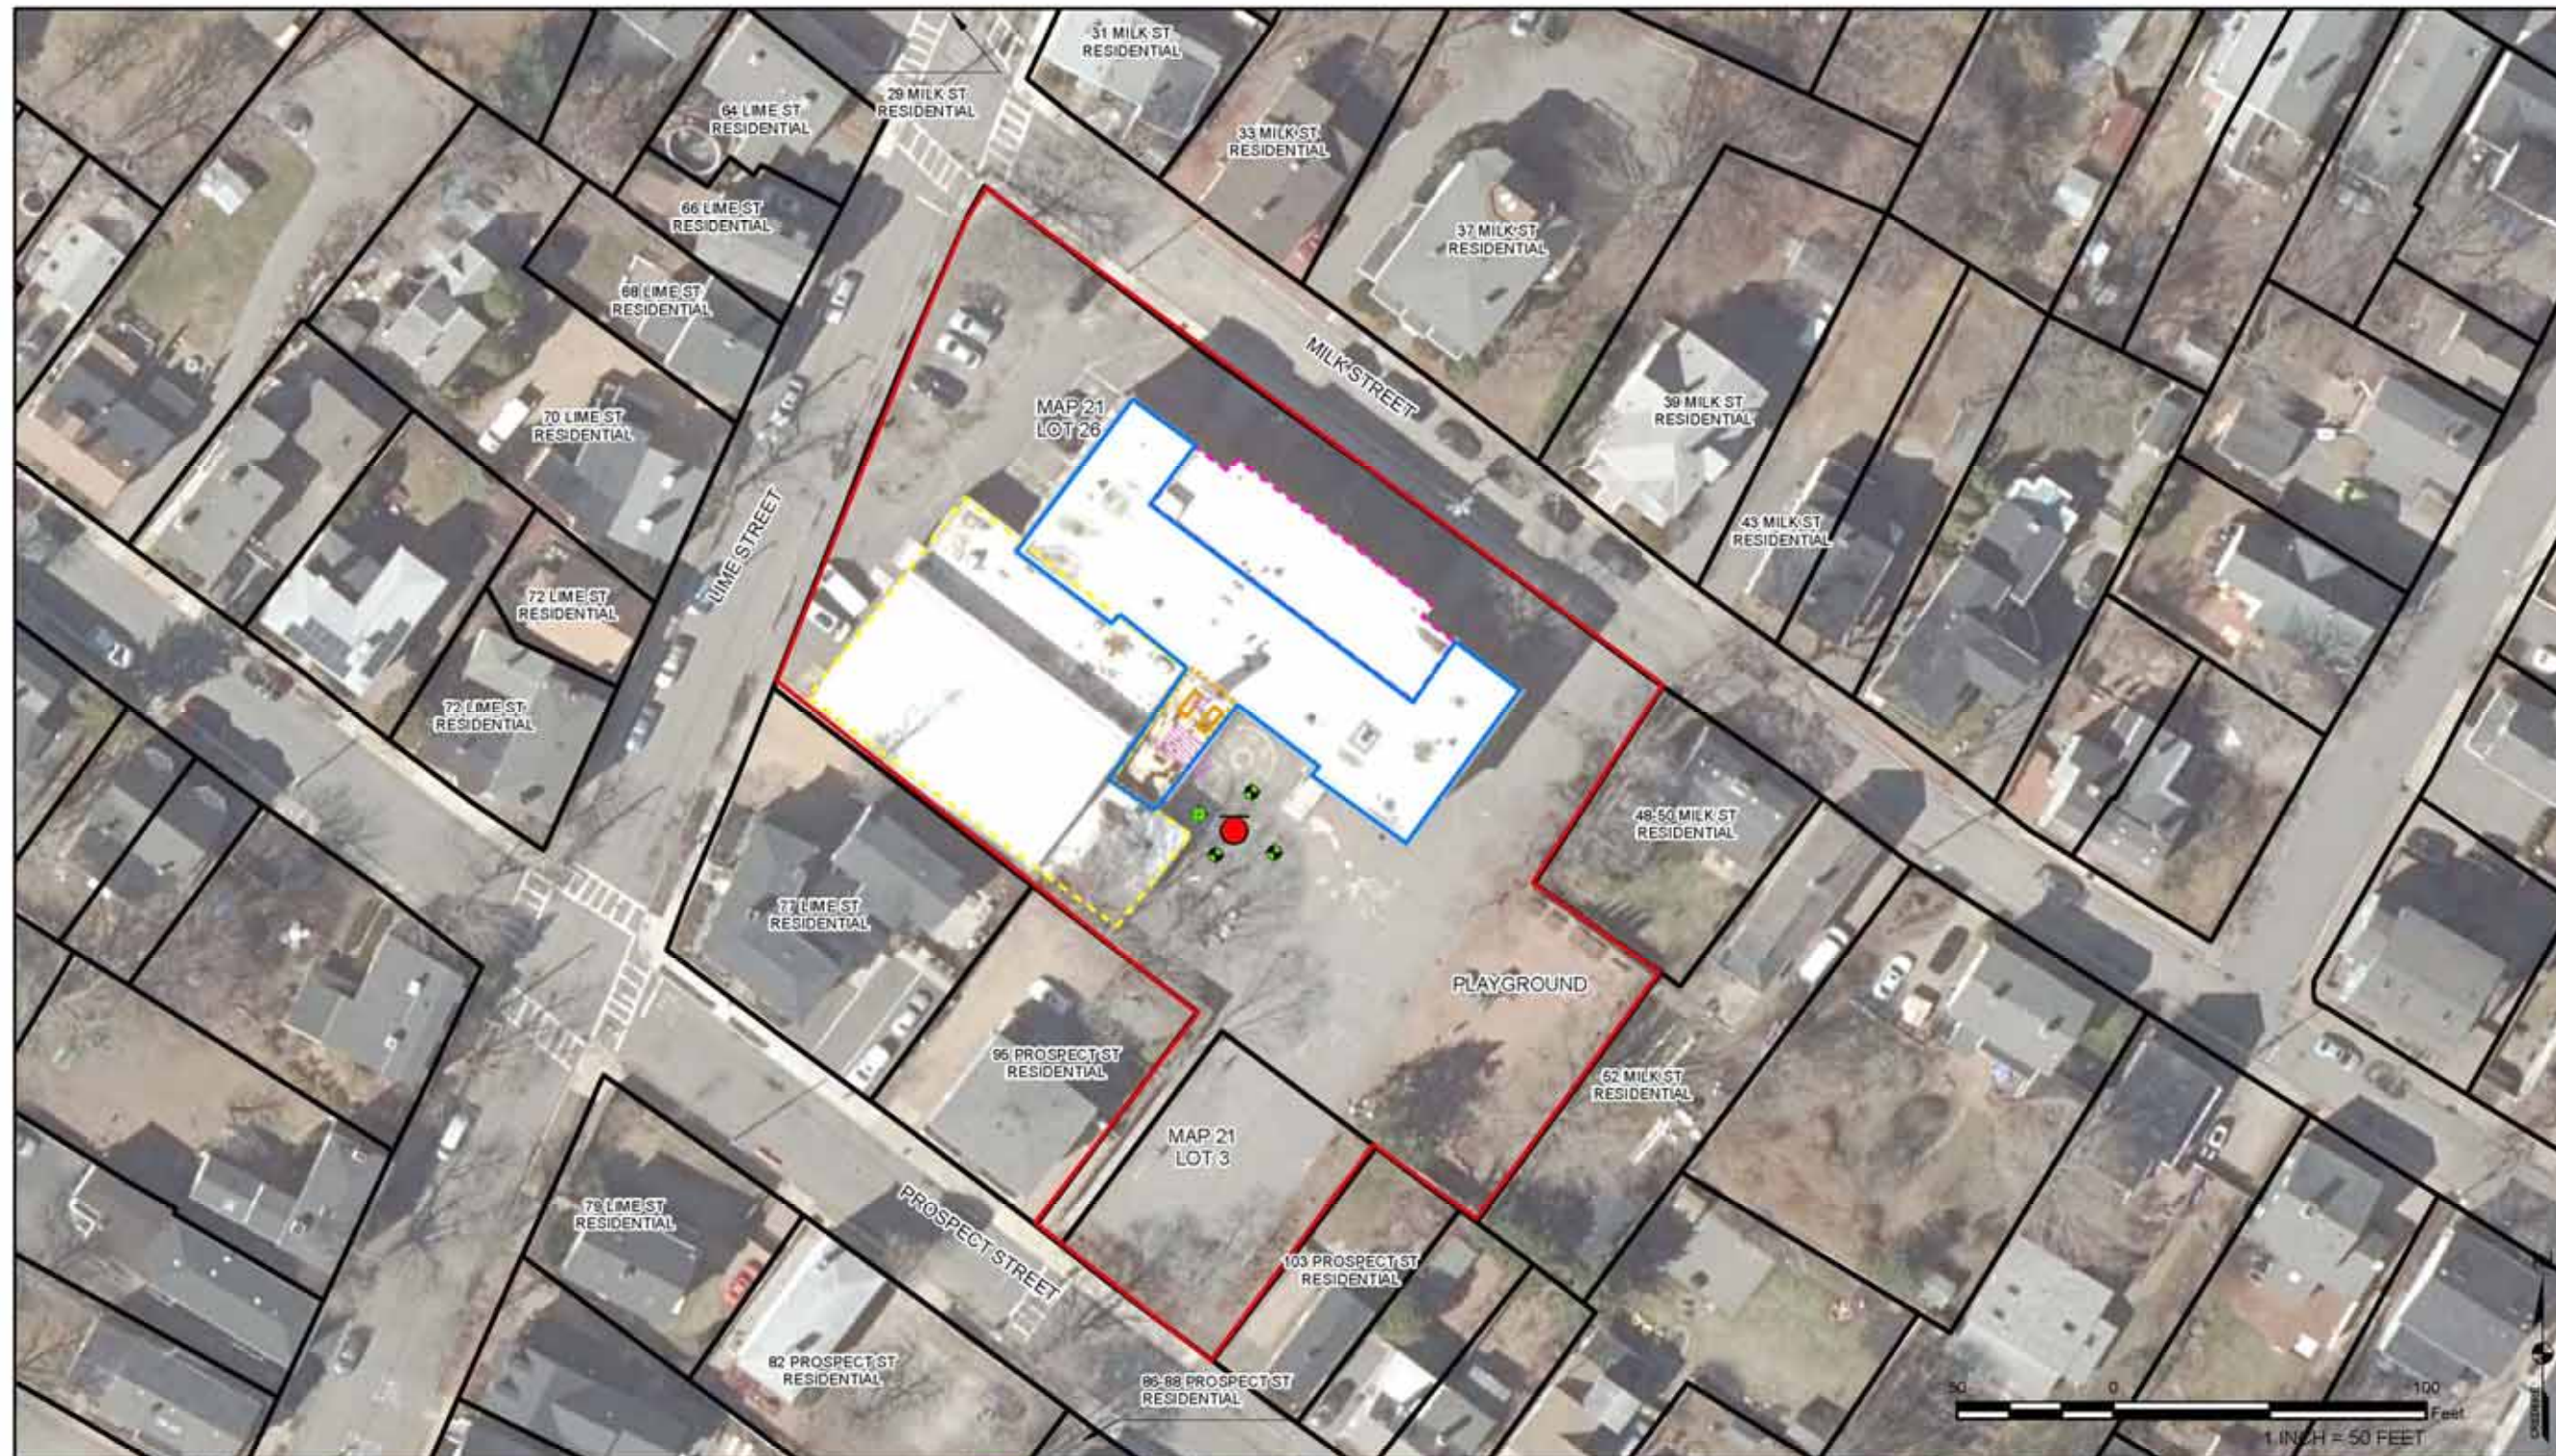
FIGURE 2
DETAILED SITE PLAN

- ▶ **Soil:** No petroleum related VPH & EPH compounds were detected in the Site soil samples collected.
- ▶ **Groundwater:** No petroleum related VPH & EPH compounds were not detected in Site groundwater.

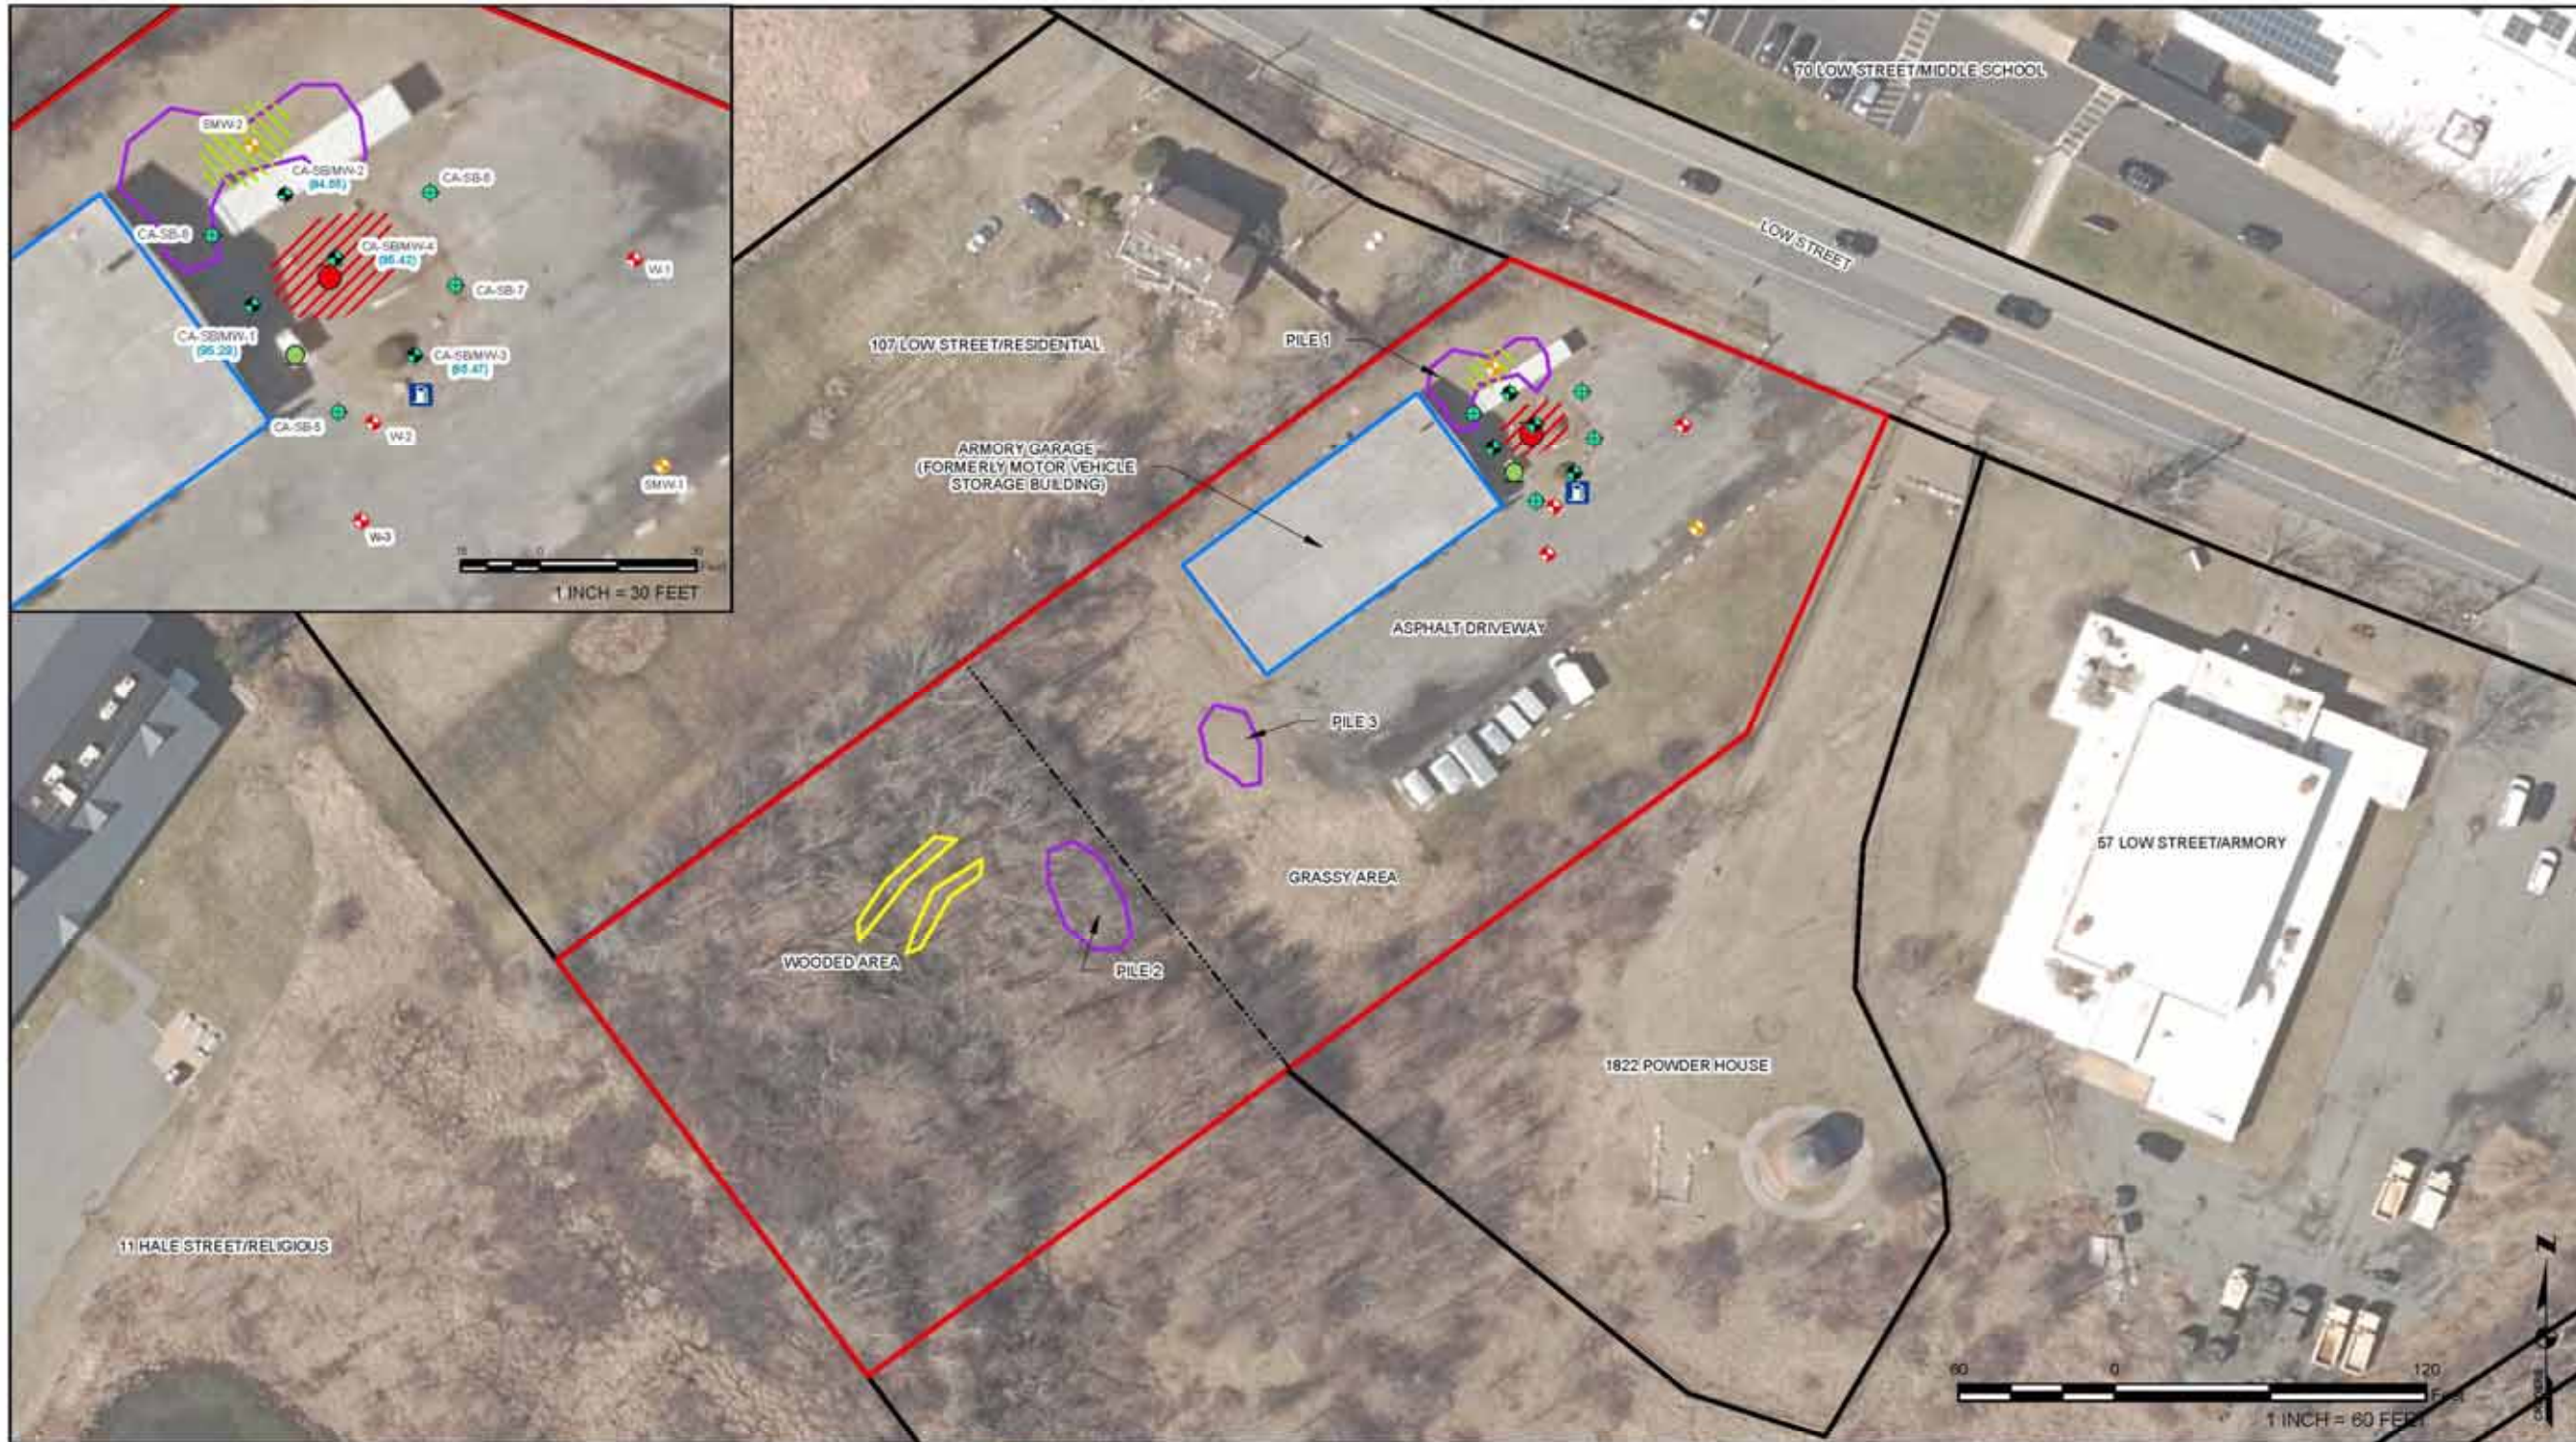
FIGURE 2
DETAILED SITE PLAN
ARMORY GARAGE
57 LOW STREET
NEWBURYPORT, MASSACHUSETTS

- ▶ **Soil**: Two Samples (CA-SB-4 & CA-SB-8) contained low concentrations of both VPH and EPH compounds below the Massachusetts applicable standards
- ▶ **Groundwater**: Methyl-tert-butyl ether (MTBE) is present in one well (CA-MW-2) but below applicable Massachusetts applicable standards. No EPH compounds were detected above laboratory reporting limits
