**Subject: Hazardous Building Materials Survey
Armory Garage
57 Low Street, Newburyport, Massachusetts**

Hazardous Building Materials Survey

**Armory Garage
57 Low Street
Newburyport, Massachusetts**

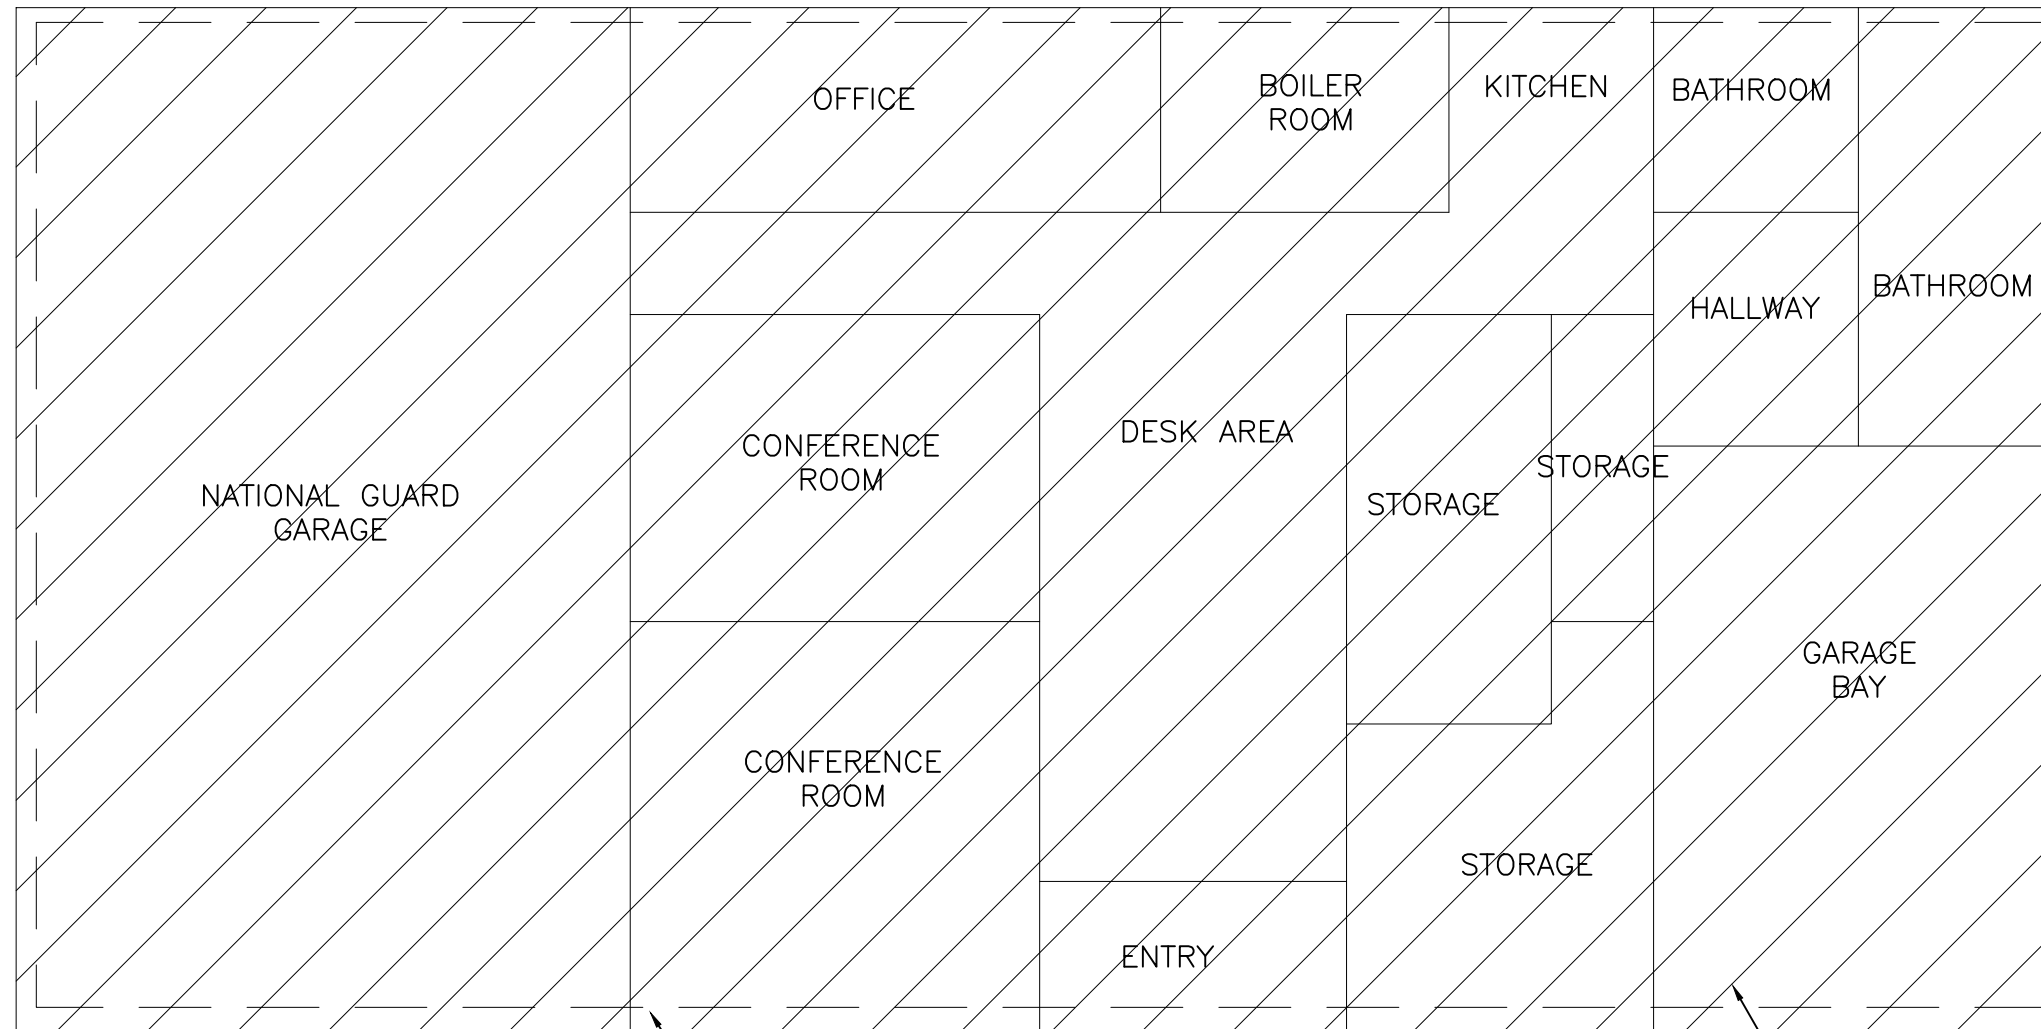
FIGURE 3

300 LF OF ASBESTOS EXPANSION GASKET
 LOCATED BETWEEN THE CONCRETE FLOOR
 AND THE CONCRETE FOUNDATION WALLS

6,800 SF OF ASBESTOS
 CORRUGATED TRANSITE
 LOCATED ON THE ROOF

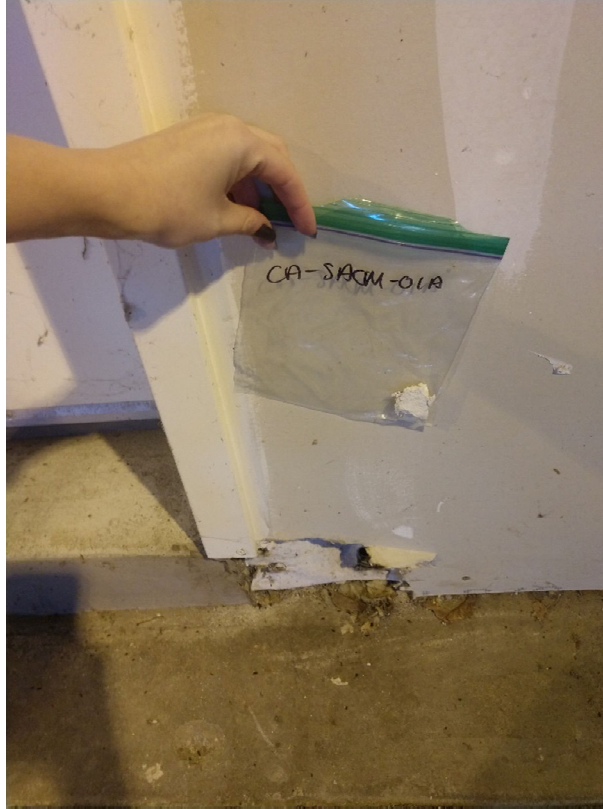
1. Material CA-SACM-01, light gray sheetrock found throughout the building

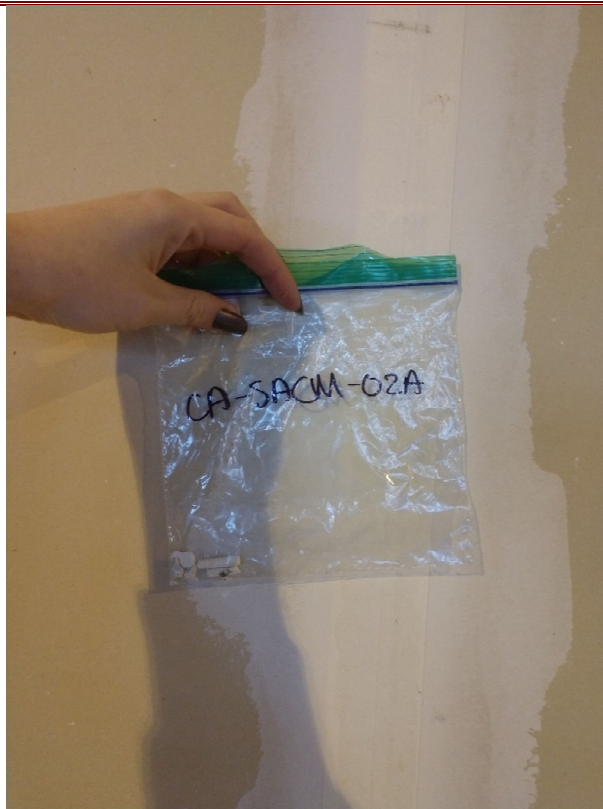
2. Material CA-SACM-02, white joint compound found throughout the building.

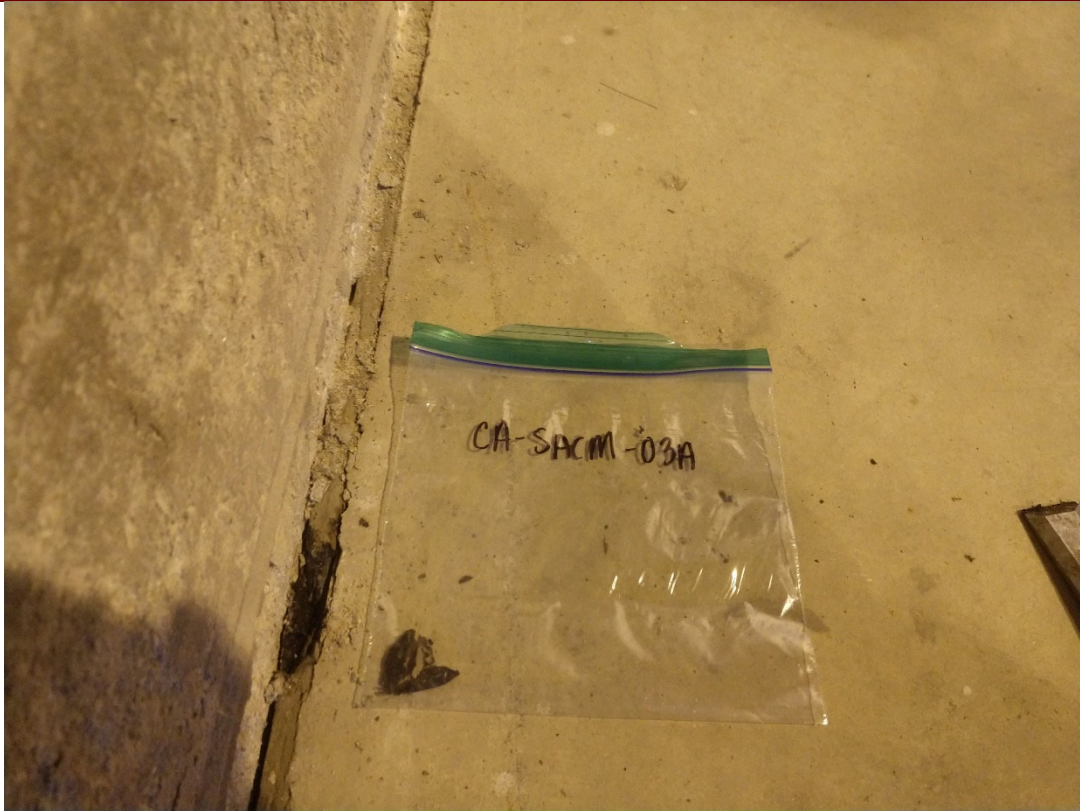
- CA-SACM-03, expansion gasket, found at the seam where the concrete floor meets the concrete foundation.
- CA-SACM-04, corrugated transite roofing

- Expansion gasket located between the concrete floor and the concrete foundation (estimated 300 linear feet)
 - Corrugated transite panels that comprise the building roof (estimated 6,800 square feet)

3. Material CA-SACM-03, expansion gasket found between the concrete floor and the concrete foundation wall

Client Sample ID: CA-SACM-03A **Lab Sample ID:** 622001620-0006
Sample Description: NAT GUARD BAY/EXPANSION GASKET

TEST	Analyzed Date	Color	Non-Asbestos		Asbestos	Comment
			Fibrous	Non-Fibrous		
PLM Grav. Reduction	11/30/2020	Black	0.0%	91.9%	8.1% Chrysotile

- The identified ACM can stay in use because they are not friable. However, prior to any planned building renovation or demolition, these materials should be properly abated by an asbestos abatement contractor and disposed at a facility licensed to accept the asbestos waste. If during renovations any untested suspect materials are encountered, they should be sampled and analyzed for asbestos or presumed positive to allow for proper abatement.

The budget to properly remove and dispose of the roofing materials is estimated between \$6 and \$10 per square foot. The gasket would not be removed unless the entire building is demolished. For planning purposes, the estimated cost for gasket removal and disposal will be between \$2 and \$3 per lineal foot.

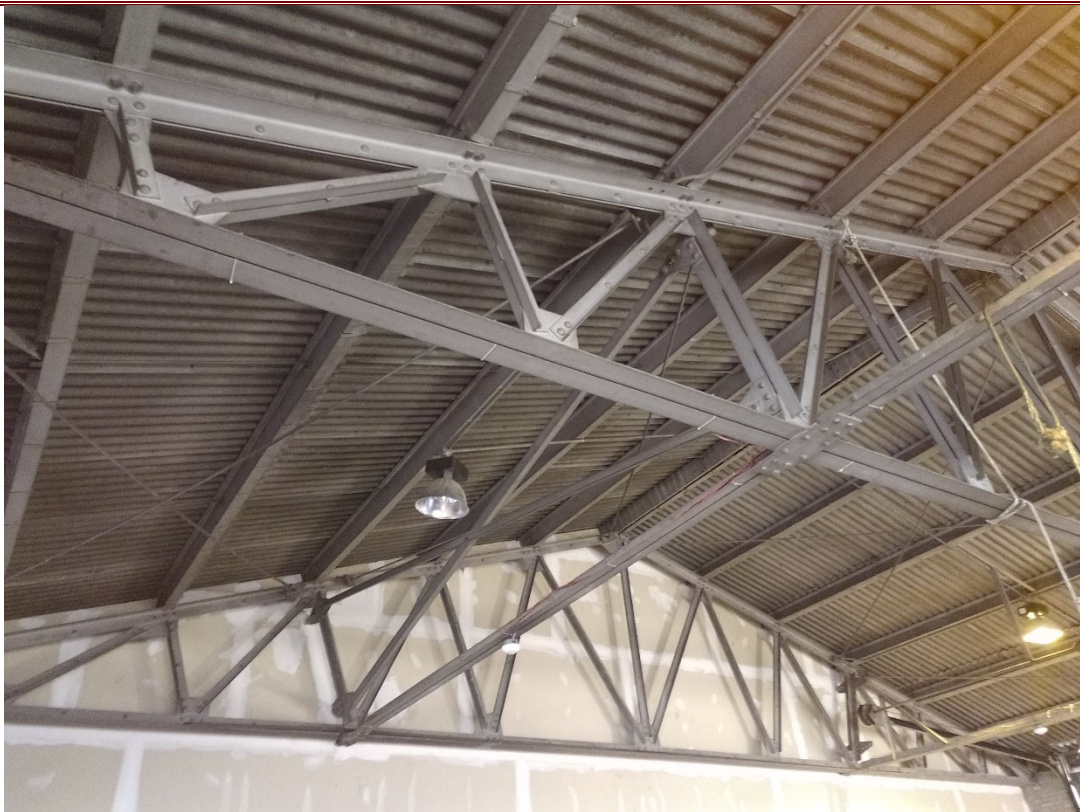
4. Material CA-SACM-04, corrugated transite panels in place on the building roof as viewed from below.

TEST	Analyzed Date	Color	Non-Asbestos		Asbestos	Comment
			Fibrous	Non-Fibrous		
PLM	11/30/2020	Gray	0.0%	85.0%	15% Chrysotile

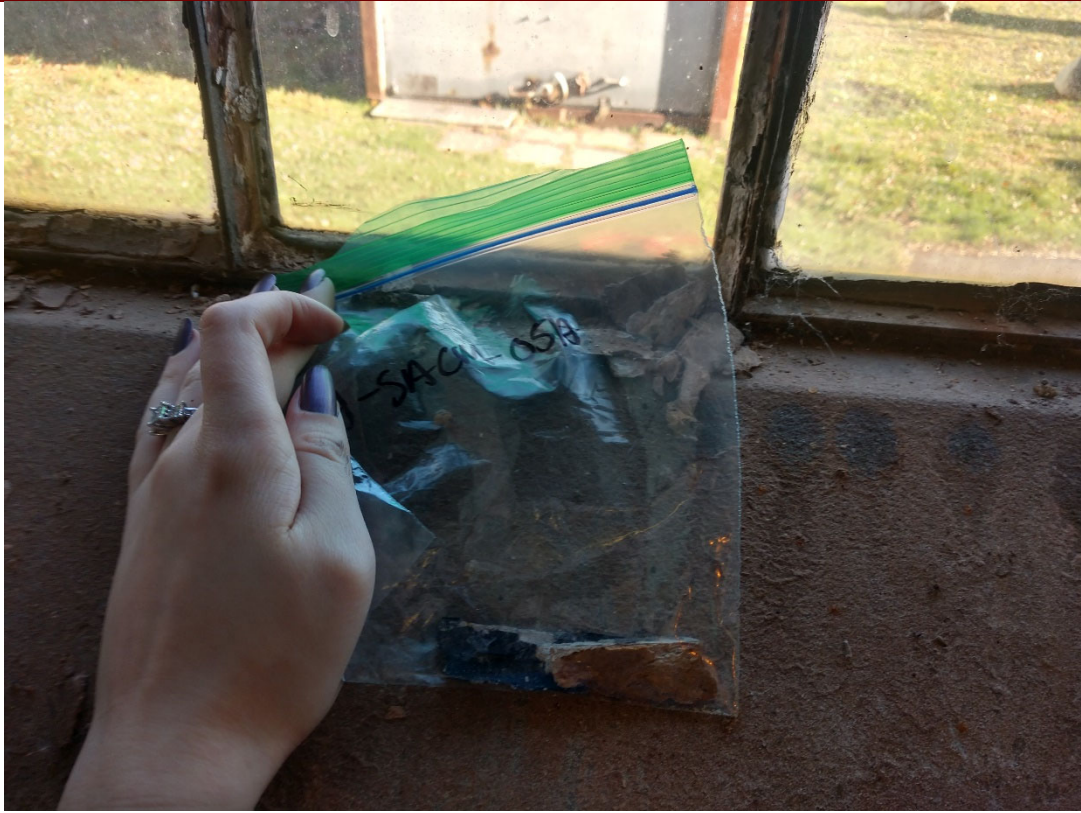
5. Material CA-SACM-05, off-white glazing found on the original building windows

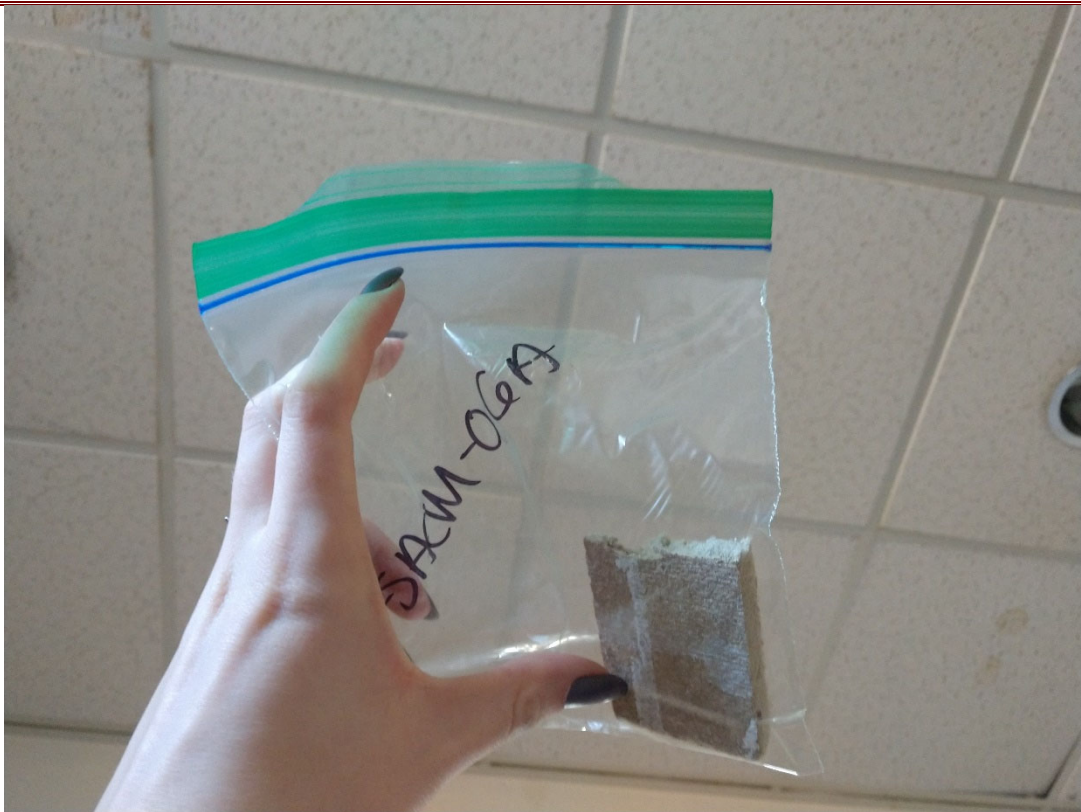
6. Material CA-SACM-06, 2' x 2' Ceiling tiles with a dot squiggle pattern.

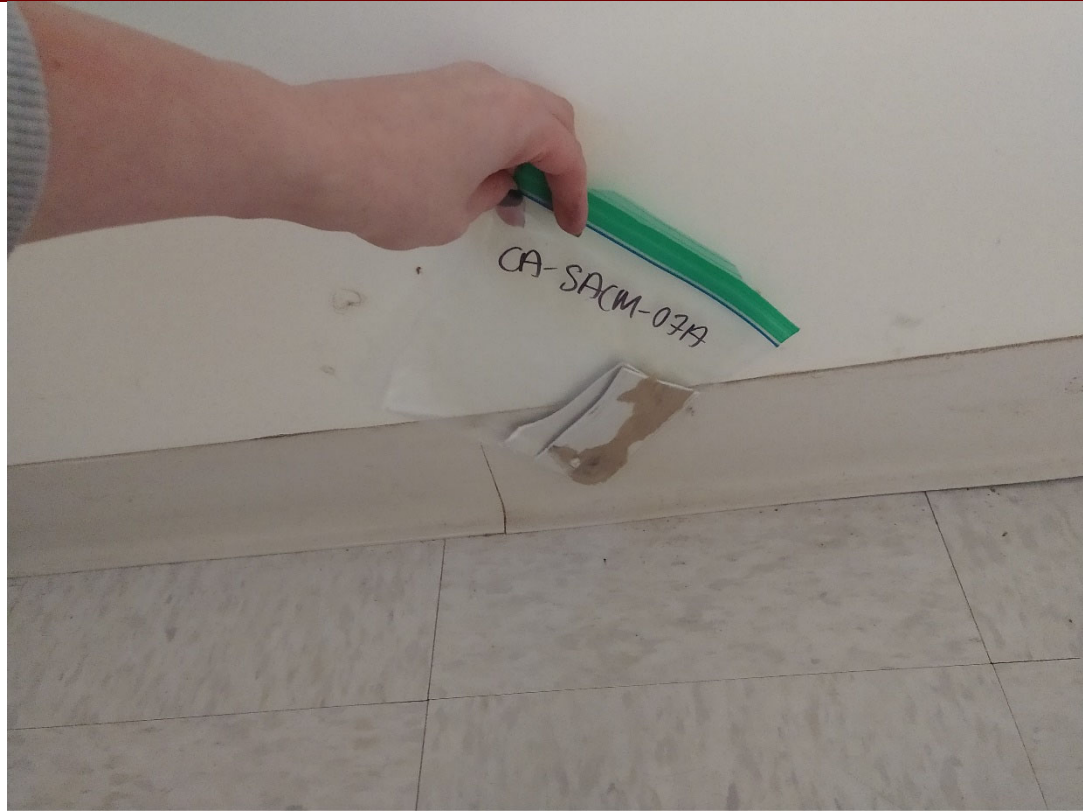
7. Material CA-SACM-07, beige baseboard adhesive. Present throughout the building.

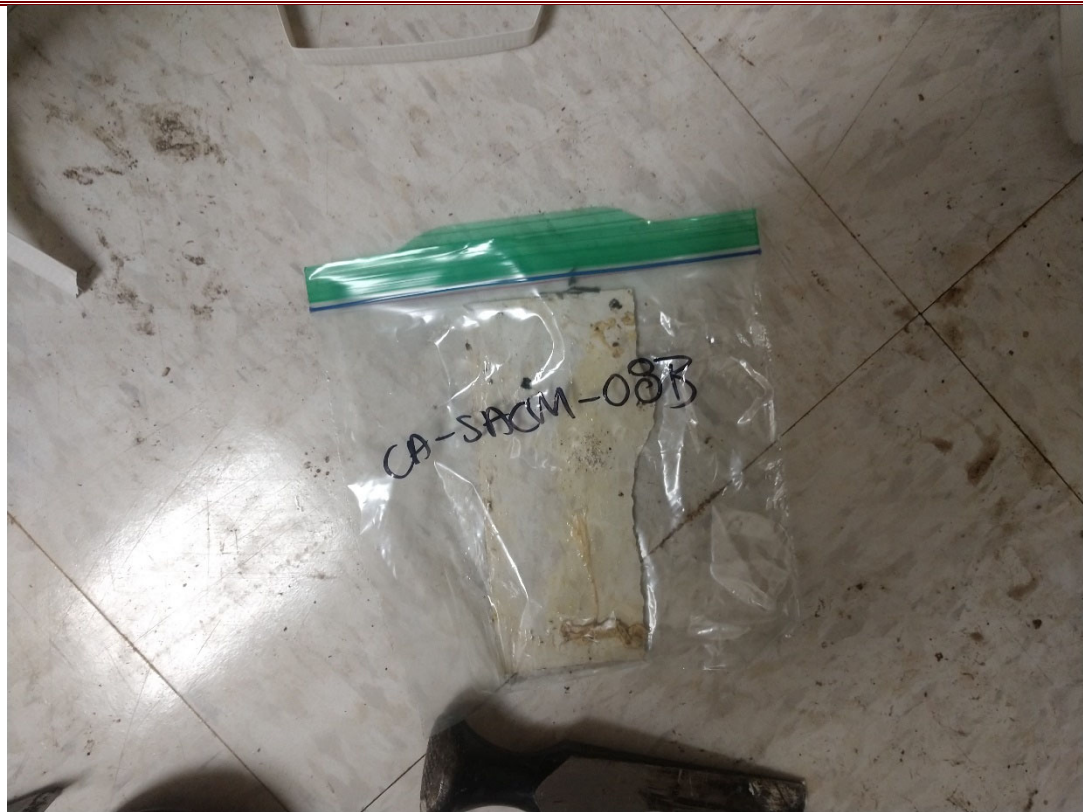
8. Material CA-SACM-08, white 12" Floor Tile found throughout the building
