**From:** Gove, Doug <Doug.Gove@aecom.com>  
**Sent:** Friday, August 11, 2017 10:55 AM  
**To:** Andrew Port  
**Cc:** DeNatale, Doug; Ted Angelakis; Anthony Furnari; Gove, Doug  
**Subject:** RE: Newburyport Well No. 2 Groundwater Levels  
**Attachments:** IMG\_5949.jpg; IMG\_5950.jpg

**From:** Gove, Doug  
**Sent:** Thursday, August 10, 2017 4:19 PM  
**To:** Andrew Port (APort@CityofNewburyport.com)  
**Cc:** DeNatale, Doug; Gove, Doug; Ted Angelakis (TAngelakis@CityofNewburyport.com); AFurnari@CityofNewburyport.com  
**Subject:** Newburyport Well No. 2 Groundwater Levels

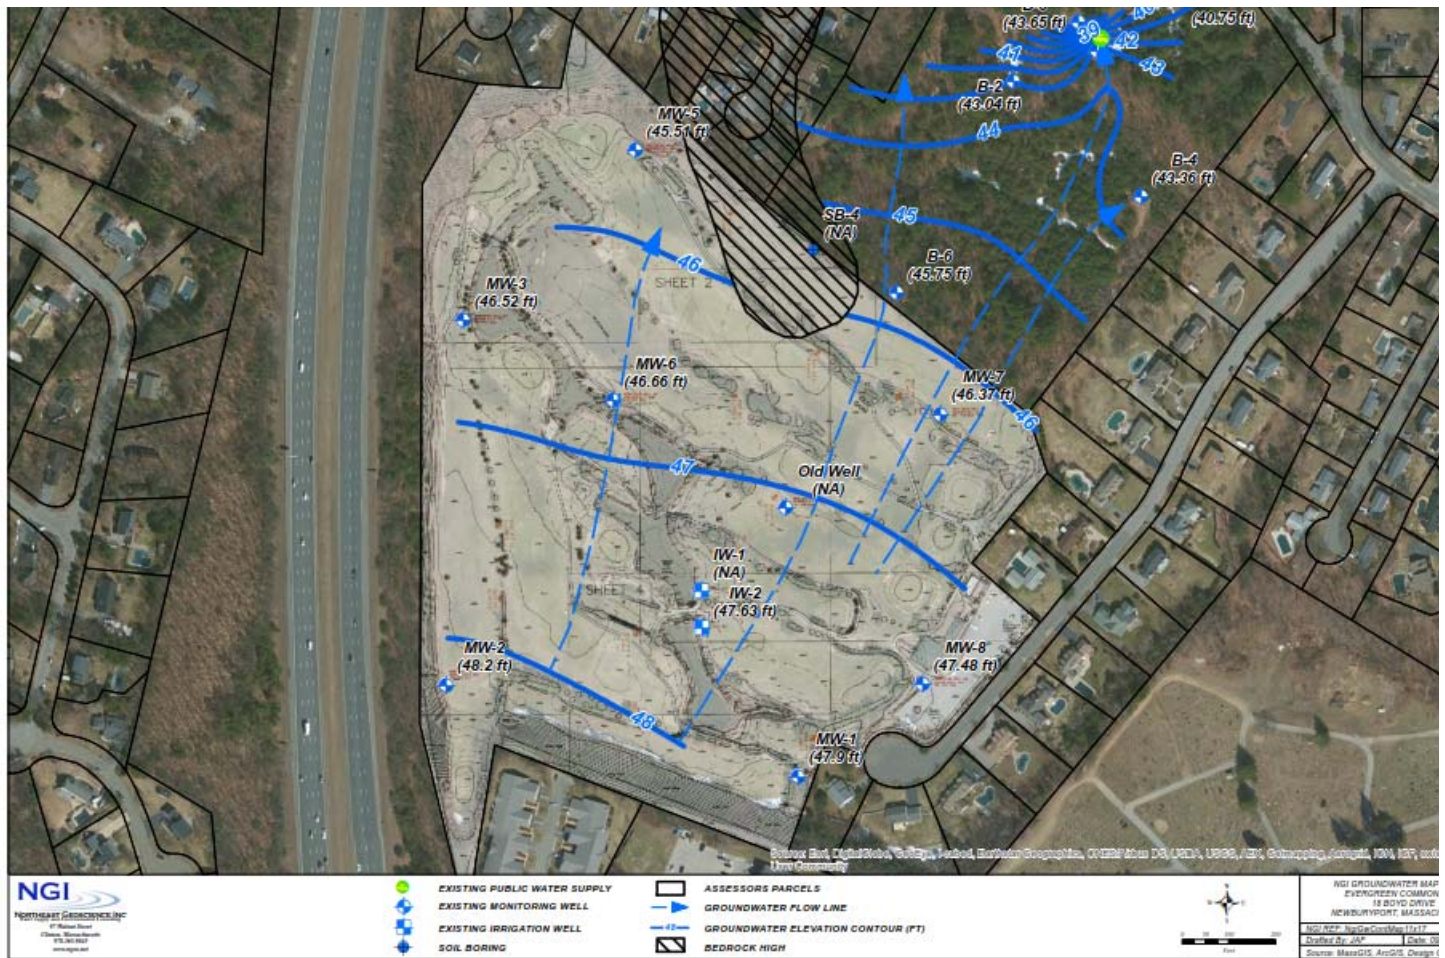
As part of our evaluation of the pump test results at the Evergreen Golf Course, we reviewed historic groundwater levels at the Well No. 2 for the period from November 2000 to June 2016. The groundwater levels were recorded by Water Department Staff and are summarized for observation well OB-6 in the attached spreadsheet. Observation well OB-6 (B-6 in figure below) is 700 feet southwest of Well No. 2, and is assumed to represent ambient groundwater conditions since it is apparently outside the influence of pumping. OB-6 is also adjacent to the golf course site. Based on our review of the data, we found a 14.4 foot fluctuation in groundwater levels at OB-6 with a high groundwater elevation of 59.4 feet (MSL) in June 2006 and a low of 45.0 feet (MSL) in November 2016. Per the figure below, groundwater elevations at the Evergreen Golf Course could be 1 to 2 feet higher than what was observed at OB-6 meaning a groundwater level of between 60 and 61 feet (MSL) was possible on the golf course in June 2006.

We are bringing this information to your attention so that the City can use it in their review of the subdivision plans. It would appear that the groundwater elevations show that there could have been two occasions when there was widespread flooding at the golf course site --- both in June 2006 and in March 2010. These high groundwater elevations should be considered when evaluating the potential water quality risks to the Well No. 2 supply both during construction of the development and after the construction is completed.
