**Subject: Phase I Environmental Site Assessment - Brown School
42 Milk Street, Newburyport, Massachusetts**

Phase I Environmental Site Assessment

**Brown School
42 Milk Street
Newburyport, Massachusetts**

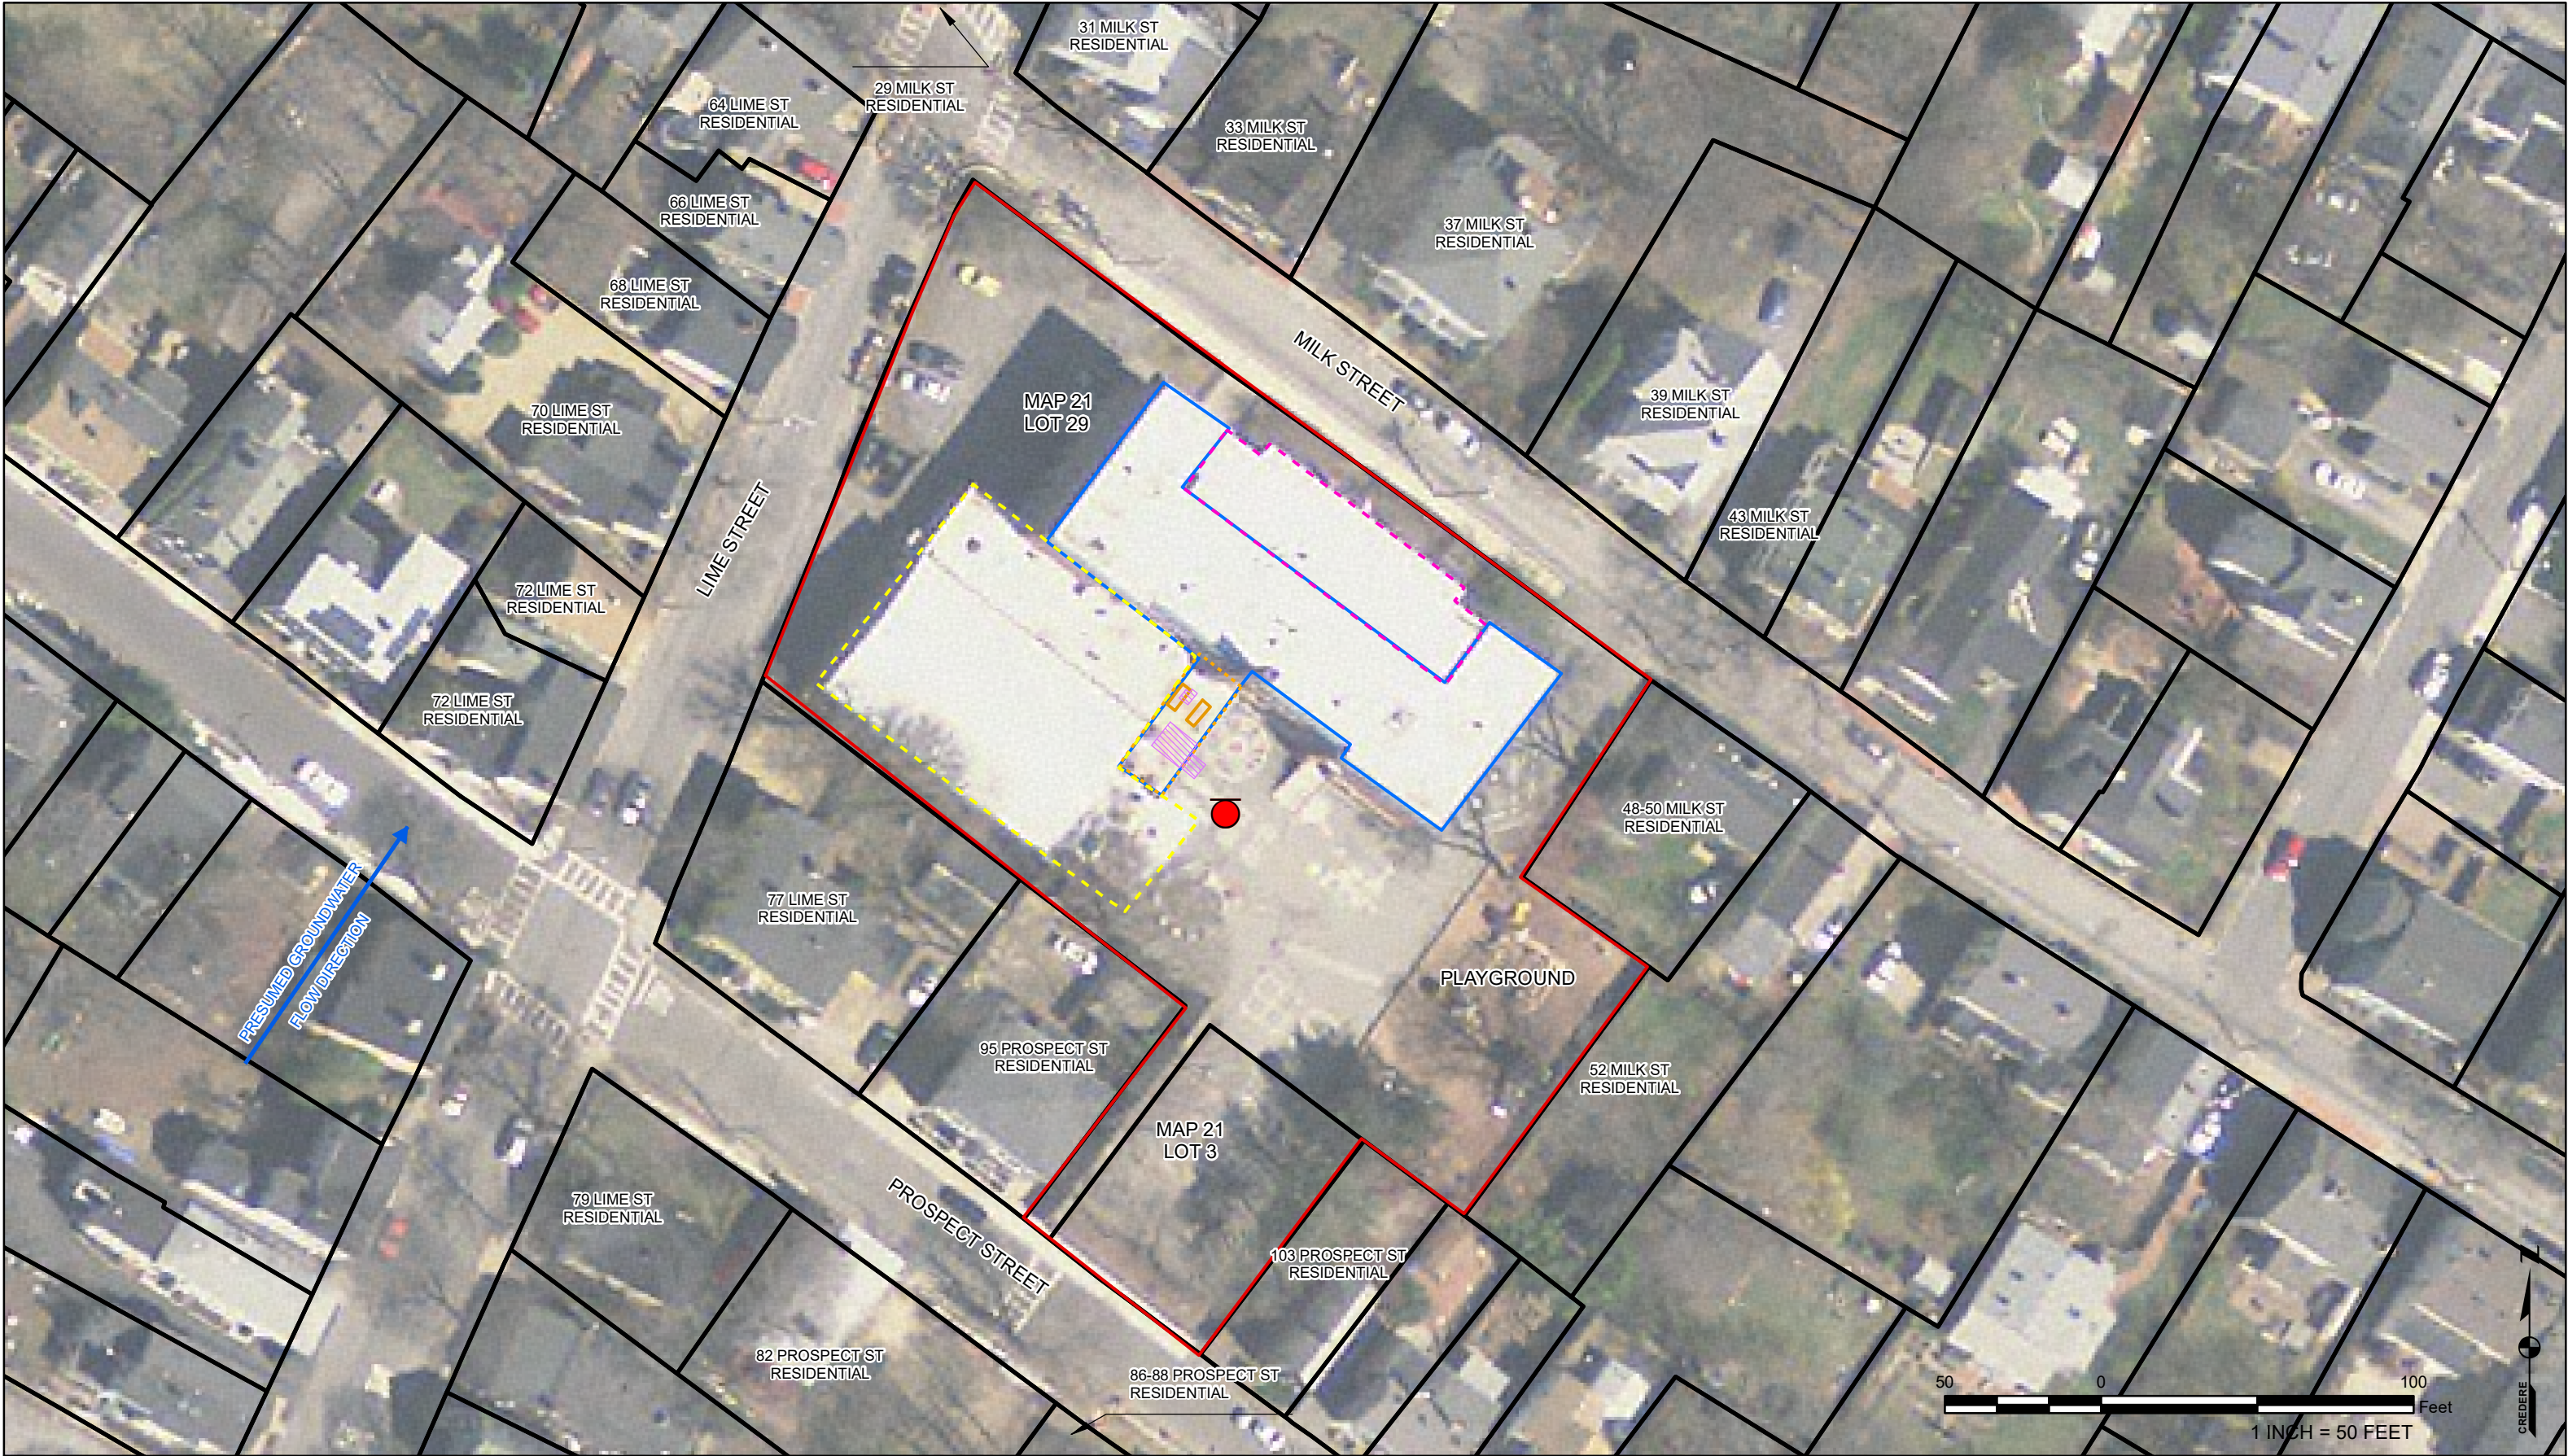
**FIGURE 2
DETAILED SITE PLAN**

BOILER ROOM
-

BOILER
-

NOVEMBER 2001 EXCAVATION AREA
-

UNKNOWN SIZE #2 FUEL OIL UST
-
