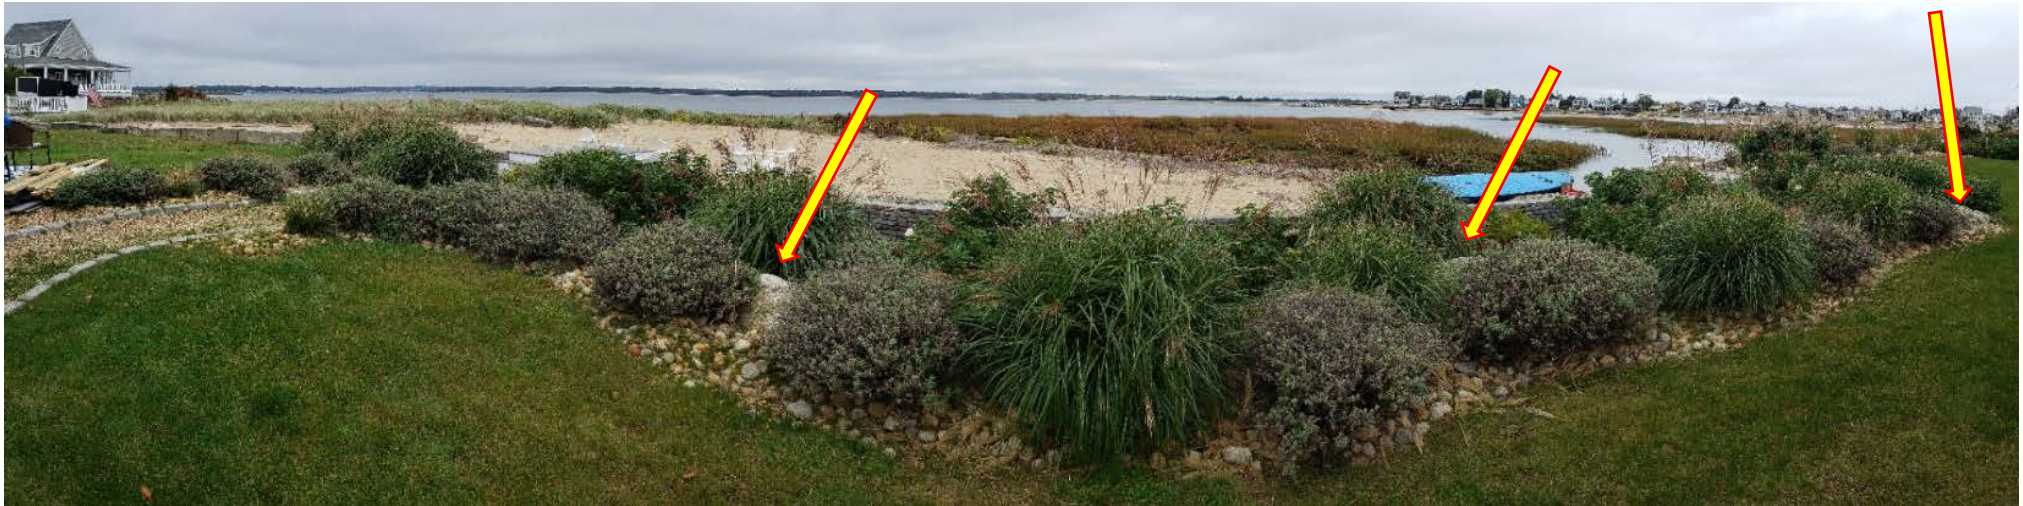
The above photo is a panorama shot of a large portion of the unpermitted landscaping done on the northern end of the property. The arrows indicate three of the large stones present. The below photo shows an aerial photo from the spring of 2020 in which several of the large stones present can be seen (circles).

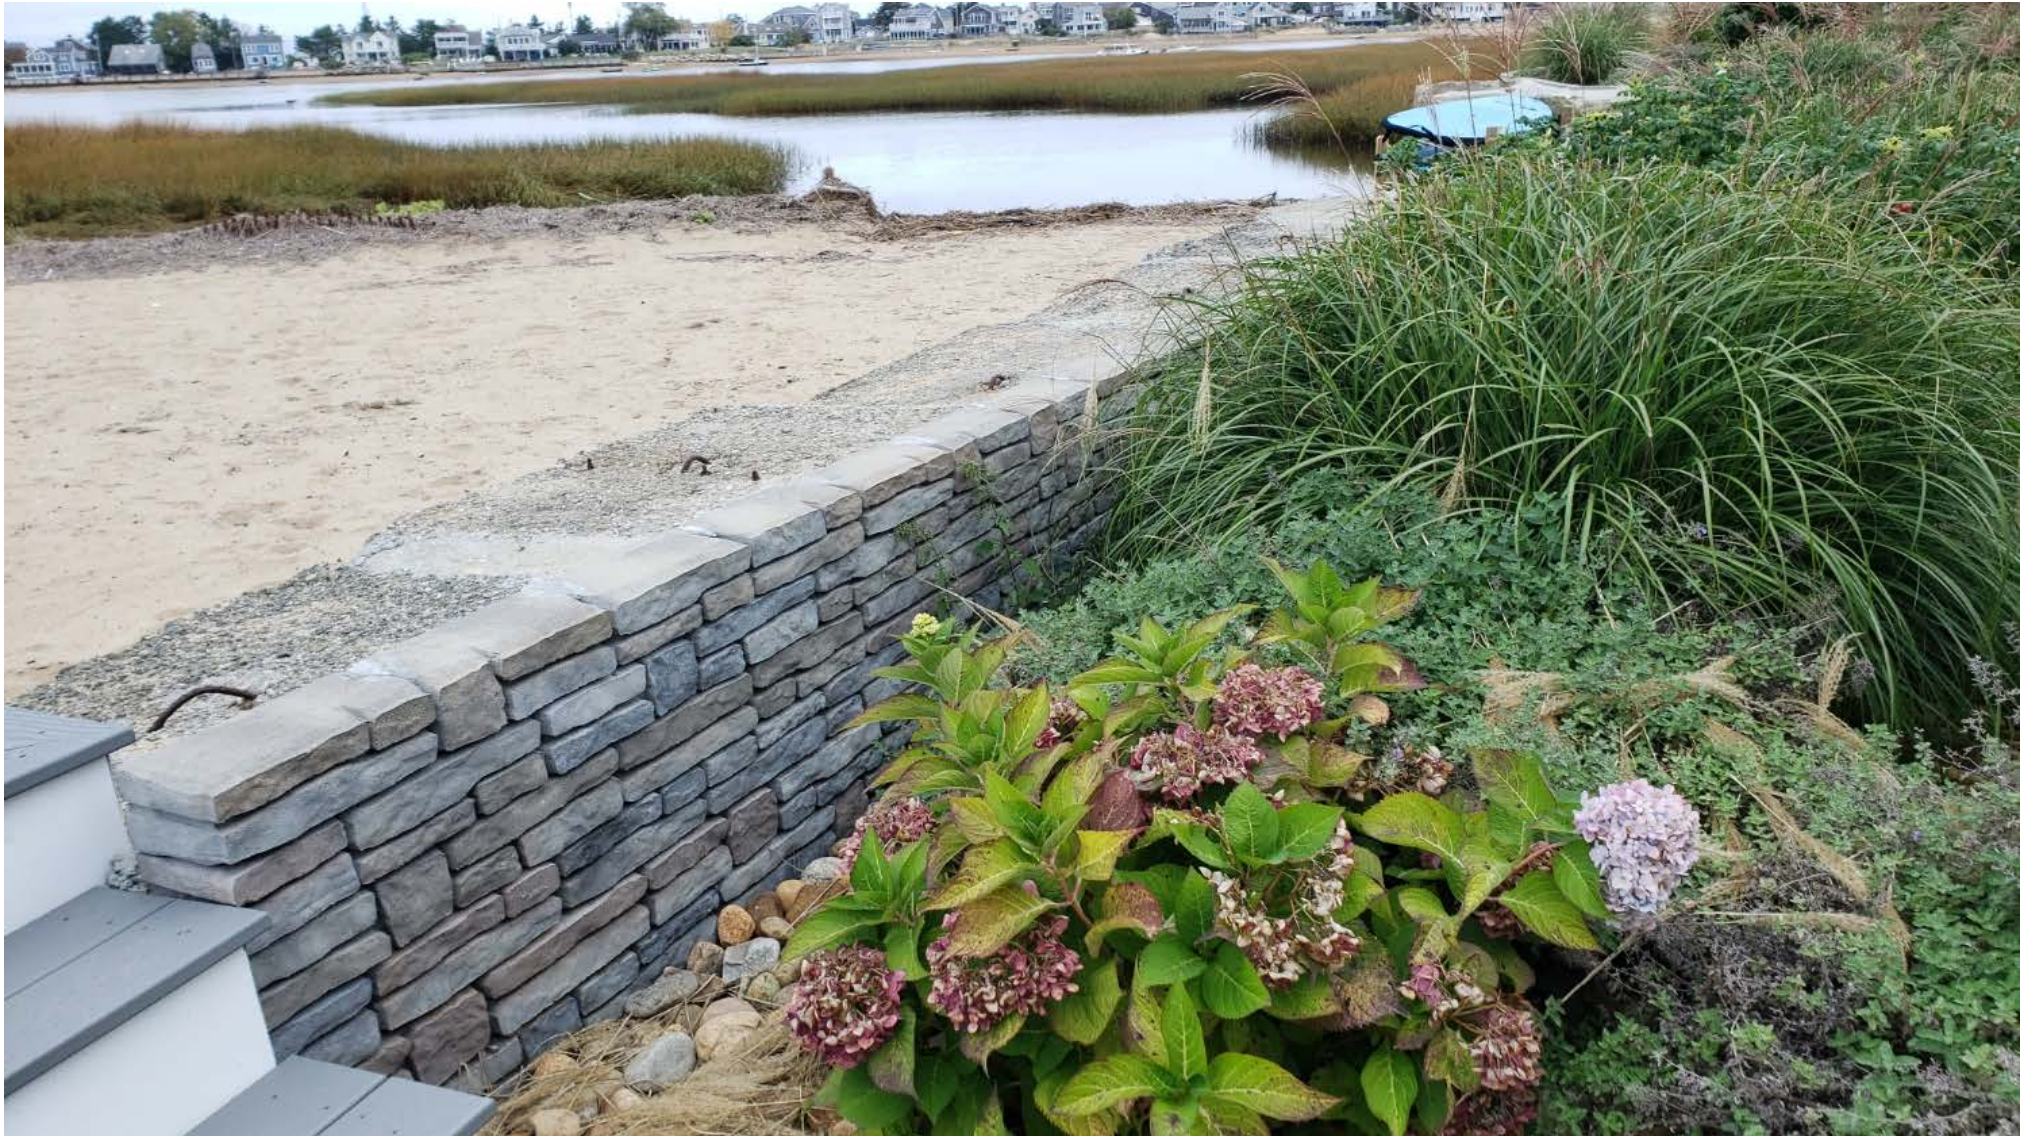
The above photo shows the imitation stone facing added to the existing concrete blocks.

12. Construction or alteration of any coastal engineering structures shall require review and approval by the Conservation Commission.

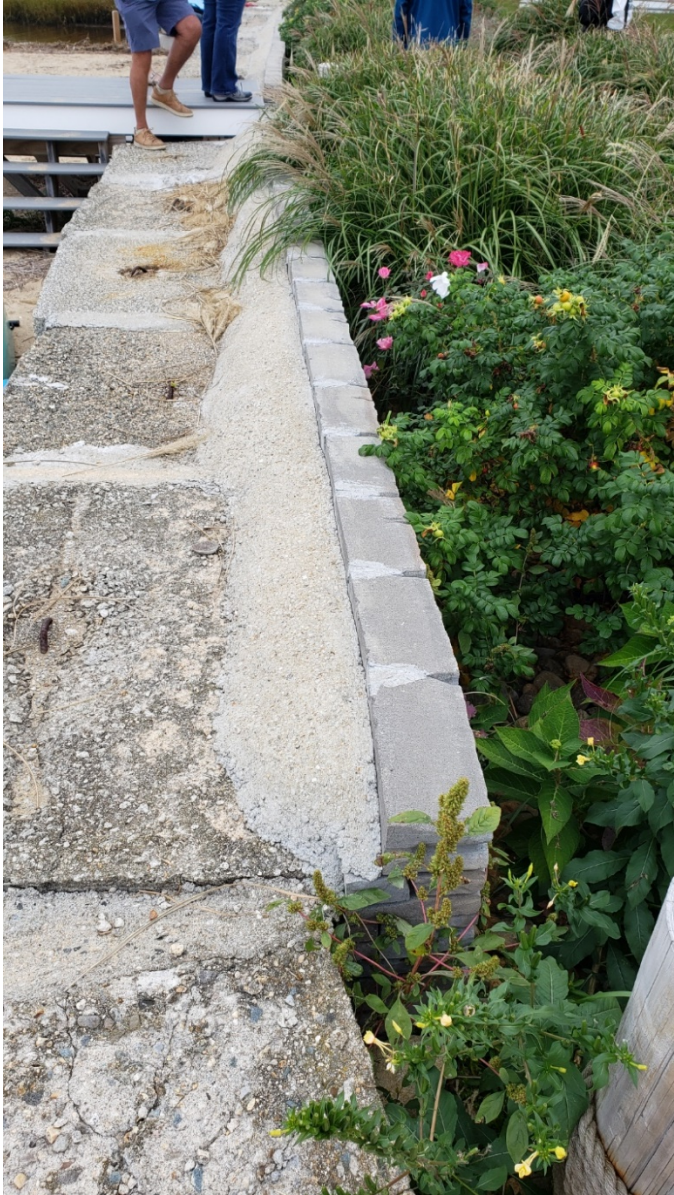
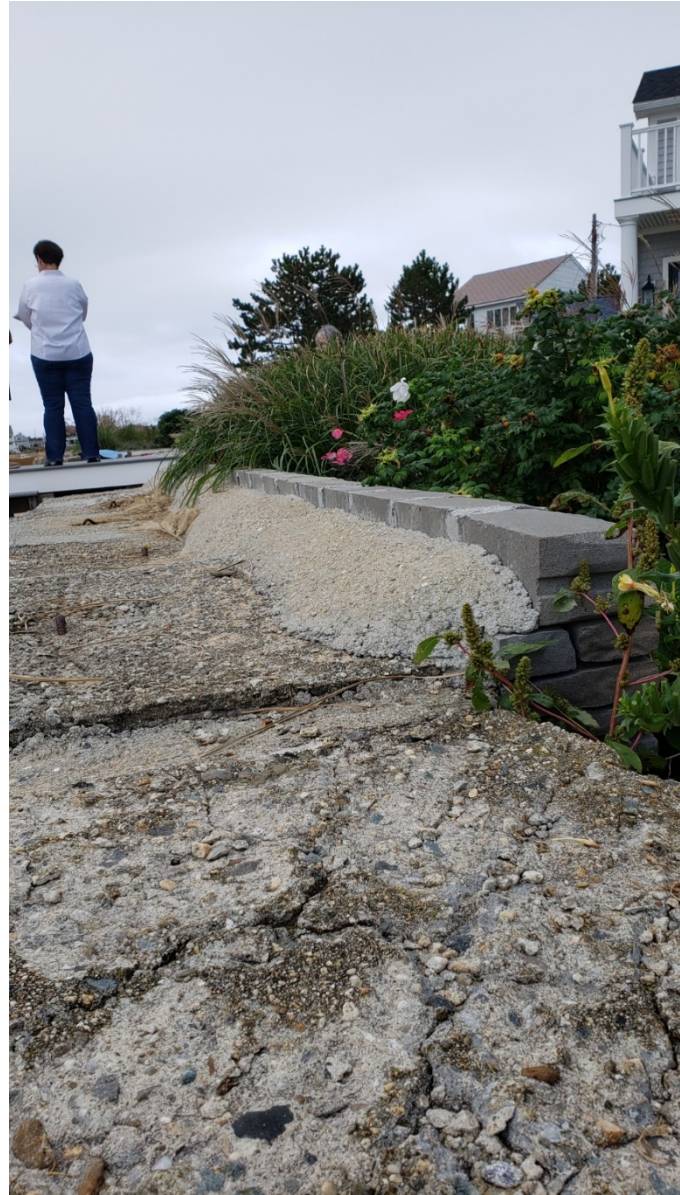
The above two photos show the top of one section of the stone facing connected to the blocks by a line of concrete.

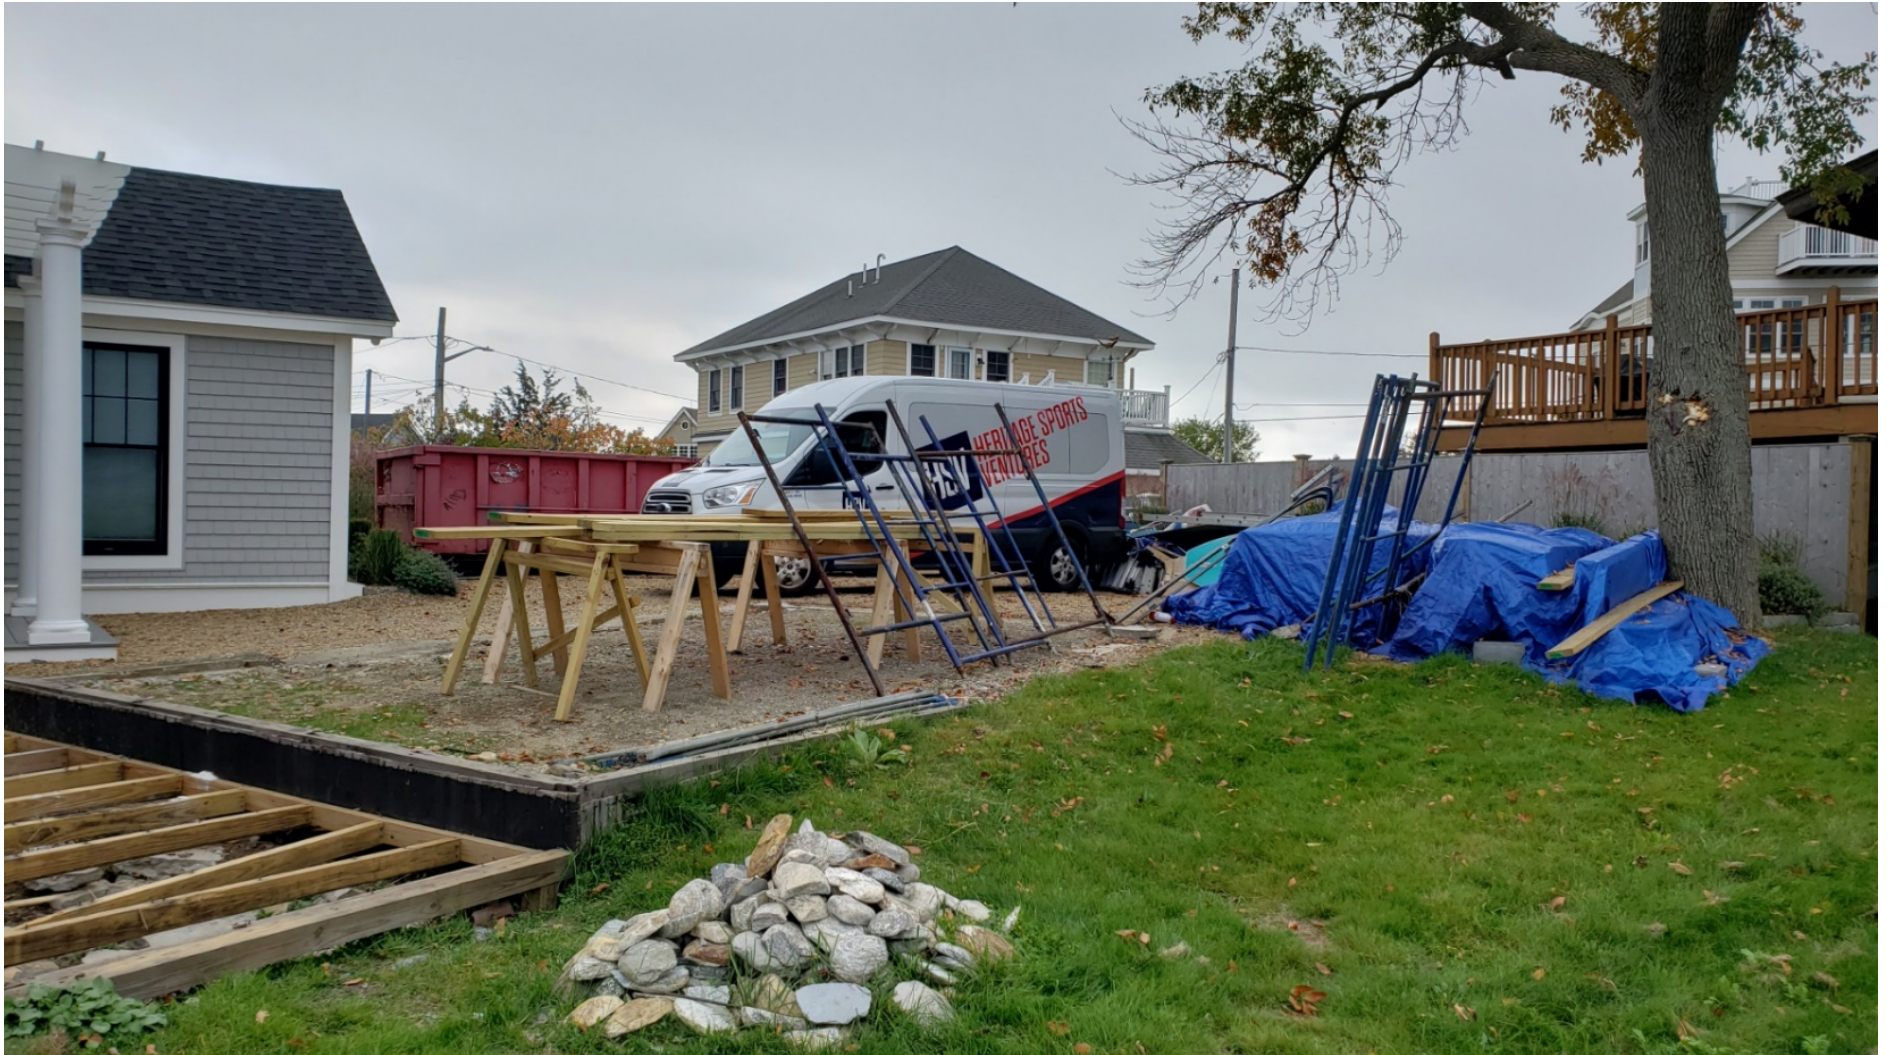
The above photo shows the demolished garage foundation.
