Newburyport Historical Commission Instructions for a NHC Demolition Permit Application

Re: Request for Demolition Permit
490 Merrimac Street, Newburyport, MA (the "Property")
Assessor's Map: 69 Lot: 4

Re: Structural Assessment of Existing Conditions at 490 Merrimac St., Newburyport, MA

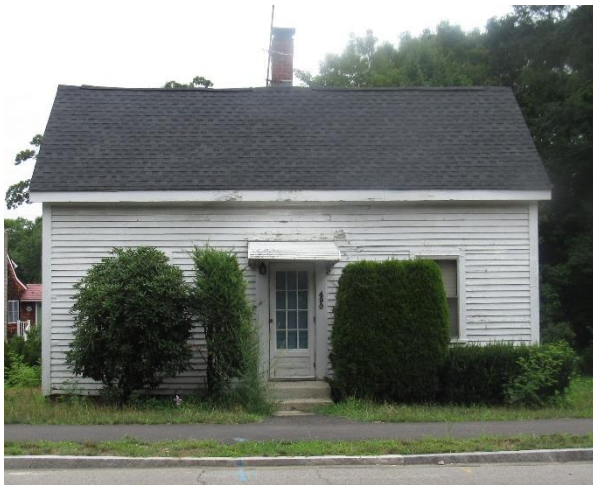
ORIGINAL BUILDING

The single-family, single-story, Conventional-style residence and attic were constructed facing south on Merrimac St. in 1890 as shown on the photos and Assessor sketch below.

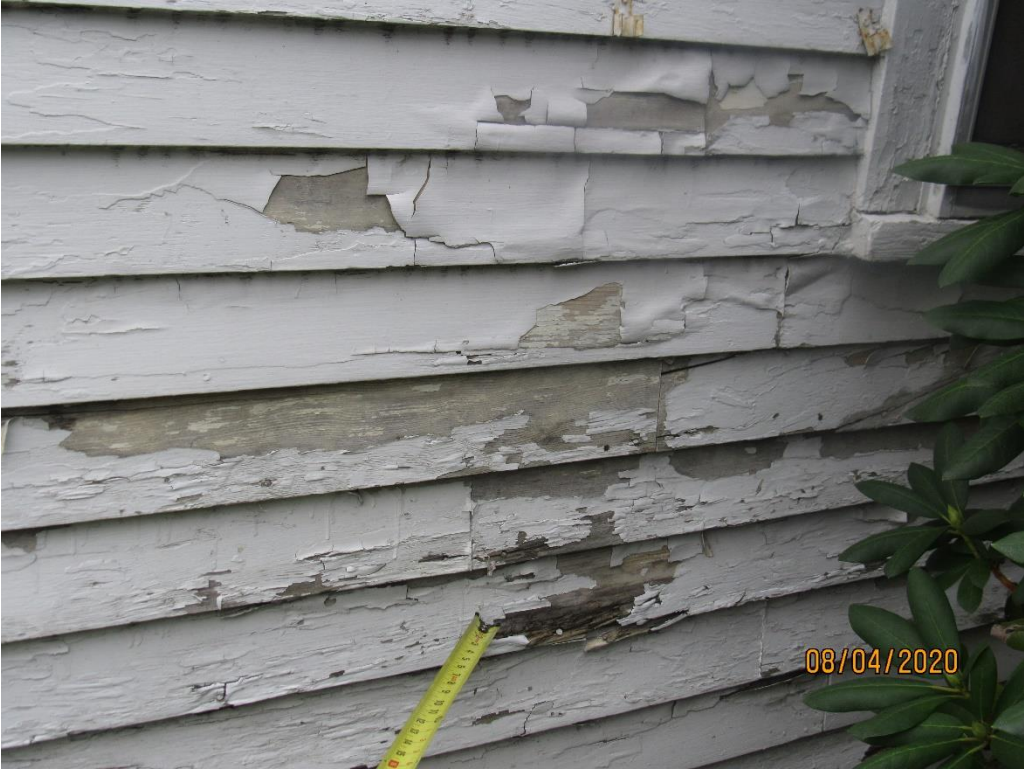
Photo 1 Deteriorated exterior clapboards

1. The exterior clapboards and shingles are beyond repair and the brick and mortar chimney is severely deteriorated and caused moisture intrusion in interior rooms. We recommend replacement of the clapboards, asphalt roof shingles and deteriorated chimney bricks and repoint the mortar joints.

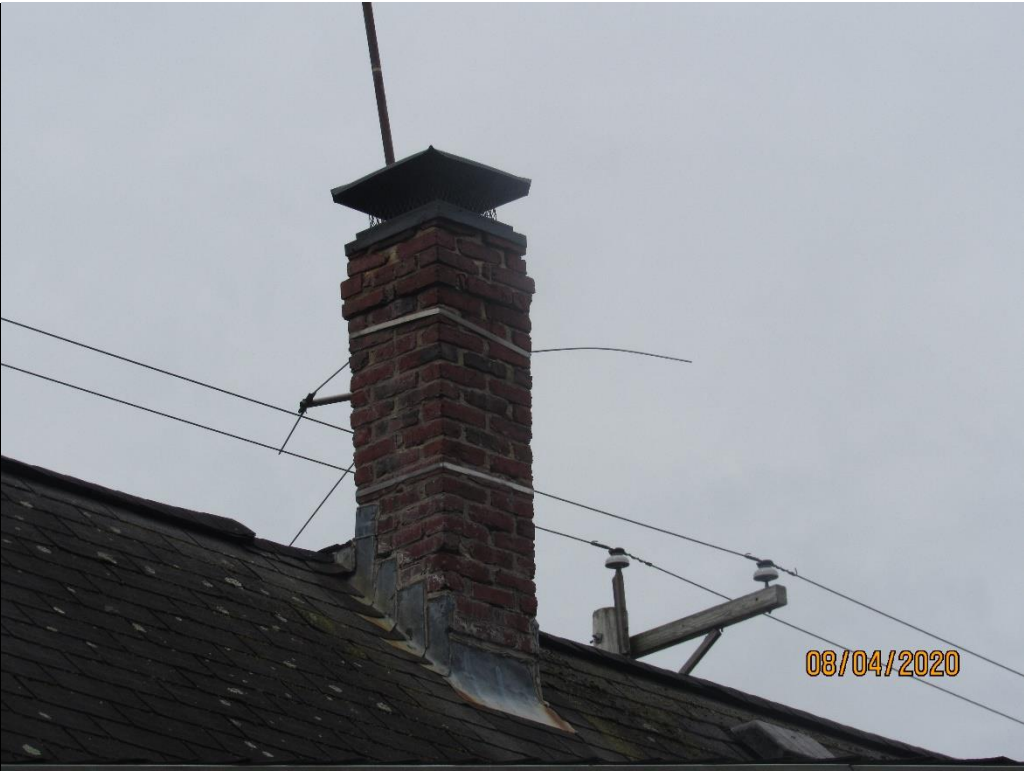
Photo 2 Deteriorated chimney bricks and aged roof shingles

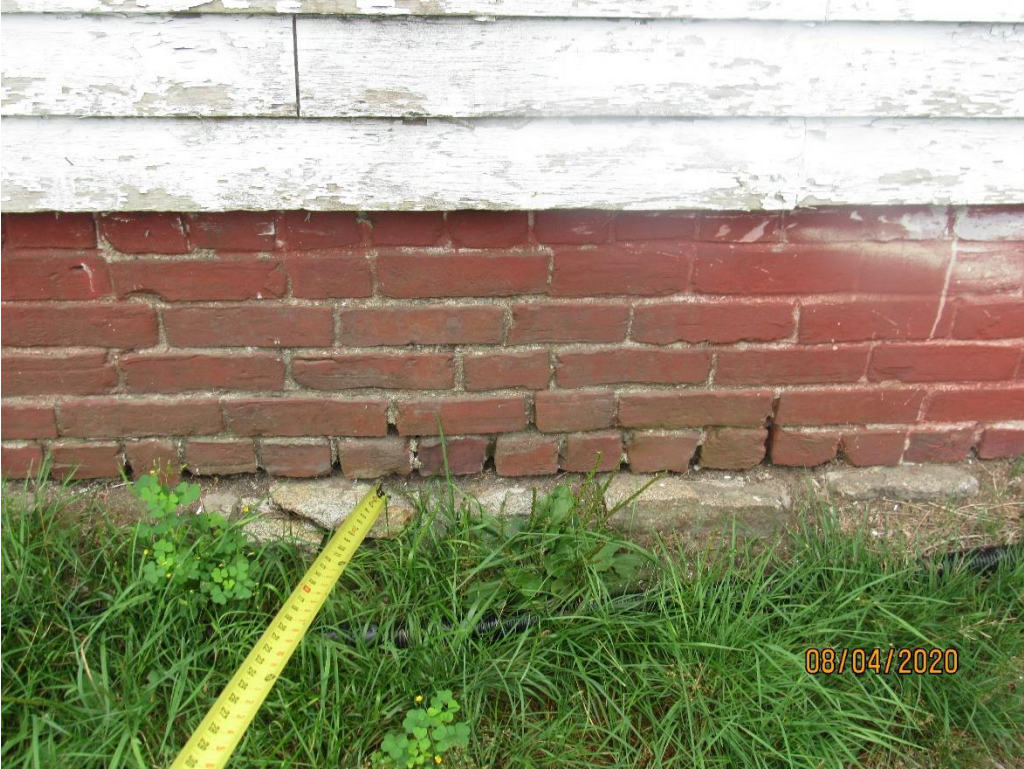
Photo 3 Brick and mortar deterioration on the West side foundation

2. The fieldstone and brick and mortar foundation walls are severely deteriorated. We recommend repointing the fieldstone and brick and mortar foundation walls.

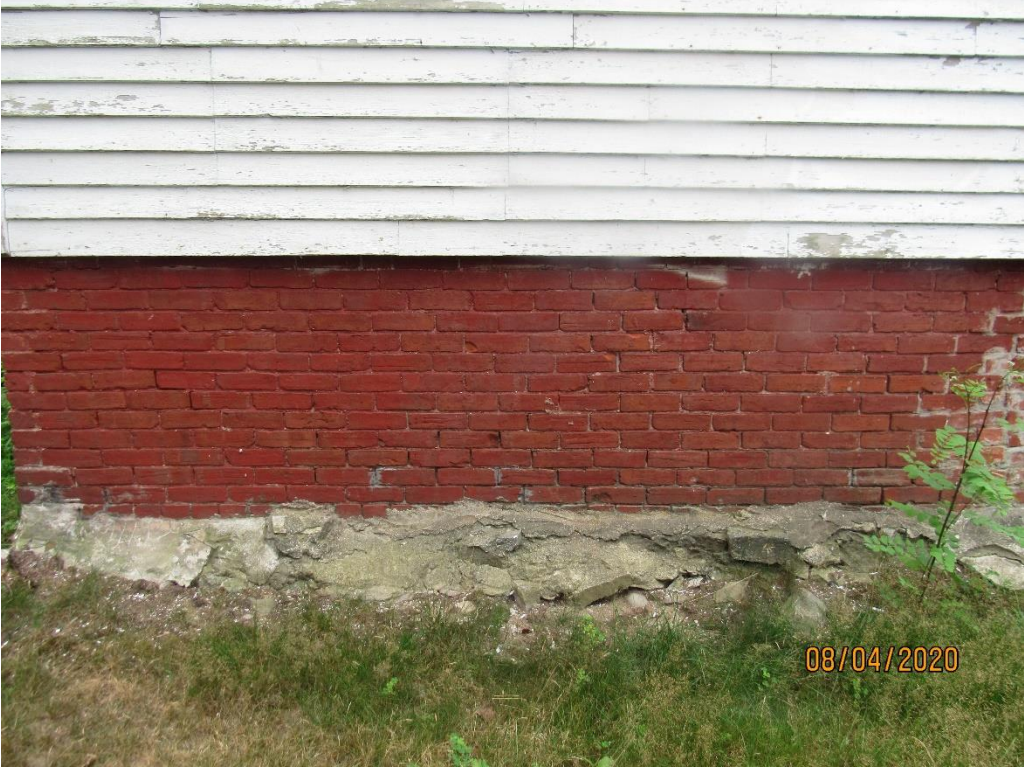
Photo 4 Fieldstone and brick wall deterioration on the North side foundation wall

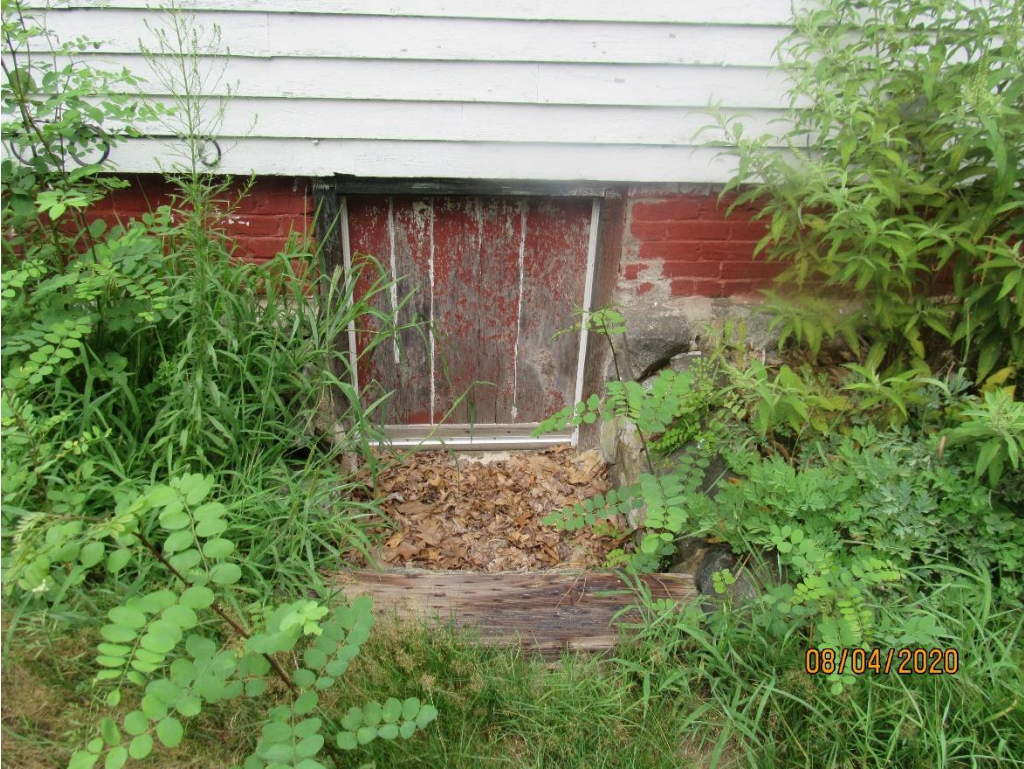
Photo 5 Exterior stairs uncovered and allow water intrusion into basement

3. The moisture intrusion at the exterior stairs to the basement causes deterioration. We recommend repointing the fieldstone stairs and installing a bulkhead covering.

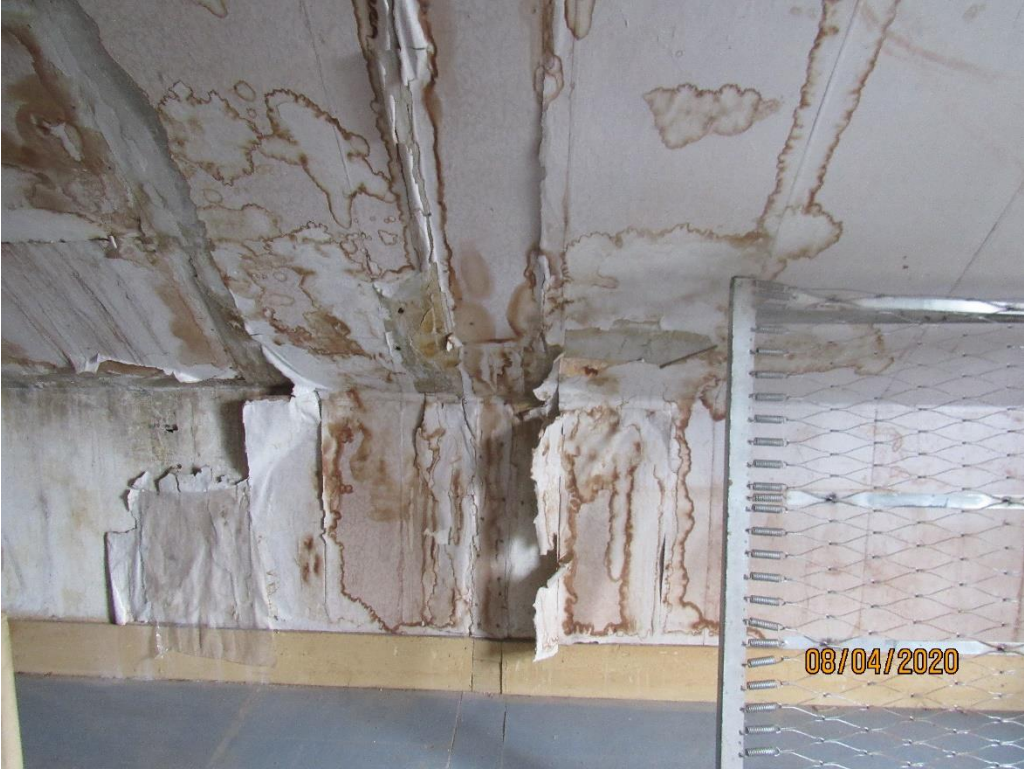
Photo 6 Moisture intrusion throughout the interior rooms

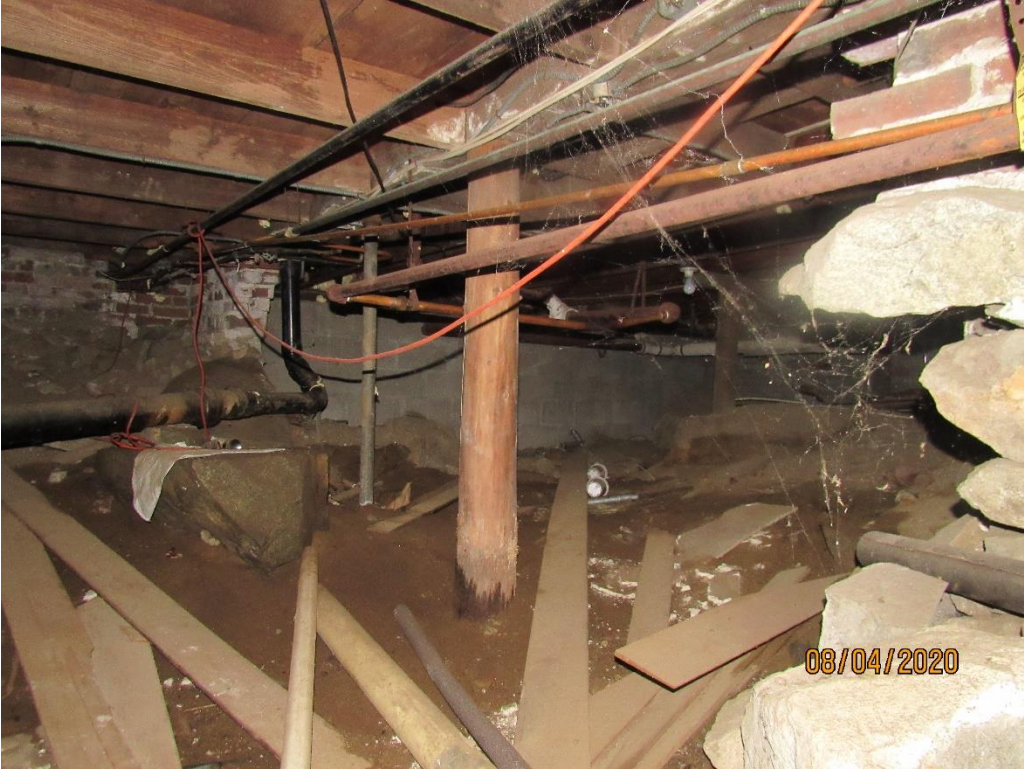
Photo 7 Antiquated timber framing with posts extending below grade and foundation walls demolished

4. The substandard timber framing does not comply with the current building code. We recommend reinforcement of the timber framing and replacement of the timber posts with Lally columns bearing on concrete piers.

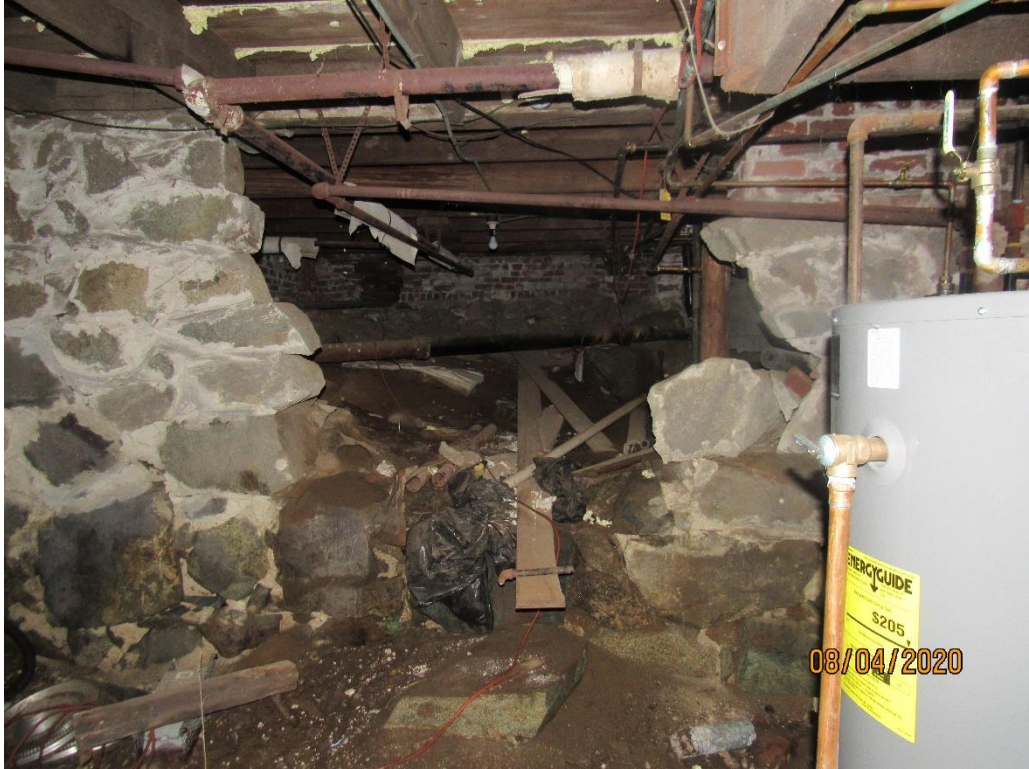
Photo 8 Foundation walls partially demolished to allow additions

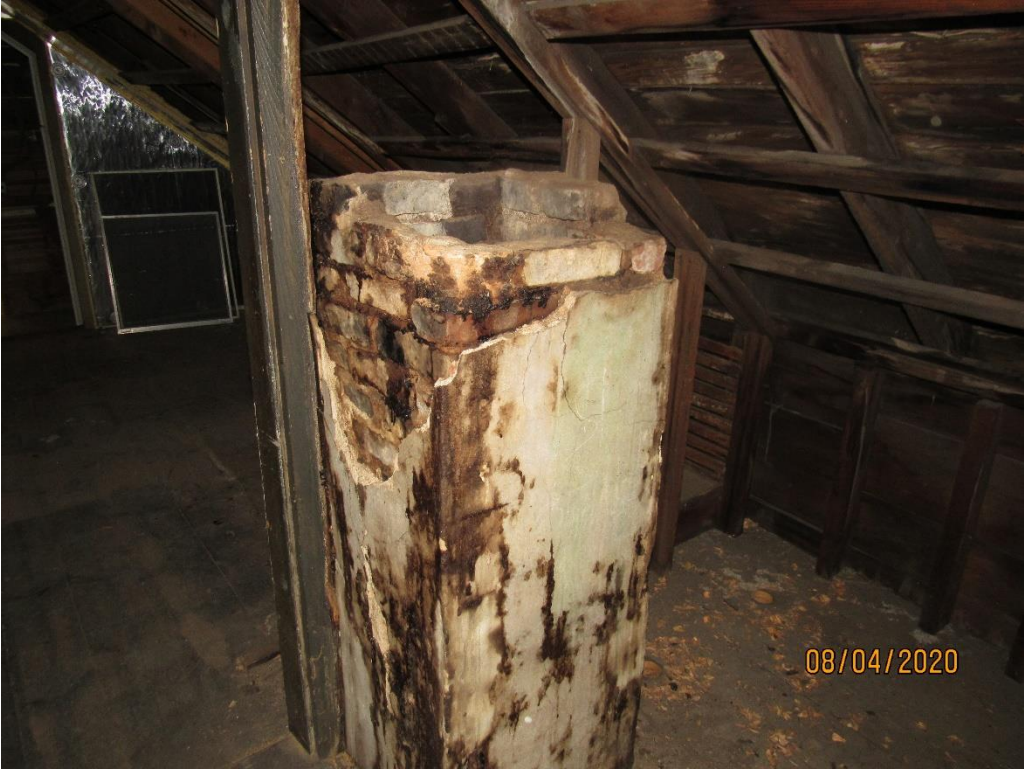
Photo 9 Balloon framed walls to support roof and chimney demolished and abandoned in the attic

6. The balloon framed walls and antiquated roof framing do not comply with current code requirements for snow and wind loads. We recommend demolition and removal of the abandoned chimney and replacement of the wall and roof framing in the attic to resist code loads and provide adequate headroom and ventilation.

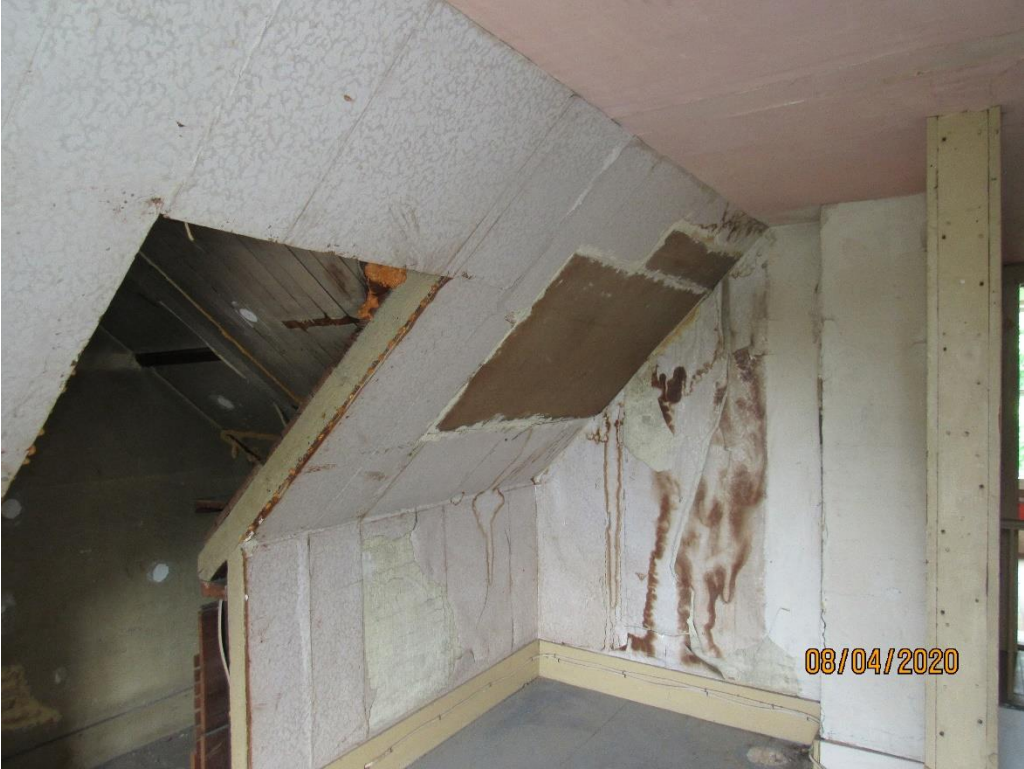
Photo 10 Lack of attic headroom

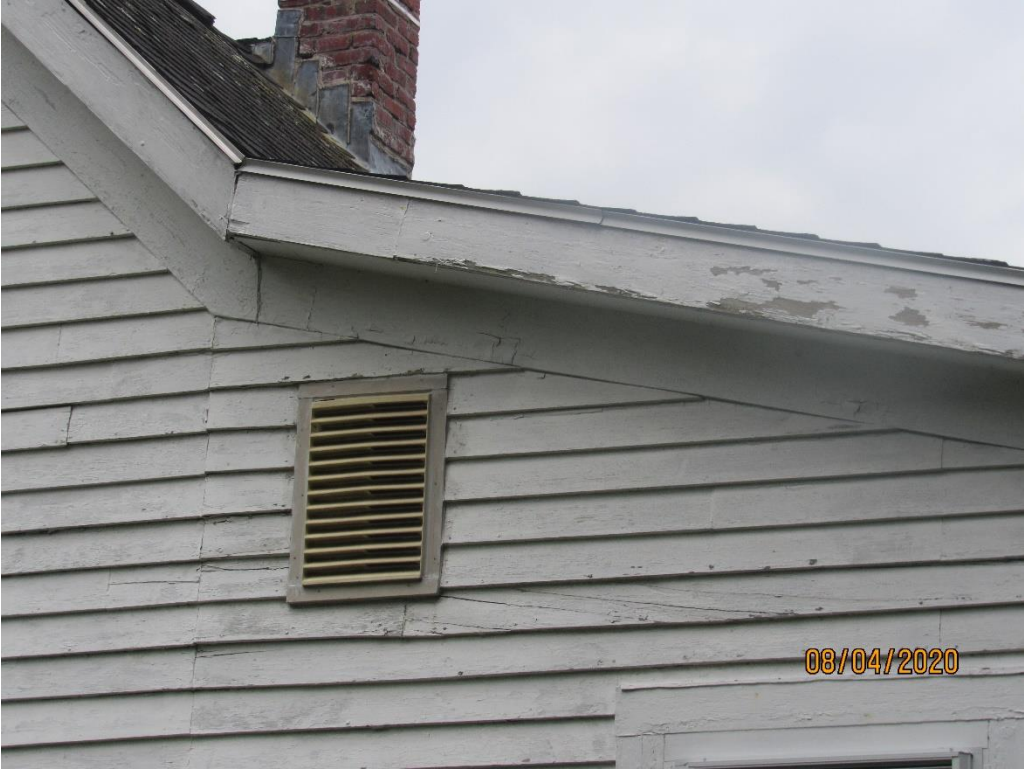
Photo 11 Ventilation beneath the roof

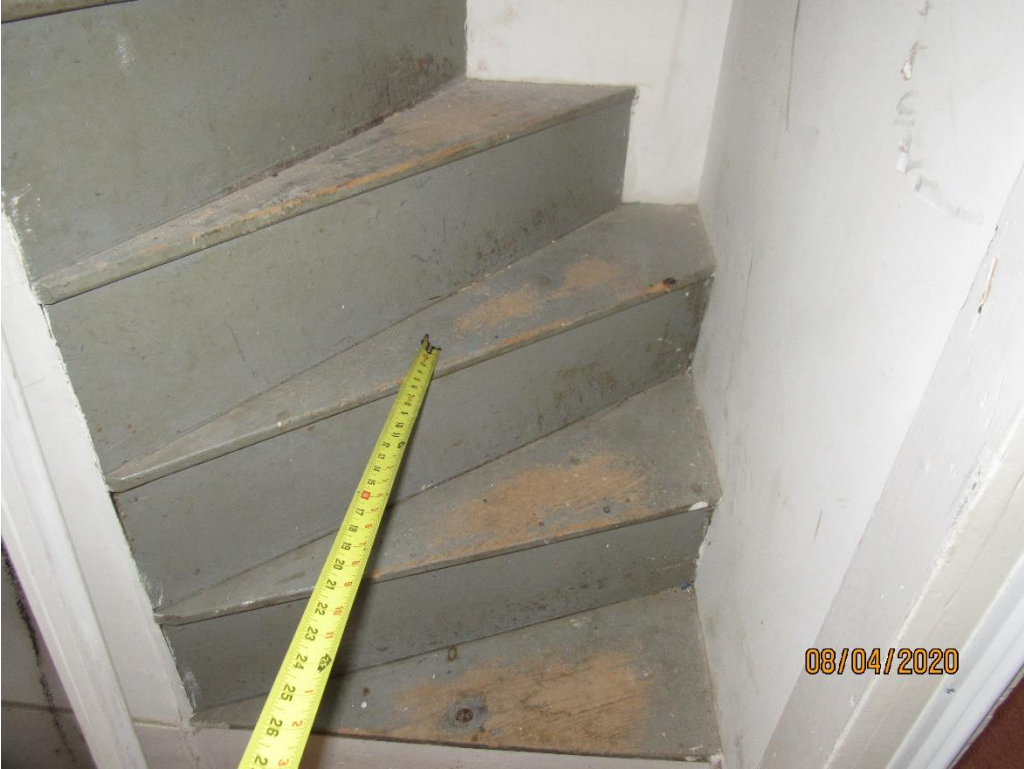
Photo 12 Stairs to attic are steep and difficult to climb

7. The attic stairs are too steep and do not provide sufficient headroom for safety. We recommend relocation and reconstruction of code compliant attic stairs.
