Bartlet Mall Restoration Project

Presentation to City Council – August 15, 2023

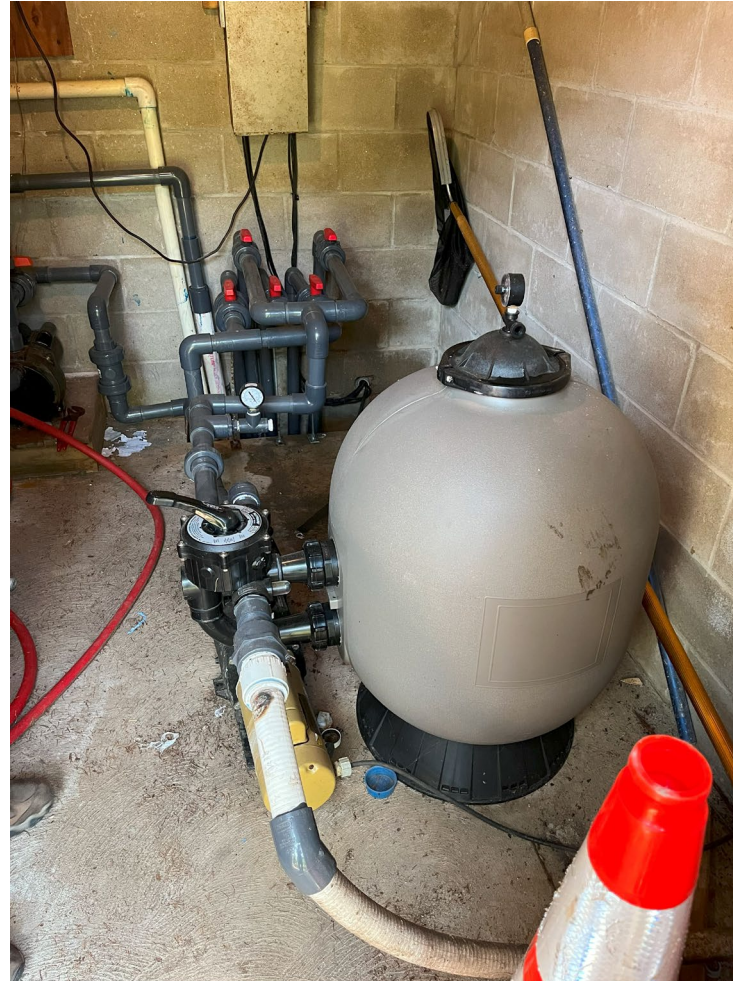
SIMILAR EQUIPMENT AND SHED
AT ATKINSON COMMON
(PRECEDENCE)

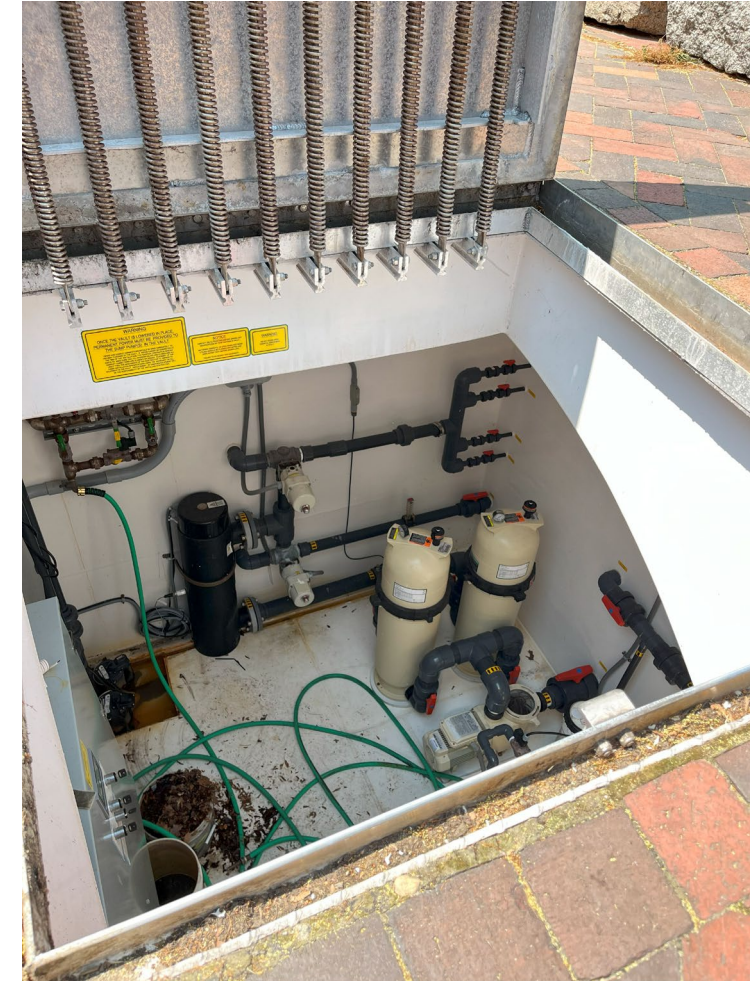
EASIER AND LESS DANGEROUS TO
MAINTAIN THAN INN STREET
(U.G. POWER & CHEMICALS)
