# Bartlet Mall Restoration Project Conservation Commission Hearing – May 2, 2023

## Project Introduction: A Brief History

## Proposed Restoration Effort

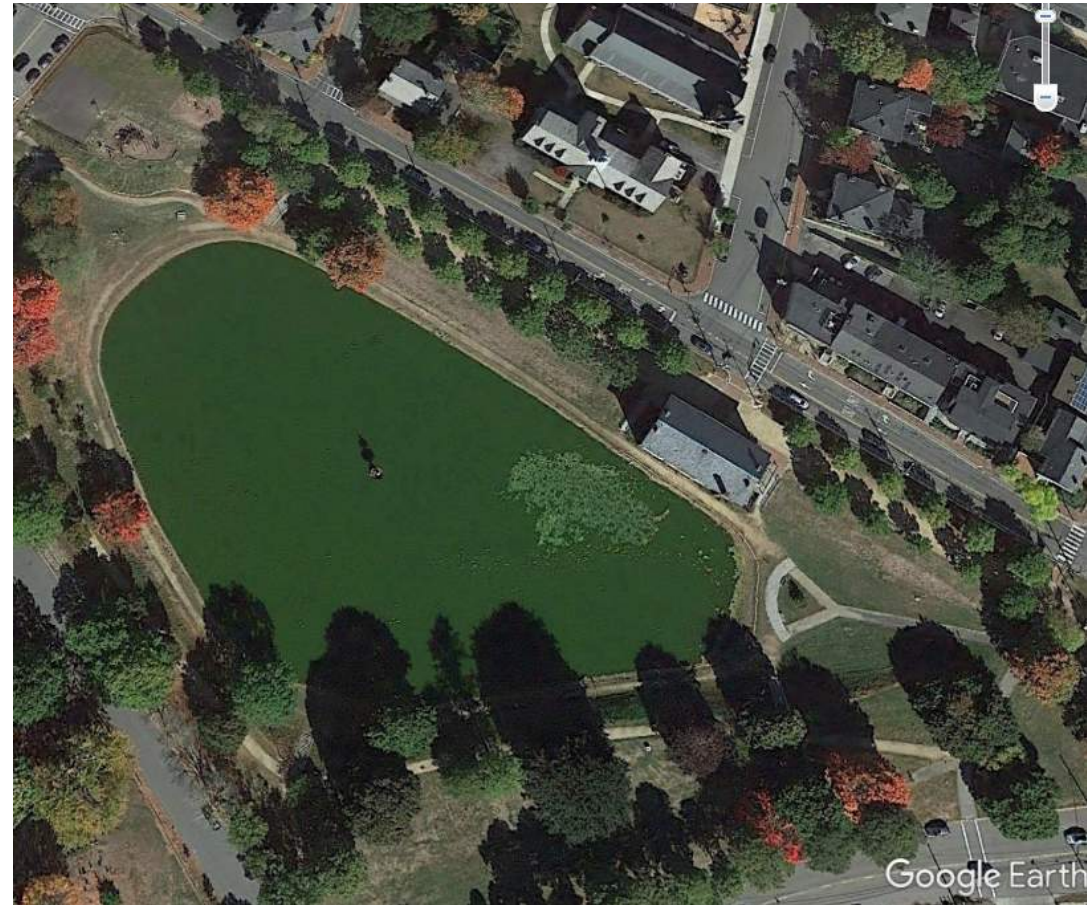
## Overview of Current Conditions

- The Bartlet Mall was modified into a park in 1800 and treated as a man-made feature since
- Pond is highly eutrophic and has been for ~200 years
- No apparent connection of the pond to groundwater
- Nutrient loads in sediment present to depths of up to 12 ft
- Urban contaminants present in shallow sediment
- Water not safe for human contact

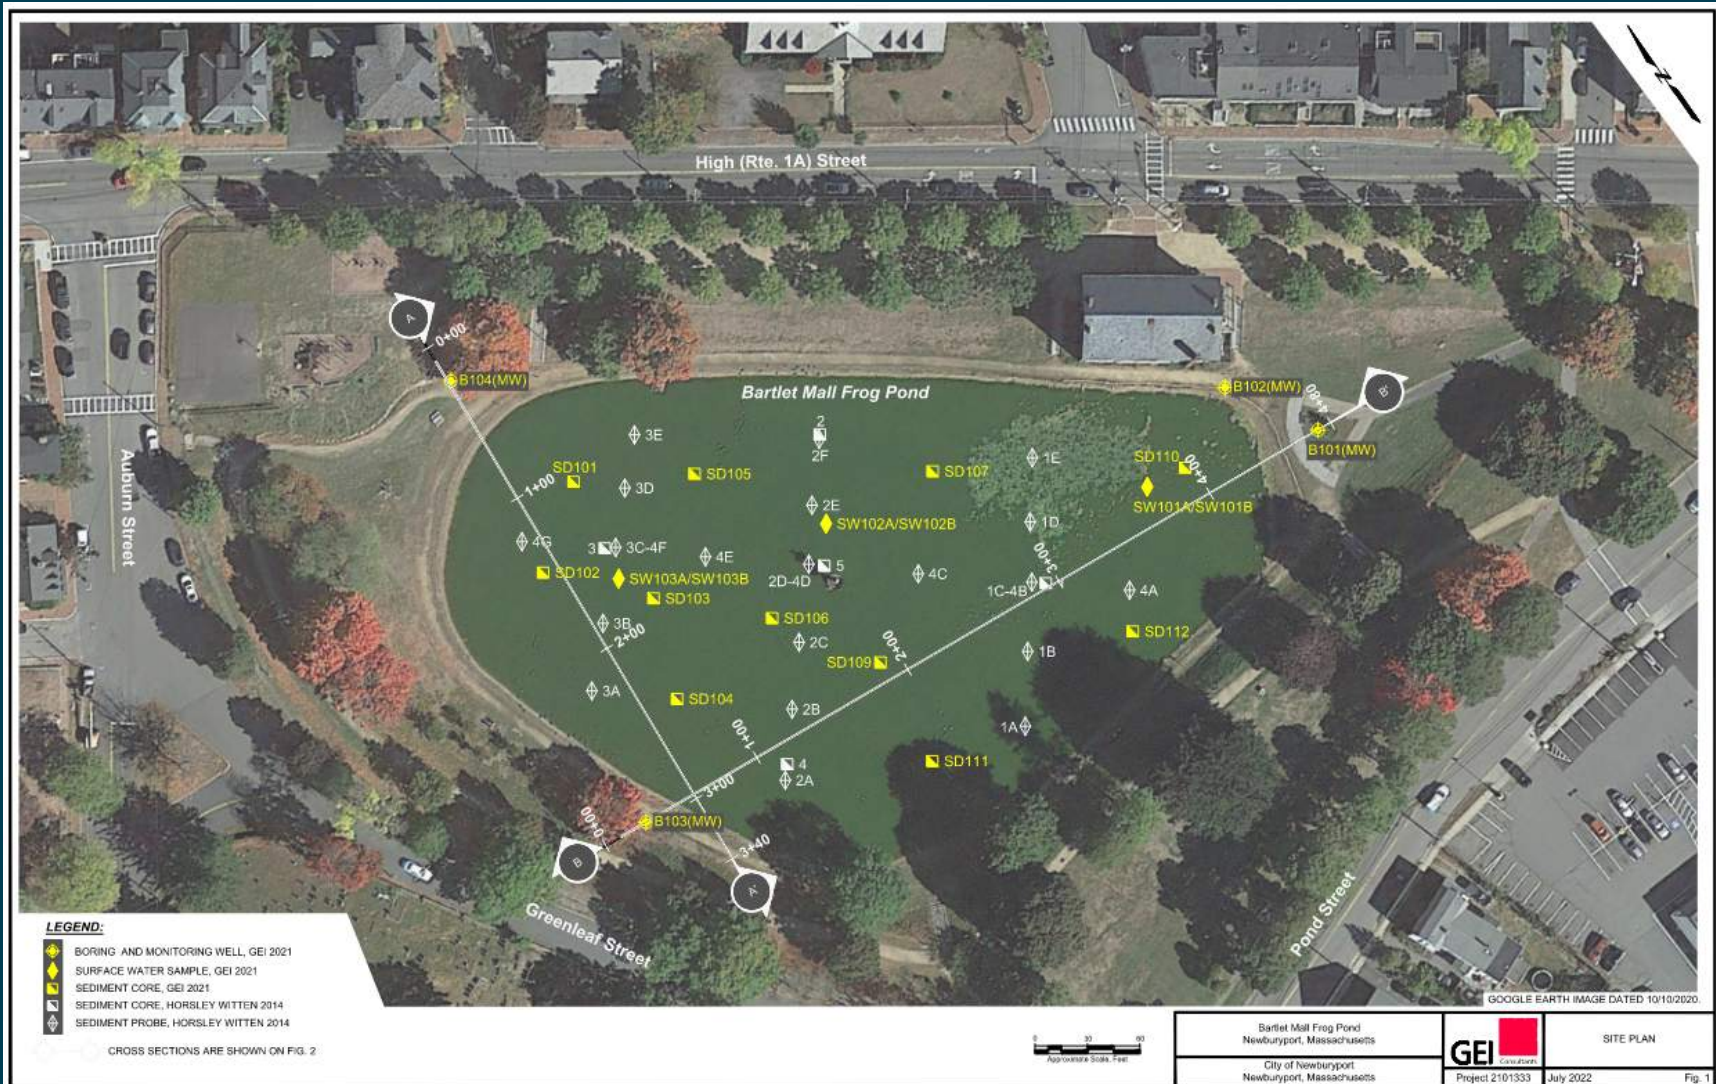
# Investigation Locations

- Reviewed previous investigations & data
- Performed additional investigations in 2021 to close data gaps:
  - Pond Investigations: sediment investigation, in situ shear vane testing, bathymetric survey, in-situ surface water quality assessment, and surface water sampling.
  - Upland Investigations: subsurface investigation, monitoring well installation and survey, in-situ groundwater quality assessment, and hydraulic conductivity testing.

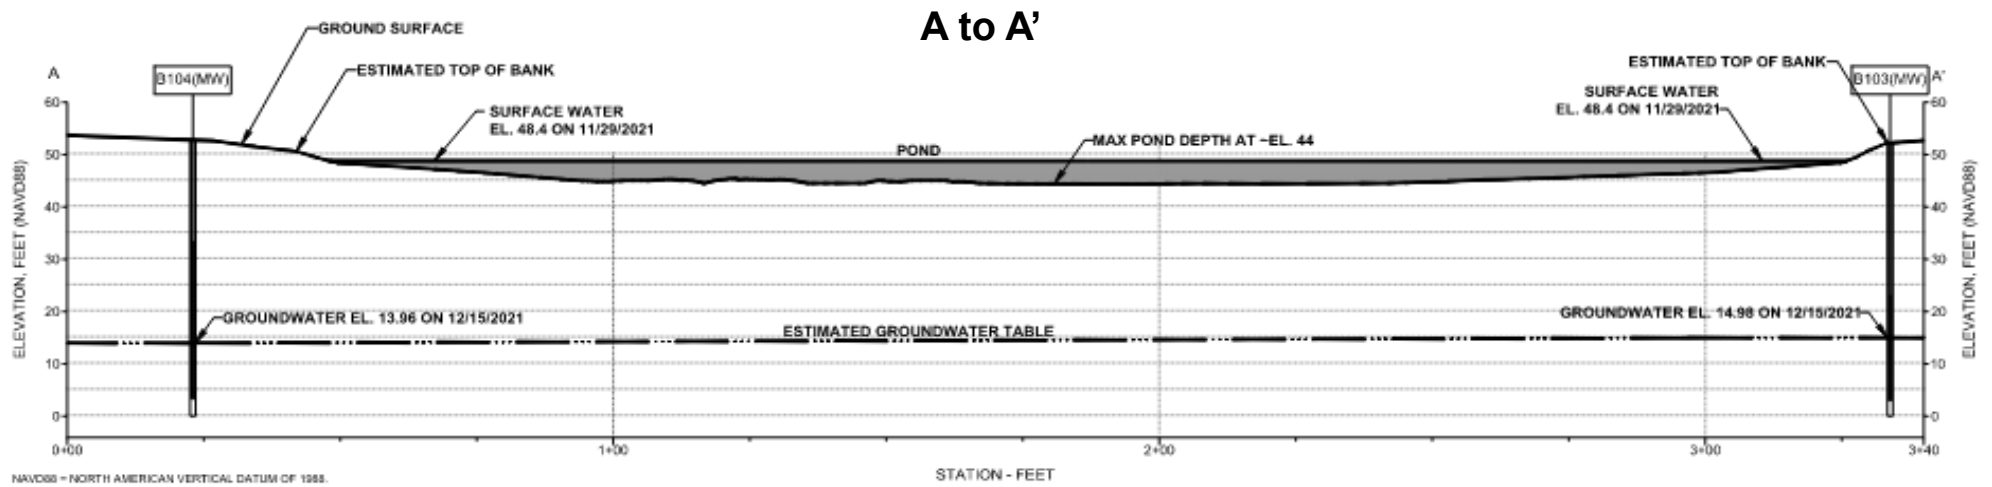
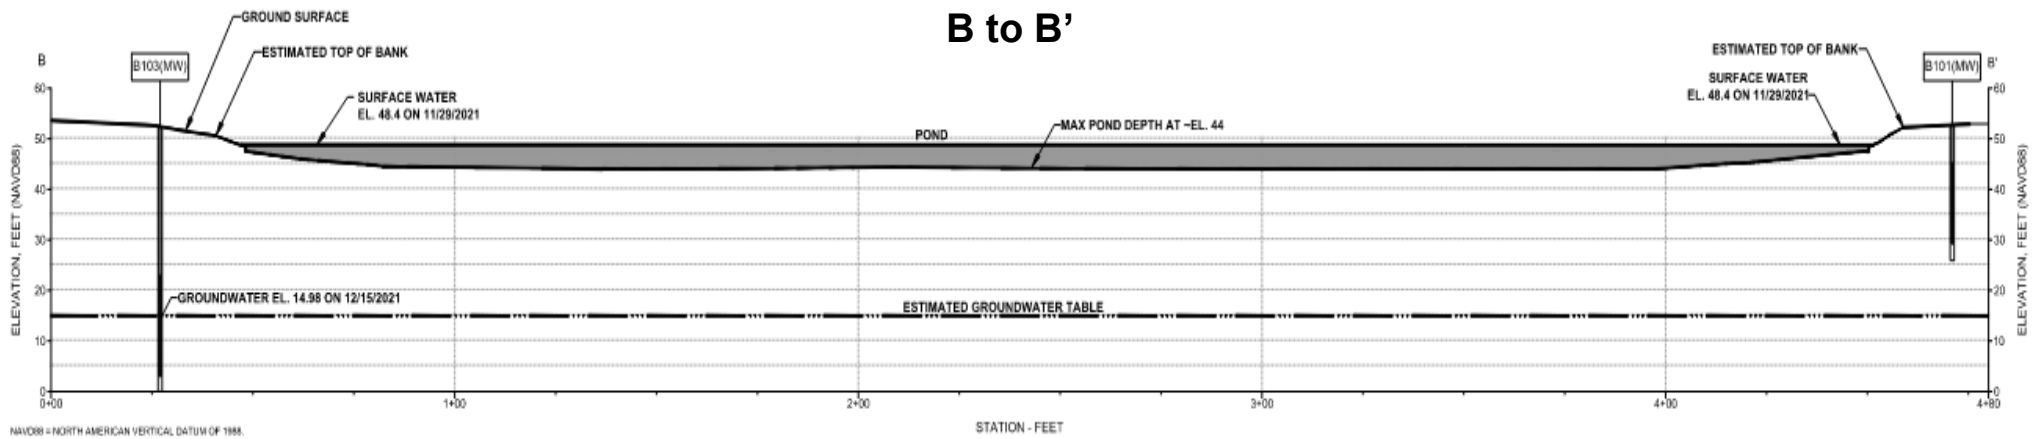
# Findings - Existing Conditions

- Urban contaminants are present in shallow sediments
- Shallow sediment is not suitable for disposal at a Massachusetts lined landfill
- Phosphorus present up to 12 feet below bottom of pond
- No hydraulic connection to groundwater - groundwater is ~ 30 feet below the bottom of the pond
- Surface water in the pond is contained by low-permeability sediment

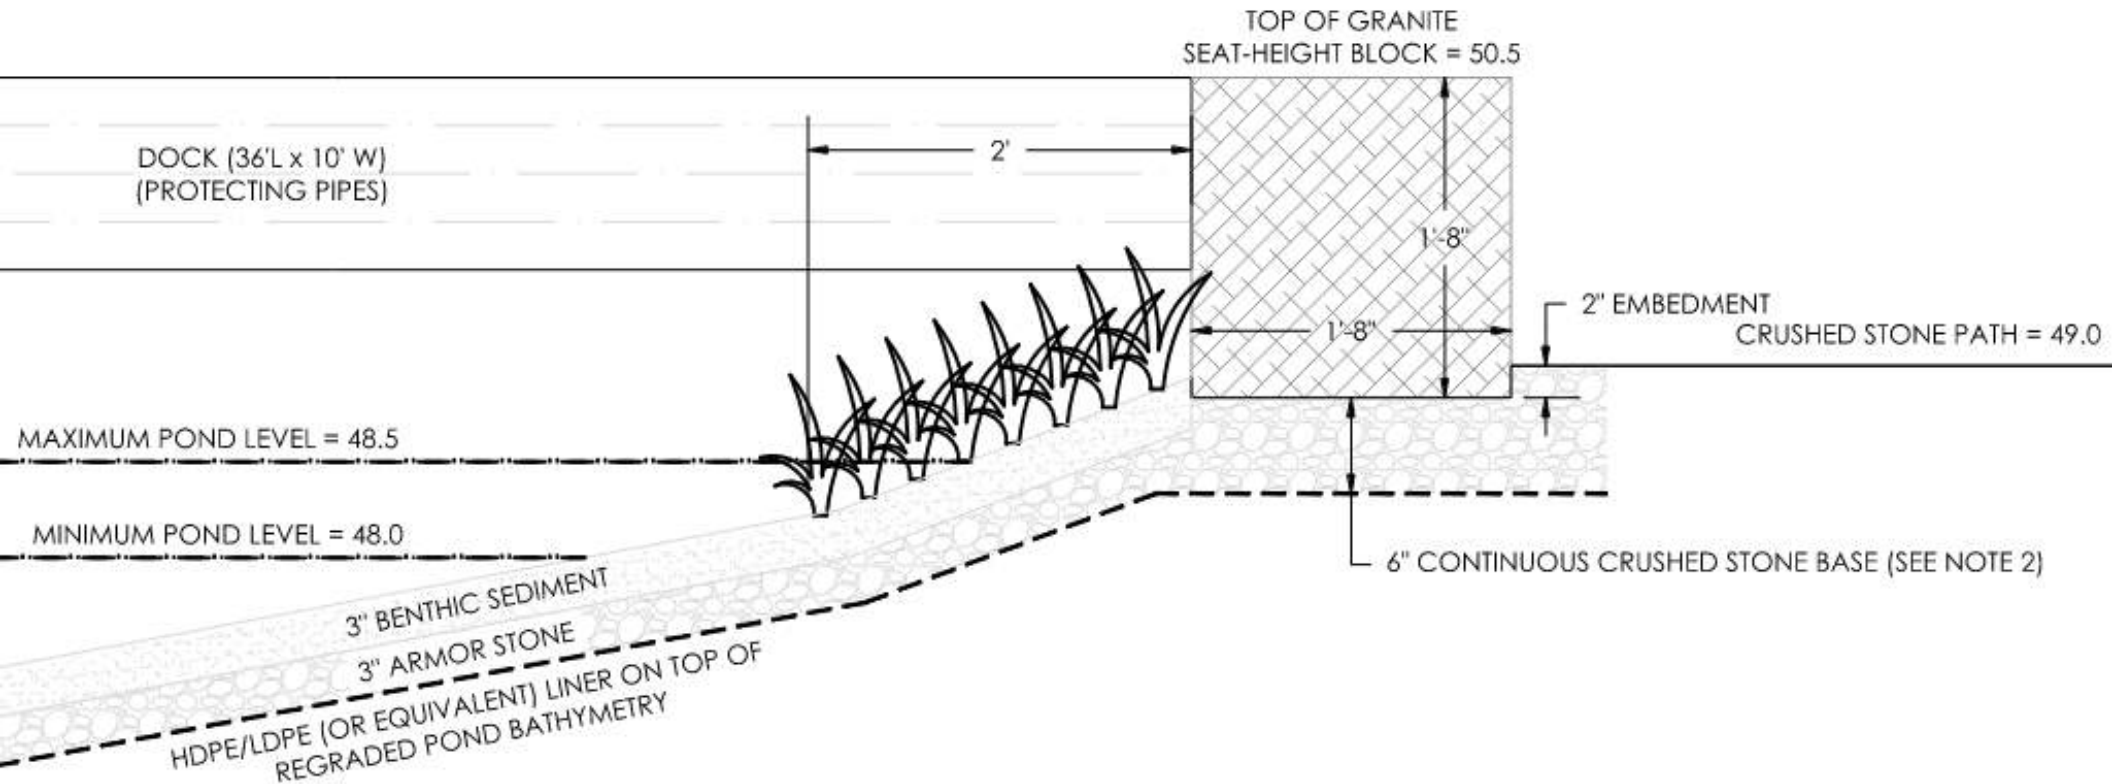
# Conceptual Liner Installation – Bank Detail

\* Concept Only - Granite Seat-Height Block to be installed above the Top of Bank\*

- Restore grading/slope conditions to generally match existing conditions
- Increase Bank to ~ 1,314 LF from current 1,295 LF
- Install a new vegetated zone and clean benthic sediment to improve ecological health of the pond
