Preliminary Alternatives Evaluation

Bartlet Mall Frog Pond
Newburyport, Massachusetts

June 23, 2021
Project 2101333

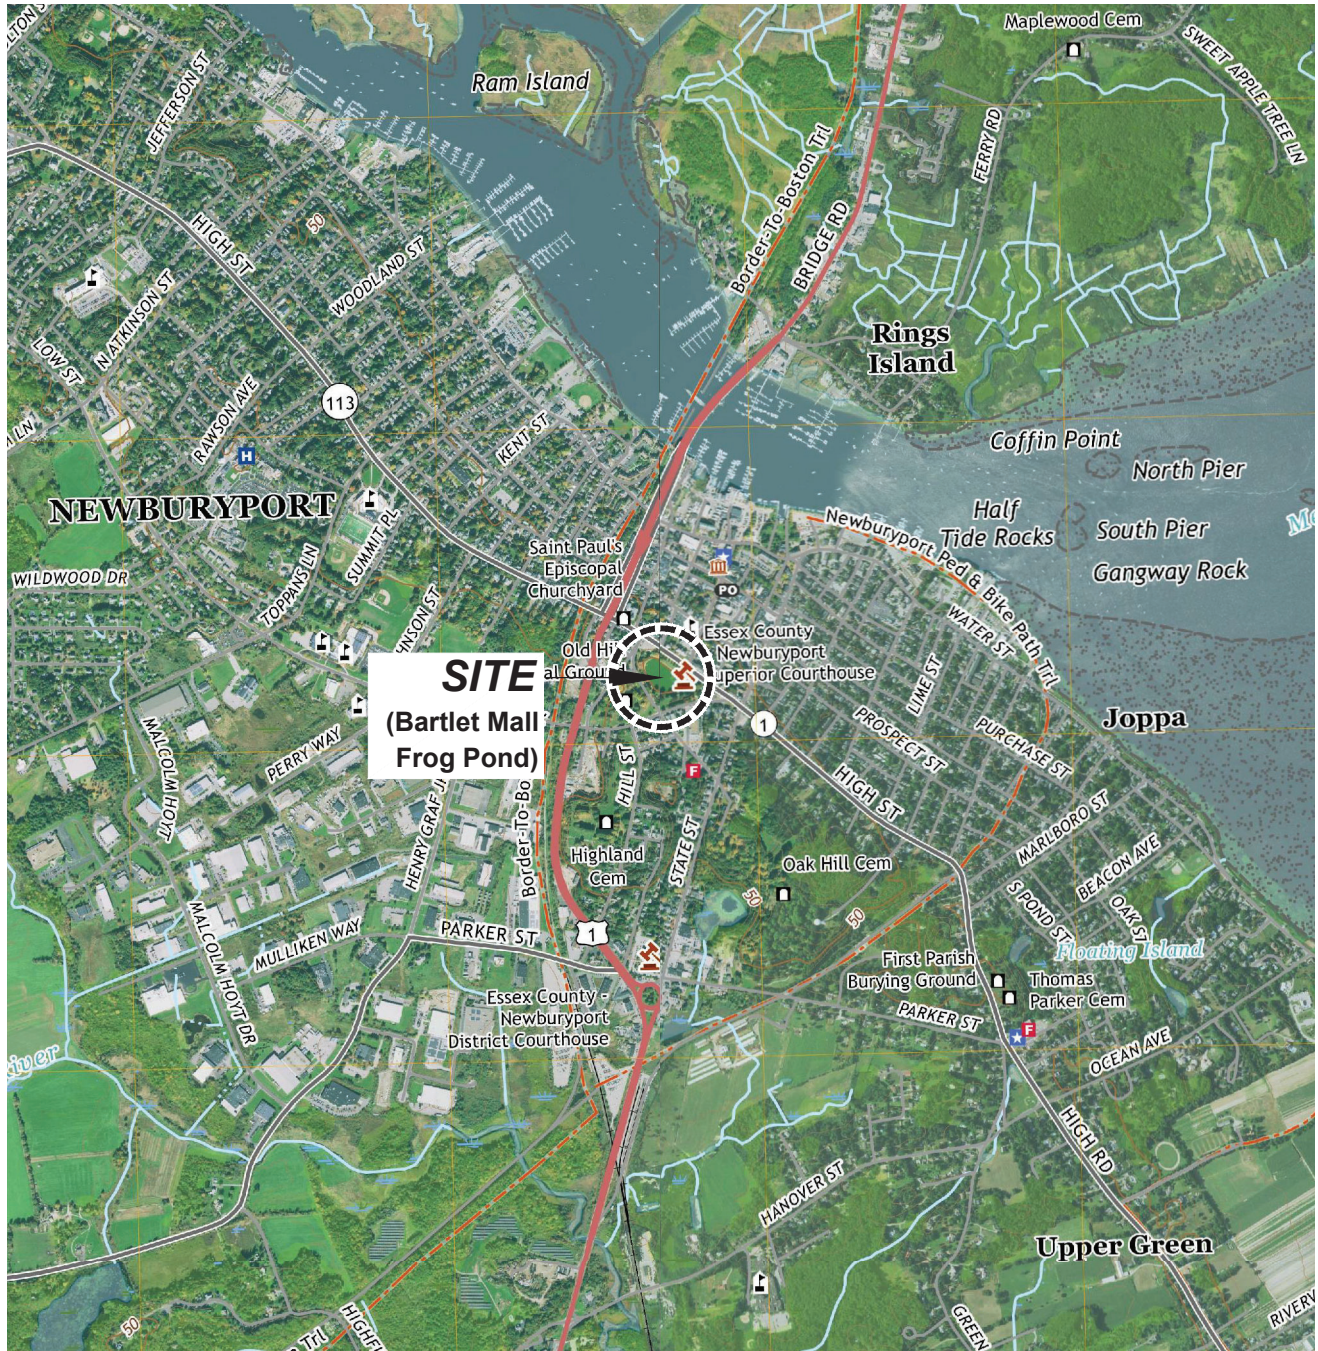
Fig. 1

This Image is from U.S.G.S. Topographic 7.5 Minute Series
 Newburyport East, MA-NH Quadrangle, 2021 and
 Newburyport West MA-NH Quadrangle, 2021
 Datum is North American Vertical Datum of 1988 (NAVD88).
 Contour Interval is 10 Feet.

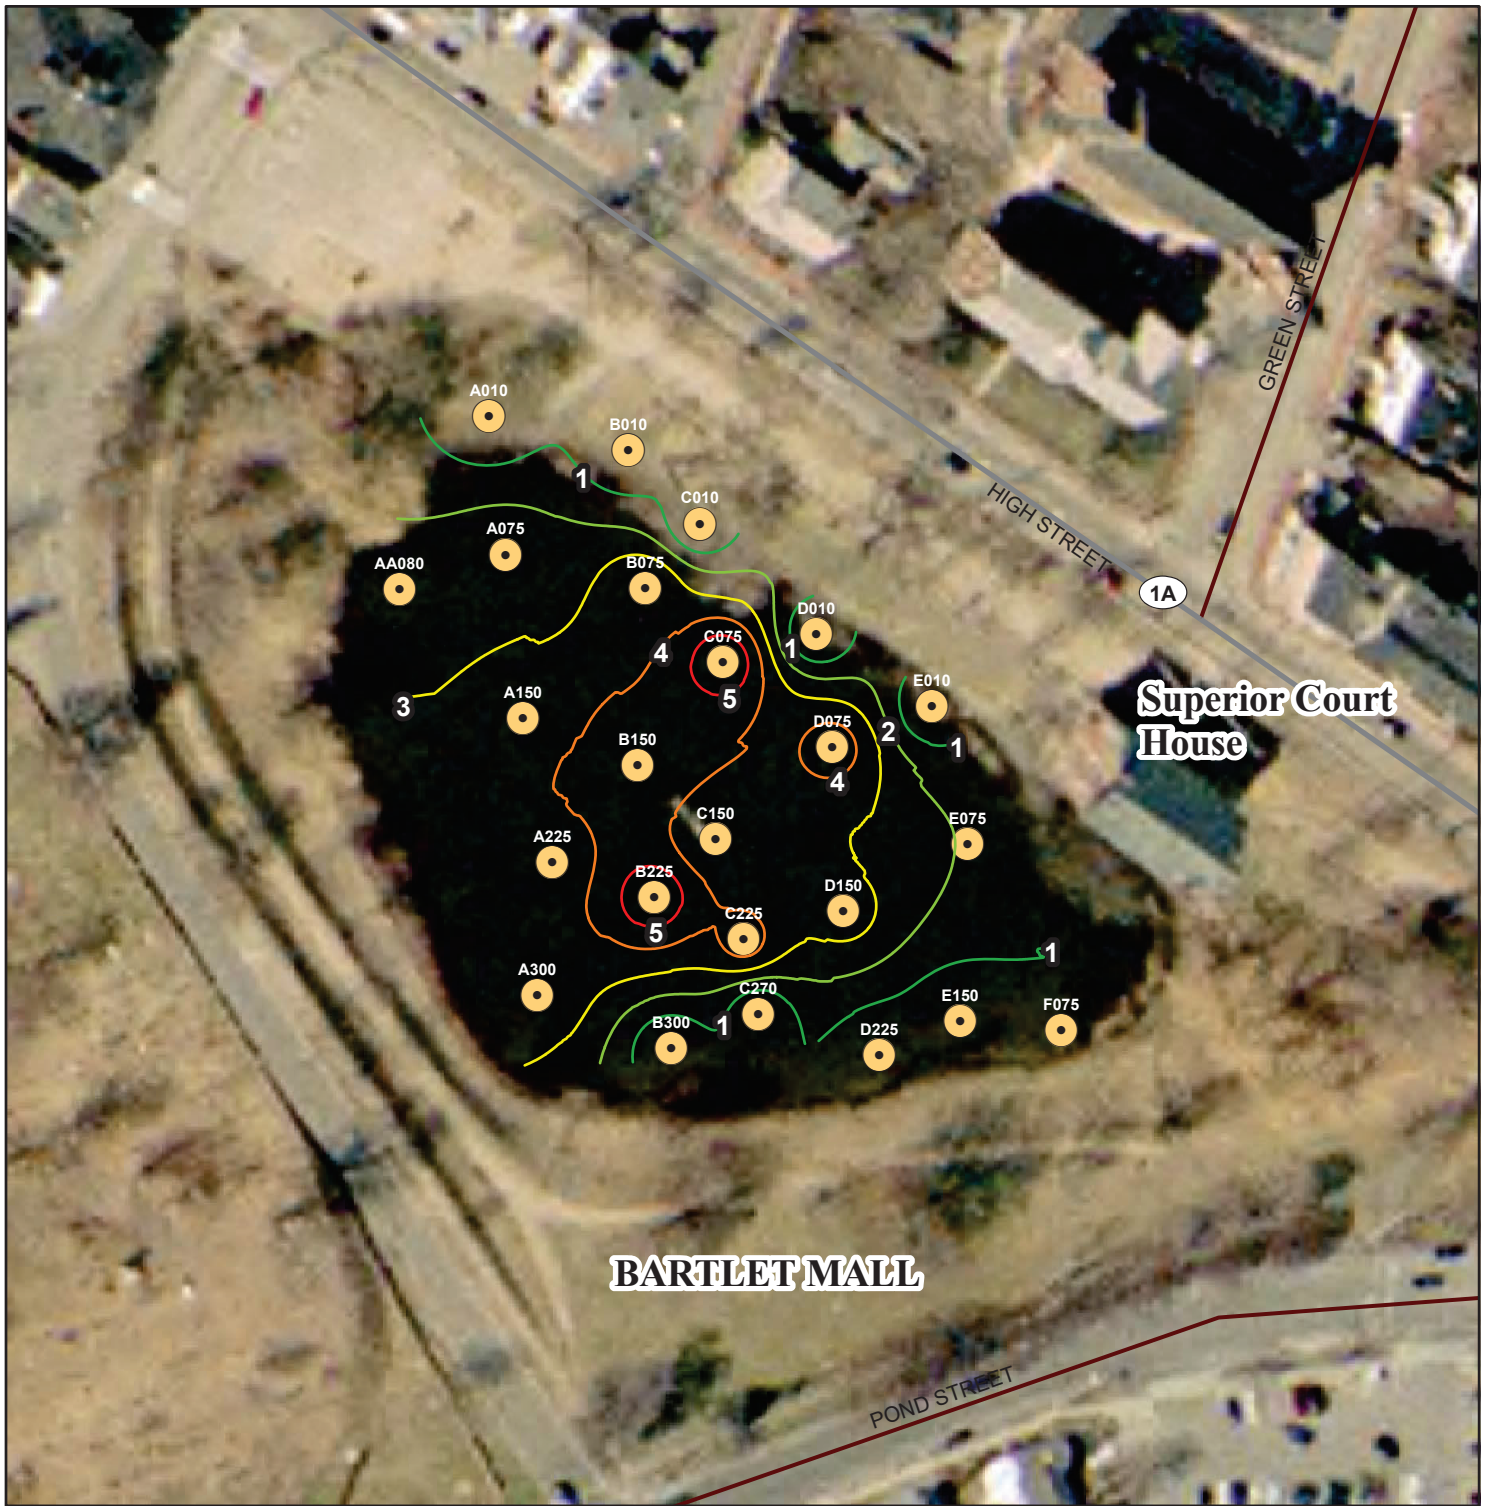
FIGURE 4 - Frog Pond, Bartlet Mall, Newburyport, MA

Thickness of Soft Sediment (feet)

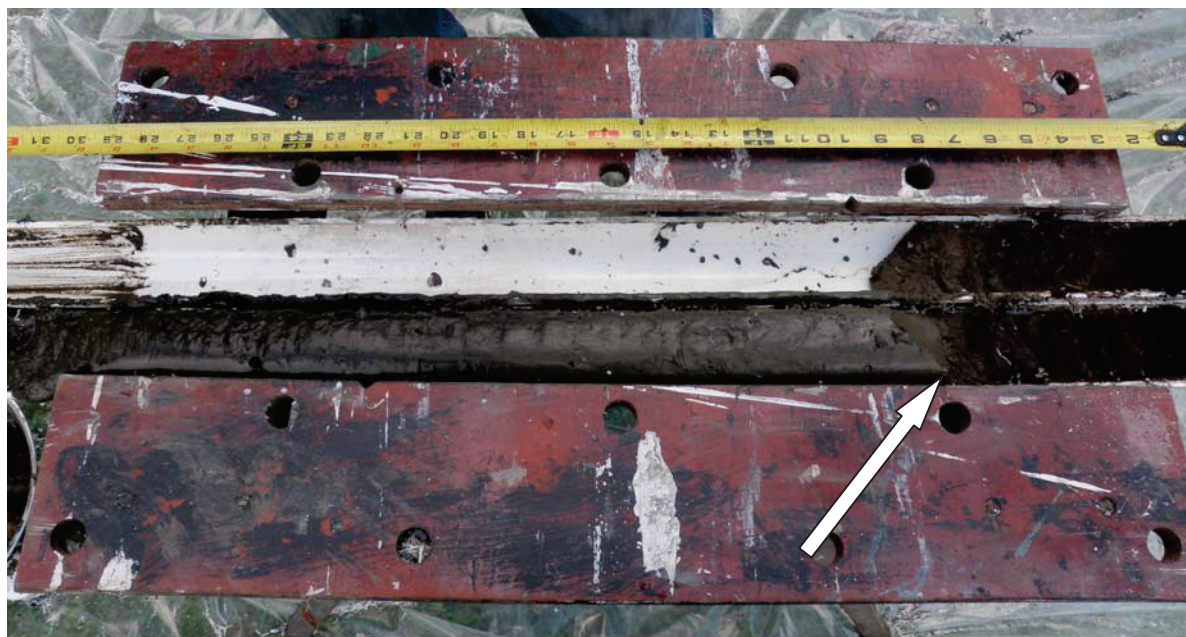
Photo 1. Sediment core sample 2 after cutting the PVC tube open, note transition from gray organic silt to dark brown peat.

A consistent stratigraphy was observed across all of the core samples, generally described as a layer of dark brown peat beneath several feet of dark gray organic silt with sand. Peat is a consolidated mix of organic and mineral materials containing visible root materials and wood debris, and is the preserved remains of wetland vegetation that has accumulated over long periods of time. Additional details on each of the sediment sampling locations are summarized in Table 1, below:

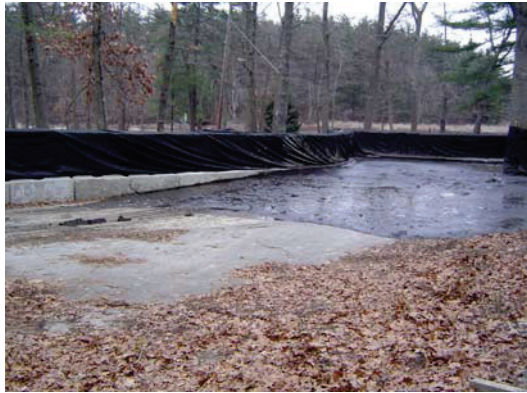
Photo 2. Sediment immediately after dredging.

Dredged sediment would need to be dewatered at the site before it can be transported to a receiving facility for disposal. Dewatering techniques vary between projects, but typically involve the temporary stockpiling of sediment within a bermed containment area to allow

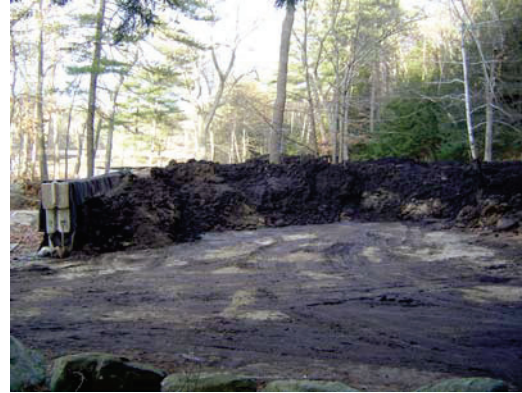
Photo 3. Sediment after several weeks of dewatering.

water to drain from the material. Once dewatered, the material can be more efficiently managed, and the overall weight of the sediment will be reduced, decreasing transportation and disposal costs, which are priced per ton. To support the preliminary cost estimates for transportation and disposal costs in Table 4, the weight of dewatered sediment was estimated at 0.80 tons per c.y.

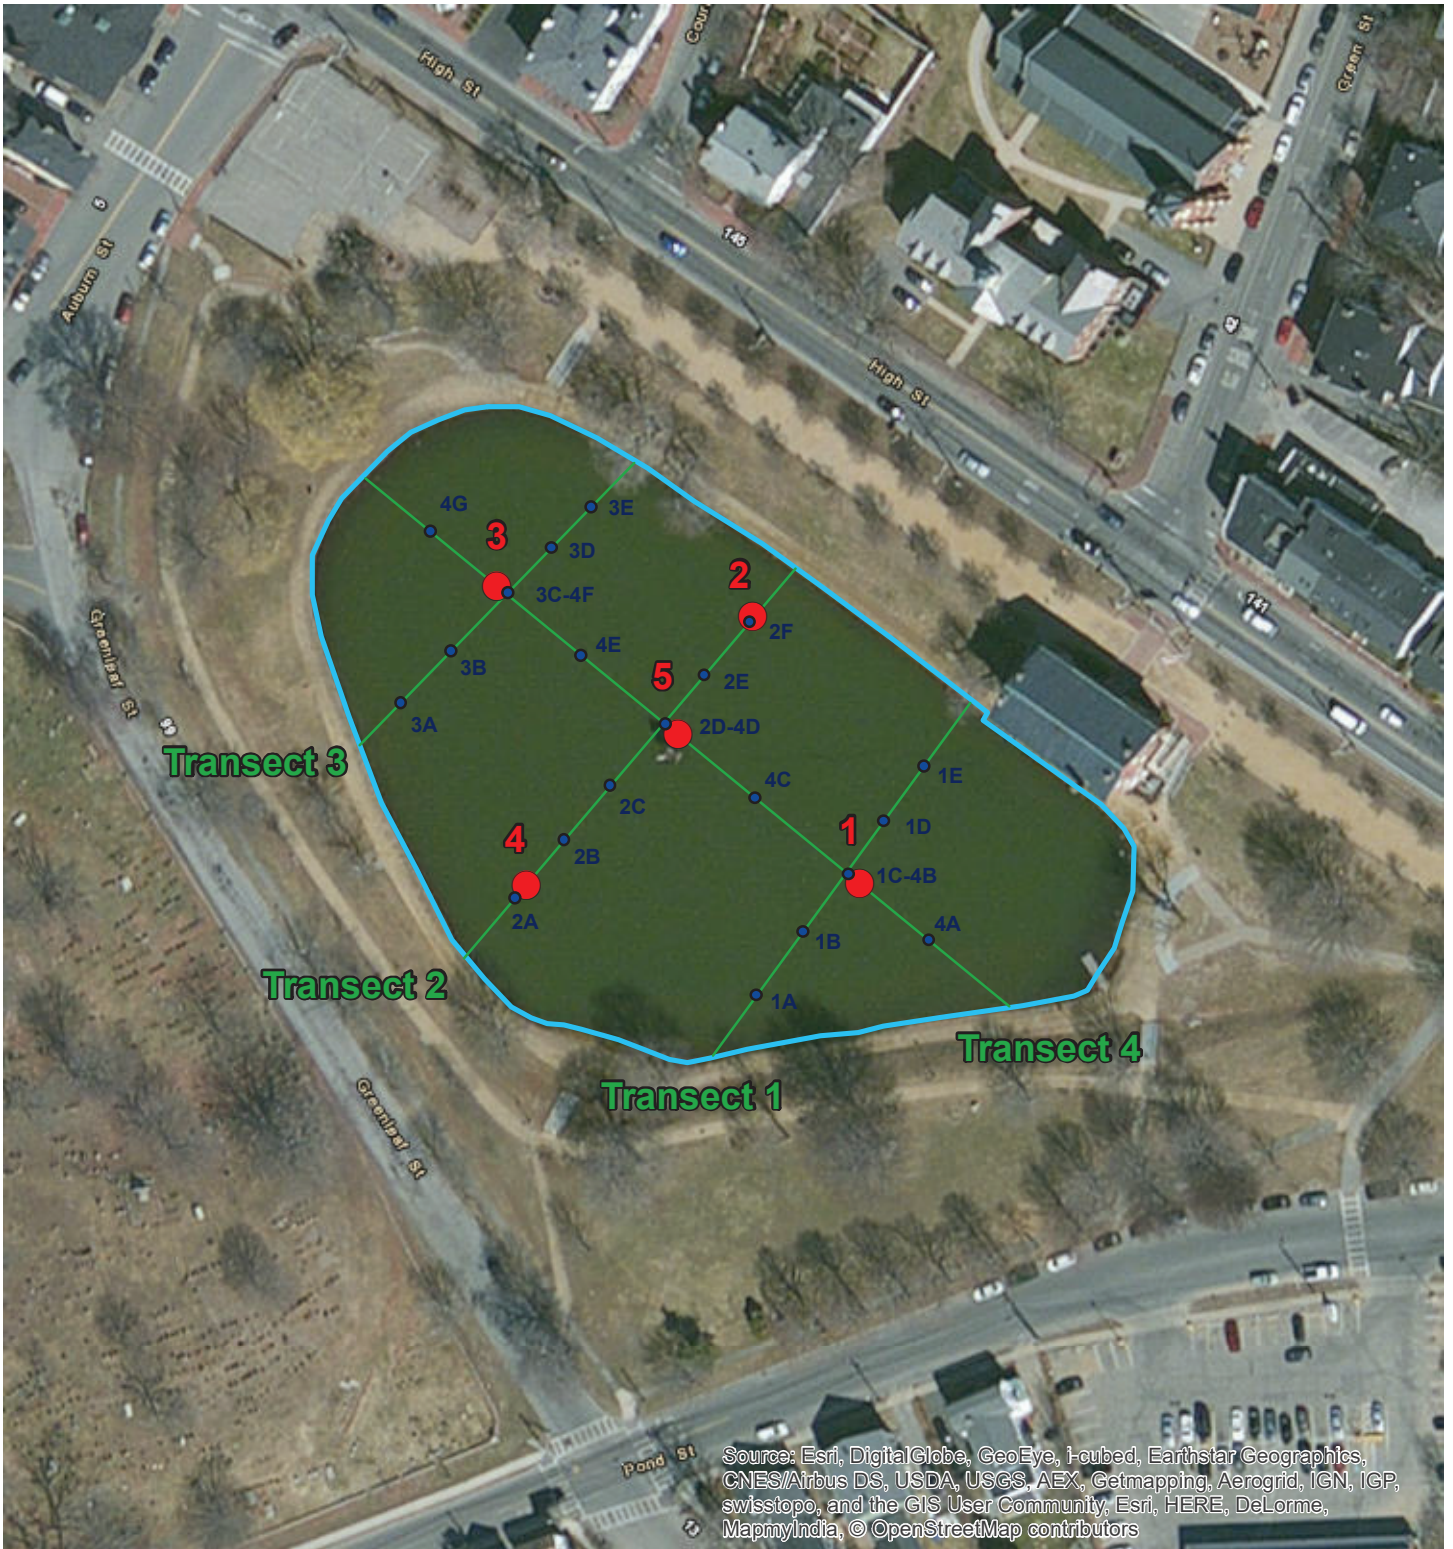
Figure 1

To measure sediment thickness in the pond, HW probed the sediment at the bottom of the pond at 20 locations across four transects. Three transects were completed across the width of the pond, and one transect was completed across the length of the pond (Figure 1). At each of the 20 measurement locations, a 15-foot long 3/8-inch diameter fiberglass rod was lowered into the pond water until reaching the top of sediment, and an initial measurement of depth below water surface (BWS) was recorded. The rod was then advanced into the soft, shallow sediment until a transition in sediment composition was detected, based on the level of force necessary to push the rod deeper. This transition indicated the bottom of soft, shallow sediment, and the depth BWS was recorded. The rod was then further advanced until refusal, and that depth BWS was recorded. Refusal was encountered between 10 to 14 feet BWS at the profile locations. This depth is more likely reflective of limitations to the sediment profiling methodology, and not indicative of a transition to a more consolidated sediment layer (i.e., native, mineral substrates). It is likely that several more feet of peat material exists beyond the sediment probe refusal depth.

HW collected a total of five sediment cores from the pond bottom on August 28, 2014. Sampling locations were distributed across the area of the pond (Figure 1). Sediment cores were completed using ten-foot lengths of two inch inner-diameter PVC tubing. At each sediment core sampling location, the PVC tube was advanced into the pond bottom sediment with a safety hammer until effective refusal was encountered. At each of the sampling locations, the PVC tube could only be advanced approximately four feet into the pond sediment before refusal. The depth to which the core could be advanced is referred to as the penetration. A plug seal was then installed at the top of the PVC tube and the tube was retracted, with the sediment core contained within. The sediment cores were then brought ashore to a work station, where excess water from the sediment core tubes was drained. The PVC tubes were then cut open with a circular saw to allow for inspection. The amount of sediment retained in the core after removal from the pond is referred to as the recovery.

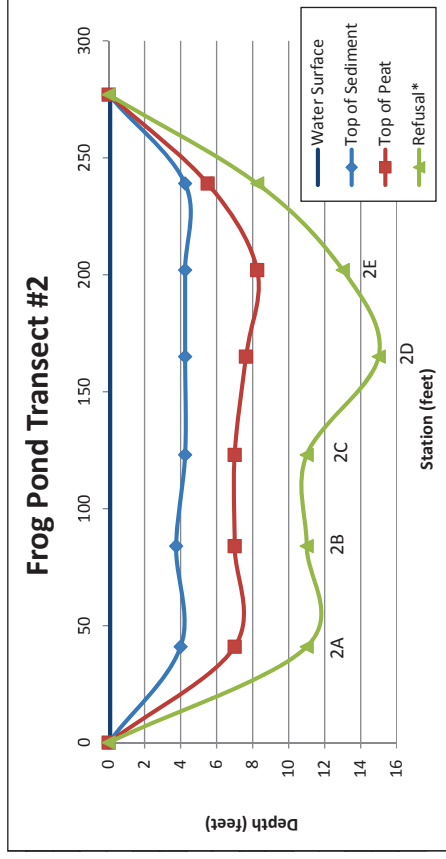
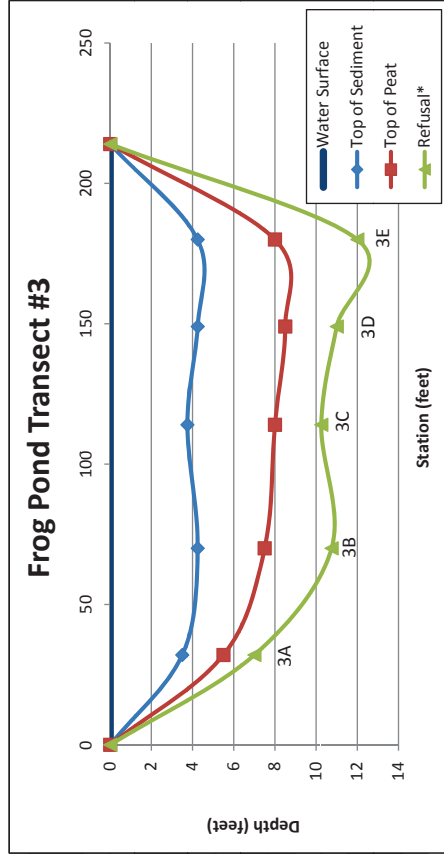
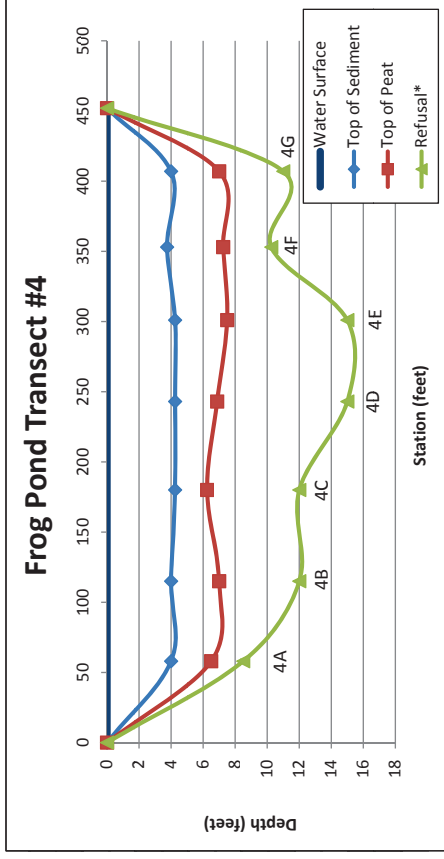
FIGURE 2 – FROG POND TRANSECTS

*Note: Refusal is based on maximum rod depth achieved through hand advancement. Peat bottom likely several feet lower than shown.

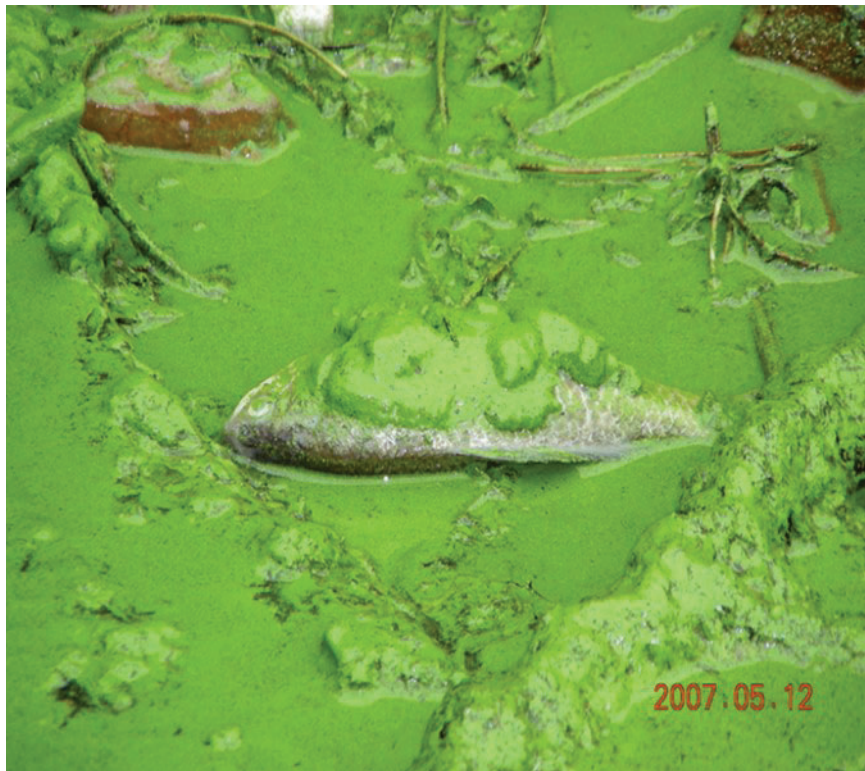
Hypertrophic water bodies are ponds and lakes with very high algal content, sometimes of specific species called cyanobacteria, Figure 1, that produce toxins. There is an anecdotal confirmation that cyanobacteria pea soup algal blooms causing rash appeared in the pond several years ago. Based on transparency only, Frog Pond could be borderline eutrophic to hyper trophic. In short, because the depth of Frog Pond is around 2 ft if one cannot see the bottom the pond is most likely hypertrophic.

Figure 1
Highly hypertrophic
water body Lake Taihu
in China

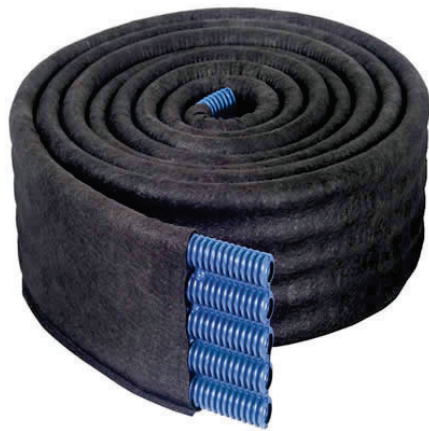
Figure 3 Pond underliner

However, impermeable (e.g., vinyl) liners installed over muck wherein microbial decomposing is occurring may cause the liner to float up off the bottom. Also, high organic matter soil (muck) tends to give off excess methane gas. This and an occasional high groundwater table can cause the liner to float from the bottom to the surface. Previously, the only solution would have been to cut and patch the liner which would require dewatering the pond. Using the proper pond commercial *underliner* venting will help prevent this. An underliner contains perforated tubes wrapped by non-woven geotextile for more protection and function (see Figure 3)

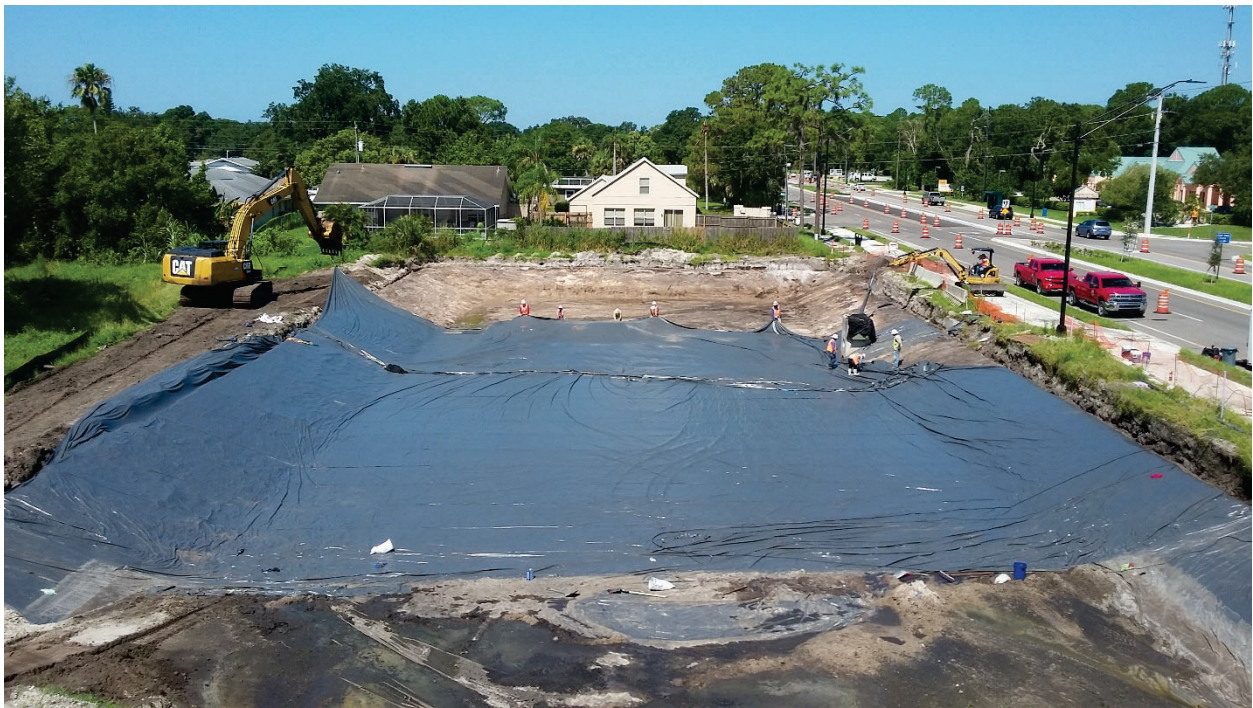
Figure 4 Pond synthetic liner installation (COMANCO). Note anchoring the liner with stones.

Synthetic plastic (vinyl), rubber or tarp liners are relatively cheap (less than \$0.5/sq ft). A 6-inch gravel base and then soil can be laid over it. Some installing companies (e.g. *Reef Industries, Houston, TX*) claim that heavy equipment can be used on top of their liners to move gravel and soil without damage. Plastic vinyl liners are shipped in large sections that can be welded together during installation. Liner installation is shown on Figure 3.

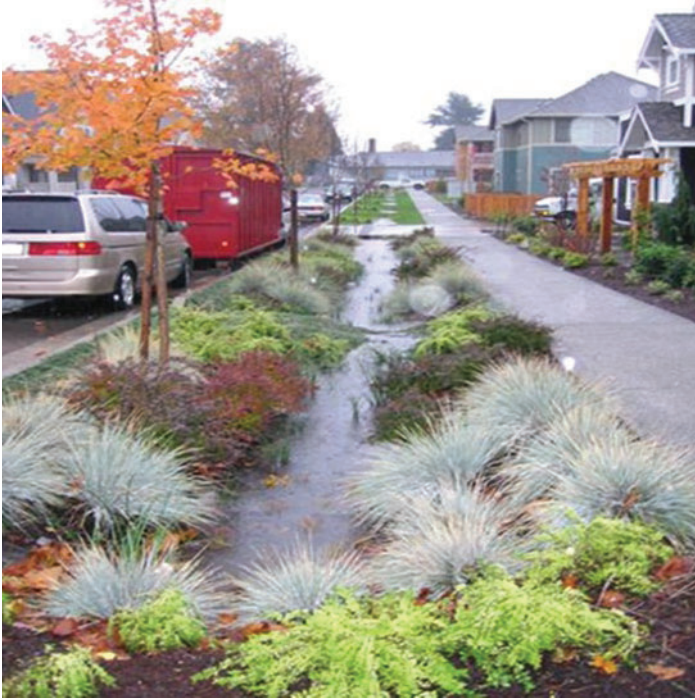
Figure 5 Surface raingarden channel for clean water /stormwater and pond outlet flow during rainfall in Malmö Sweden.
