**Subject: Phase II Environmental Site Assessment, Rev 1  
Brown School - 42 Milk Street  
Newburyport, Massachusetts 01950**

# **Phase II Environmental Site Assessment, Rev 1**

**Brown School  
42 Milk Street  
Newburyport, Massachusetts**

**Appendix B – Photo Log**  
**Brown School**  
**42 Milk Street, Newburyport, Massachusetts**

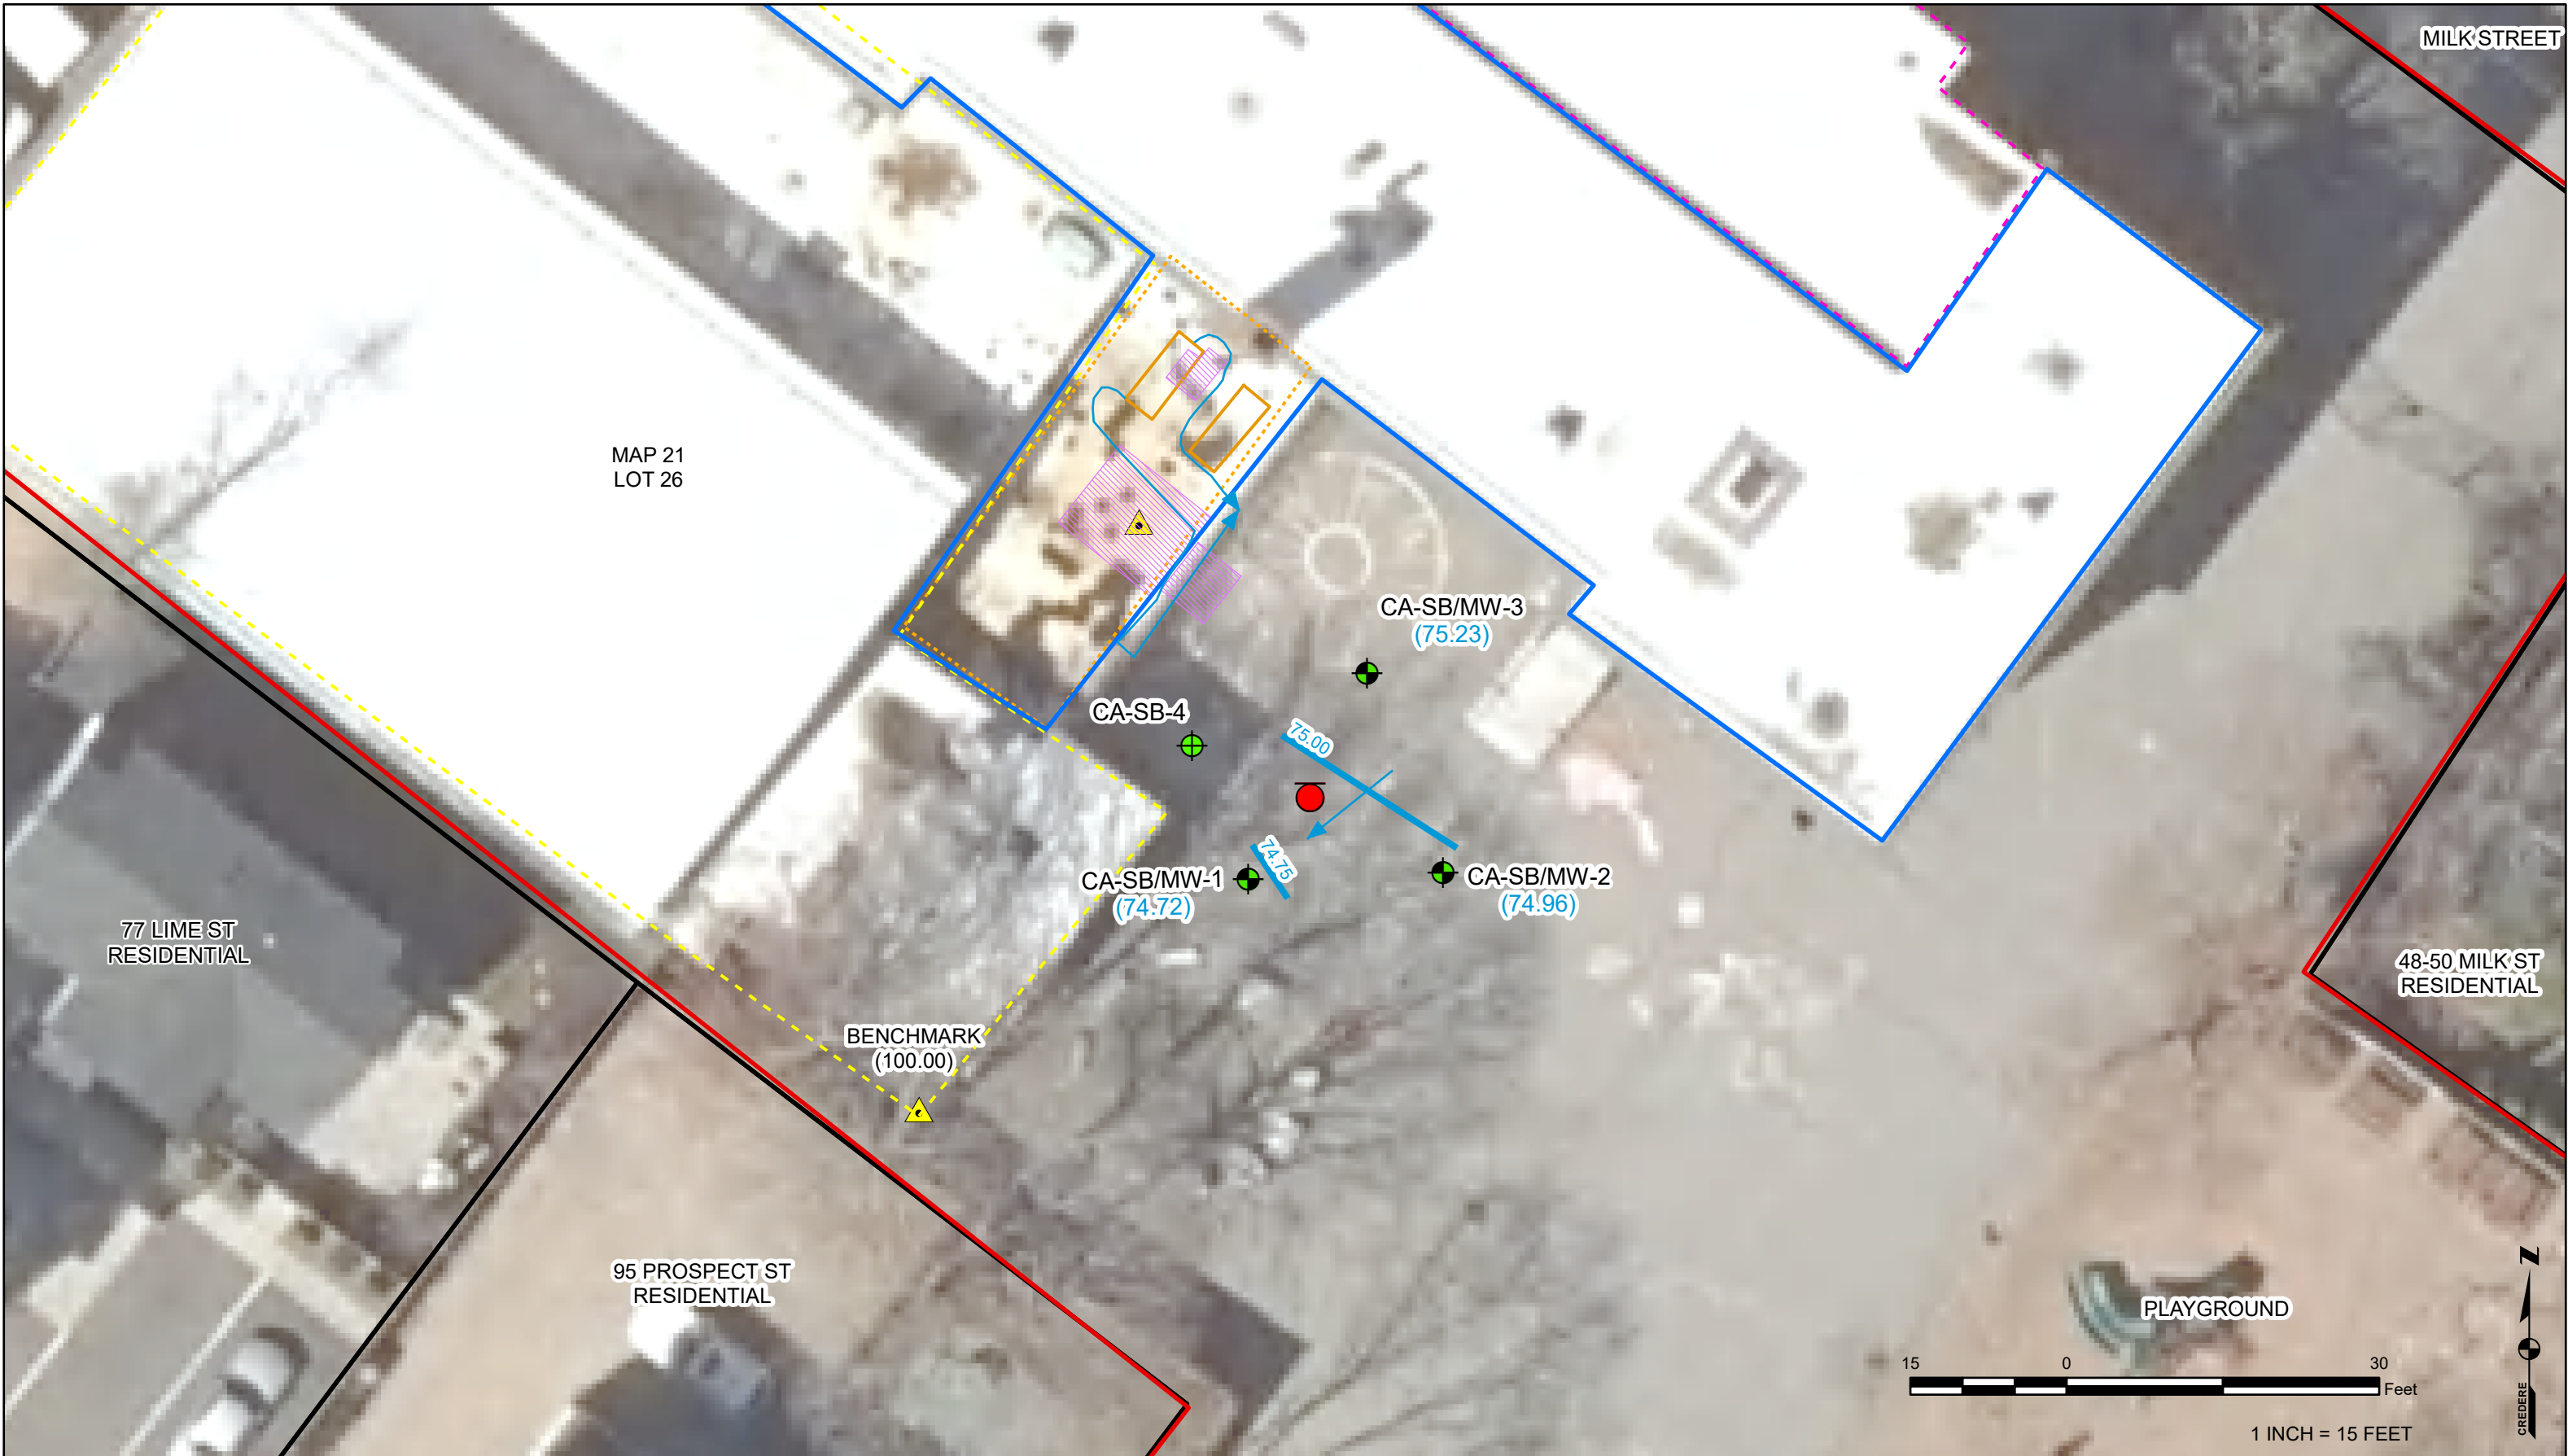
The top of casing well elevation data derived during the stadia survey was used to calculate relative groundwater elevations for each monitoring well and determine a groundwater flow direction for the monitoring well network. Results of the elevation survey, well gauging measurements, and calculated groundwater elevations are summarized in **Table 2** and a Groundwater Contour Plan is included as **Figure 3**.

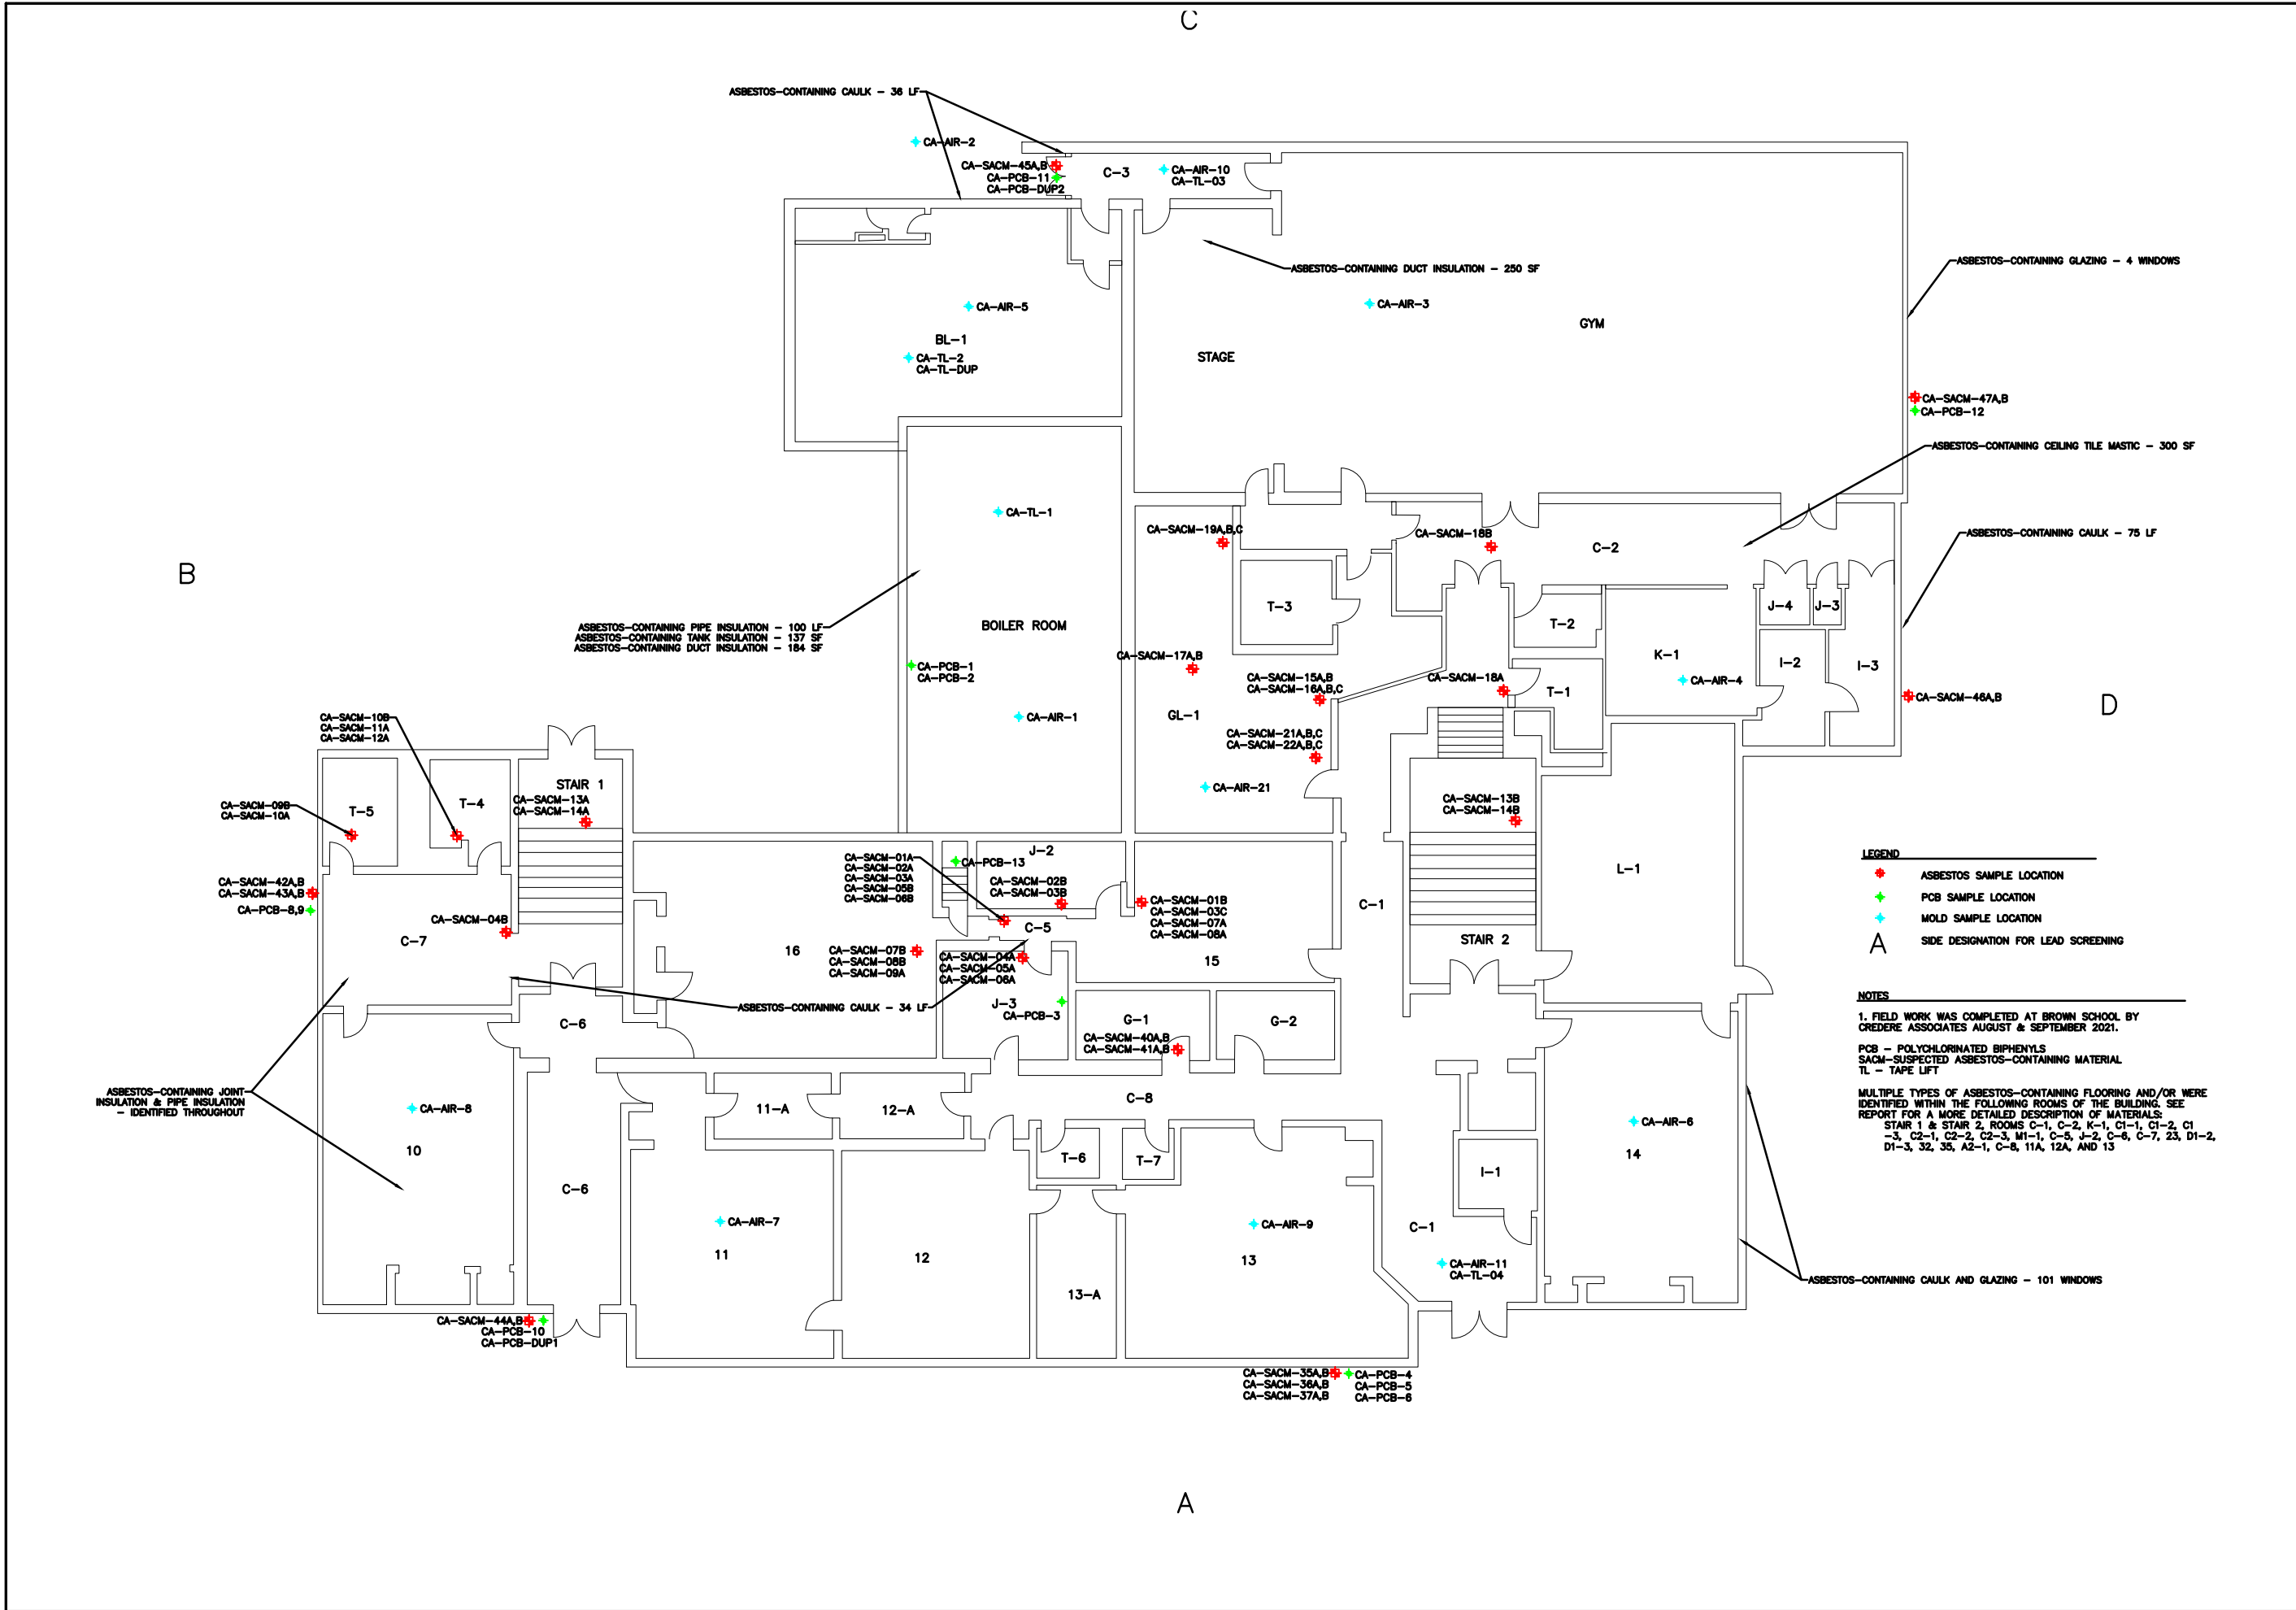
Collected asbestos samples were sent to EMSL Analytical, Inc. of South Portland, Maine, for analysis using polarized light microscopy (PLM) and PLM non-organically bound (NOB) methods. A summary of suspect ACM samples collected is included as **Table 5**. Sampling locations are depicted on **Figures 4, 5, and 6**.

Requested analysis and results are summarized in **Table 5**, and complete laboratory analytical reports are provided in **Appendix E**. An outline of the Site building showing locations of sampled materials from floors 1, 2 and 3 are included in **Figures 4, 5, & 6**, respectively.
