Brown School Feasibility Study - Draft

City of Newburyport
Newburyport, MA
October 1, 2014

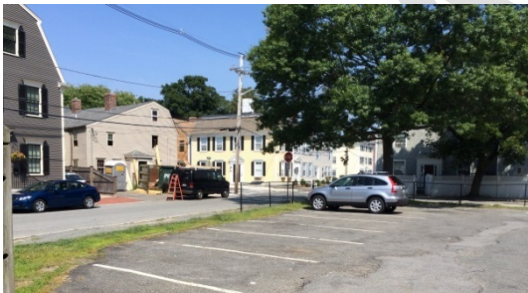
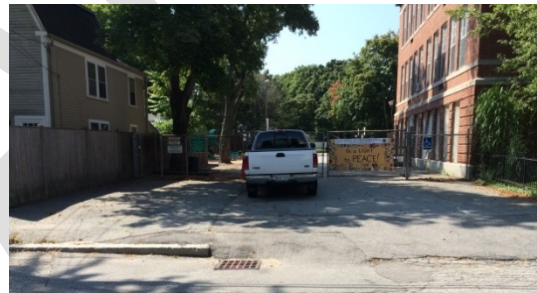
Off-Street Parking:

The site currently provides a total of 15 designated parking spaces. Of these spaces, 14 are located in the paved lot in the northwest corner of the site. The 15th space is a handicap space facing the fence in the northeast corner of the site. Additional parking takes place between the gymnasium and the Lime Street curb line on the east side of the site; however, these spaces are not marked. Review of aerial photographs indicates that as many as six additional cars may park in this area bringing the effective available off-street parking provided to approximately 21 spaces.

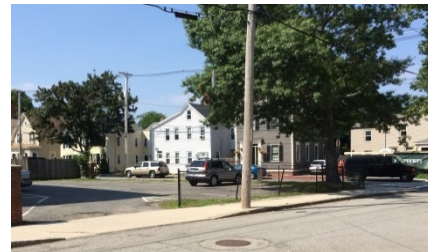
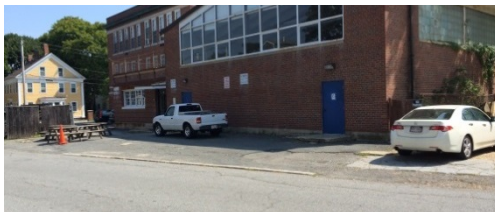
Site Access:

Vehicular site access is provided by curb cuts on Milk Street on the east and west sides of the building. The western curb cut provides direct access to the parking area in the northwest corner of the site. The eastern curb cut provides access to the playground areas in the eastern portion of the site, but is restricted by a chain link fence.

There is direct and uncontrolled access to the informal parking area between Lime Street and the gym since the granite curb along the edge of the Lime Street travel way is nearly flush with the surrounding pavement.

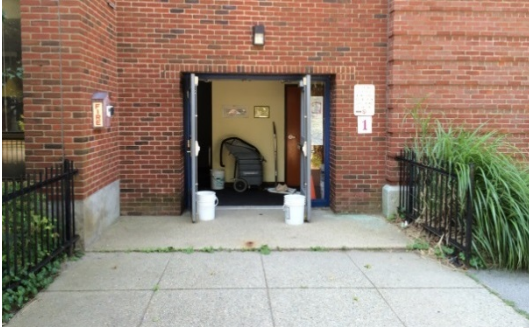
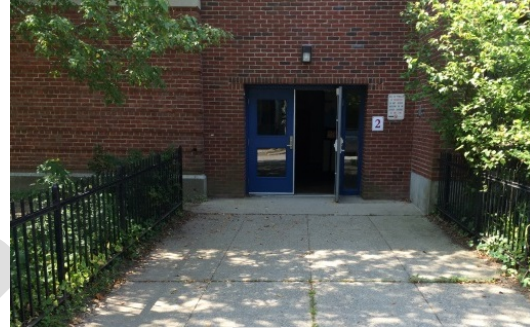
Primary Entrances (Accessible)

Pedestrian access to the primary building entrances (Doors 1 and 2) is provided by concrete walks. These walks are in good condition and appear to be compliant accessible routes.

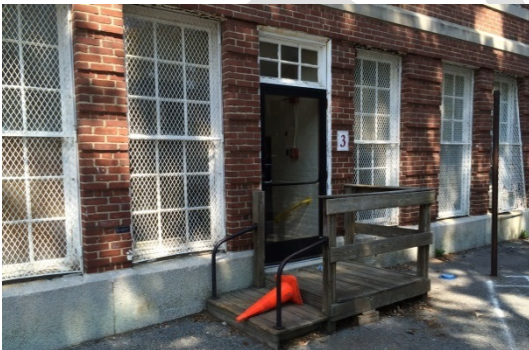
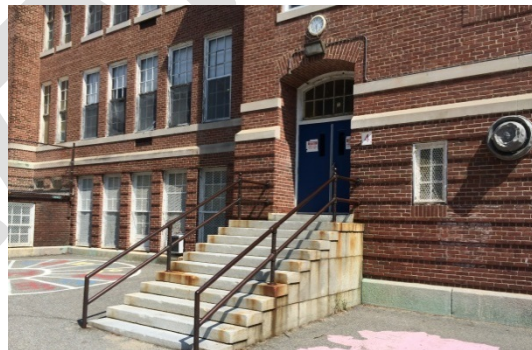
Secondary Entrances:

Secondary entrances to the building are located in the playground area (Doors 3 through 5) and along the east side of the building facing Lime Street (Doors 6 through 8). These entrances are not accessible. Doors 3 and 4 are provided with timber and concrete steps, respectively which appear to be in fair to good condition. Door 5 is a service door to the boiler room.

Doors 6 through 8 have concrete pads/steps that are in fair to poor condition. Most notably the concrete pad at Door 7 has fallen into disrepair and should be replaced.

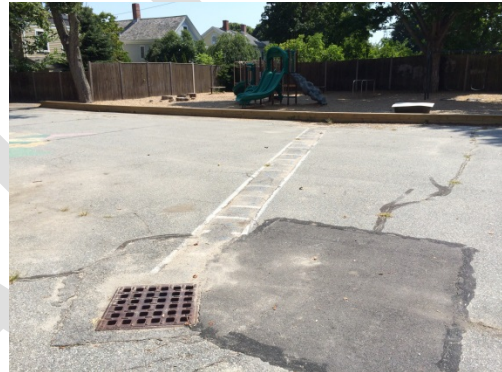
Storm Drain Systems:

Stormwater from the site flows into the municipal storm drain system on Milk Street. There are two on-site catch basins located in the paved playground area southeast of the building. Visible trench patches in the pavement indicate that these structures are connected to a third catch basin on Milk Street near the northeast corner of the site. These systems are presumed to provide adequate site drainage for existing conditions.

Since no increase in impervious area is anticipated, existing stormwater management systems are presumed to be adequate for the proposed adaptive reuse of the site. However, there do not appear to be any stormwater Best Management Practices (BMPs) in place beyond the catch basins. Should reuse plans for the site require Site Plan Review in accordance with Section XV of the Zoning Ordinance of the City of Newburyport (Zoning Ordinance), additional stormwater BMPs may be required to comply with the Massachusetts Department of Environmental Protection Stormwater Management Policy.

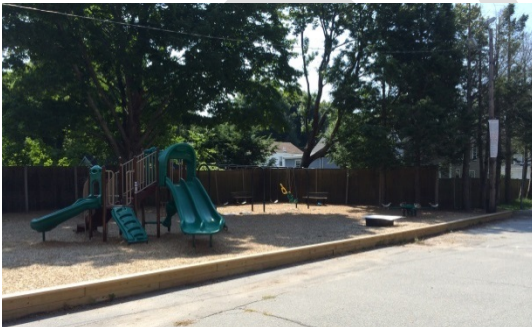
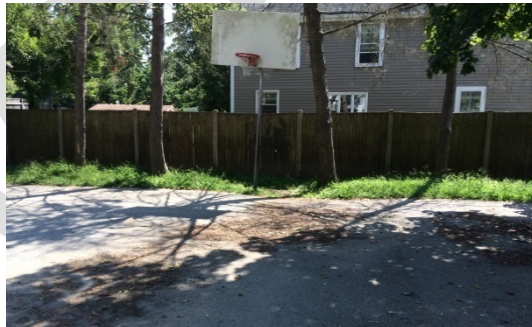
Playground equipment is installed on a wood chip surface in the eastern portion of the site. This equipment and surrounding surface appear to be in good condition and adequate for continued use. There are also basketball hoops in the southern end of the playground near Prospect Street. The hoops are in fair to good condition and will require maintenance for continued use.

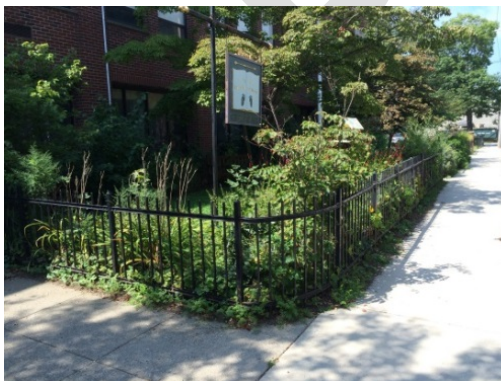
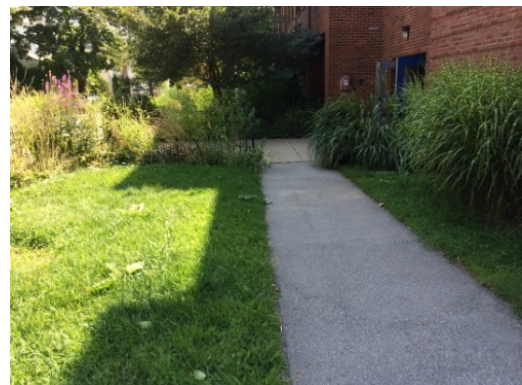
There are various fences located throughout the property. These fences include chain link fences and iron ornamental fencing near the front of the building. The ornamental fencing surrounds landscape areas and is in fair to poor condition with significant corrosion in certain locations. The chain link fence in the northeast corner of the site controlling access to the playground area from Milk Street is in good condition. A similar chain link fence controlling access from Prospect Street at the south end of the site is in fair condition and requires minor repairs.

A chain link fence in the northwest corner of the site also requires minor repairs. This fence encloses only a portion of the parking area and does not provide security to the site or adequate protection to the sidewalk from vehicles on the site. The purpose of this fence should be considered with site planning for the adaptive reuse of the site and it should be replaced with guard rail, additional fencing and/or screening as appropriate.

Site landscaping includes an area of assorted plantings within the ornamental fence on the front of the building as well as trees and grass areas around the perimeter of the paved playground and parking areas. The vegetation in these landscaped areas appears to be healthy and suitable for the site. Adaptive reuse may consider aesthetic landscape improvements. If additional designated parking is proposed, internal landscaping and trees may be required in accordance with Section XV of the Zoning Ordinance.

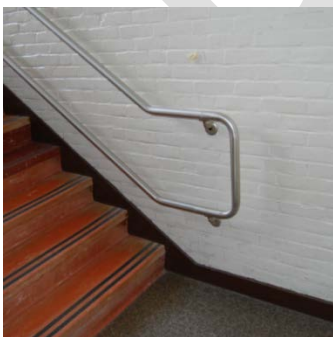
- Handrails – Compliant handrails have been added to one of the egress stairs but the other remains non-compliant. Handrails have been installed on the internal ramp but they are not continuous thereby rendering them non-compliant.

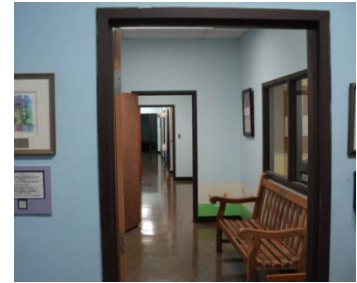
- Corridor Clearances – Required doors clearances blocked by furniture.

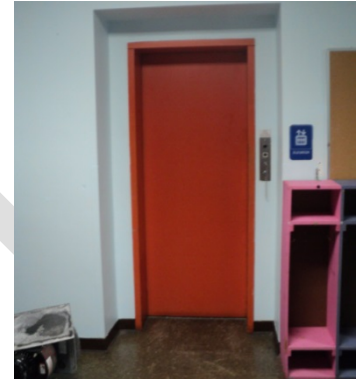
- Elevator is undersized. The shaft will have to be enlarged enough to accommodate a gurney.

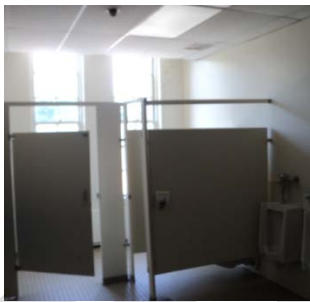
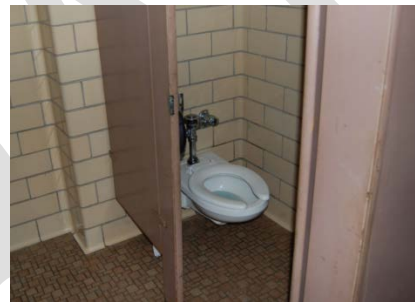
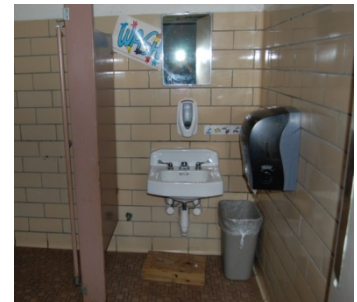
- Bathrooms have been upgraded and comply with many accessible requirements, however a number of non-compliant issues remains:
 - Non-compliant clearances at HC stall doors
 - Protruding objects, poorly located waste receptacles, non-compliant mirror height, non-compliant soap dispenser location

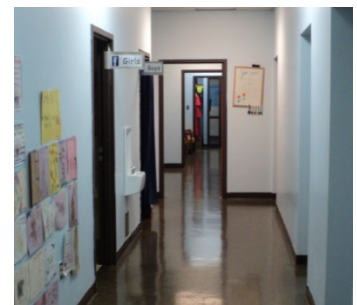
- Protruding objects – the water fountain protrudes into the corridor.

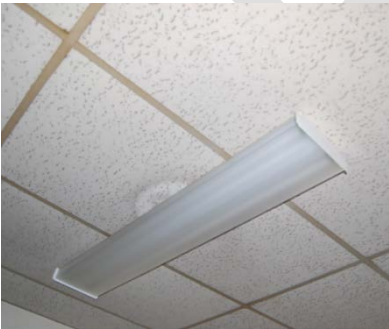
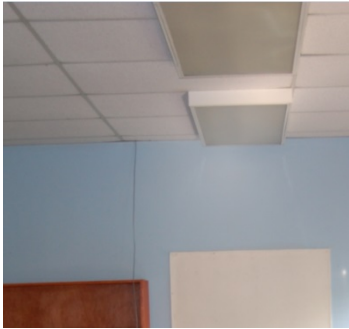
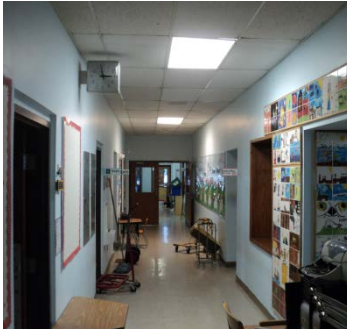
2 x 4 dropped ceilings are installed throughout and are in fair to poor condition. 1 x 1 ceiling tiles are installed in the hallway outside the women's bathroom and Tectum ceiling tiles are installed above/between the exposed joists in the gymnasium. Plaster ceilings remain at all stairways.

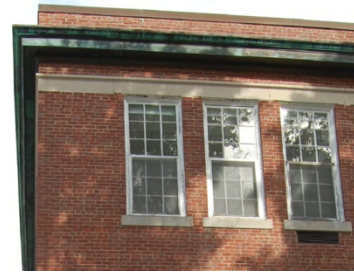
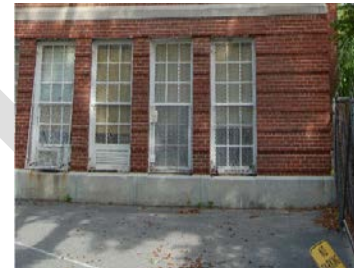
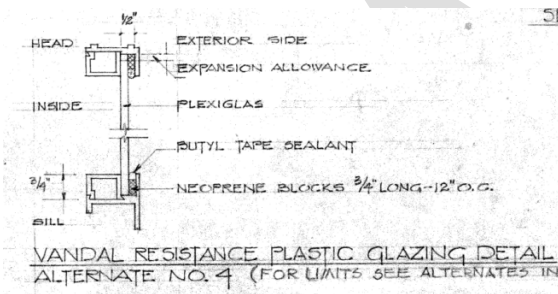
The exterior windows of the original structure are single glazed double-hung wood windows that appear to be in relatively poor shape. All are in need of paint on both the interior and exterior. Most all of these original windows have screens but no storms. Some have been modified to accept window installed AC units. Windows on the first level are protected by expanded metal.

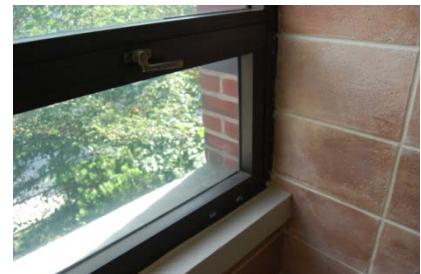
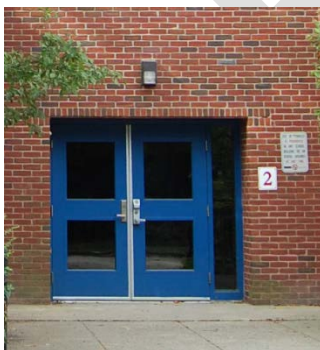
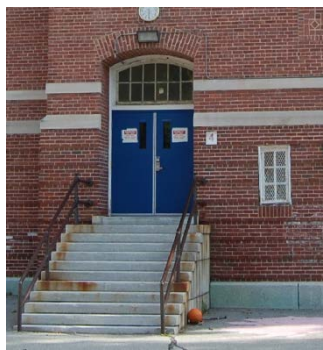
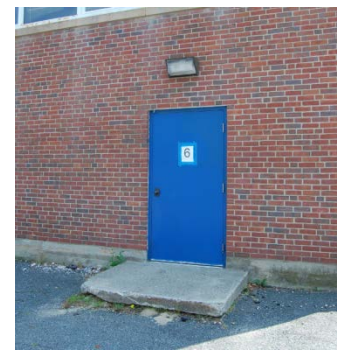
SE Exterior windows in the three story addition are singled glazed aluminum fixed windows with operable hoppers below. The aluminum frames are not thermally broken and the Plexiglas glazing is weathered etched and scratched.

The exterior doors are generally hollow metal and appear to be in fair shape. The main entrance doors have some glazing as do the stair egress doors, but most exterior doors are standard hollow metal with no lites. Doors exiting the original structure generally have transom lites above.

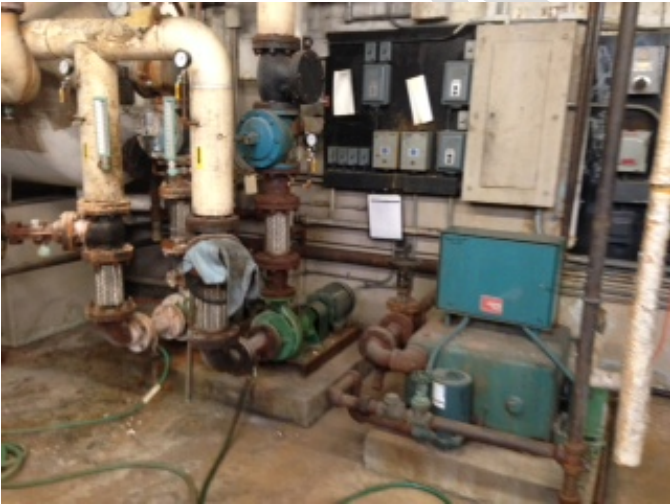
This hot water system was installed in 1975, thus making it almost 40 yrs old. The pumps, heat exchanger and piping are in poor condition. There have been several leaks in the hot water distribution piping recently due to age and deteriorating of the piping.

HOT WATER CIRCULATION PUMPS

It is not recommend utilizing the existing heating and ventilation system in the new design because of its age and also due to the fact that there is no air conditioning component. A new system should be considered that would have both air conditioning and heating. A system under consideration is the The Mitsubishi Electric multi-unit system. It uses a variety of air handling units ranging from ductless ceiling units to traditional air handling units. This system uses the heat pump technology and could provide a high efficient heating and cooling system for the space and eliminate the need for the existing hot water heating system.

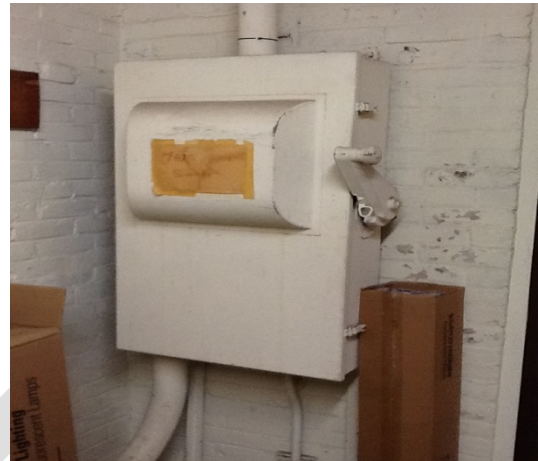
The main electrical service is a 120/208v 3 phase 4 wire system fed underground from a National Grid power pole to the main electric room located on the 1st floor. The main power comes into a 24”x24” pull box and from there to a 400 amp main switch. This switch then feeds a Westinghouse 120/208v 3ph 4w -400 amp main distribution panel. This panel serves has the main distribution for the entire building. This distribution includes (6) subpanels, the elevator, and the hot water pumps. The (6) subpanels are rated at 225 amps but fed with 125amp and 150amp breakers.

400 AMP 120/208V-3P MAIN SWITCH PUMPS

These subpanels provide the distribution to the lighting, mechanical equipment, and general outlets in the area it serves. Most of these panels are Westinghouse or Federal Pacific. Both of these panel types are obsolete and breakers and misc parts are no longer available. The electrical system is approximately 40 years old and in poor condition.

Although, this was sufficient for the existing needs, a typical multiuse office type building should have 8-10 Watts/ Sq. Ft. available. Thus, thus there is no additional power available for any future loads such air new air conditioning equipment. If a new HVAC system is considered for the building then the electrical system needs to be upgraded to accommodate this. The new system should be a 120/208v 3ph 4wire 800 amp system which

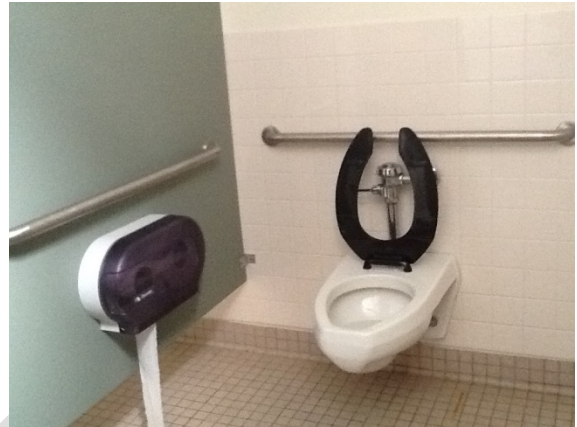
TYPICAL WALL HUNG TOILET WITH A MANUAL FLUSHOMETER.

The plumbing fixtures are in satisfactory condition. The toilets are wall hung with manual flushometers. The sinks are wall hung with manual chrome faucets. Although the condition of these fixtures is satisfactory, they have a dated industrial appearance.

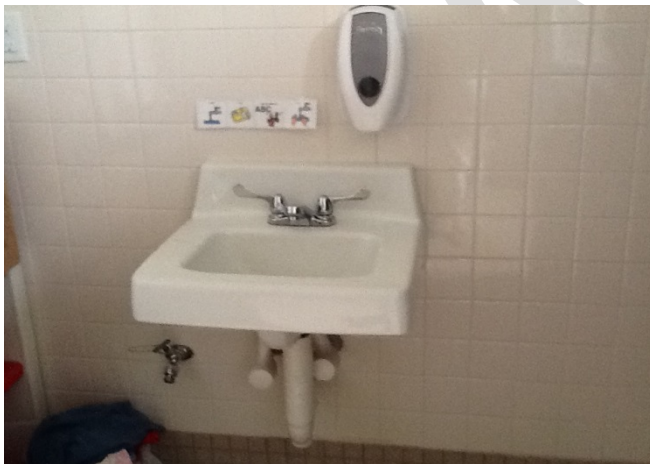
TYPICAL WALL HUNG SINK
