**Newburyport Historical Commission  
DEMOLITION PERMIT APPLICATION (Step 1)**

Property Address: 195 High Street

# DeLisle Barn

Existing Conditions Assessment Photo Documentation

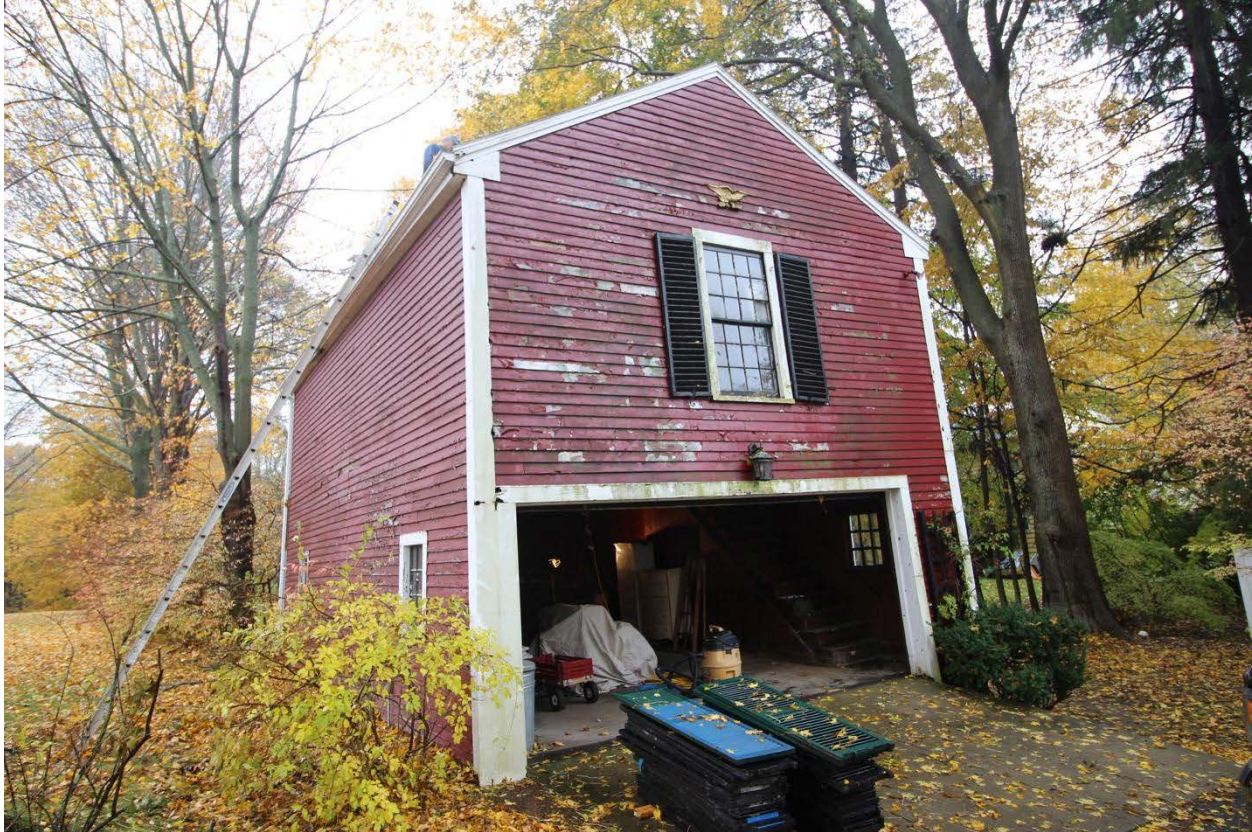
**New sheathing in this corner indicates long term water damage and the brace has rotted away from the corner post. Attempts were made to fill in the rot with new materials, but it is time to replace in kind and make the structure sound again.**
