Re: Request for Determination of Historic Significance and Demolition 35 Munroe Street, Newburyport, MA (the "Property")
Assessor's Map: 53 Lot: 7

June 1, 2020

Re: Site Visit to 35 Munroe Street Newburyport, Massachusetts 01950

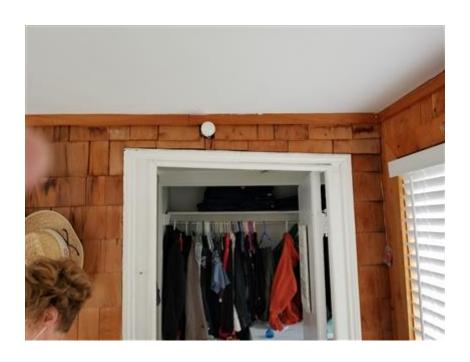
Image 1:

The existing sunroom is attached to the kitchen and was constructed during the 1980's according to the owner, Mr. Lingerman. The sunroom is sloping in the same direction as the kitchen [Image 1]. The floors are also sloping towards the rear of the lot. I observed some dry rot on the exterior wood support beams/joists of the sunporch.
