**A Landscape Preservation Plan
for the Laundry Yard and Courtyard
at the**

Caleb Cushing House

Newburyport, Massachusetts

November 2017

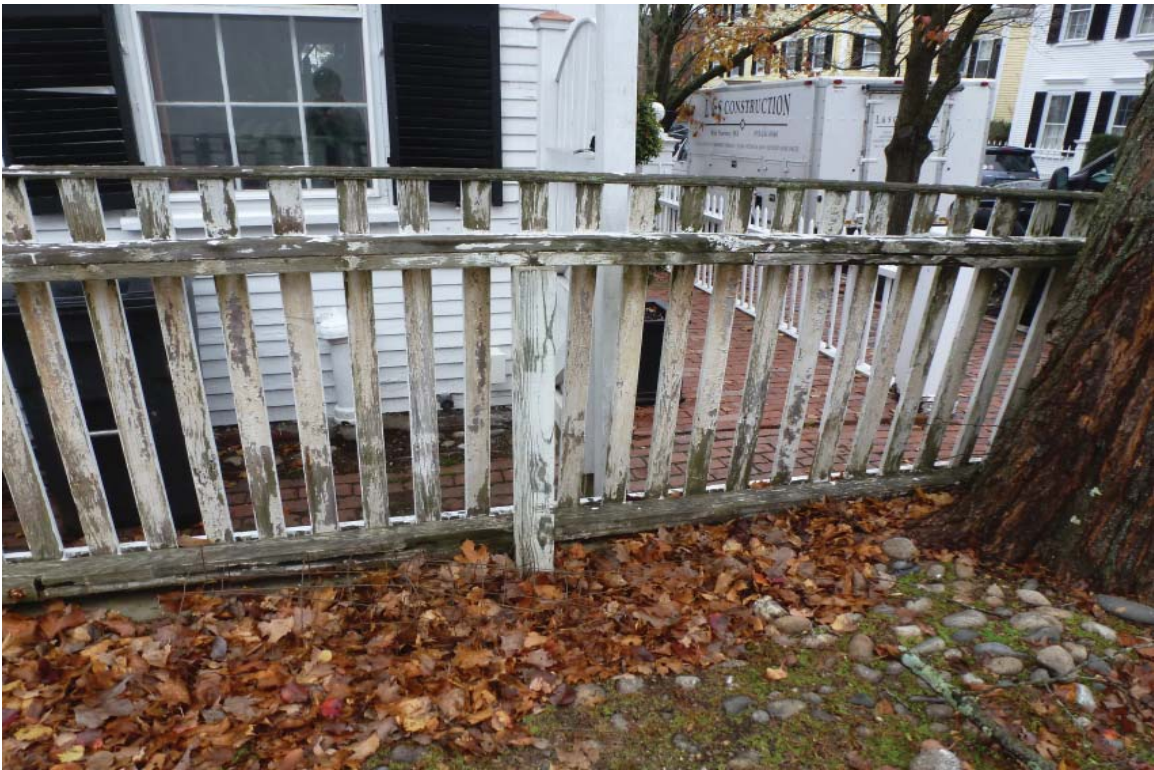
CA4: Northwest view of fence separating Cushing Alley from neighbor

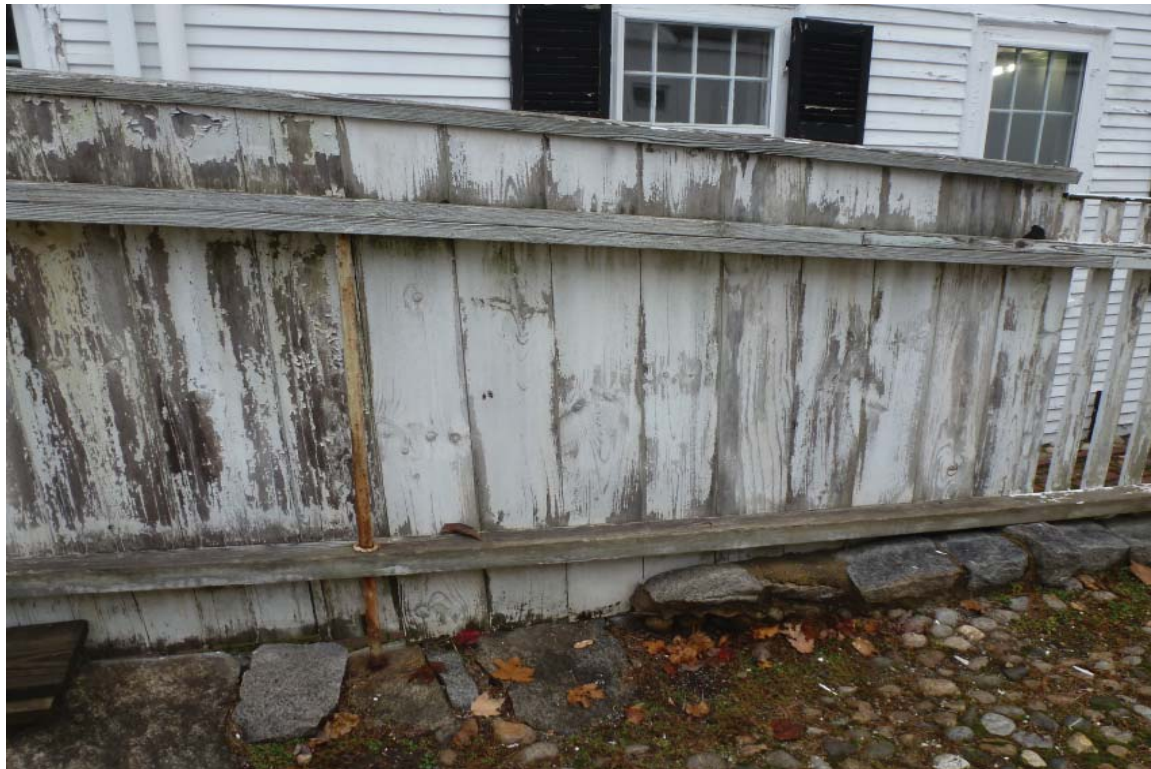
CA8: Close up of north fence between Cushing Alley and neighboring property

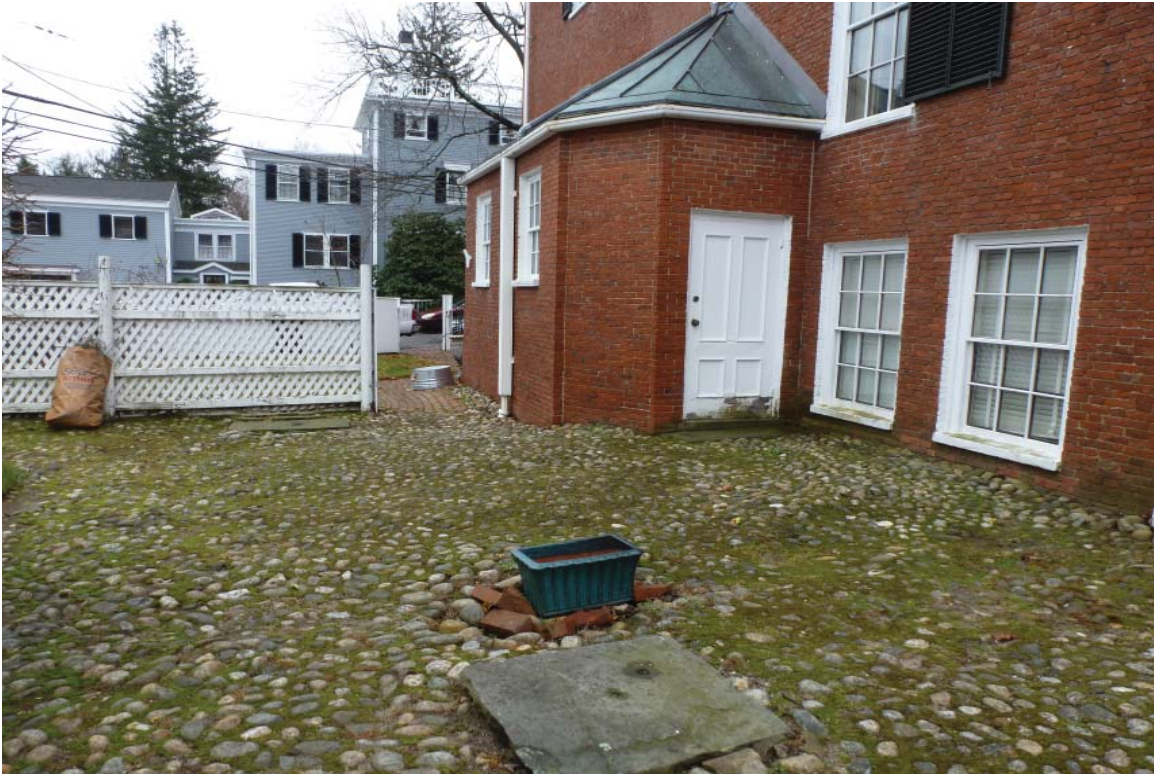
CY5: View South towards Cushing House East entrance

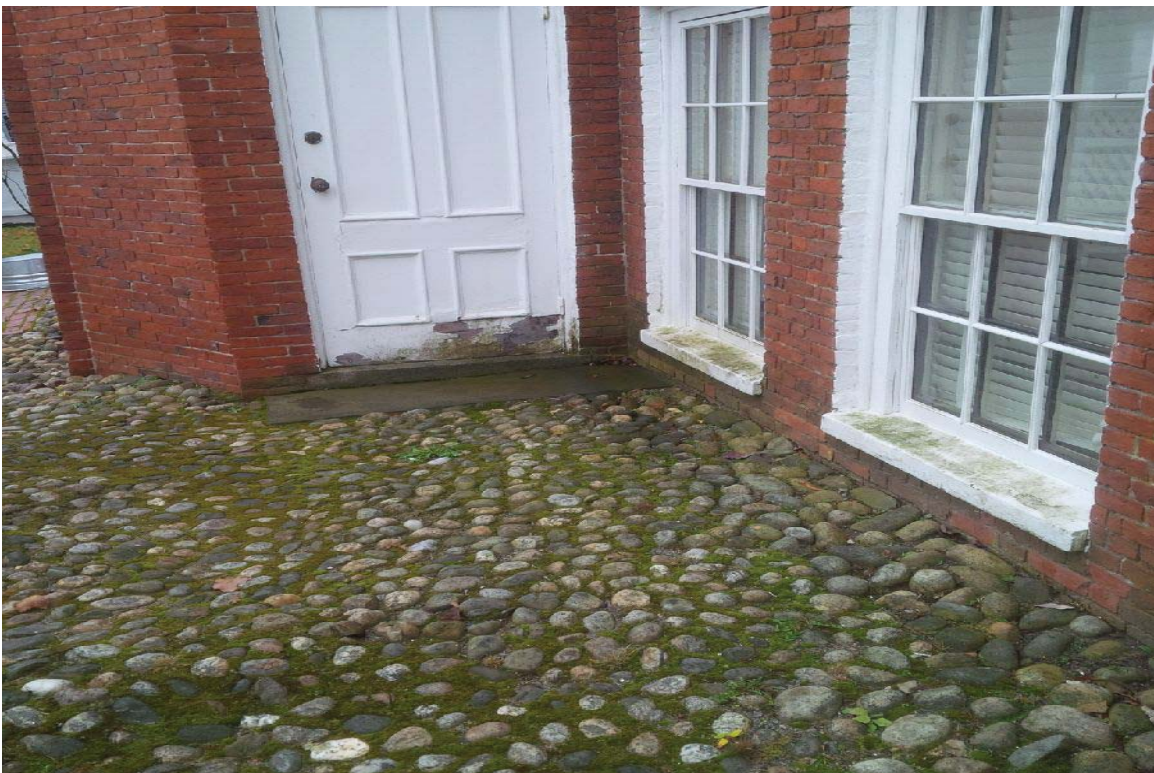
CY6: Close up of Cushing House East entrance

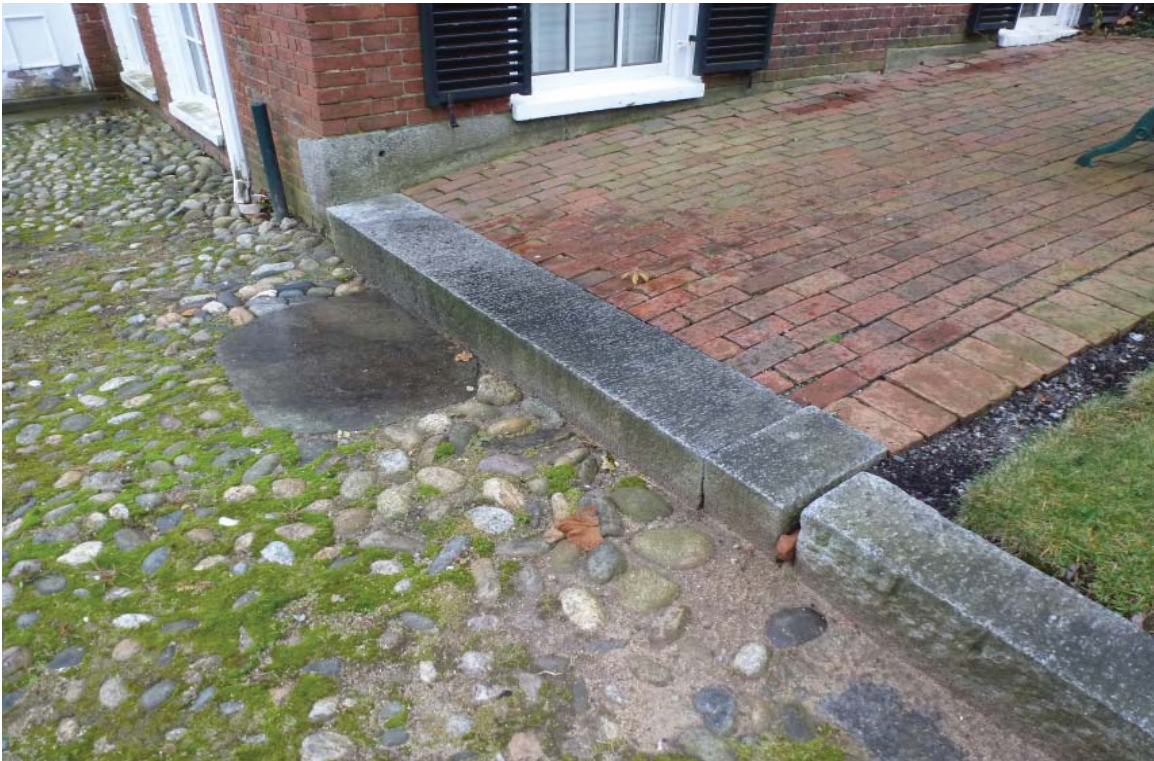
CY9: Close up of granite curb and step on Side Yard path

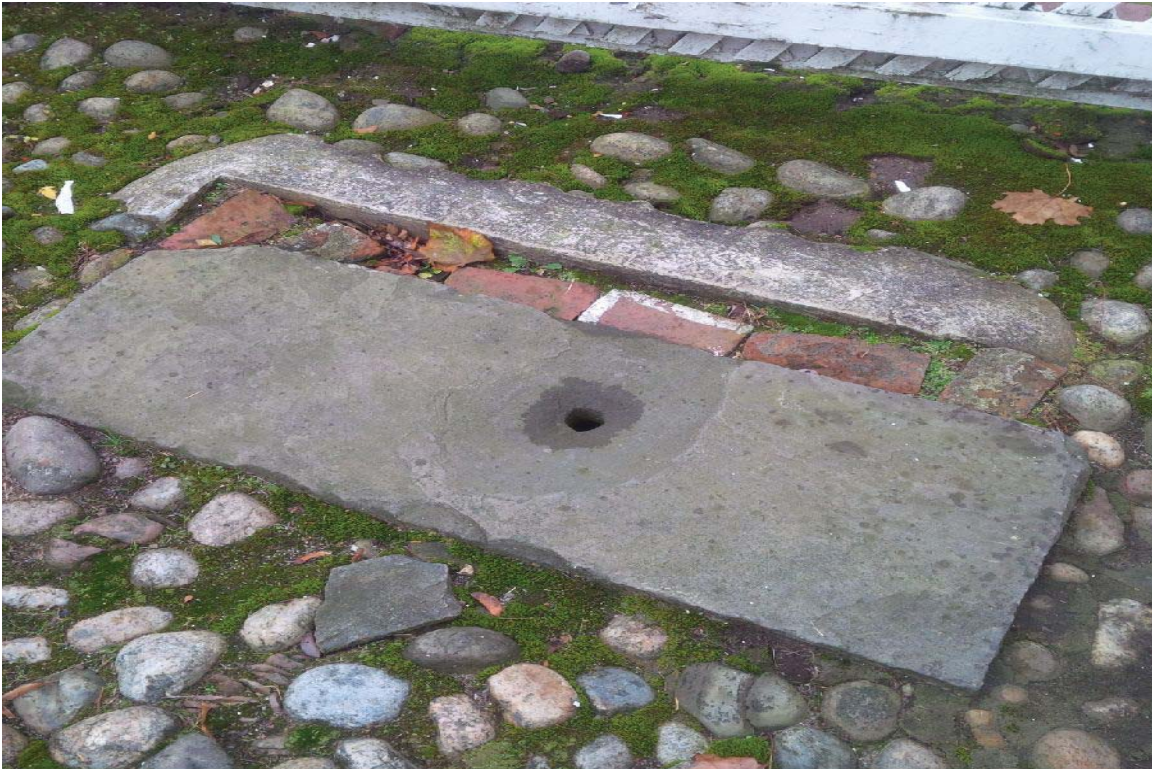
CY12: Close up of pump location in Courtyard

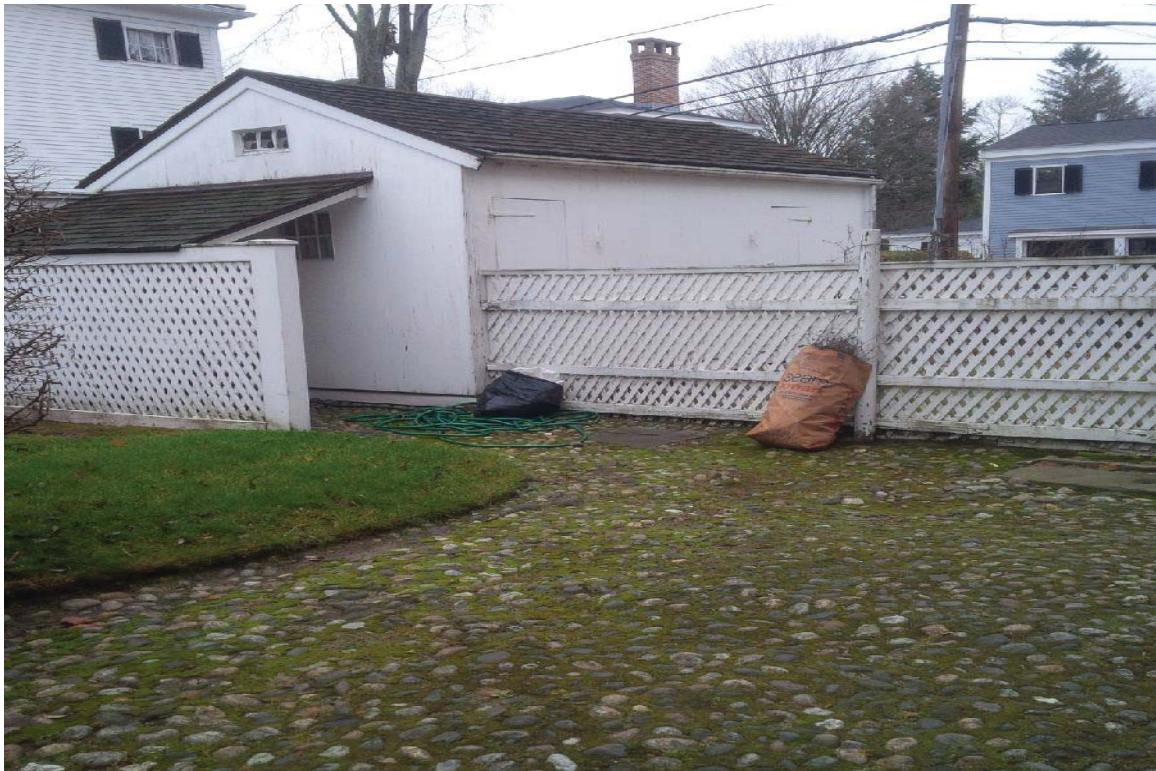
CY13: Courtyard view facing North towards Laundry Shed/Privy

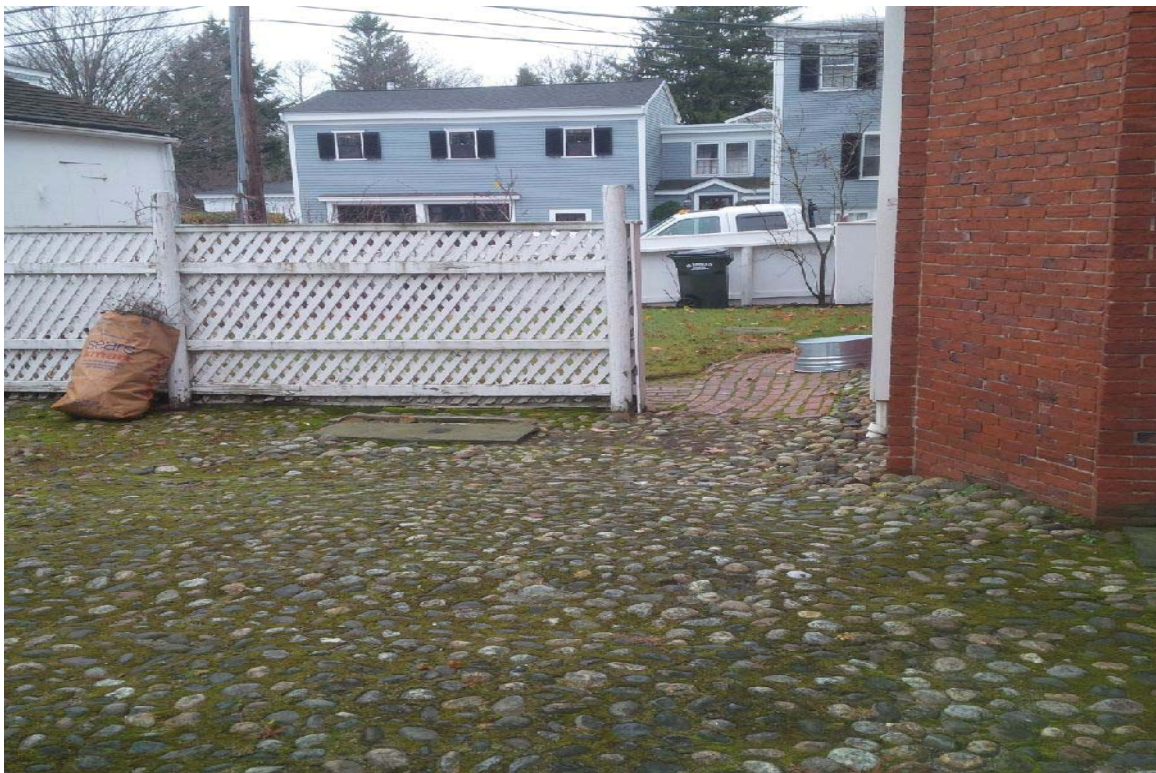
CY14: Southwest view from Courtyard towards Cushing Laundry Yard

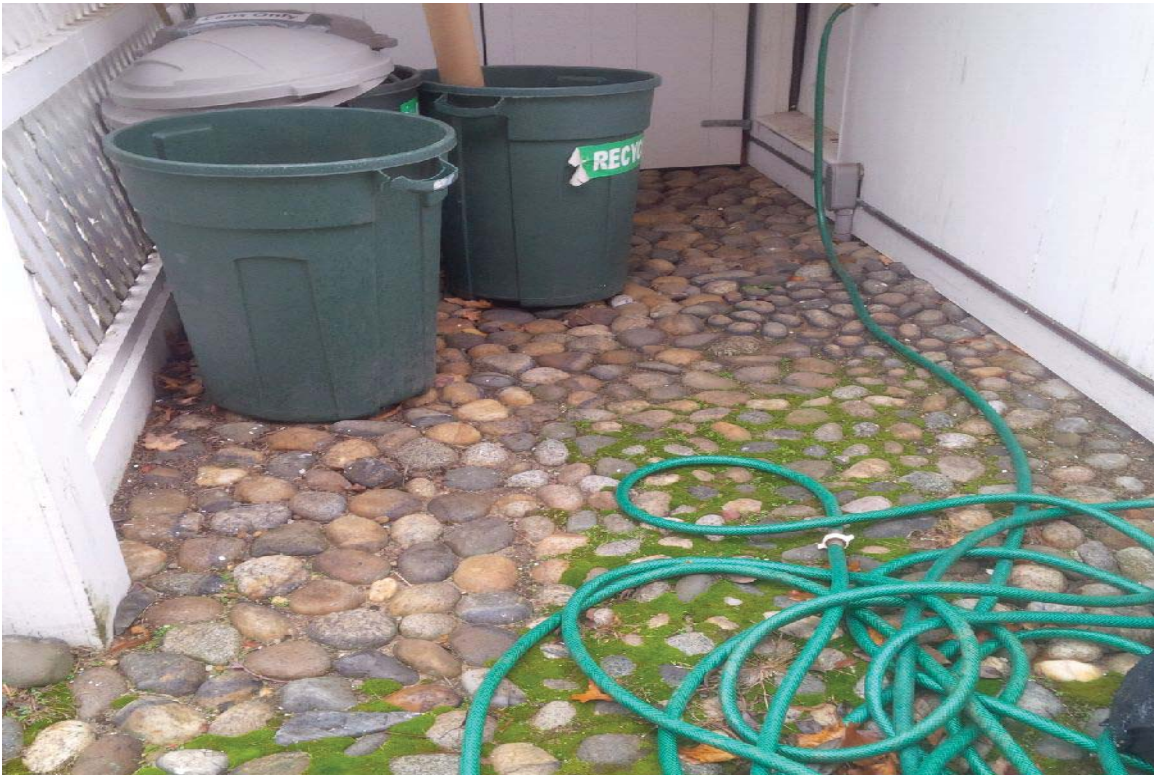
CY15: View of Laundry Shed/Privy overhang area

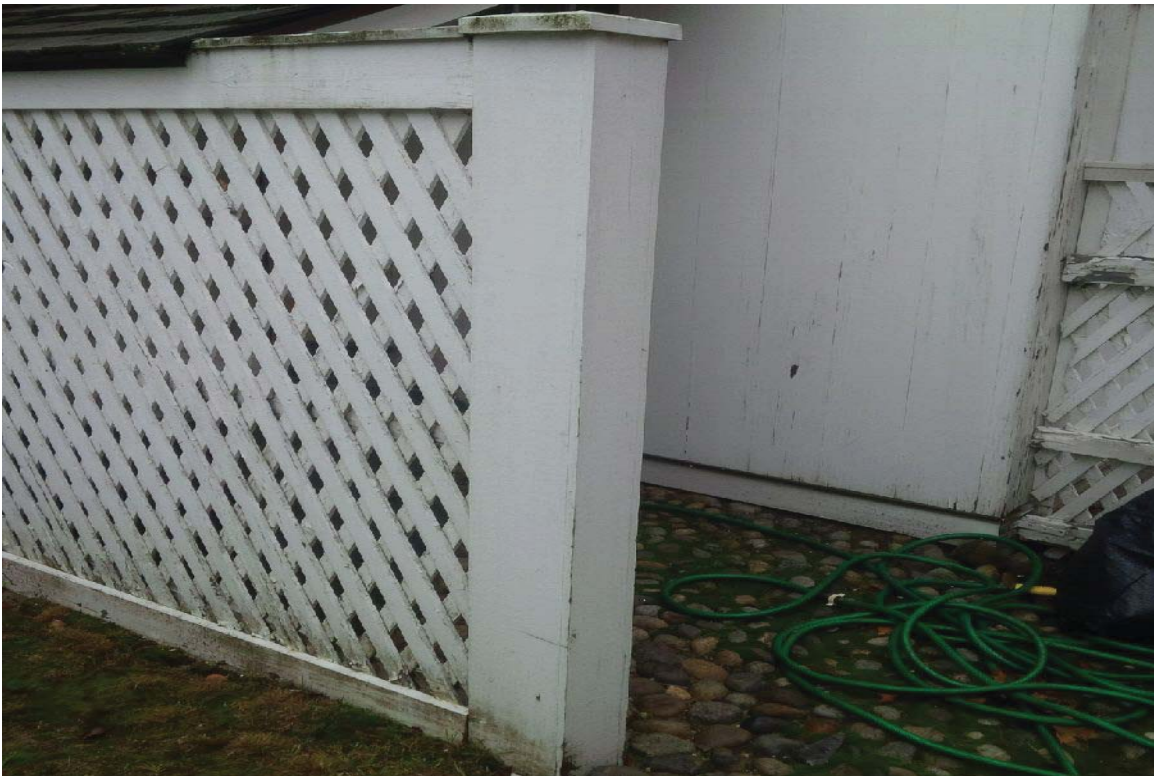
CY16: Close up view of fence enclosing Laundry Shed/Privy overhang area

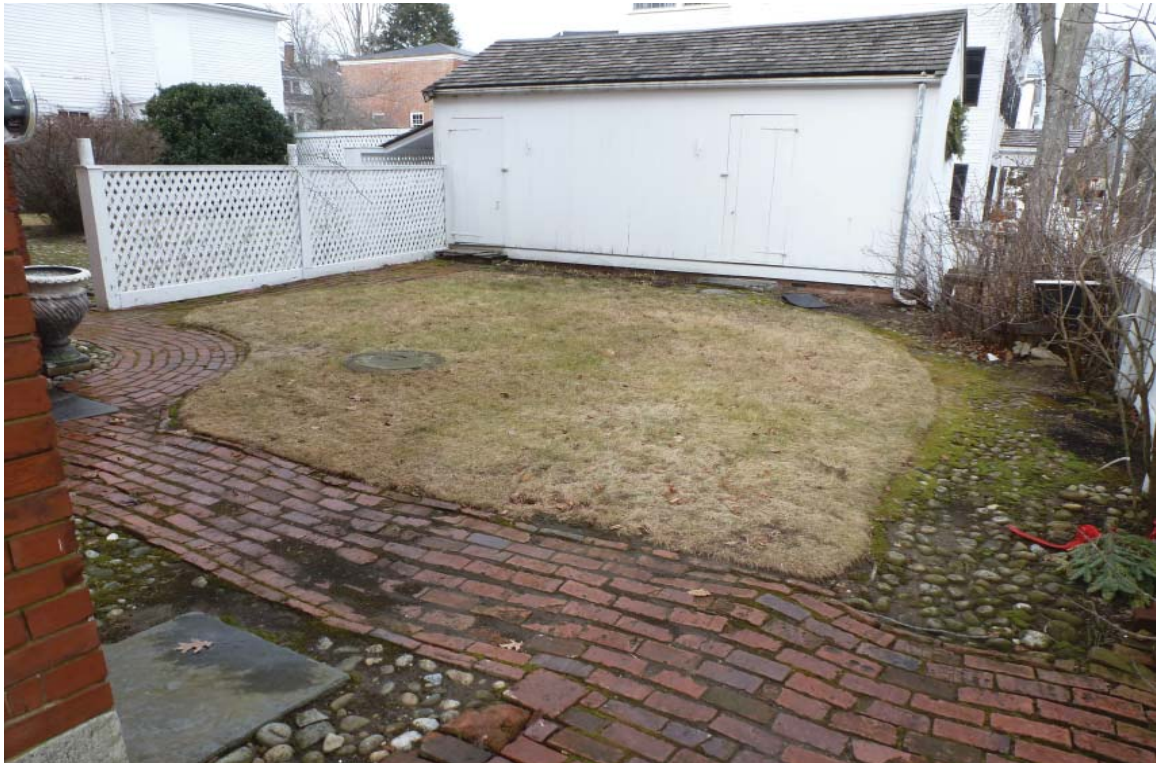
LY1: View of Laundry Yard facing North

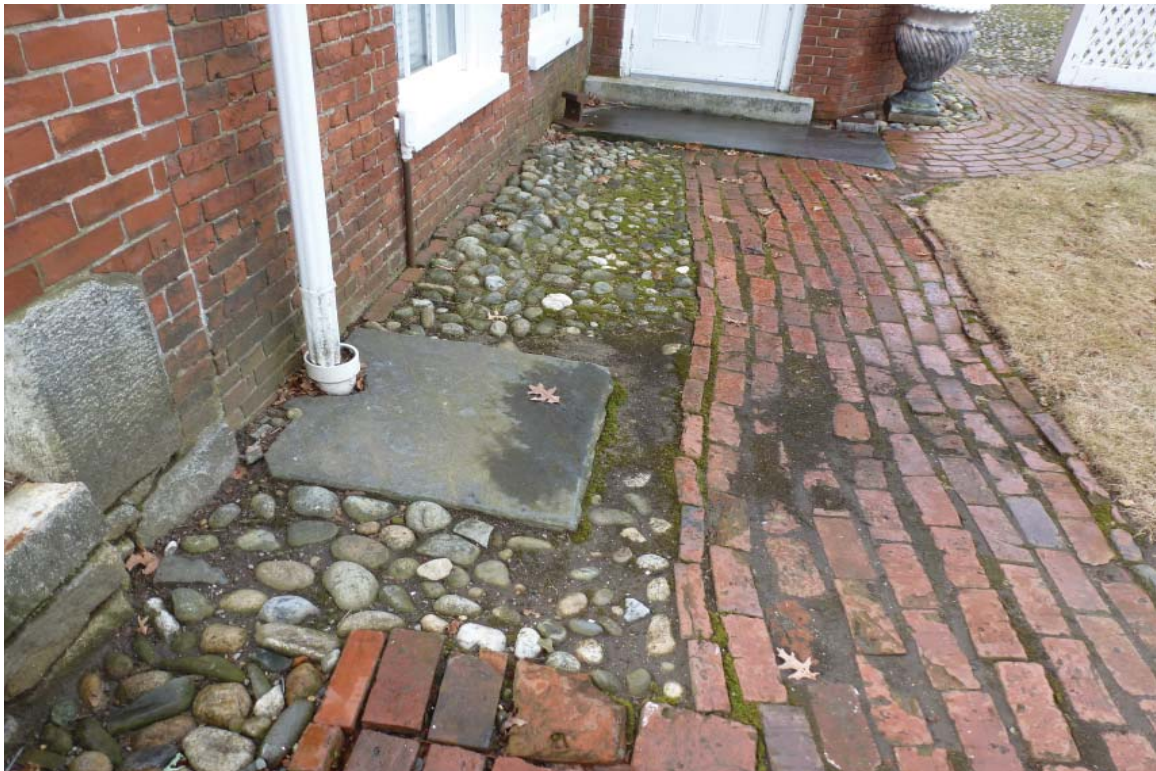
LY2: View of Cushing House Southeast lower level entryway

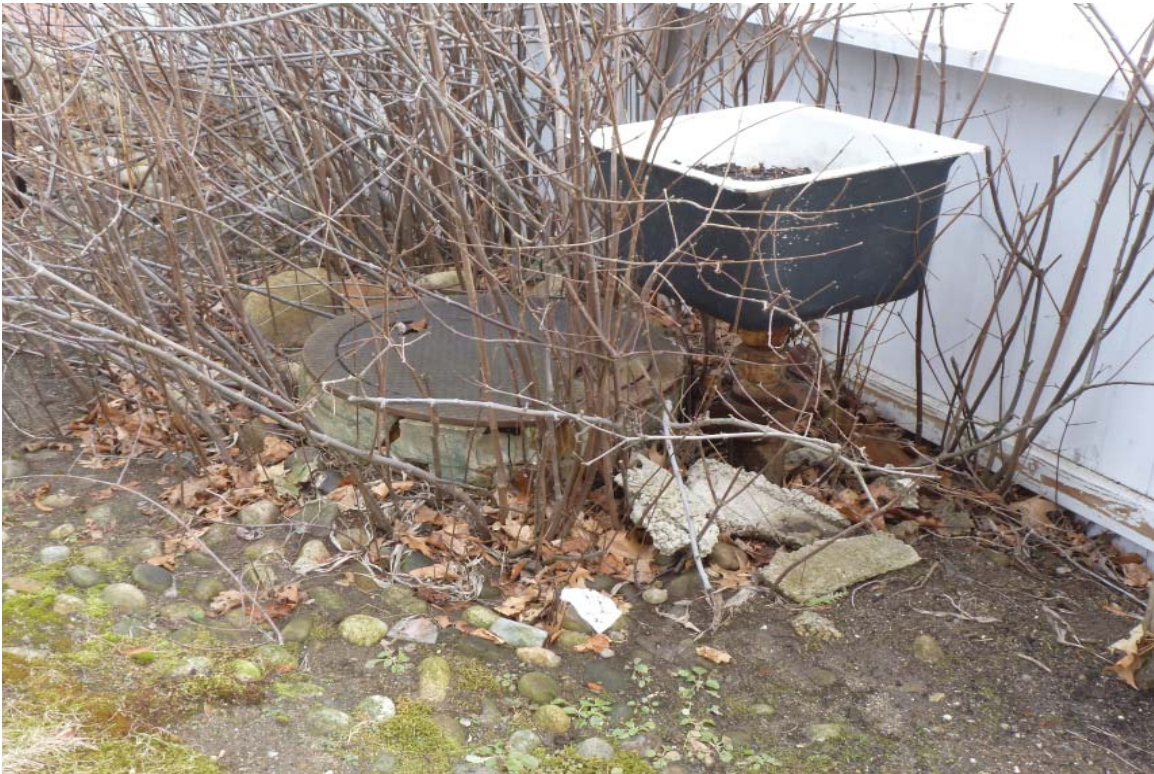
LY5: Laundry tub along east side of Laundry Yard/Privy

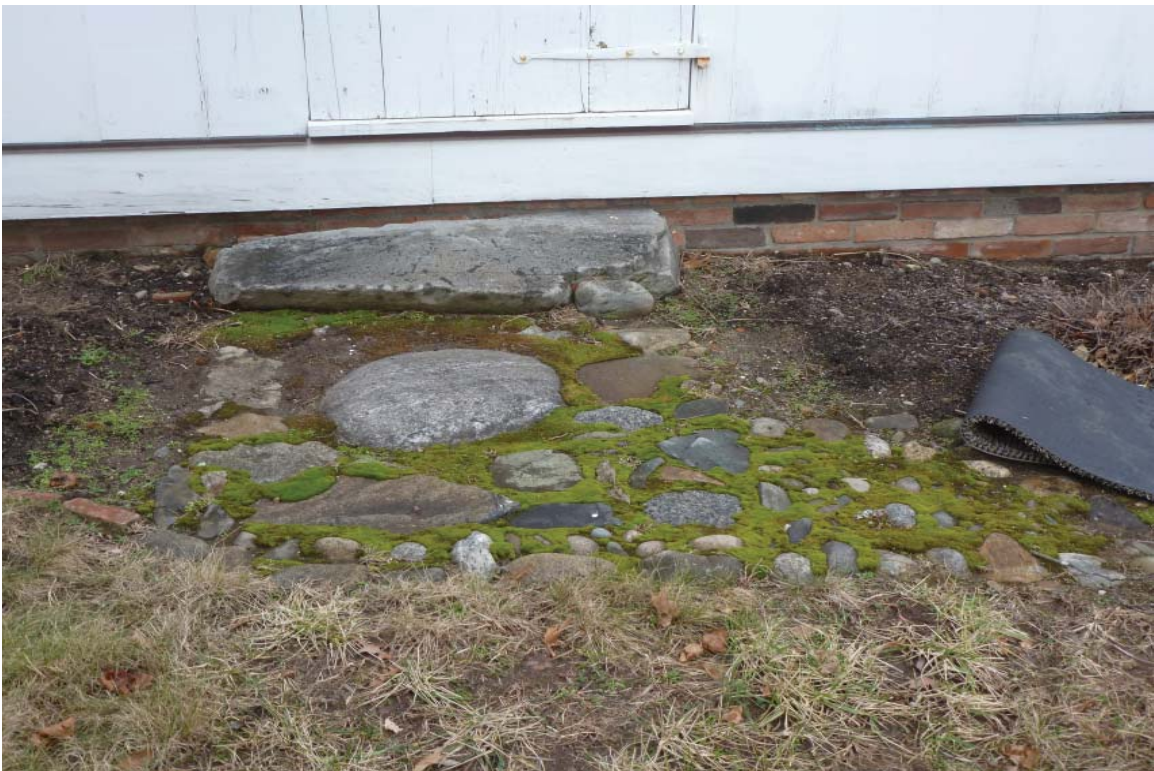
LY6: Southeastern Laundry Shed/Privy threshold

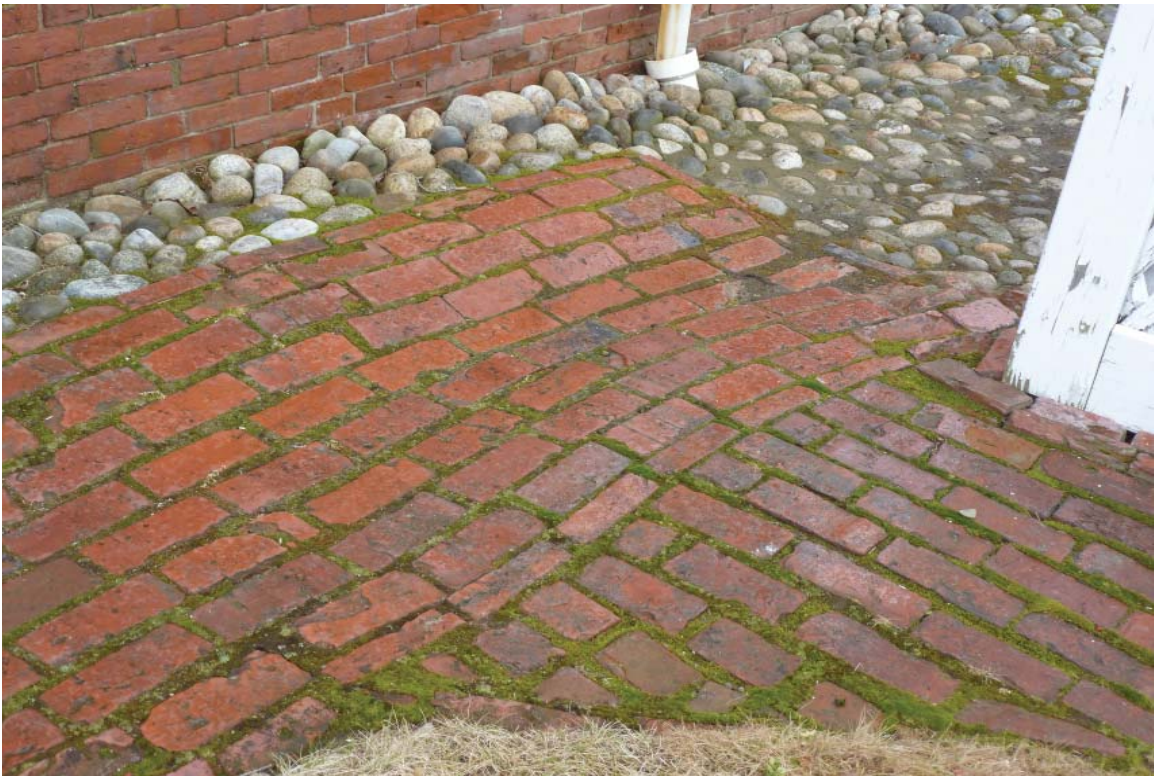
LY9: Detail of brick walkway leading from Courtyard toward Laundry Yard

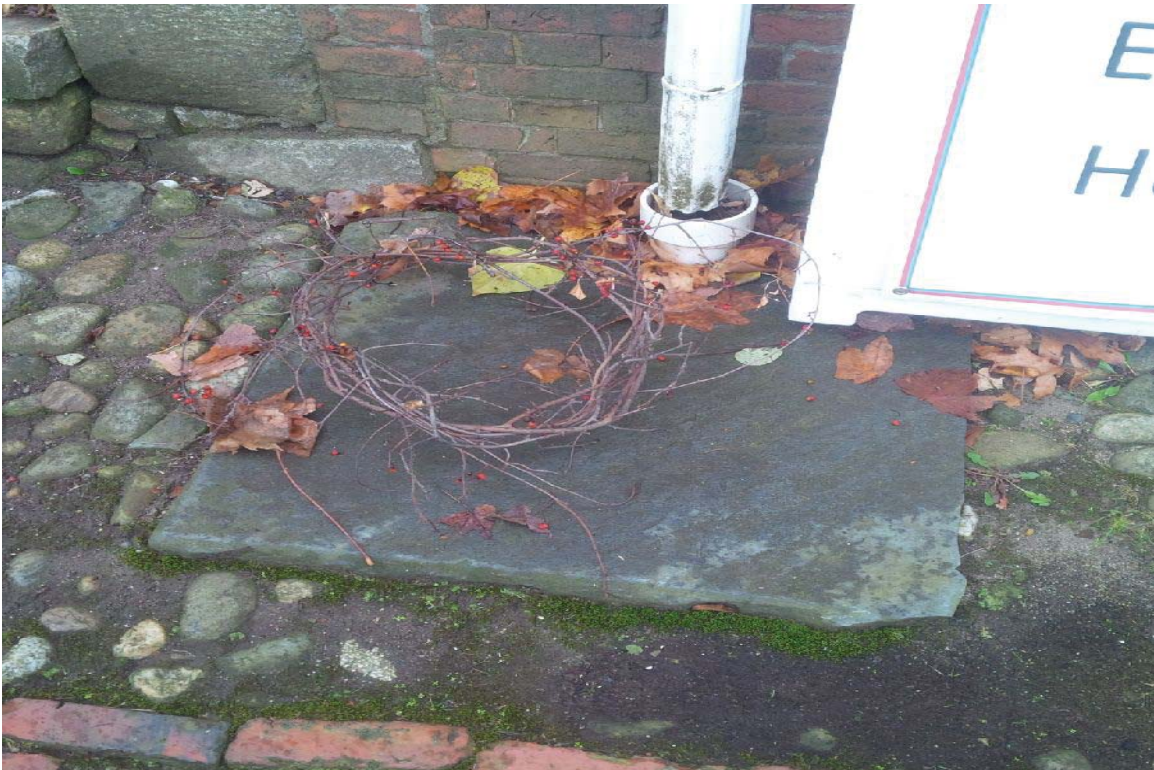
LY12: Detail view of downspout at East corner of Cushing House

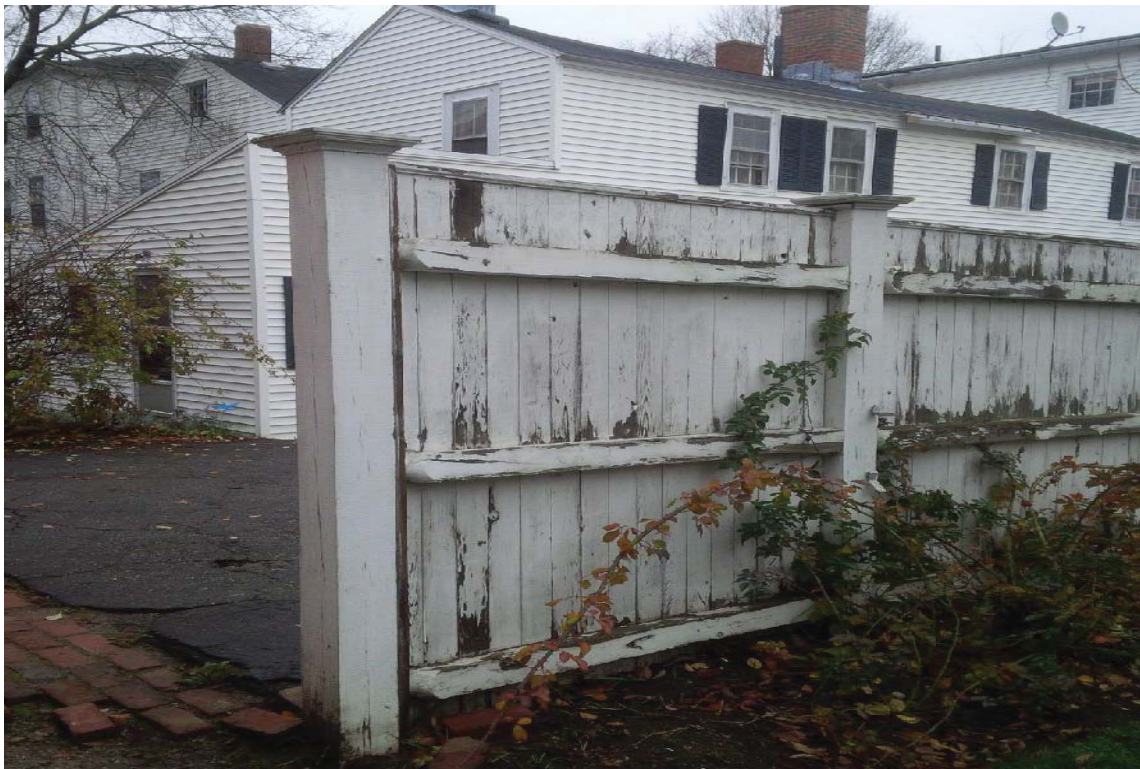
ON12: Detail view of fence between Orchard area and drive property map 14 lot 2

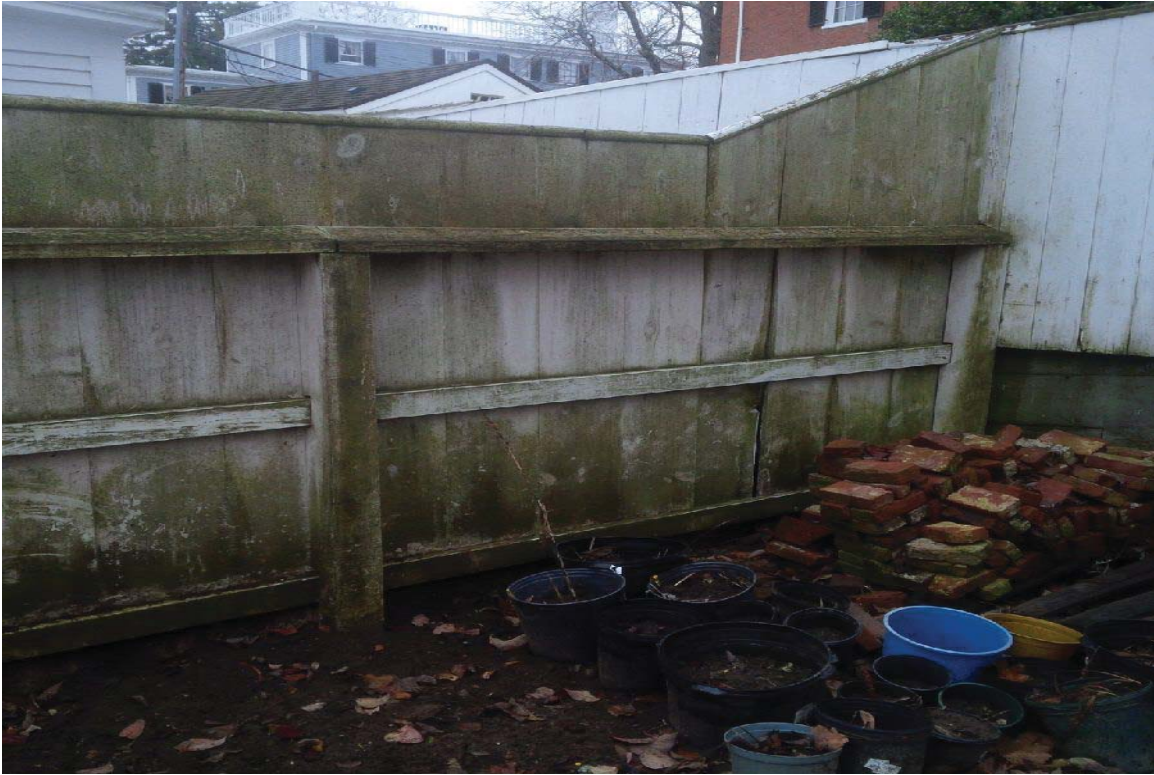
ON13: Detail of fence at Northeastern corner of Barn structure

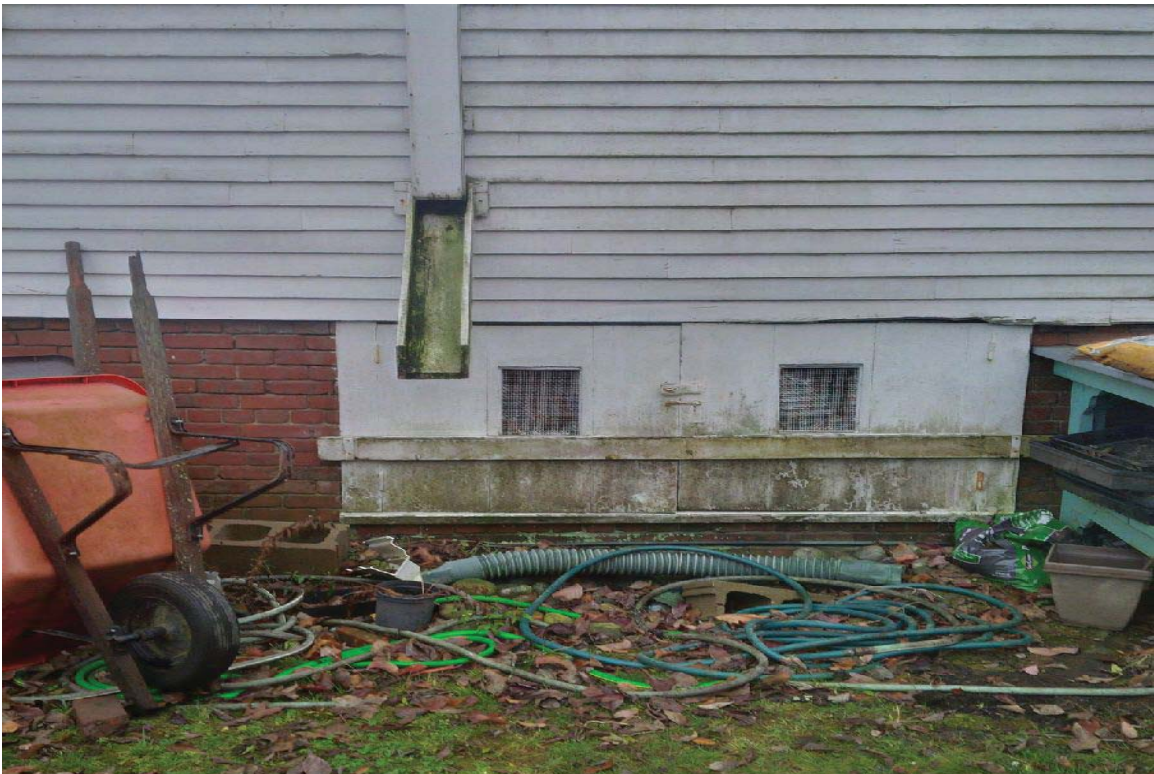
ON14: Northeastern side of Barn structure; view of gutter and hardware materials

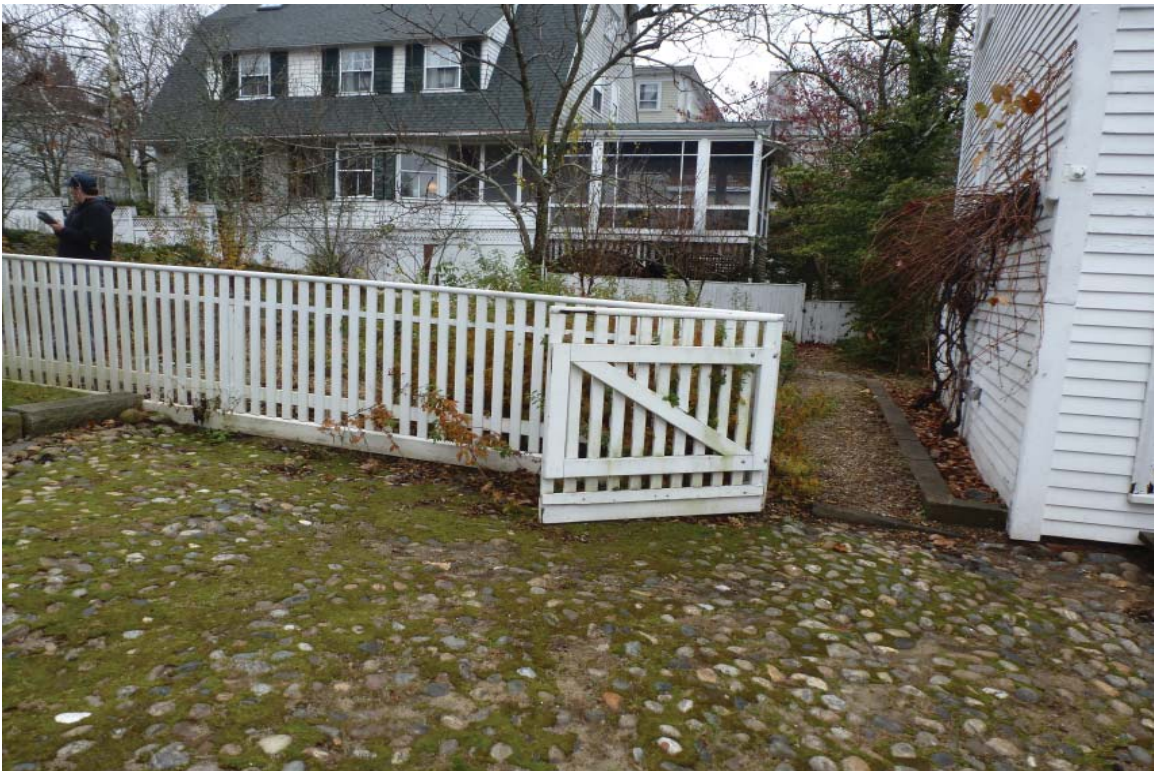
SY2: View of fence separating Cushing Sideyard and Gardens

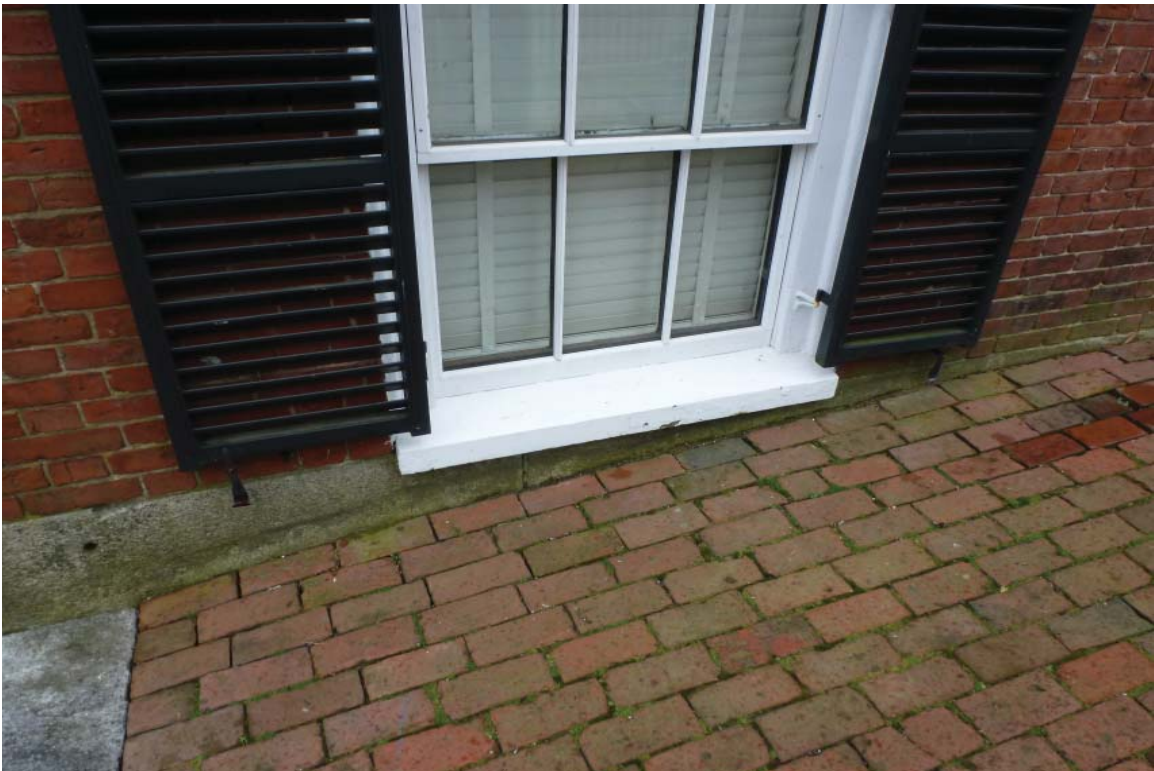
SY6: Detail of windowsill along side yard

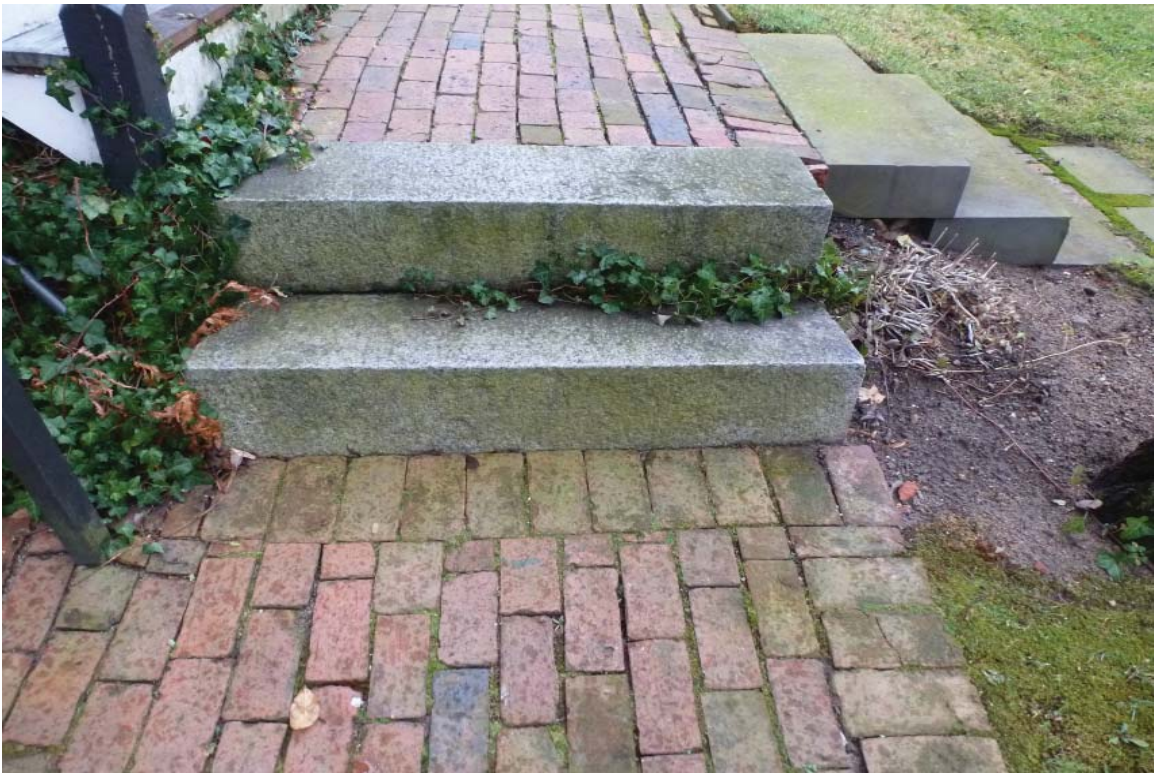
SY8: Detail of stairs leading to Cushing House sideyard threshold

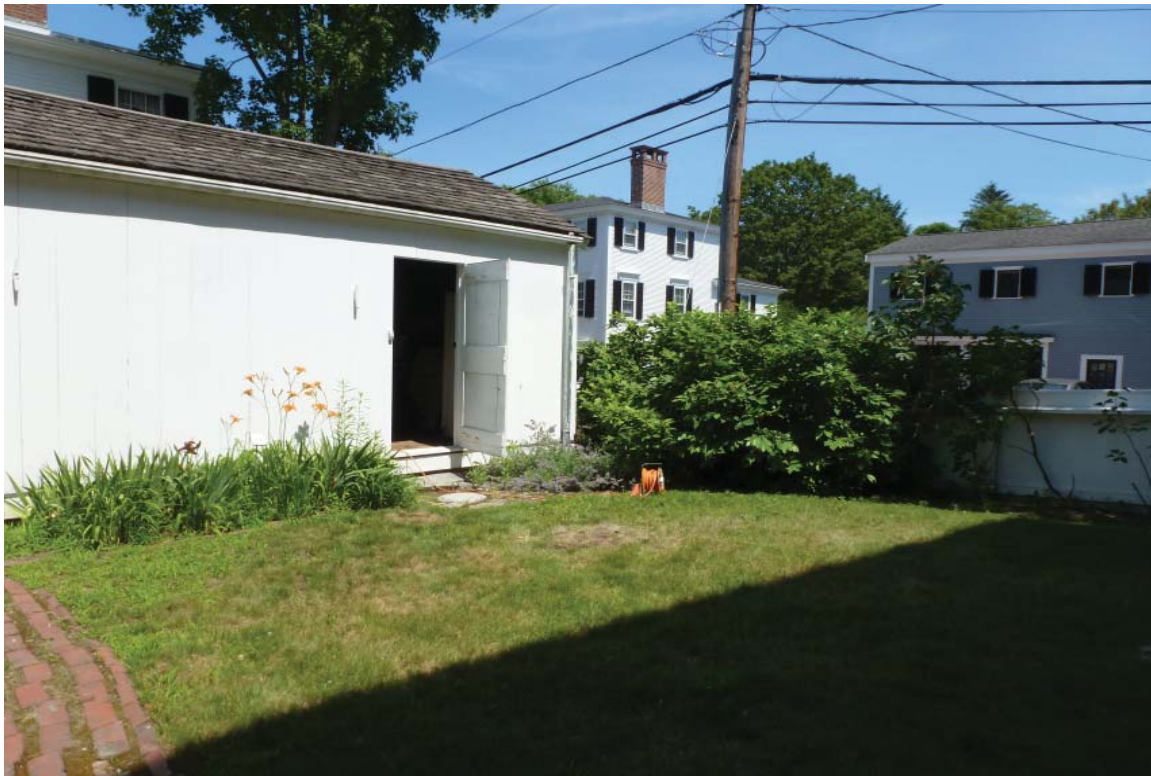
- Laundry Yard
 - Common Lilac (*Syringa vulgare*) - poor condition, suffering from mildew, not historic plants. Shown on 1936 HABS drawings. recommend replanting with mildew resistant variety used in gardens between 1920 and 1950.

Laundry Yard looking towards Privy; From L to R Perennials, Mock Orange and Lilacs.

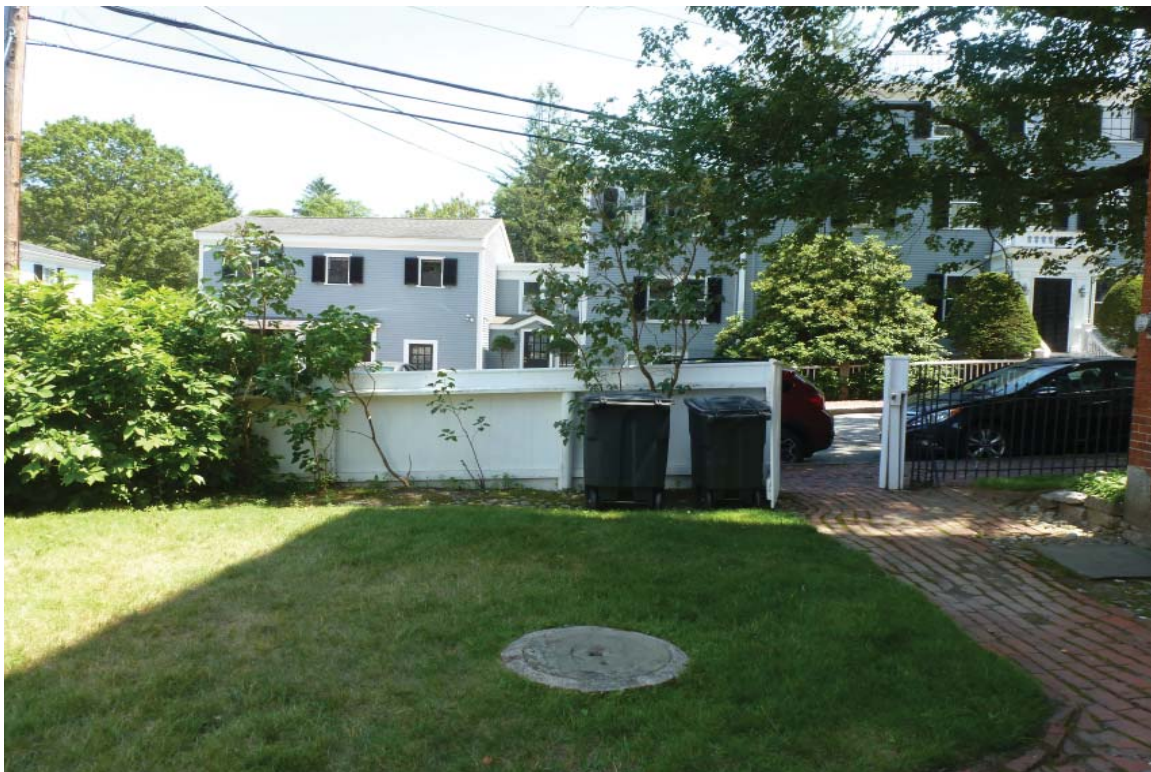
Laundry Yard looking towards Fruit Street. From L to R Mock Orange and Lilac

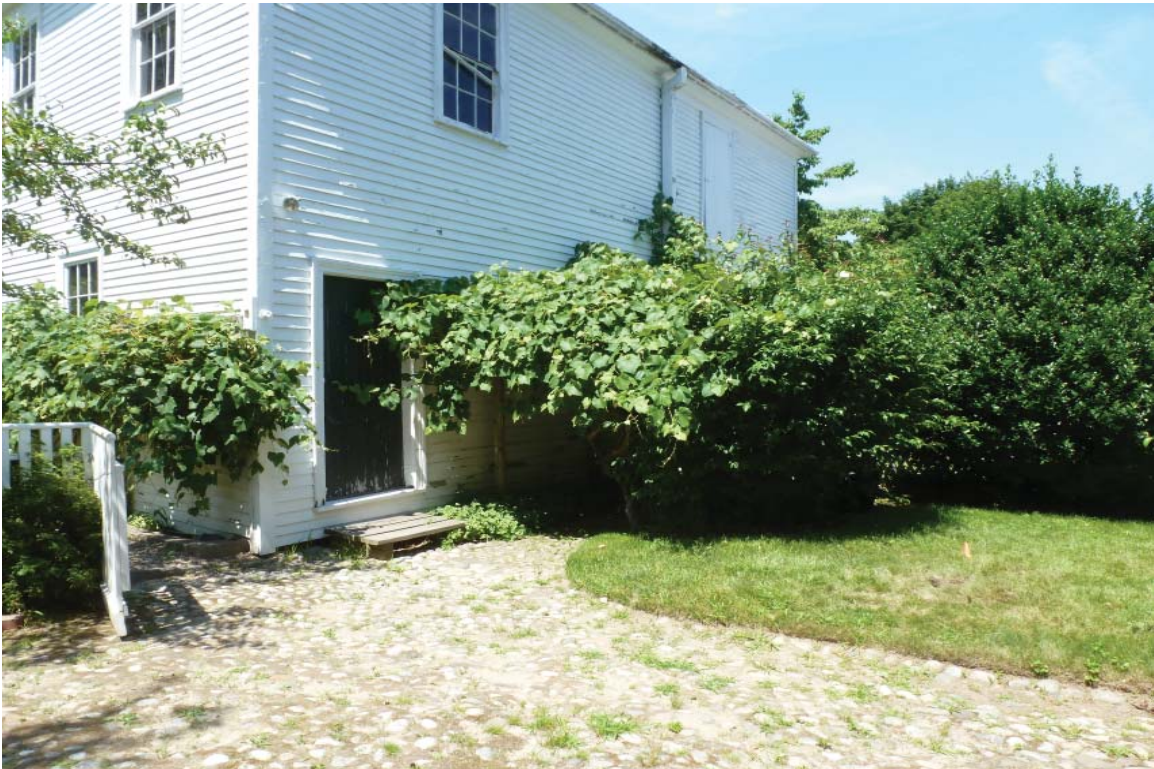
Courtyard looking towards Carriage Barn: From L to R - grapevines, quince, holly
