**A Landscape Preservation Plan
for the Laundry Yard and Courtyard
at the**

Caleb Cushing House

Newburyport, Massachusetts

November 2017

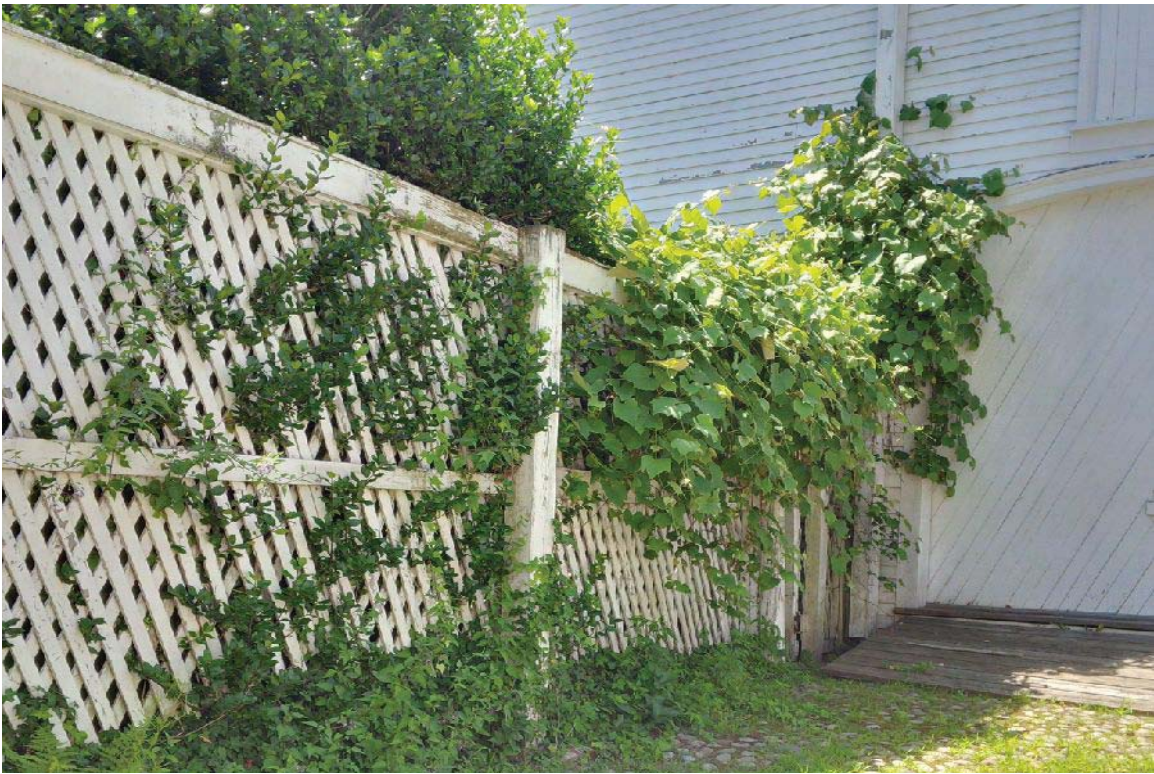
Alley looking towards Carriage Barn: Shows grapevine and holly shrub over lattice fence

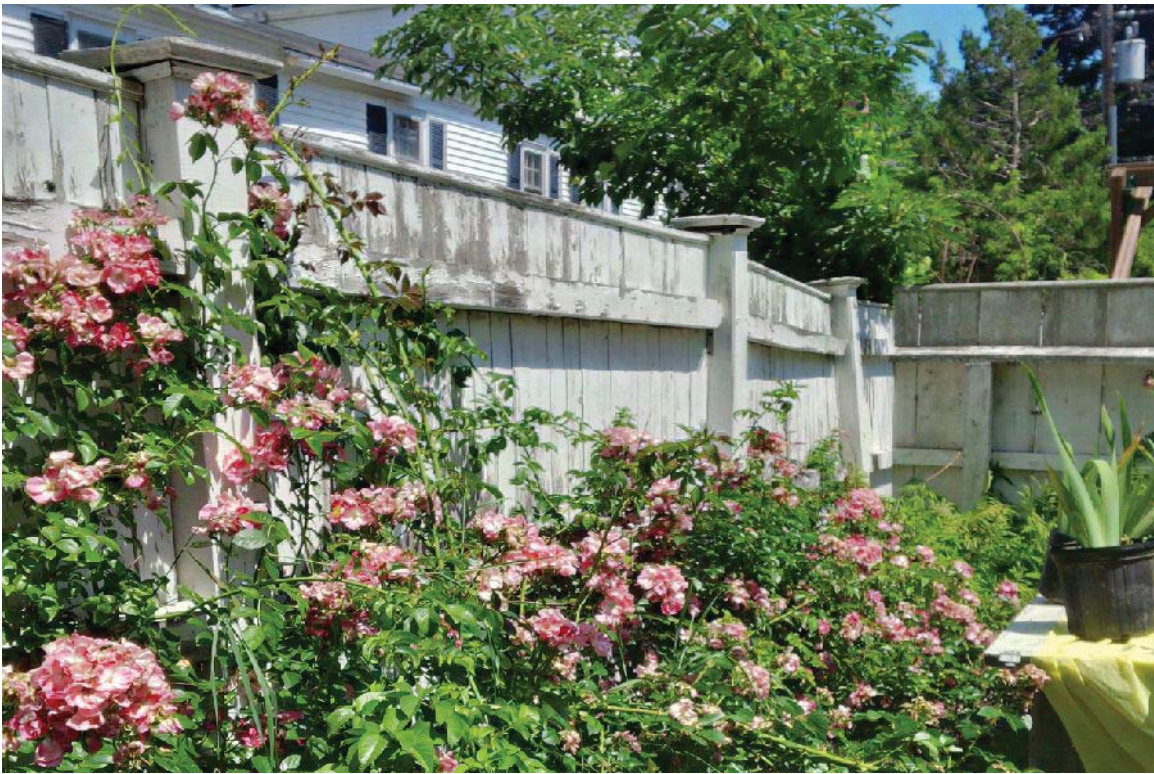
Nursery-Orchard Area: Roses along fence on south side of lawn near Perkins Mint.
