Brown School

42 Milk Street
Phase I ESA

Armory Garage

57 Low Street
Phase II ESA

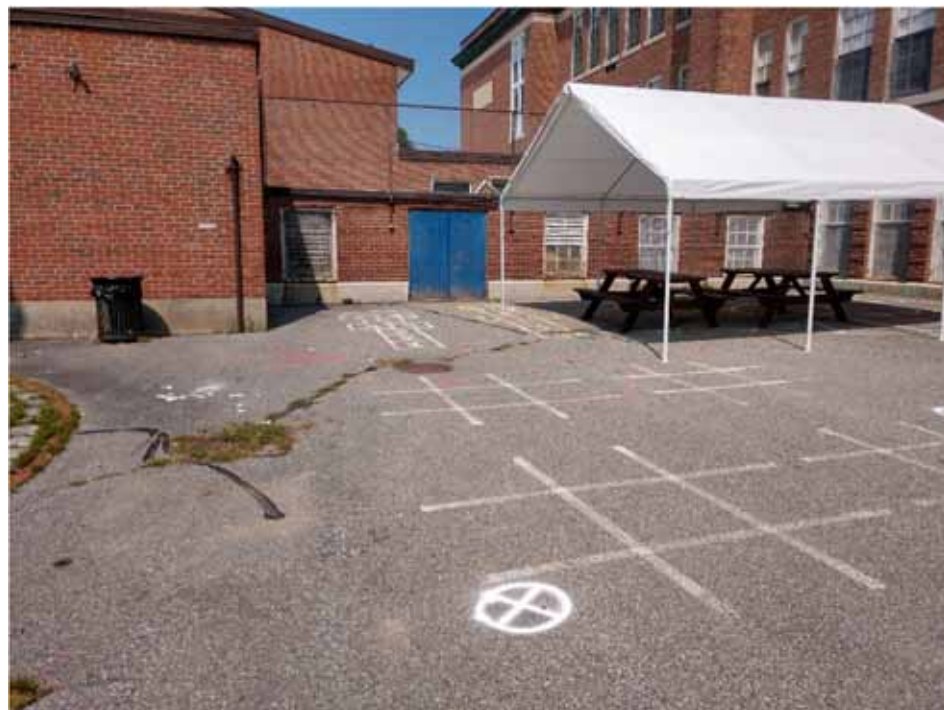
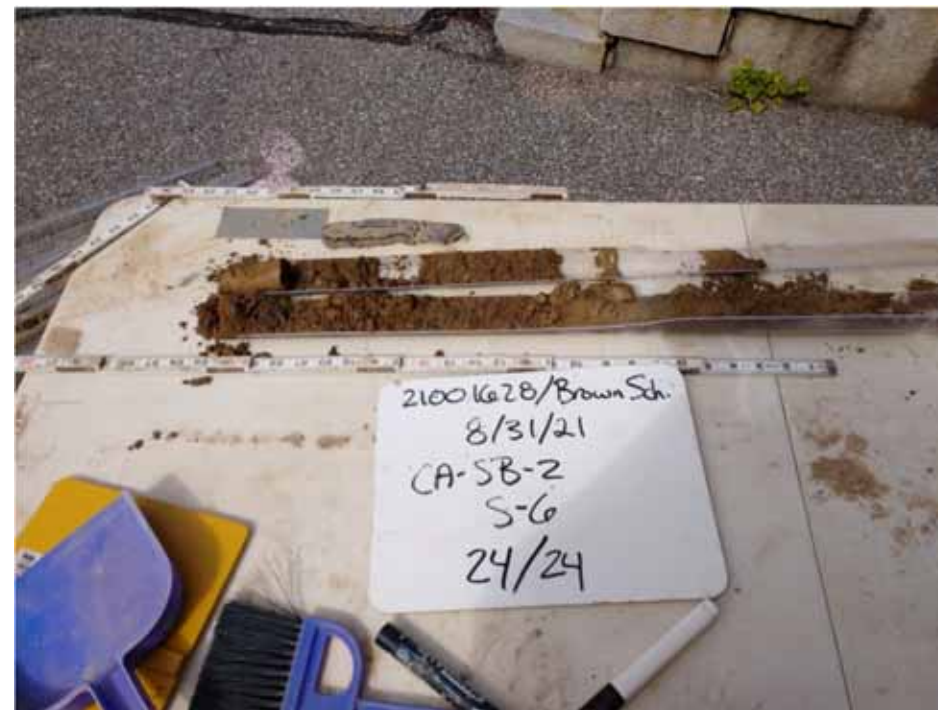
- ▶ **Asbestos:** 12 materials were identified as ACM
 - ▶ Tan caulk
 - ▶ Brown stair tread mastic
 - ▶ Tan 9" floor tile
 - ▶ Gray glazing - 1923 original windows
 - ▶ White caulk - 1923 original windows
 - ▶ Black mastic
 - ▶ Pink sink coat
 - ▶ Light gray caulk - 1923 original windows
 - ▶ Light gray caulk - 1923 original windows
 - ▶ White caulk - gymnasium addition doors
 - ▶ White caulk - gymnasium addition windows
 - ▶ Light gray glazing compound, gymnasium addition
 - ▶ Orange linoleum
 - ▶ Layered paper insulation [ACWM (<1%)]

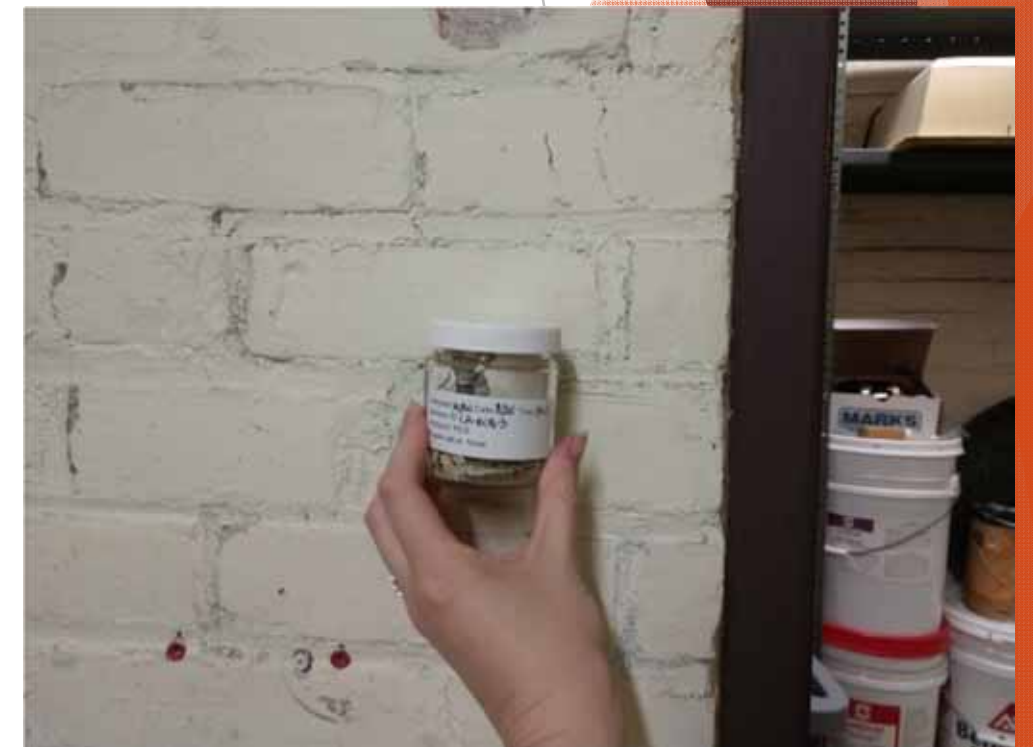
- ▶ One material was identified with PCBs detected above 50 mg/kg and is thus considered to be TSCA Bulk Product Waste
 - ▶ Paint, light yellow (Maintenance Office walls)
- ▶ Six materials were identified with PCBs detected above 1 mg/kg but below 50 mg/kg
 - ▶ Paint, gray over light blue (boiler room)
 - ▶ Paint, gray (boiler room)
 - ▶ Caulk, white (1923 original windows)
 - ▶ Caulk, light gray (1923 original windows)
 - ▶ Caulk, gray (1978 addition original building seam)
 - ▶ Paint, green (boiler room)

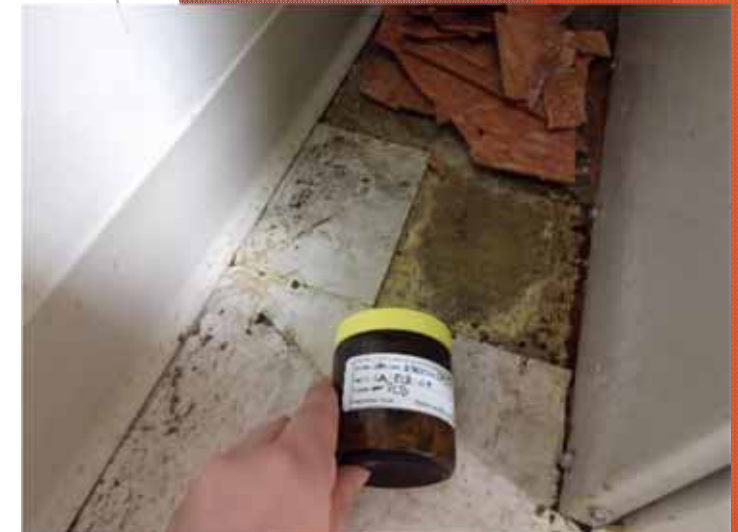
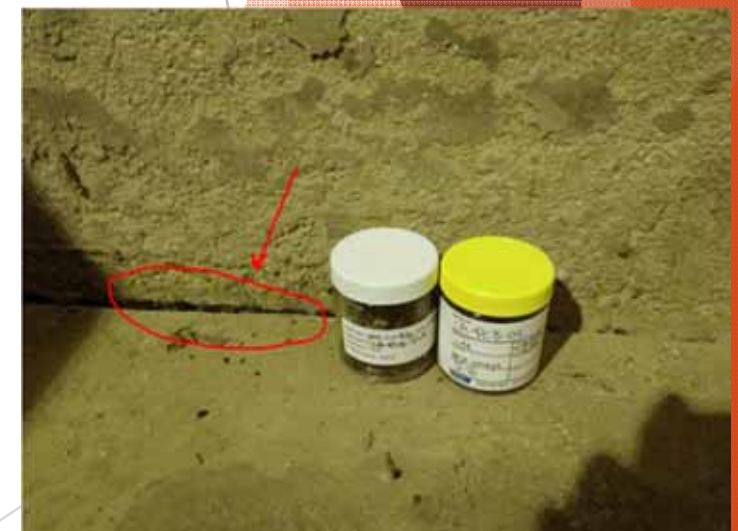
- ▶ **PCBs**: Two materials were identified containing PCBs >1 mg/kg and <50 mg/kg
 - ▶ CA-PCB-2: expansion gasket, black (foundation)
 - ▶ CA-PCB-4: mastic, black (below boiler in boiler room)
- ▶ **Mold**: None of the detected mold spore counts in the air samples exceeded any of the Calculated Reference Standards
- ▶ **Mold**: Pithomyces were identified at a “high” level in the tape lift samples from the Men’s Bathroom

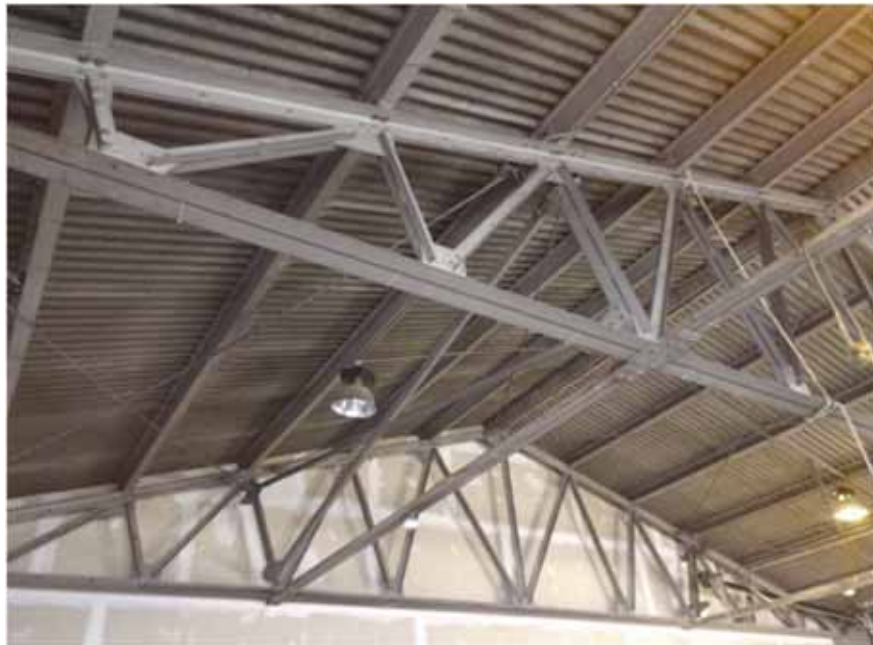
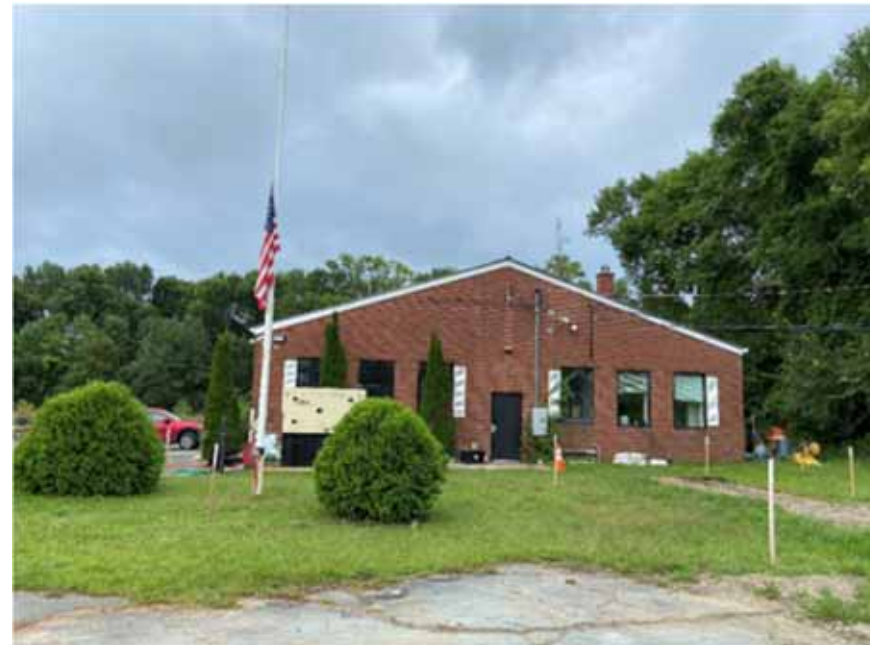
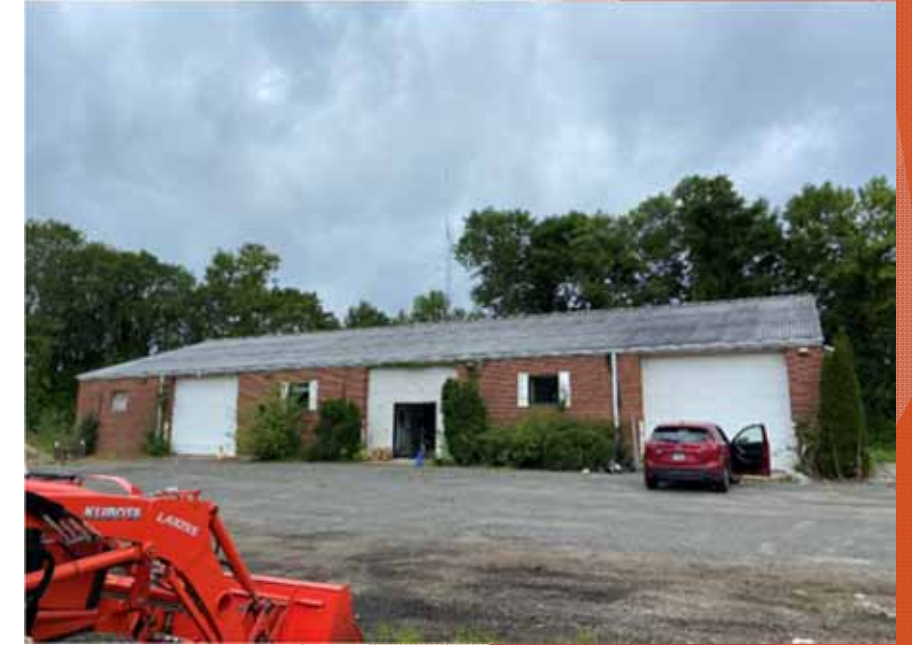
- ▶ **Residual petroleum impacted soil** onsite associated with the former leaking UST (previously cleaned up & regulatorily closed), but it is below applicable Massachusetts soil & groundwater standards
- ▶ **PCB's** are present in 2 of the 4 materials sampled greater than 1 mg/kg but less than 50 mg/kg
- ▶ **Mold** is not present in the building airspace at concentrations exceeding Site-specific calculated reference standards; however, sensitivities vary greatly by individual
- ▶ **Mold** tape lift sample results indicate that mold growth is occurring on the Men's Bathroom wall
