# Armory Garage

57 Low Street  
Env. Due Diligence

# Environmental Due Diligence

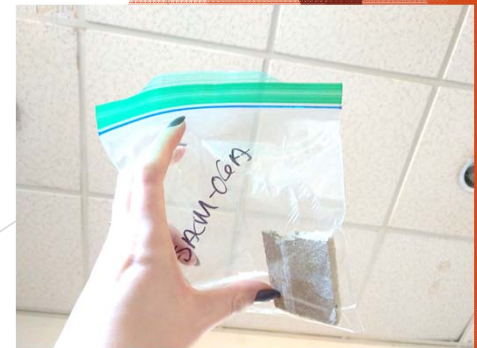
- ▶ Nine (9) potential asbestos-containing materials were identified
  - 19 Asbestos Samples send to Mass-certified lab
- ▶ Numerous painted surfaces were identified that may contain lead
  - Credere directed the screening of 88 surfaces inside & out
- ▶ Potential universal waste was inventoried (fire extinguishers, light ballasts, batteries, etc)
  - Credere inventoried products that would become wastes if removed from use
- ▶ A visual assessment of materials which could contain PCBs was performed
  - Four materials were identified to potentially contain PCBs

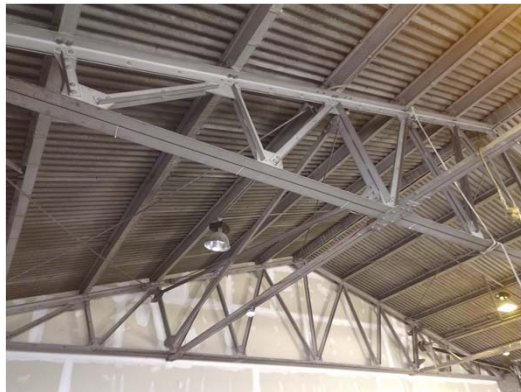
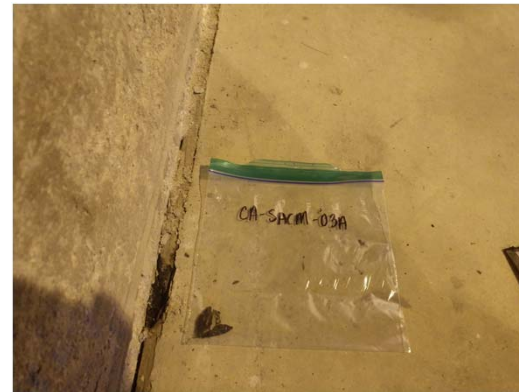
- ▶ Four materials were identified as being a low risk to potentially contain PCBs
  - ❑ Expansion Gasket
  - ❑ Beige baseboard Adhesive throughout Bldg
  - ❑ Mastic under 12" floor tile (under machinery)
  - ❑ Caulk around entrance door
