NEWBURYPORT YOUTH SERVICES

FACILITY ASSESSMENT & PLANNING STUDY

EXISTING CONDITIONS REPORT, DESIGN CONCEPTS + COST ANALYSIS

NOVEMBER 2020

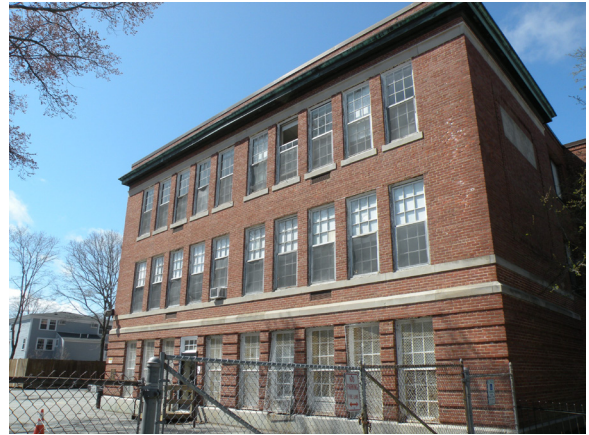
Large quantity of historic windows

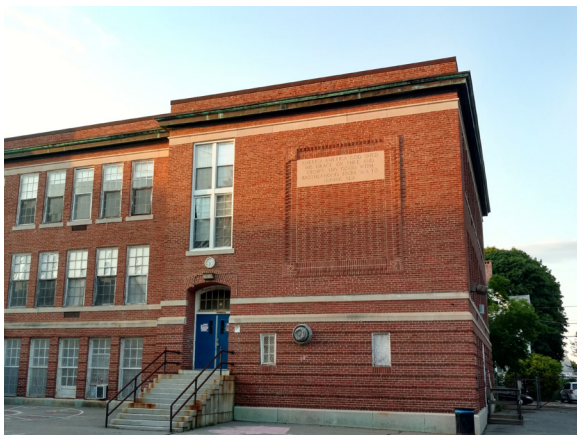
Accessibility issues exiting egress stairwell

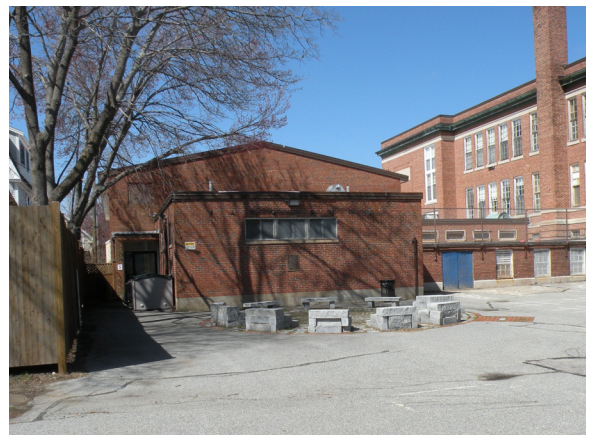
Majority of outdoor space is hardscaped

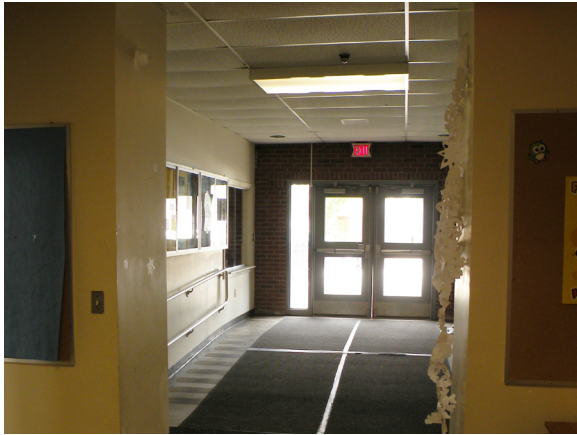
The main entrance to the NYS space is located at the east end of the main school building. The double doors show varying degrees of upkeep vs. wear and tear. Although it is a rather dark space, the adjacency to the NYS offices and Pre-school room allow for good visibility through a large check-in window. A ramp leading down to the main floor elevation is fit with a handrail / grab bar for improved accessibility.

Main NYS entrance

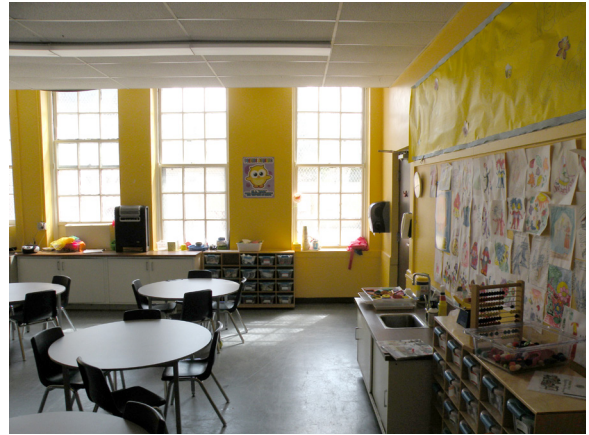
The multi-purpose and pre-school rooms are located off of the main entrance and account for some of the largest existing NYS program spaces. Positioned on the exterior of the building they have access to abundant natural light. The windows however will need significant repairs if they are required to adhere to historic guidelines, or possibly replace them with more efficient units. The flooring and ceilings will require replacement as well as the lighting, which can be upgraded to significantly enhance the usability of these spaces. Systems elements such as the sink and enclosed radiators can be updated with more efficient units to save space and increase functionality.

Large windows provide natural light

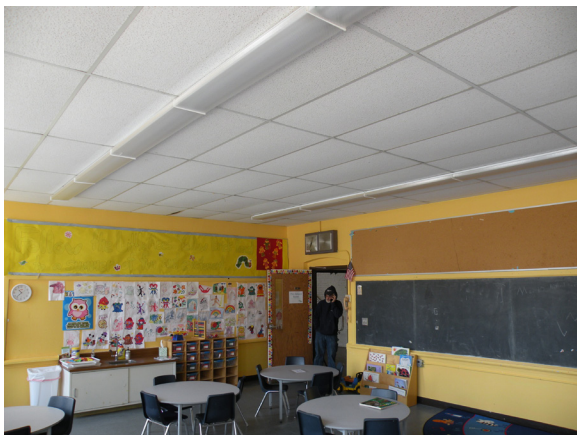
More / better storage options are needed

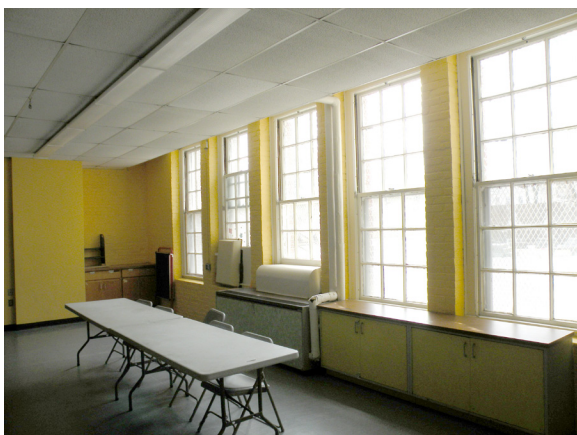
ACT ceilings do not align with windows

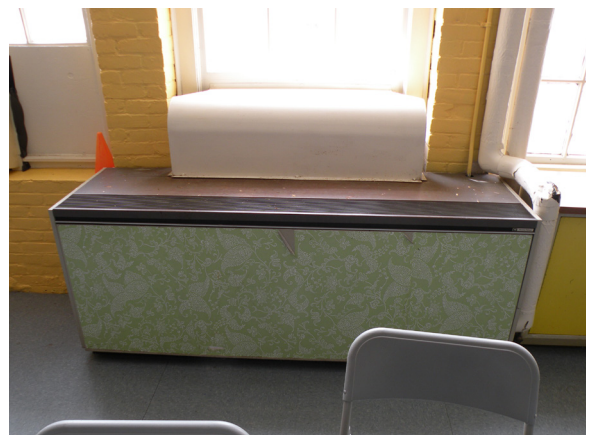
Systems upgrades are required

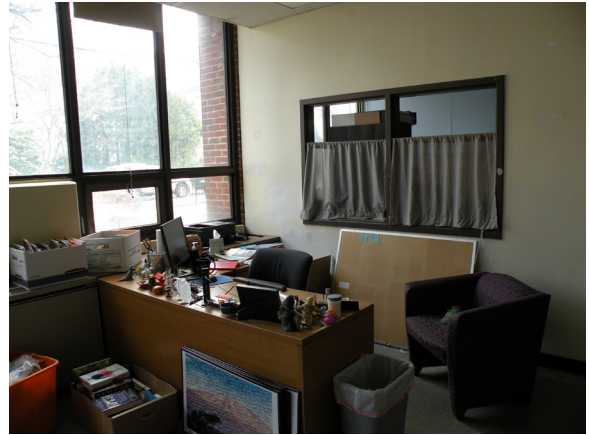
Storage / organization upgrades needed

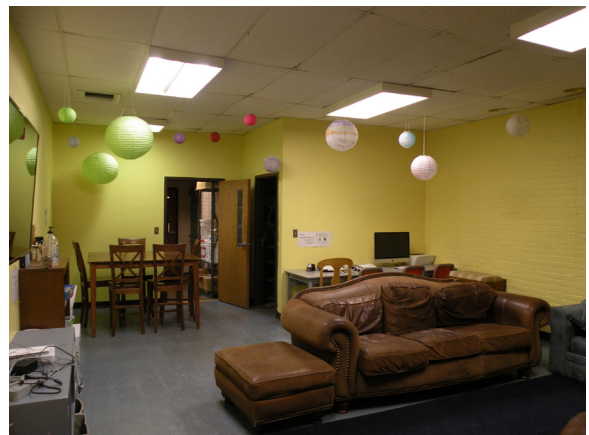
Room relies only on artificial light

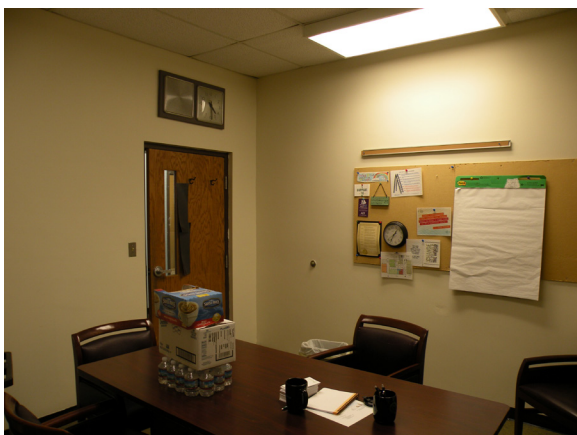
Small conference space limits use

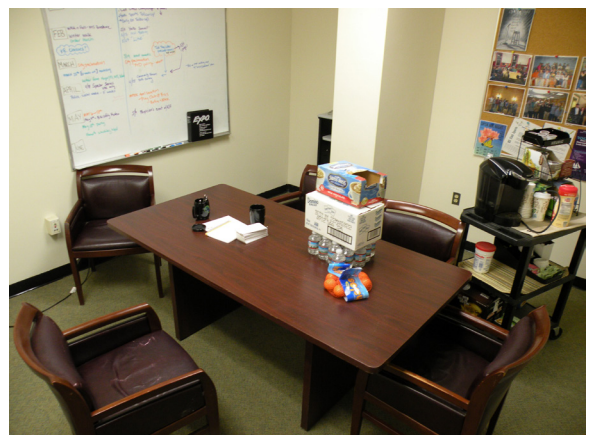
Small conference space limits use

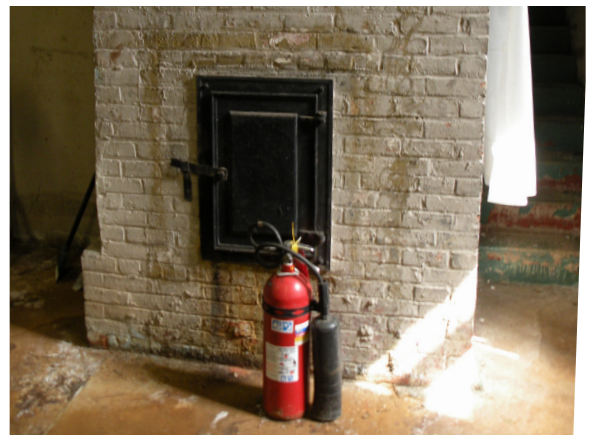
The boiler and mechanical rooms are primarily located on a lower level toward the back of the ground floor layout. The large boiler room house aging equipment which will require thorough investigation to determine what, if anything, can be salvaged and reused, and what should be removed. Please refer to the mechanical systems existing conditions report by **Garcia, Galuska, Desousa** included later in the report for further analysis.

Original furnace

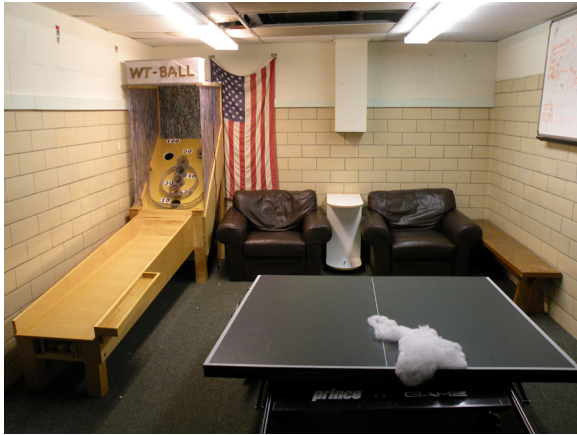
Game room buried in other program

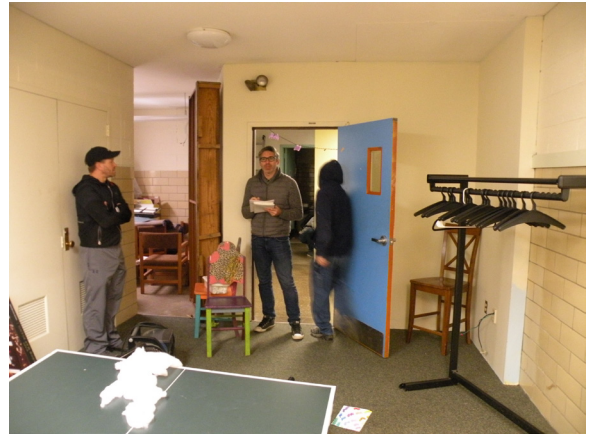
Irregular connections to adjacent rooms

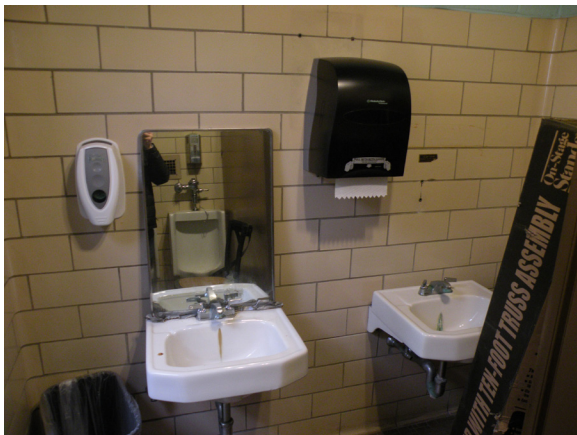
Unused restroom

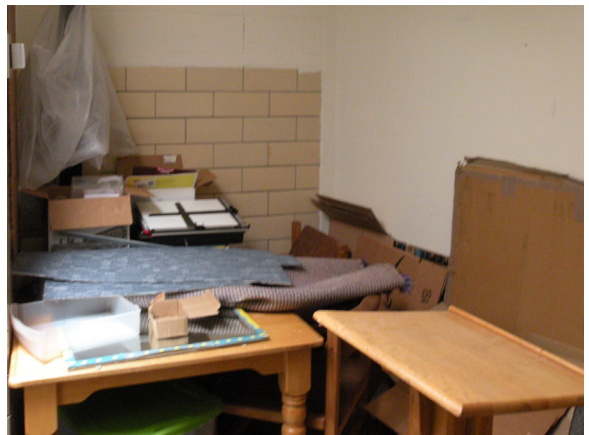
Storage room inefficiently used

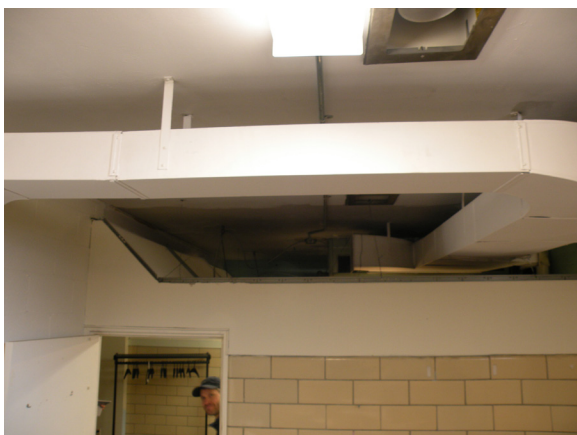
Low ceilings and exposed duct work

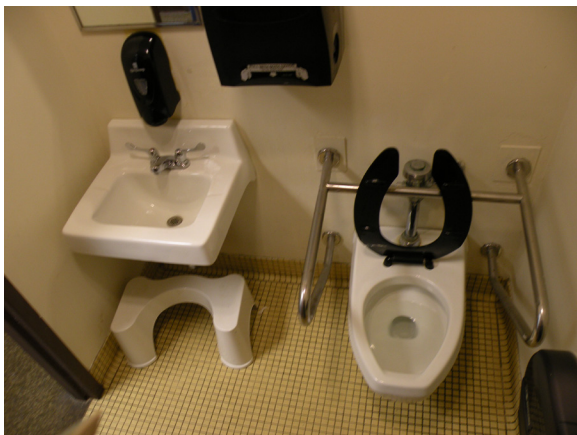
Small single restroom

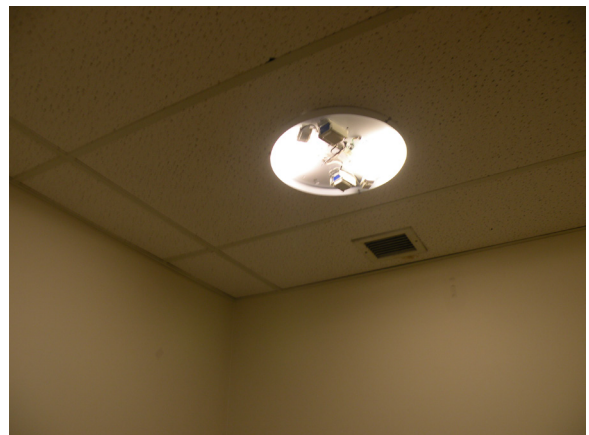
Lighting needs upgrading

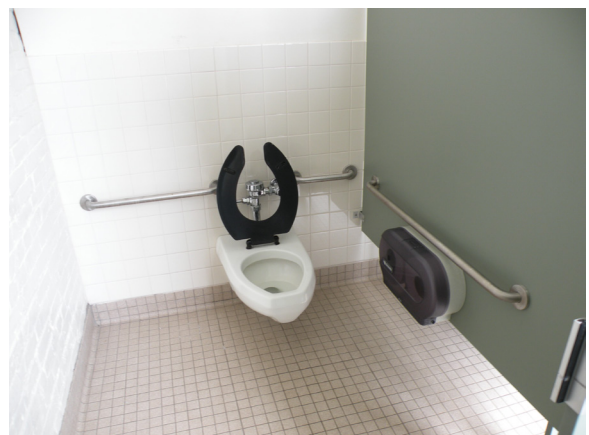
Handicap stall in pre-school restroom

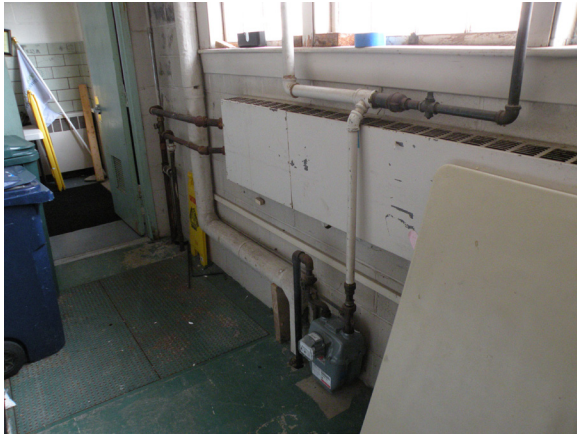
Storage / garbage room next to entrance

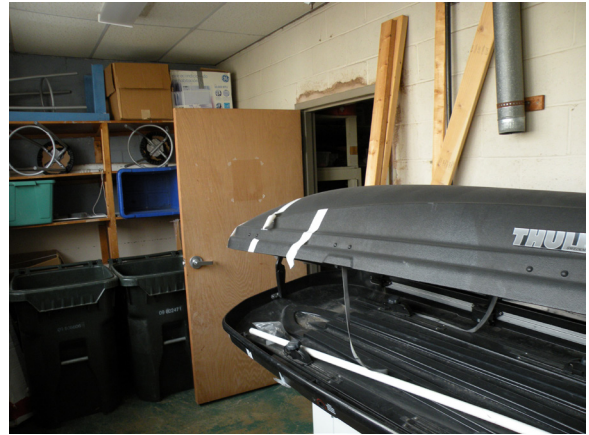
Storage / garbage room next to entrance

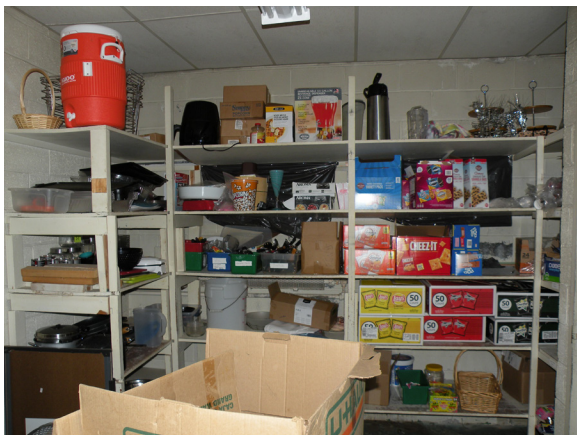
Food storage adjacent to kitchen

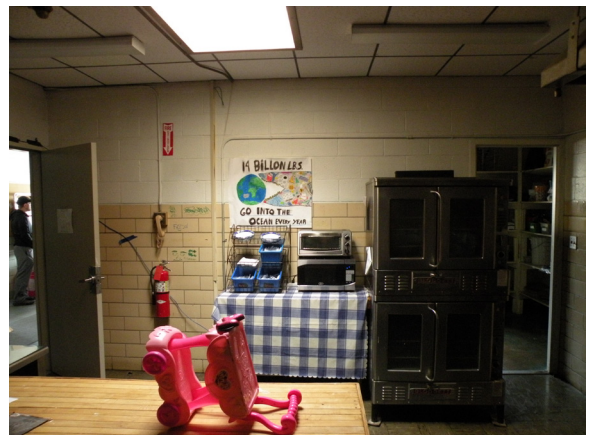
Skylight located in center of room

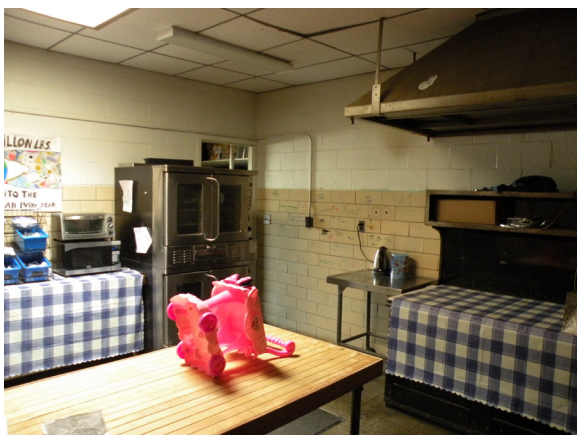
Existing oven and range in kitchen

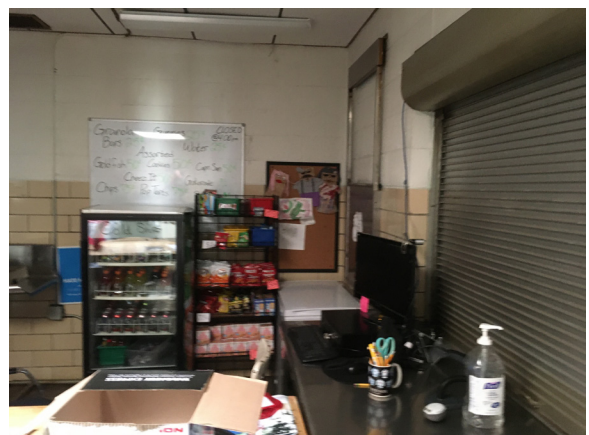
Roll up sales window

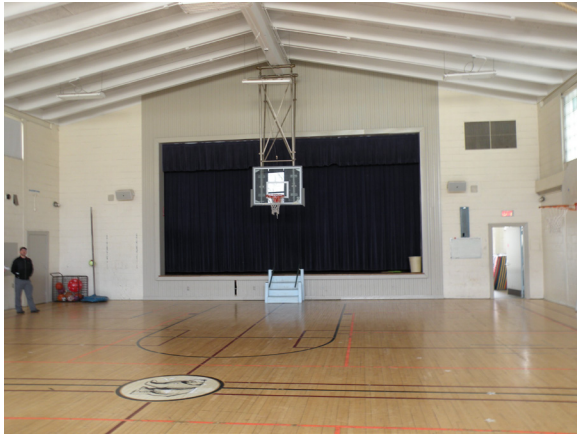
Gym and stage share the same space

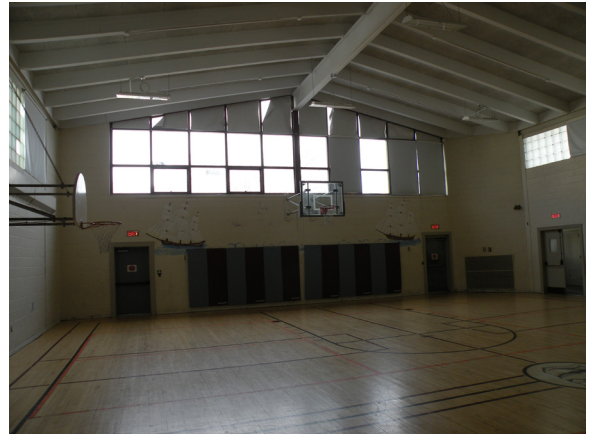
The gymnasium and stage area are important program elements for the NYS. The gymnasium building is an addition to the original structure and requires some renovation to be useful in the long term. It is a large volume of space which upon initial inspection doesn't appear to be insulated and its large expanses of glazing would require an upgrade to limit heating and cooling costs in the future.

Windows provide little natural light

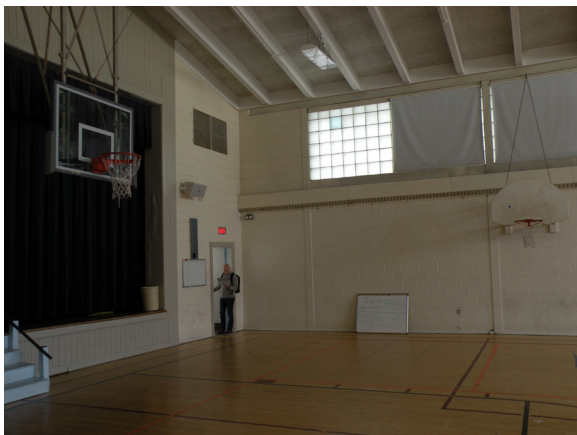
There is no space for a crowd of fans

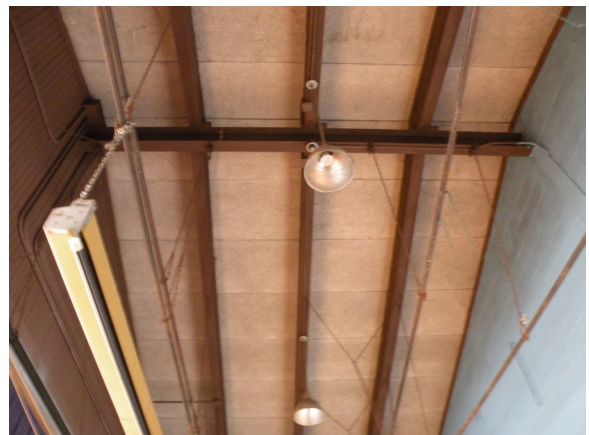
Roof structure at stage

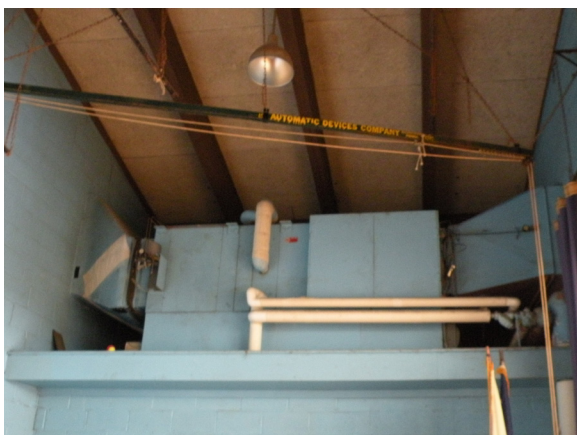
Large HVAC equipment above stage

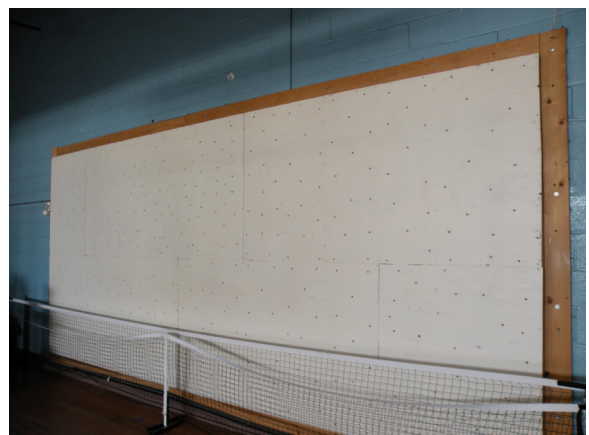
Back of stage

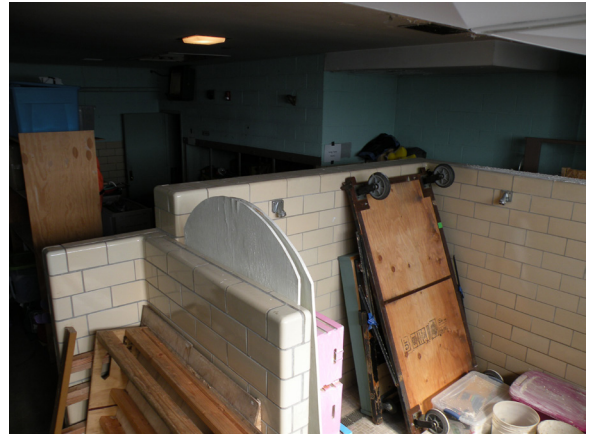
Existing showers

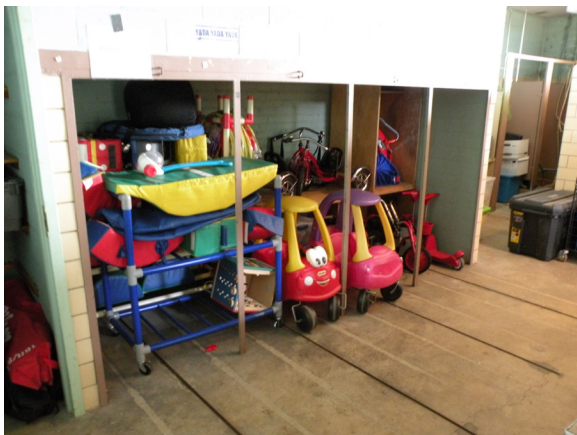
Toys stored where they fit

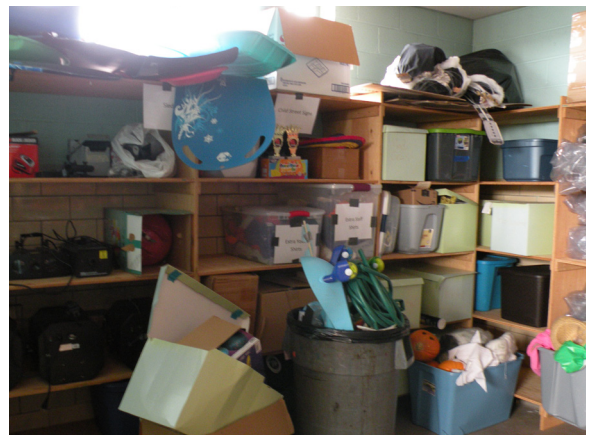
Shelving added to accommodate items

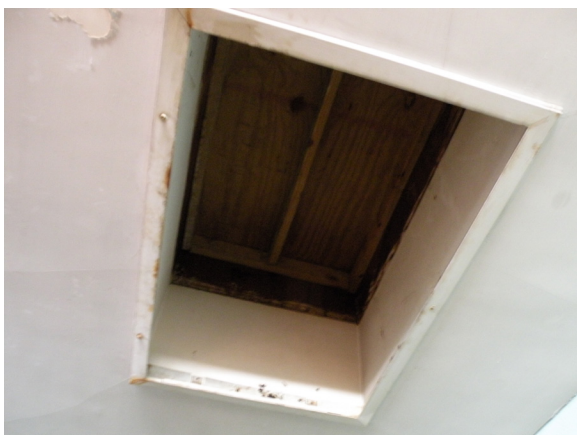
Ceiling access panel

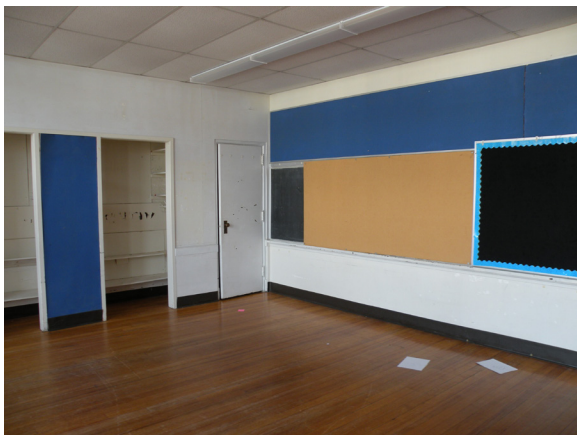
Typical classroom

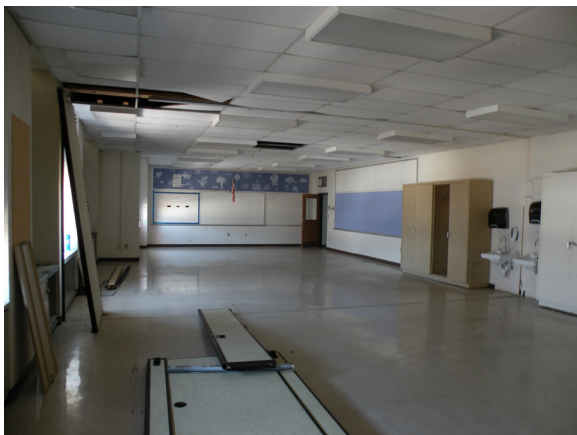
Condition at original building windows

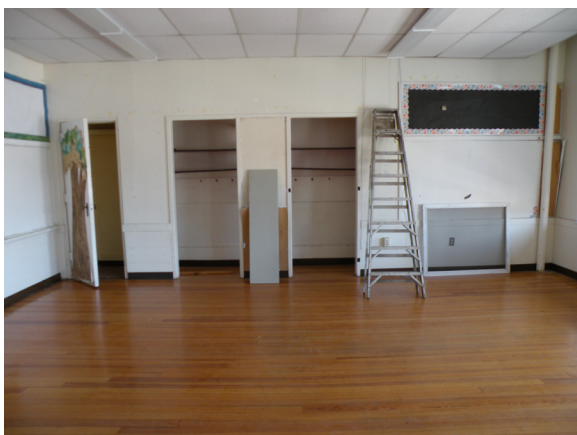
Some hardwood in good condition

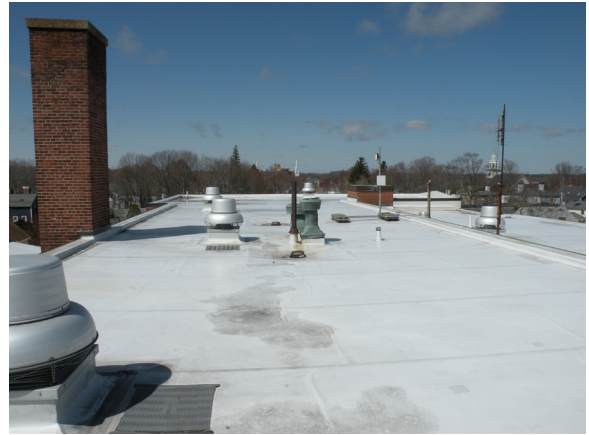
Upper roof is clean and serviceable

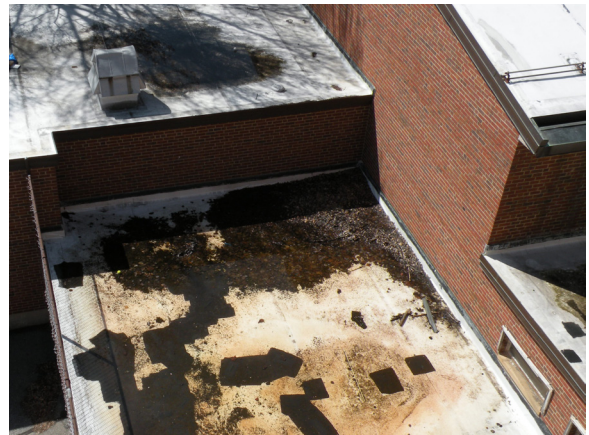
Roof over boiler room needs better drainage

6. Access was not gained to the various roofs. The age and condition of the roofs is unknown; further review/evaluation is recommended. The roof of the Boiler Room (viewed from the Third Floor of the original building), appears to be in poor condition and may have compromised the reinforced concrete roof construction. Further review and evaluation would be required, in conjunction with a future renovation and/or repurposing of the facility.

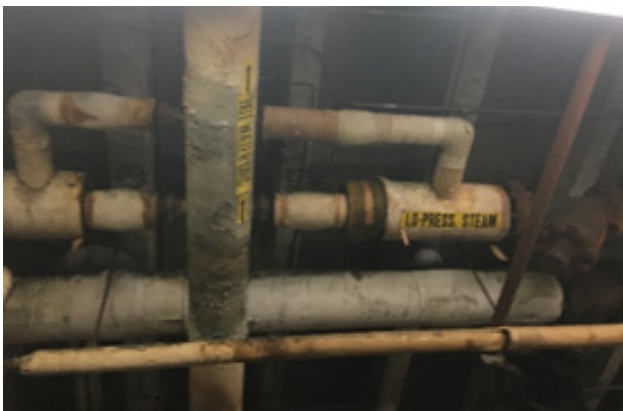
Existing Hot Water + Steam Piping

Many sections of the steam, condensate and hot water piping located in the boiler room is damaged and several sections are un-insulated. The majority of piping outside of the boiler room appears to be insulated with fiberglass insulation. Several sections of the piping insulation observed appear to be damaged or in poor condition. Steam and hot water piping is routed exposed within many areas of the building. There is a lack of sufficient shut-off valves located on both the steam and hot water piping systems. It is our understanding that some of the piping insulation may contain asbestos.

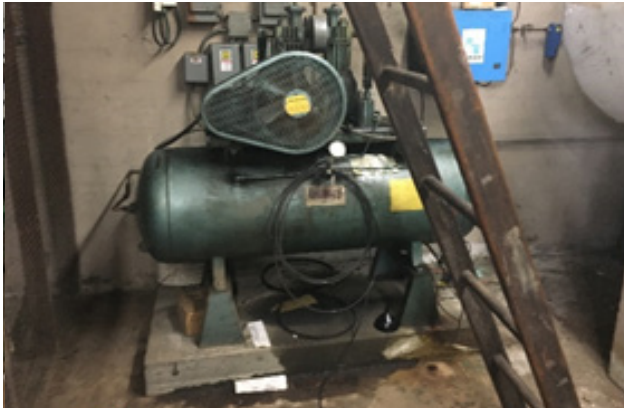
Existing ATC Compressor + Dryer

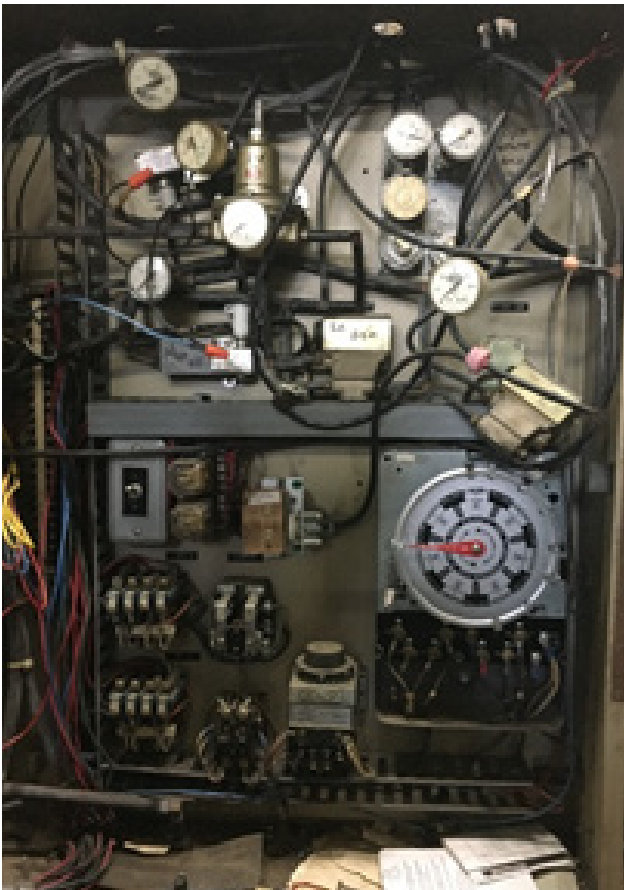
Existing ACT Pneumatic Control Panel

and generally appears to be in poor physical condition.

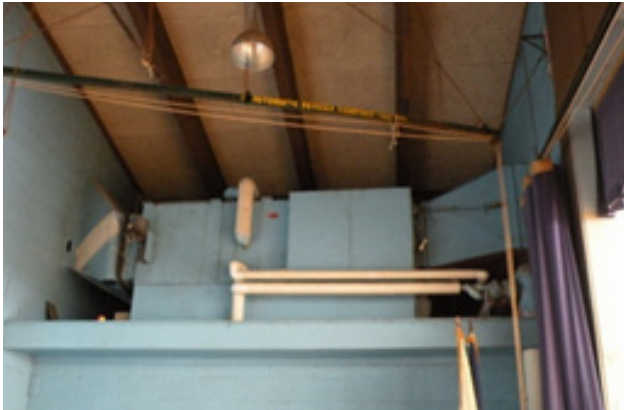
Gym - Heating + Ventilation Unit

- Replace Gym, and Kitchen heating and ventilation units. Potentially add full or partial air conditioning to these areas of the building. Replace existing kitchen exhaust hood and fan, and make-up air unit to serve the kitchen if a new kitchen is part of the proposed building renovation project.

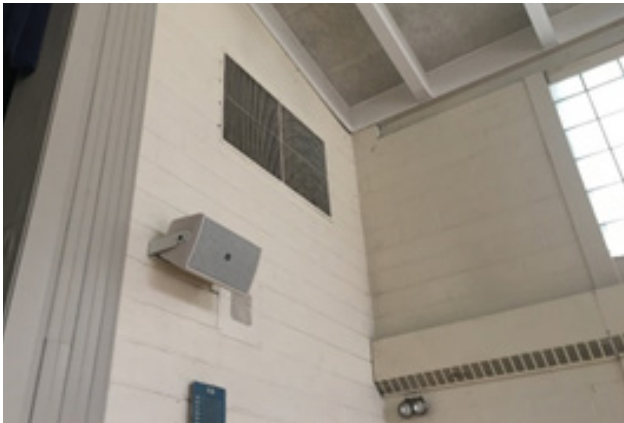
Gym - Wall Supply Diffuser + Radiation Heating

The gymnasium is provided with an indoor horizontal discharge heating and ventilation air handling unit. The unit has a steam heating coil, supply fan, filters, return air drawn at the rear of the unit, and an outside ventilation air duct connection. Supply air is provided through the unit discharge grille. The Gym also has radiation heating located on the exterior wall of the Gym. The heating and ventilation air handling equipment, ductwork and insulation are original to the Gym Addition construction in the 1950s, and appear to be in poor condition and in need of replacement.

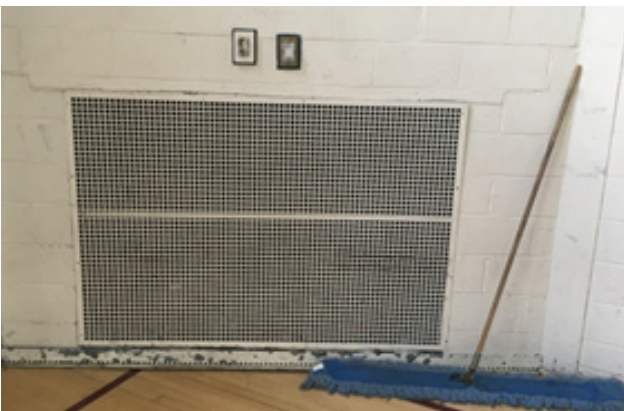
Gym - Wall Return Register

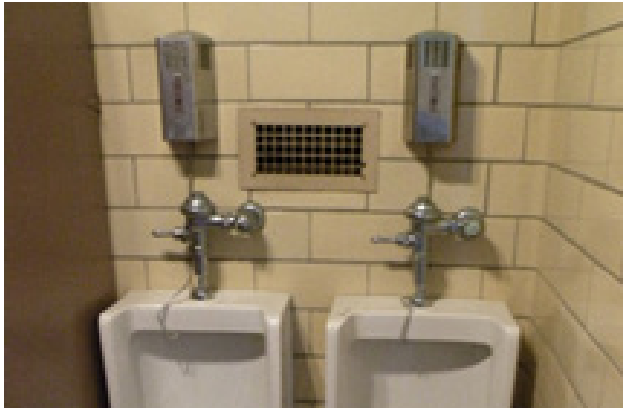
Ground Level Toilet Room - Exhaust Grille

rooms are typically provided with wall mounted exhaust registers generally in back of the toilet fixtures. The registers communicate to individual roof mounted exhaust fans through a galvanized sheetmetal exhaust ductwork system. Most exhaust registers were noted to be soiled and appear to be original to the construction of the building and additions. Make up air for the exhaust system is typically provide through the use of door louver or undercut door. In general, the toilet room heating equipment, exhaust grilles/ductwork and exhaust fans appear to be in poor condition and in need of replacement.

- Replace existing entryway, hallway and toilet room radiation and convector heating units with new hot water convectors. Hallways should be provided with code required ventilation air. Toilet rooms should be provided with new code complaint exhaust air systems.

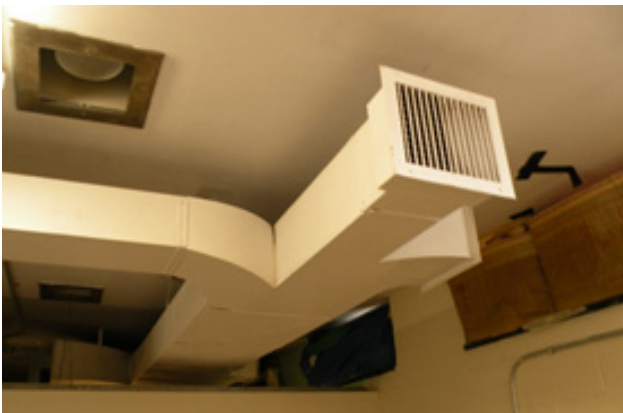
Ground Level Locker Area - Exhaust Ductwork

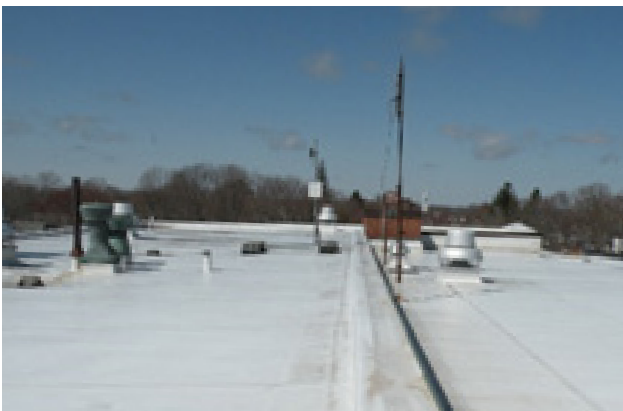
Roof Exhaust + Ventilators

In general, the majority of the building exhaust air fan and roof ventilator equipment and systems appear to be originally installed equipment and in need of replacement. While some fans may have been replaced in subsequent years, they all appear to be in poor condition and in need of replacement.

- Replace existing utility/storage room radiation/convectors/unit heaters with new hot water heating equipment.
- Replace existing exhaust fans, roof hood ventilators and associated exhaust air ductwork distribution system. If a new mechanical ventilation system with energy recovery is installed, the number of exhaust air fans required may be substantially reduced.

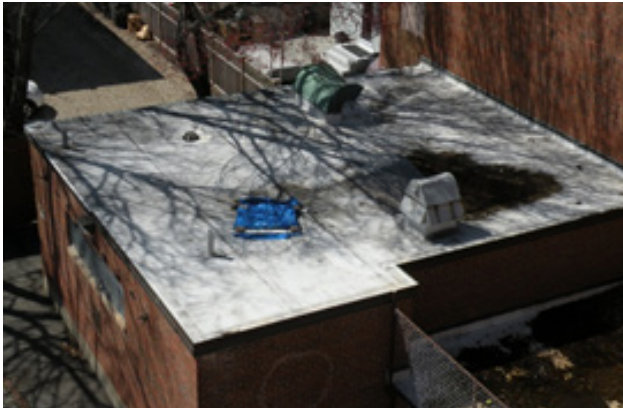
Roof Exhaust Fans + Ventilators

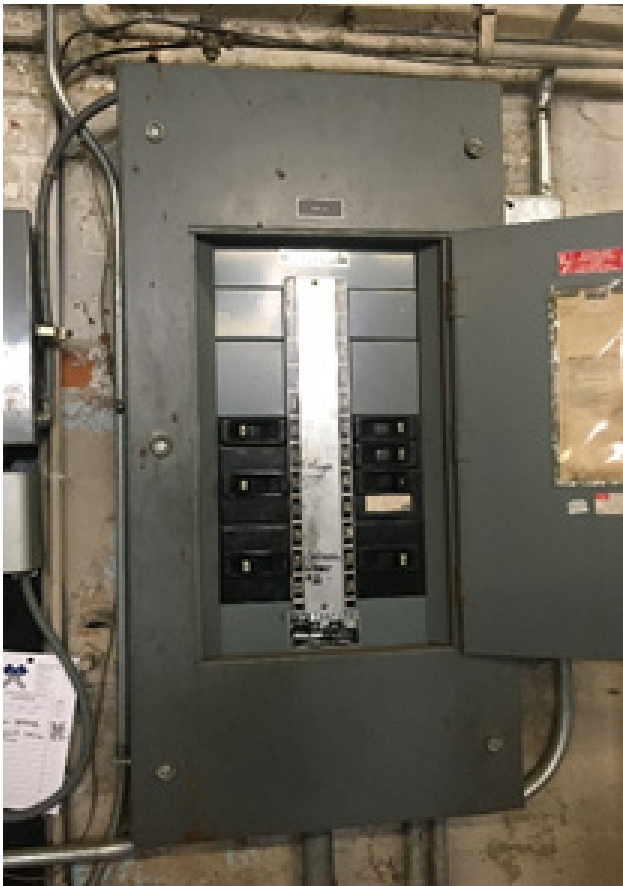
Panel "PP"

3 phase, 4 wire manufactured by Westinghouse. Sub-panels "PP" and "LP-1" are manufactured by Federal Pacific and existing Panel "P" is manufactured by Westinghouse. All panels are 1970s vintage or older with exception to a more recently added Cutler-Hammer subpanel tapped from the existing MDP. There are additional sub-panels on the 2nd and 3rd floor. The equipment is generally in poor condition and beyond its serviceable life.

- New service equipment and distribution equipment should be installed to replace the existing 1970's vintage equipment.
- Lighting in all areas should be upgraded to new energy efficiency LED type fixtures with occupancy sensors throughout.
- Receptacles should be added to accommodate the needs of the Youth Service Program to avoid excessive use of plug strips and extension cords.
- Site lighting should be upgraded to LED type with proper shielding of the light source.
- All receptacles within 6' of a water

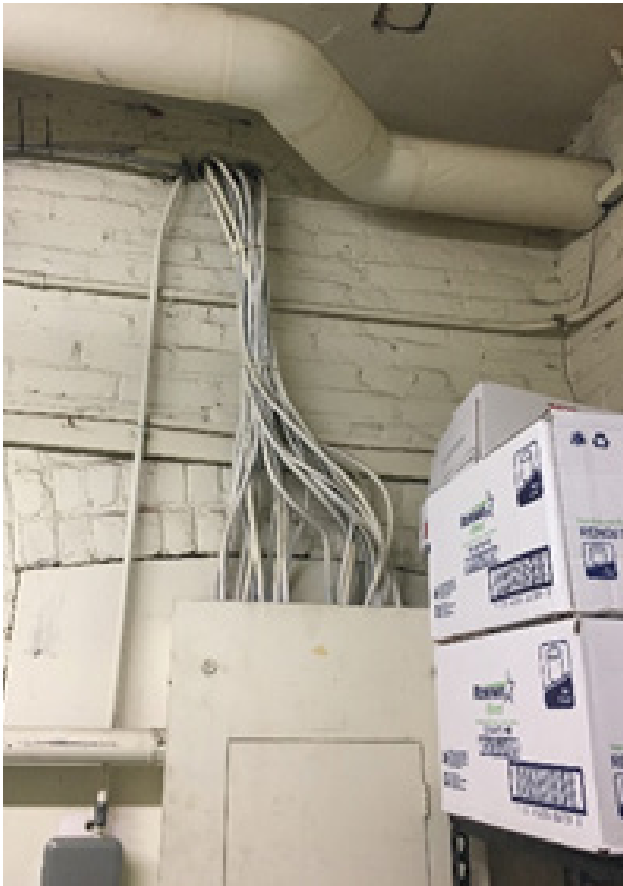
Branch circuitry consist of surface mounted conduit and receptacle boxes on brick or CMU walls, and duplex receptacles flush mounted within stud walls. Wiring is a combination of MC Cable and Romex. Romex is not typically used in commercial applications. Not all locations within 6' of a water source are provided with GFCI protection.

Romex Branch Circuits

- The existing fire alarm system should be replaced with a new addressable system. Voice evacuation shall be provided if the use group is Educational.
- Branch circuiting that is not installed in MC cable shall be replaced. MC Cable can be extended to new branch circuit panelboards.

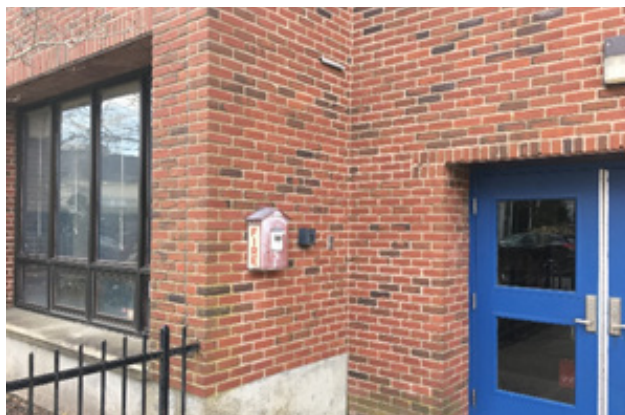
Exterior fluorescent wall packs with integral photo eyes are installed at entrance/egress doors. These fixtures contain no shielding of the light source.

Exterior Wall Packs

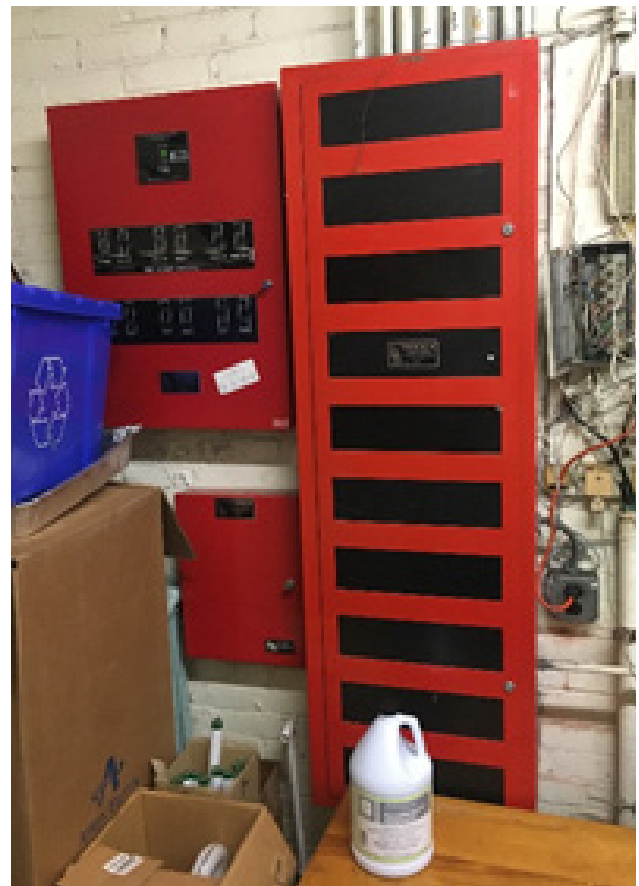
Fire Alarm Control Panel

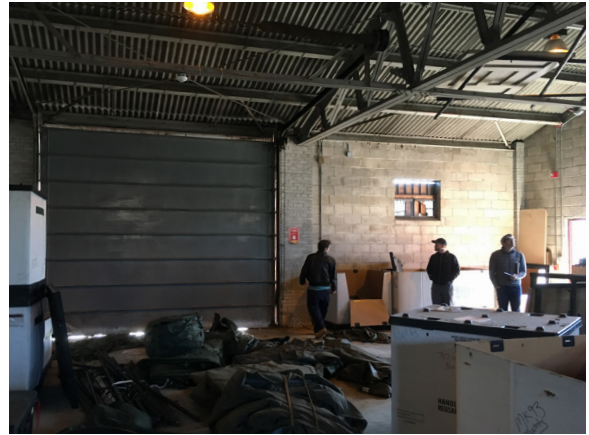
Exposed roof structure in rear bay

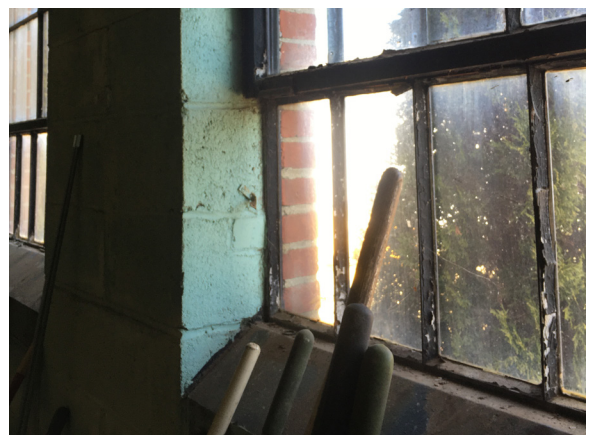
Wall are not insulated

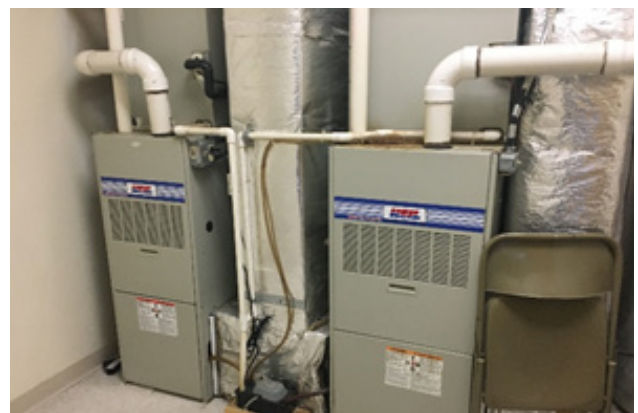
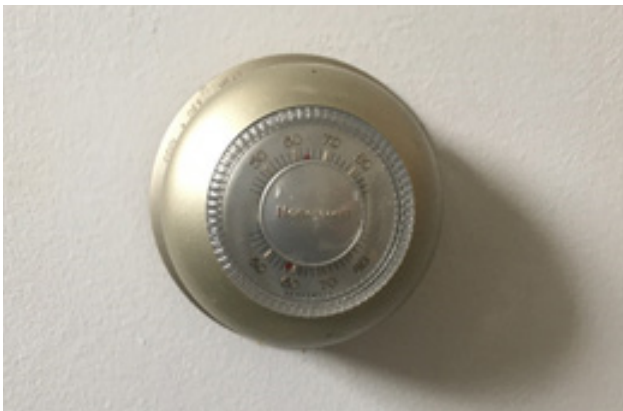
Existing Gas Fired Furnaces

The building office area is heated and air conditioned by two (2) high efficiency gas fired warm air furnaces that are equipped with split system direct expansion (DX) cooling coils that are connected to outdoor condensing units. The furnaces were manufactured by Heil (Model DC90 NTGM050E7A3) and have a heating capacity of 100 MBH input and 90 MH output. The units are 90% efficient. The furnaces are sidewall vented with PVC flue gas piping material. The heating and air conditioning system was installed circa the late 1990s – early 2000s. In general, the systems show signs of rust and corrosion and are generally considered to be in poor condition and in need of replacement.

Overall, the existing HVAC system is generally in poor condition and has exceeded its expected useful service life. Therefore, we recommend that the building HVAC system is replaced in its entirety. In addition, in order to provide code required ventilation, and a higher degree of thermal comfort for the building we would recommend that the existing HVAC system is upgraded. HVAC system replacement and

- Replace existing HVAC system with a new high efficiency variable refrigerant flow (VRF) heat recovery heat pump system with dedicated outdoor air ventilation system equipped with energy recovery.
 - Provide exhaust air systems for all toilet and storage rooms.
 - Provide supplemental perimeter electric radiant heating for backup operation to the VRF system.
 - Provide a new building control system with a new direct digital control (DDC) and building energy management system (BMS).
- Demolish and remove all existing to be replaced and abandoned in place HVAC systems and equipment.
 - Remove existing gas fired furnaces and AC units, associated piping, ductwork and controls. Remove existing gas fired garage unit heaters.

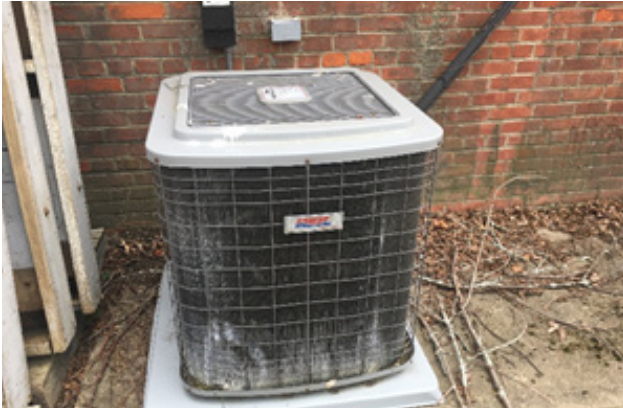
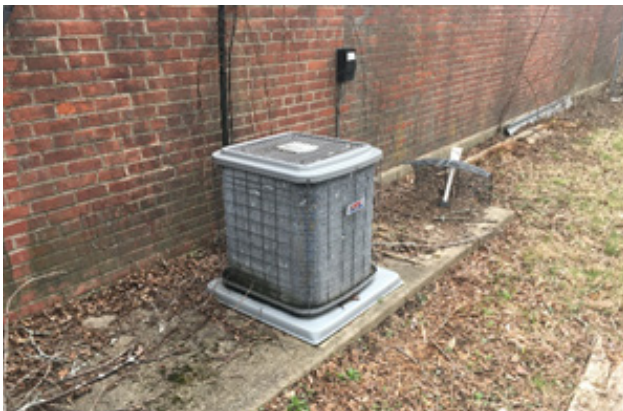
Existing Air Cooled Condensing Units

The associated air-cooled condensing (ACC) units are located outdoors on grade. The units

were manufactured by Heil (Model HAC048AKA1 and HAC036AKA1). One of the ACC units has a capacity of 4 tons and the other has a capacity of 3 tons. The ACC units operate utilizing R-22 refrigerant and have an efficiency of 10 EER. The ACC units are piped with insulated copper refrigerant tubing to the indoor AC coils located above the furnaces.

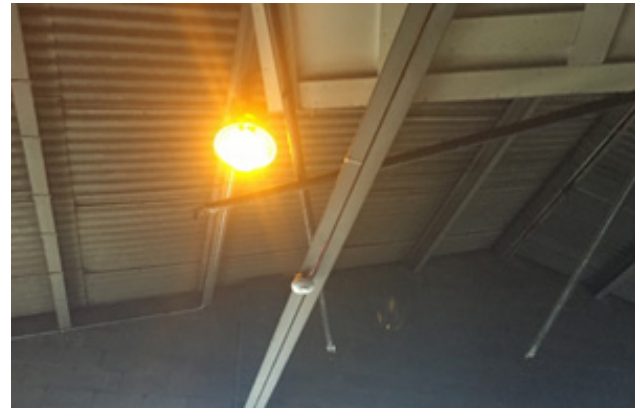
Garage Lighting

Lighting in the garage is high pressure sodium high bays, and lighting in Office areas and conference areas are fluorescent 9 cell 2x4 parabolic fixtures and 6" downlights. Lighting is in poor condition. Lighting control is via line voltage switching throughout.

- Lighting in all areas should be upgraded to new energy efficient LED type fixtures with occupancy sensors throughout.
- Emergency battery units shall be installed in egress paths and exit signs replaced with self-contained type for emergency lighting to be code compliant.

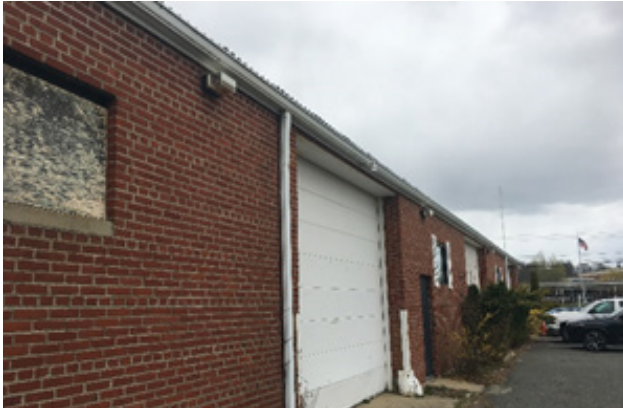
Exterior Lights

Exterior fluorescent wall packs and incandescent par style floods are installed around the building.

- Receptacles should be added to accommodate the needs of the Youth Service Program.
- Site lighting should be upgraded to LED type with proper shielding of light source.
- The existing fire alarm system should be replaced with a new addressable system. Voice evacuation shall be provided if the use Group is educational.

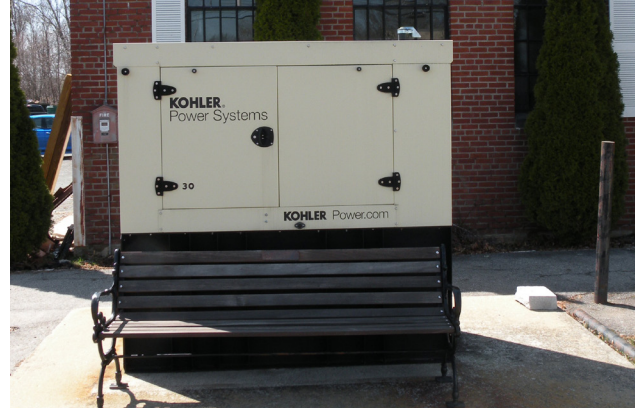
30 kW Generator

Emergency lighting is powered by an emergency generator however it is not compliant with NEC Article 700 as emergency lighting loads are not separated from optional standby loads. If this configuration were to remain battery units would be required along with self-contained exit signs.

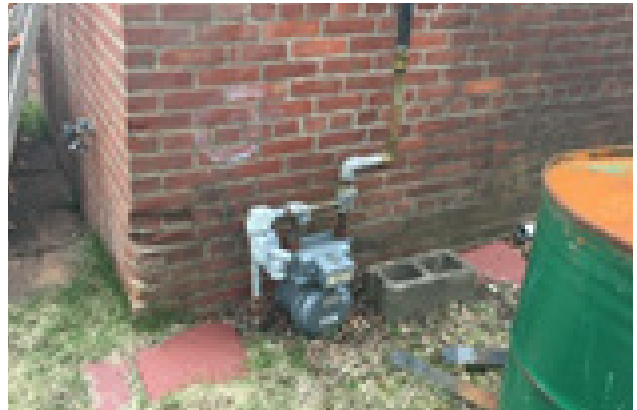
Gas Meter

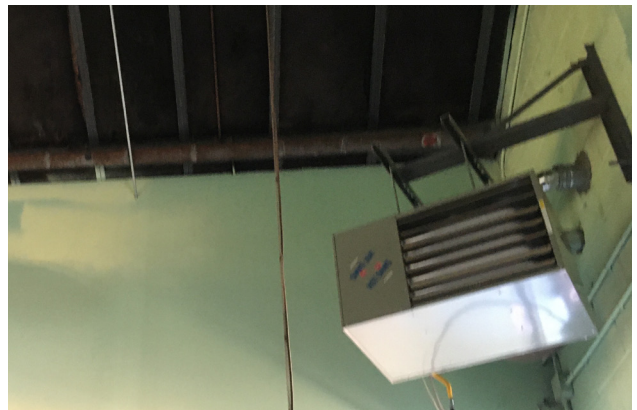
Gas Fired Unit Heater

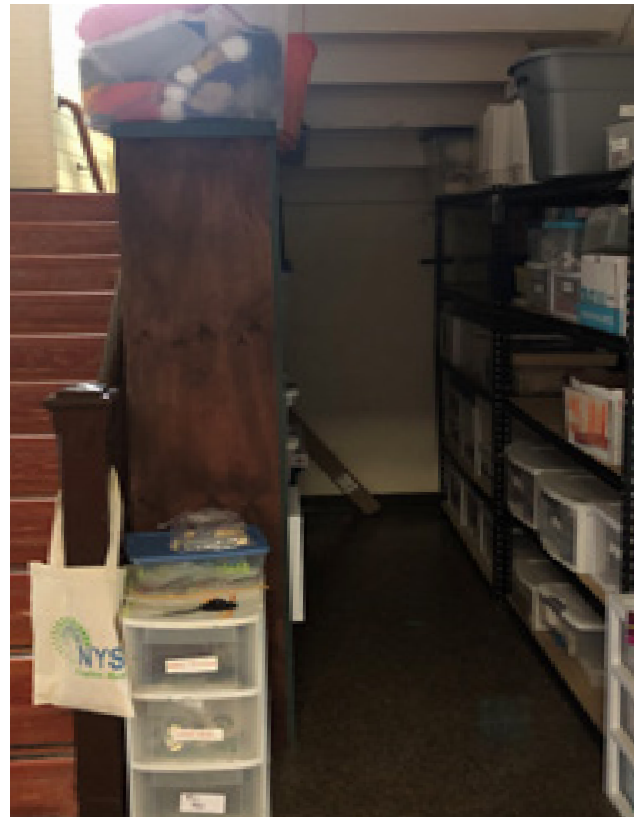
- Boiler room access and egress is non-compliant. The existing stairway to the exterior would likely require being rebuilt and compliant hardware would be required on the egress door.
- The building is currently designed with significant storage beneath the interior

egress stairways. If this space will be utilized moving forward, it must be located within an enclosed, one-hour fire-rated room as storage is not permitted within or beneath a stairway.
