NEWBURYPORT YOUTH SERVICES

FACILITY ASSESSMENT & PLANNING STUDY

EXISTING CONDITIONS REPORT, DESIGN CONCEPTS + COST ANALYSIS

NOVEMBER 2020

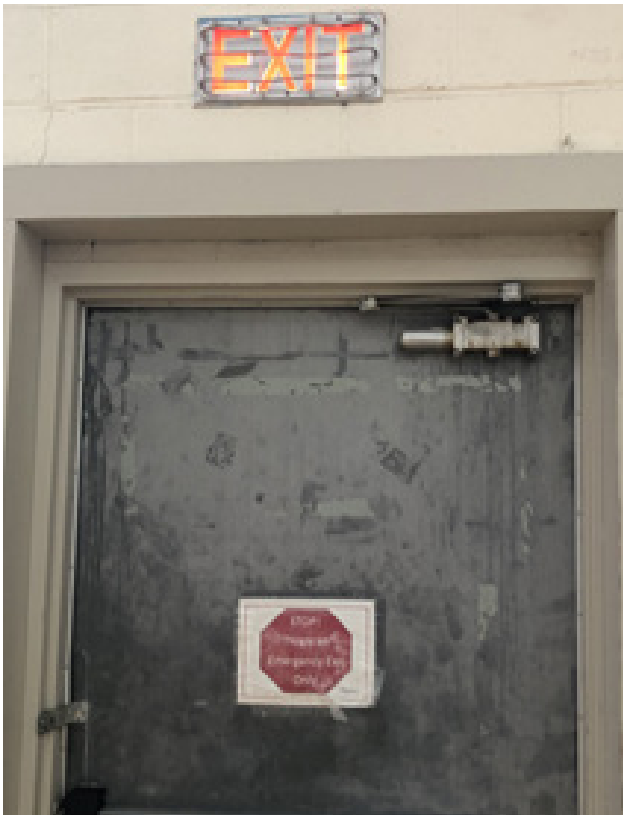
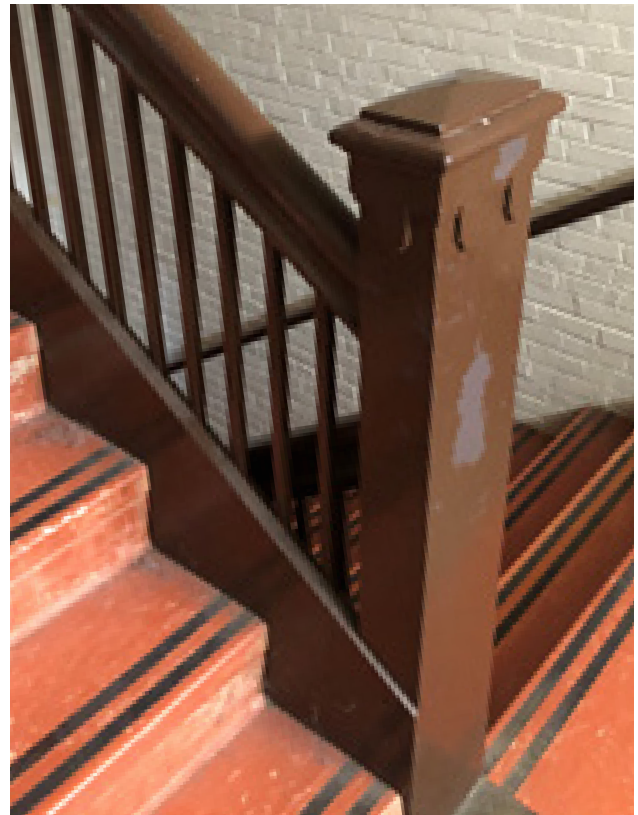
- o Existing doorways at each interior exit stair have 31.5-inch door leaves and are not large enough to provide an accessible route. Either a single, compliant active door leaf is required, or the doorway must be widened to allow for a compliant pair of doors. It is possible a variance could be pursued to maintain the existing conditions

with a push-button accessible door opener. It is up to the local code official if the issue creates a “distinct hazard to life.”

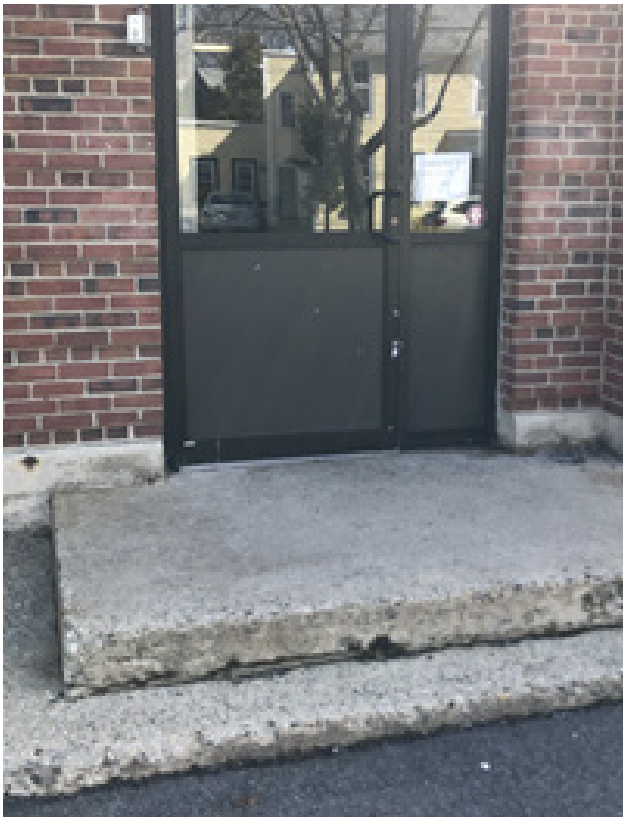
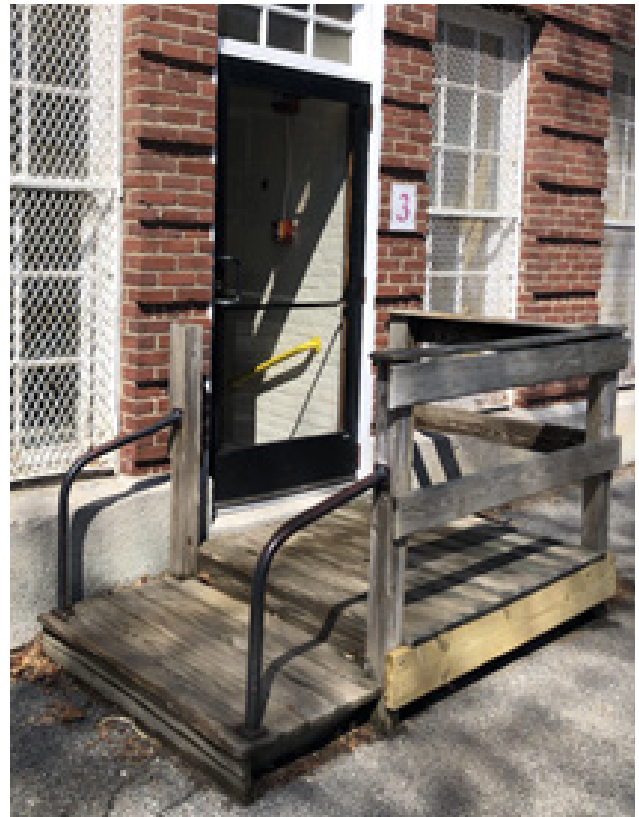
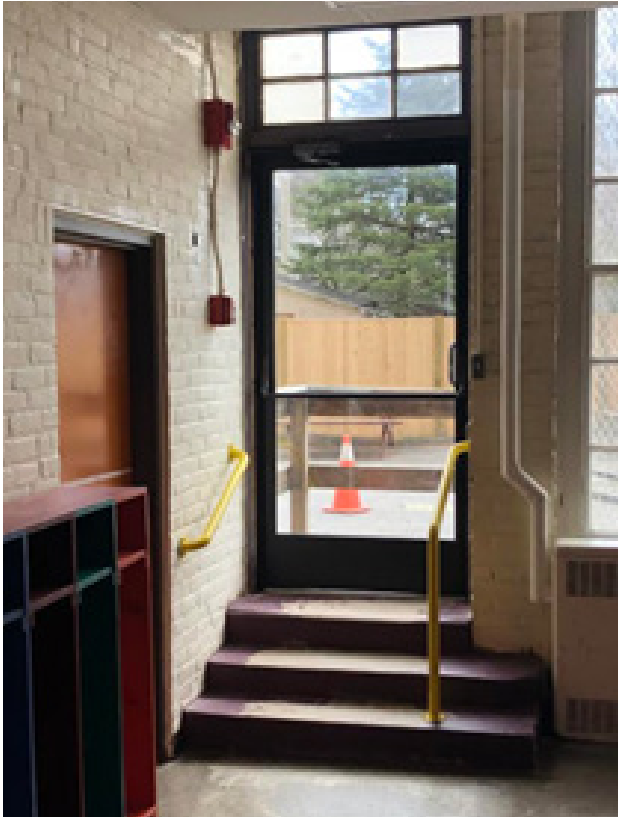
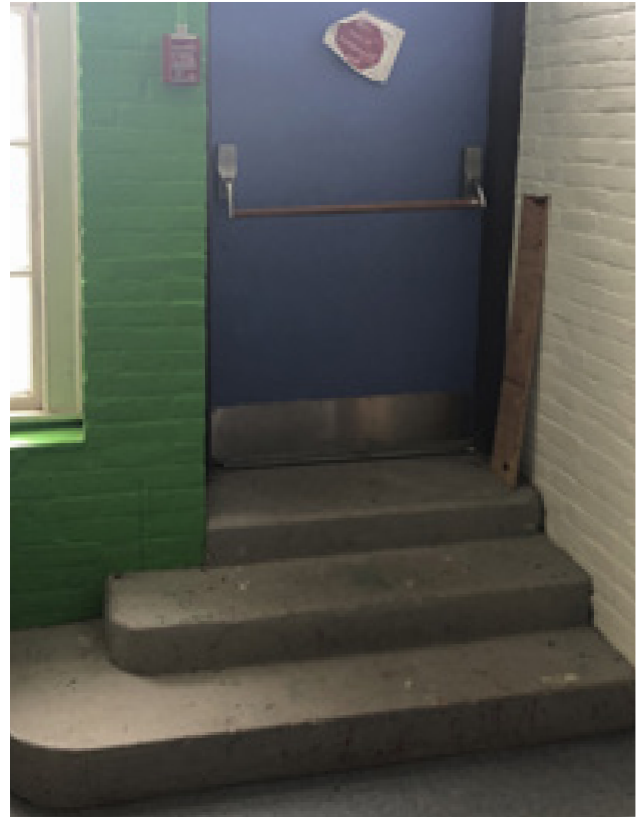
- o There are currently 6 entrances to the building. While the “main” entrances appear to provide accessible access, the four side entrances are all non-compliant as elevation changes are not provided with compliant ramps. If any of these entrances will be used, they will require accessible upgrades. Photos are examples of two such non-compliant entrances.
