**A Landscape Preservation Plan
for the Laundry Yard and Courtyard
at the**

Caleb Cushing House

Newburyport, Massachusetts

November 2017

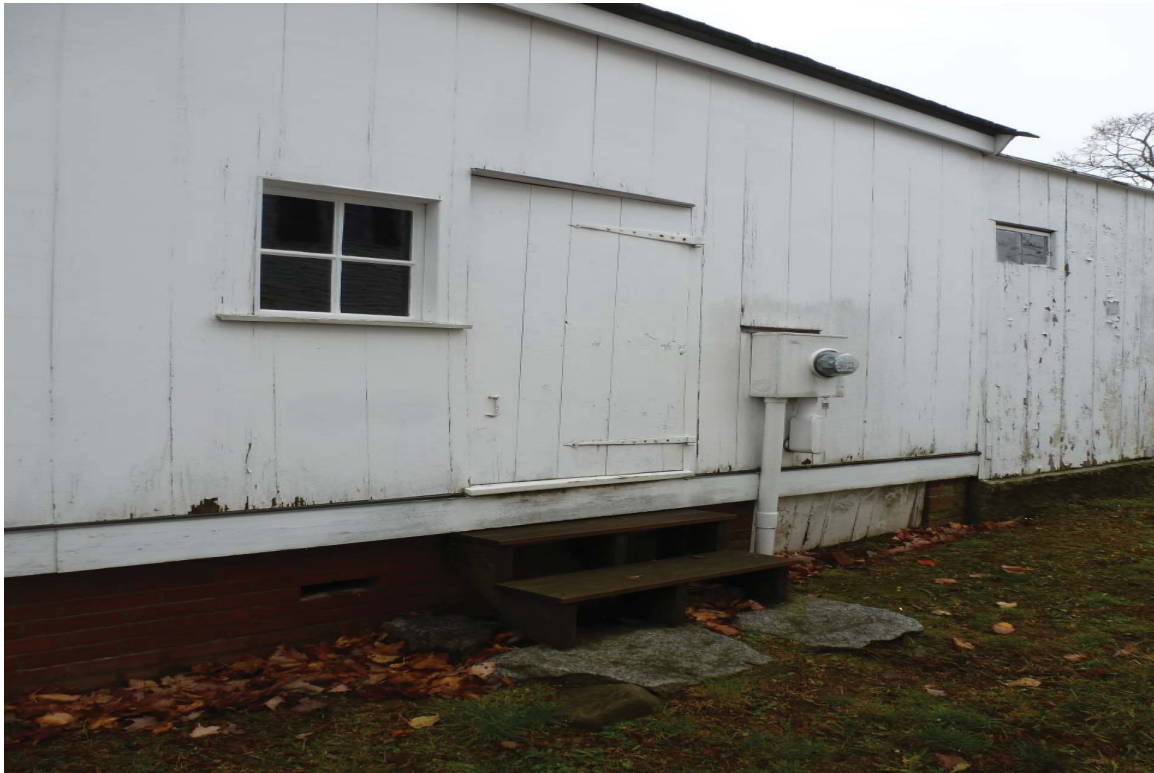
CA5: View of North Side of Privy/Laundry Shed

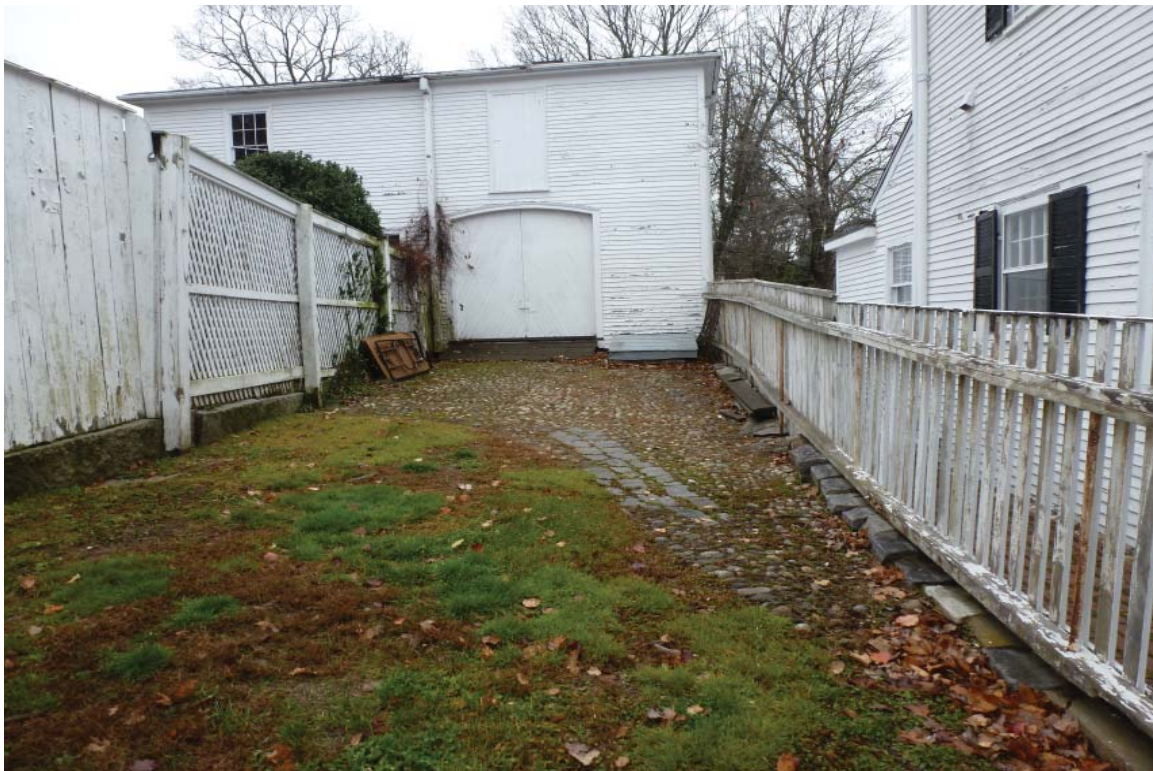
CA6: Northwest view of alley, further towards Barn

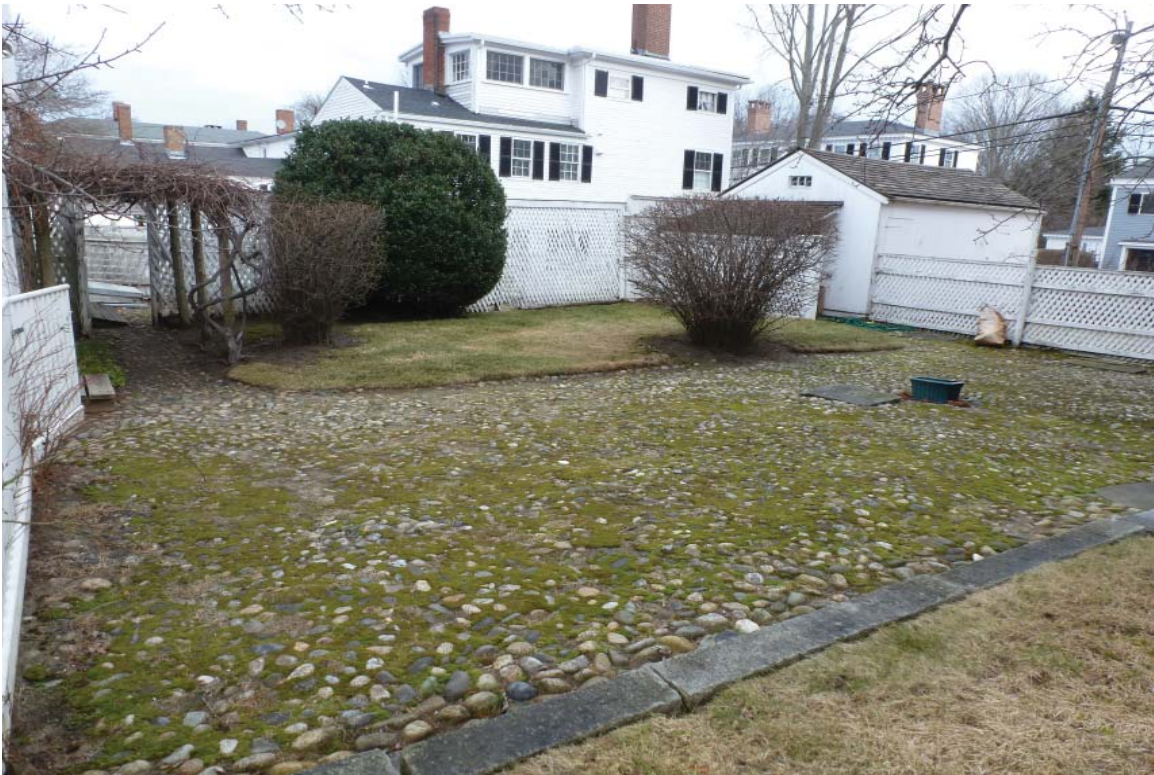
CY1: View of Courtyard facing East towards Laundry Shed

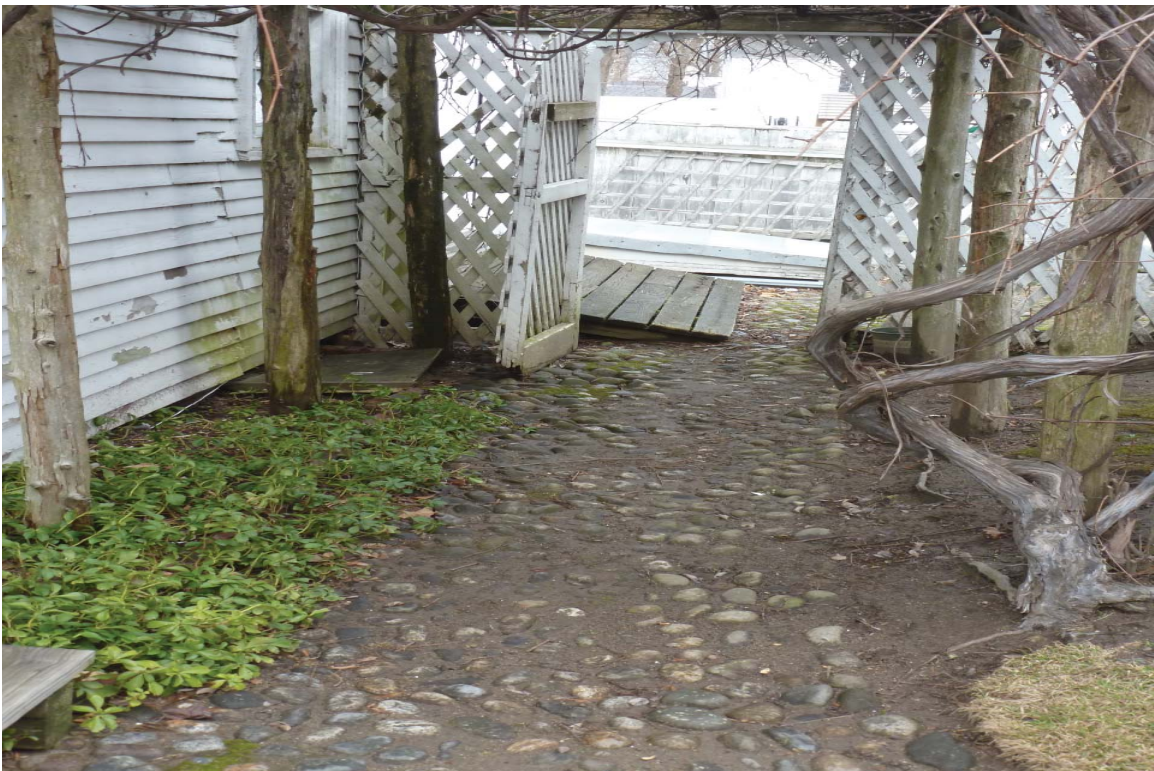
CY2: Northeast View through arbor towards Alley

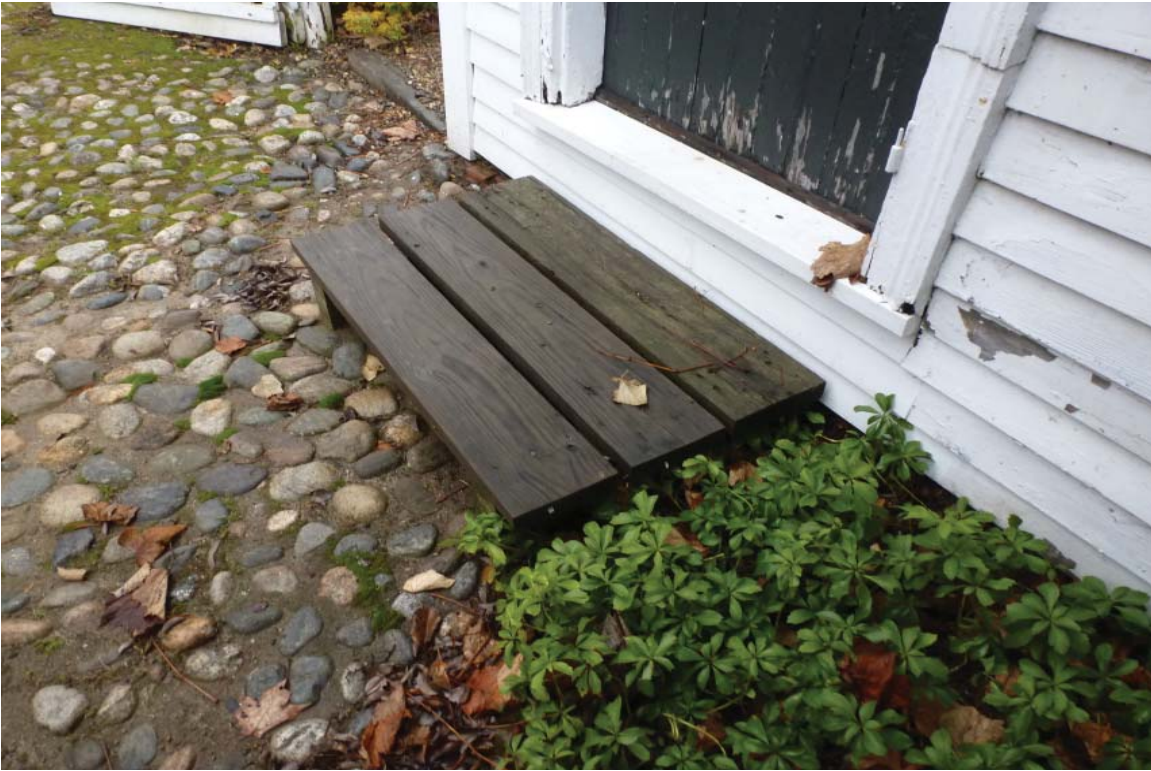
CY3: View of Barn threshold on Courtyard Side

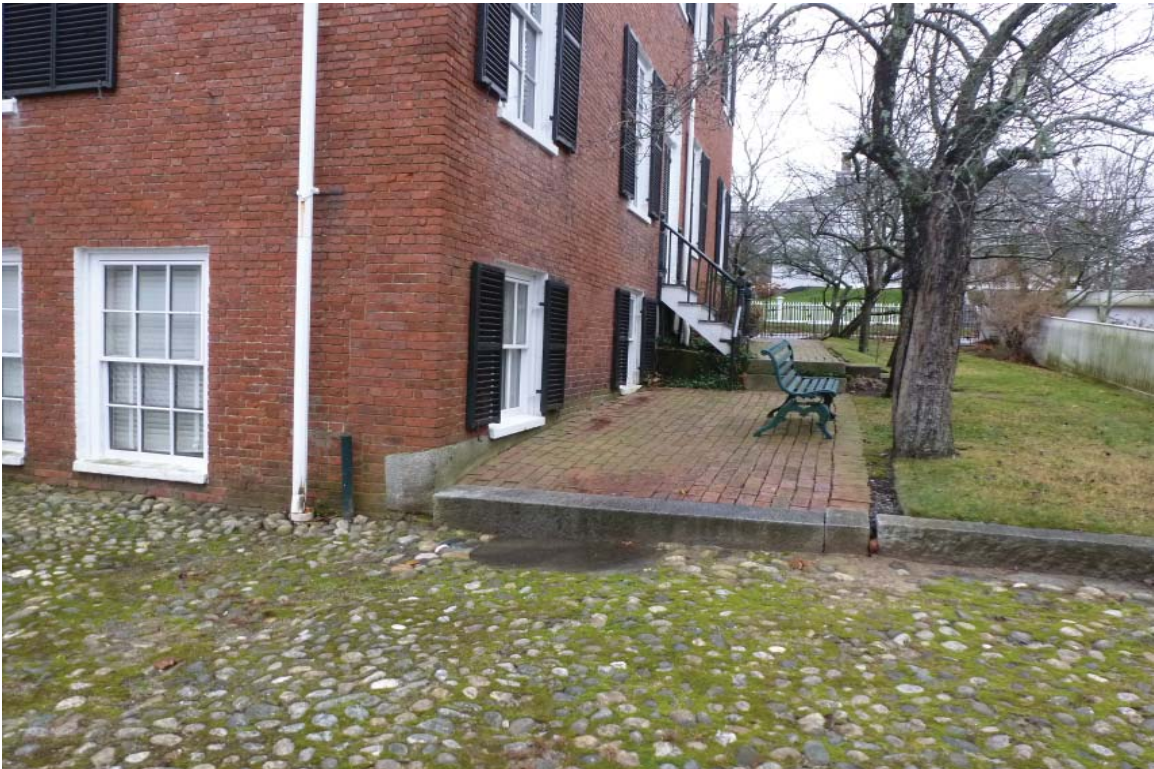
CY8: View from Courtyard facing southeast towards Side Yard

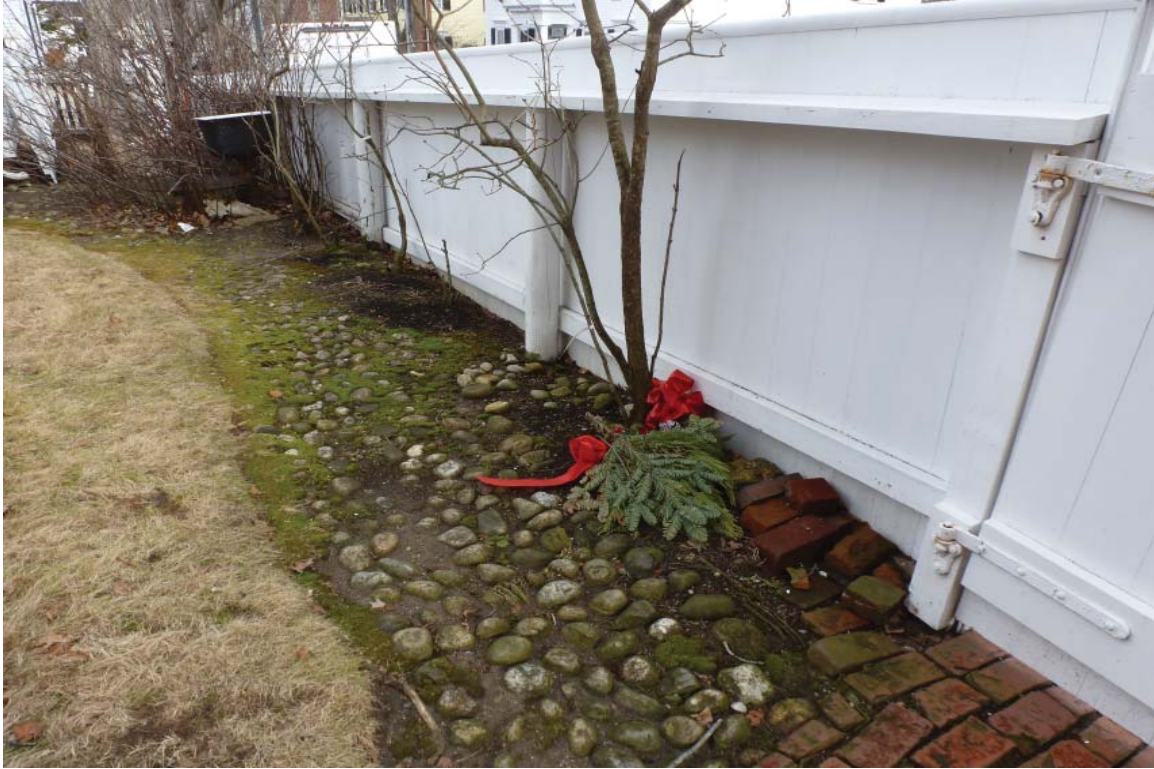
LY3: Northwest view of Laundry Yard fence along Fruit Street

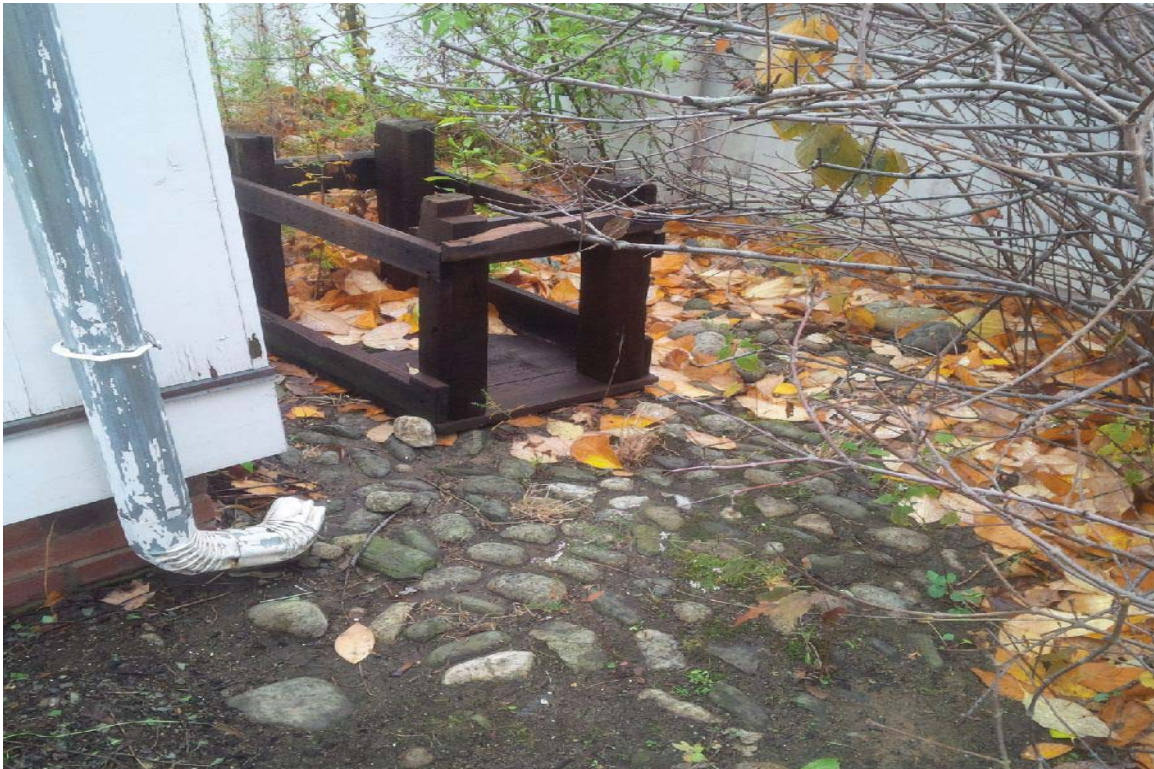
LY4: Southeastern corner of Laundry Shed/Privy

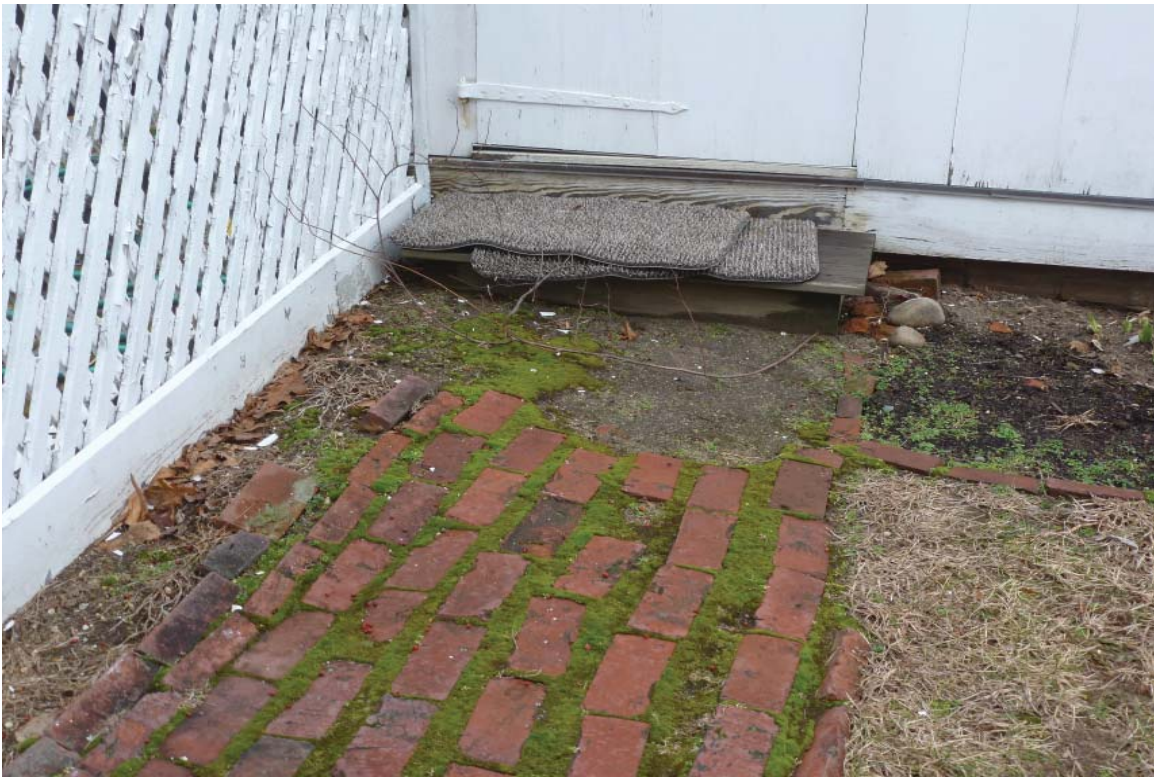
LY7: Northwestern Laundry Shed/Privy threshold in Laundry Yard

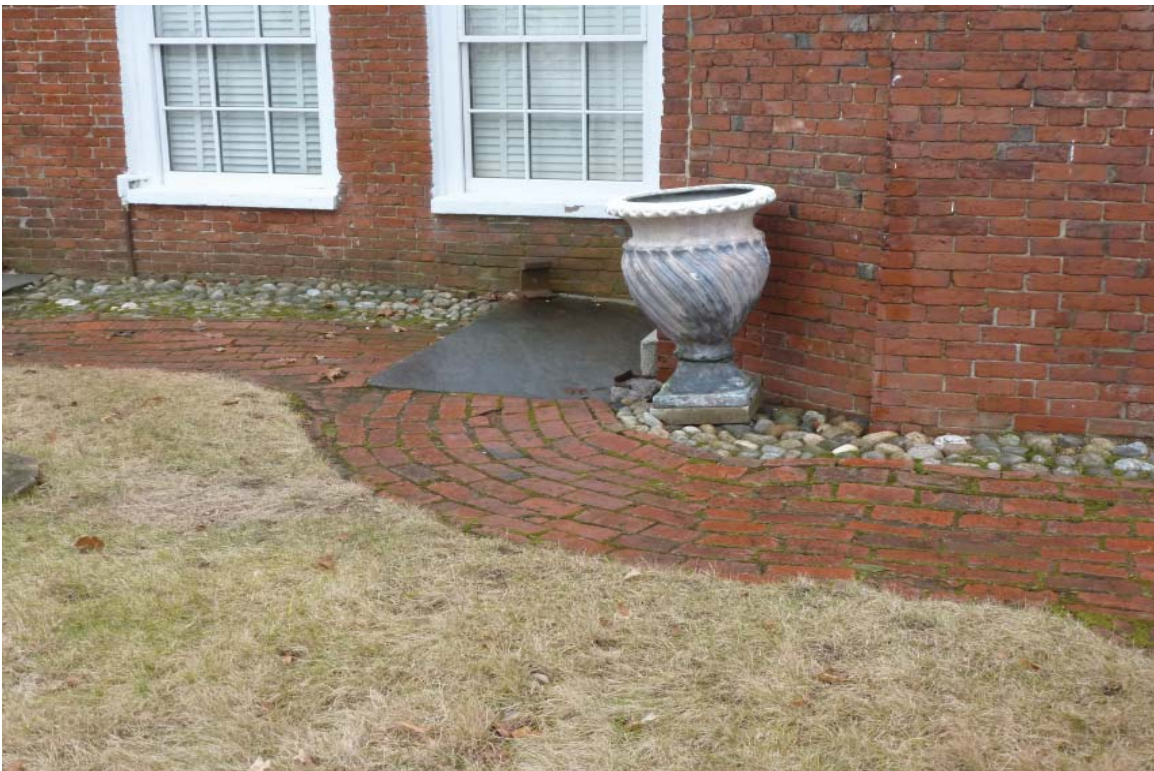
LY8: Southeastern Cushing House threshold in Laundry Yard

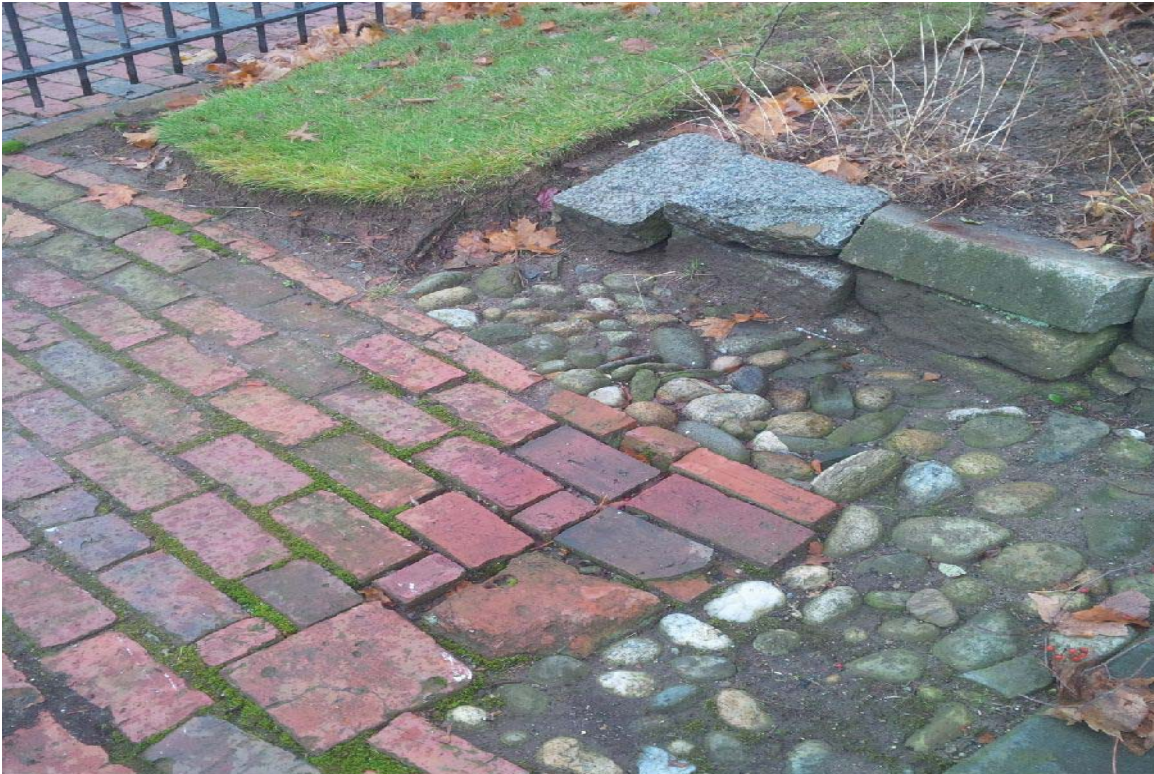
LY11: Detail of brick walkway leading towards Fruit Street

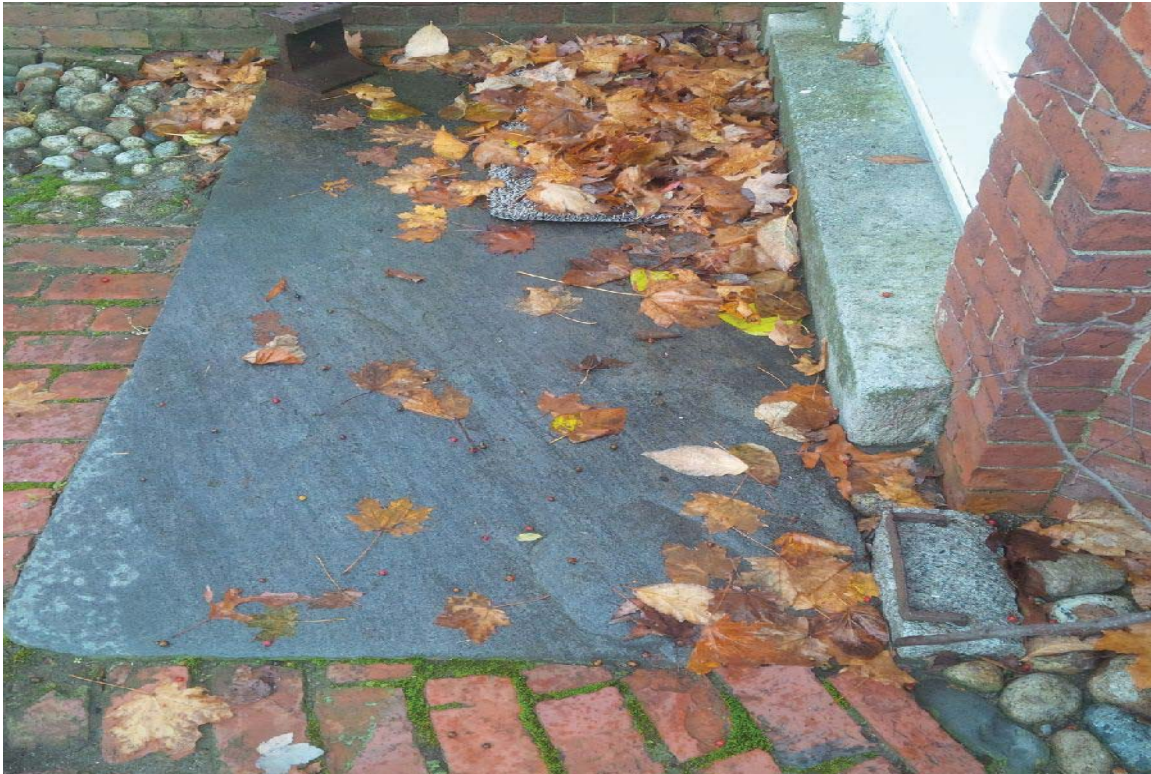
LY13: Close up of Southeastern Cushing House threshold

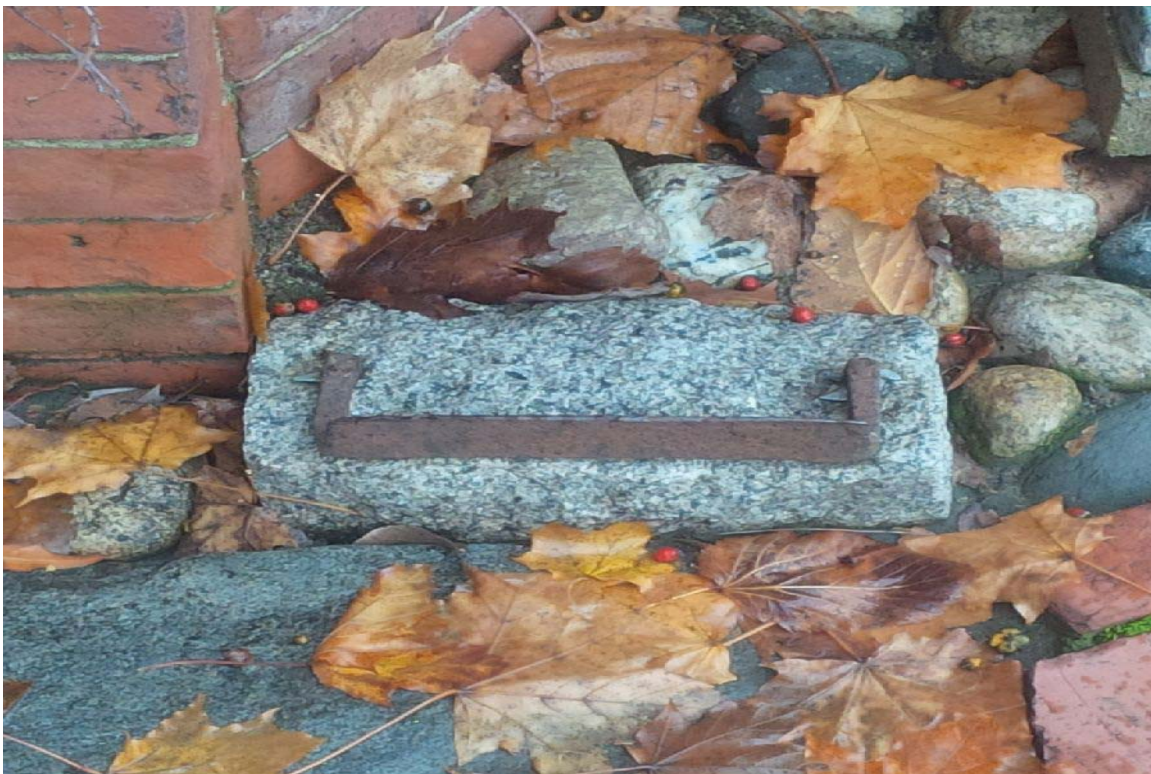
LY14: Detailed image of granite stone at southeastern threshold

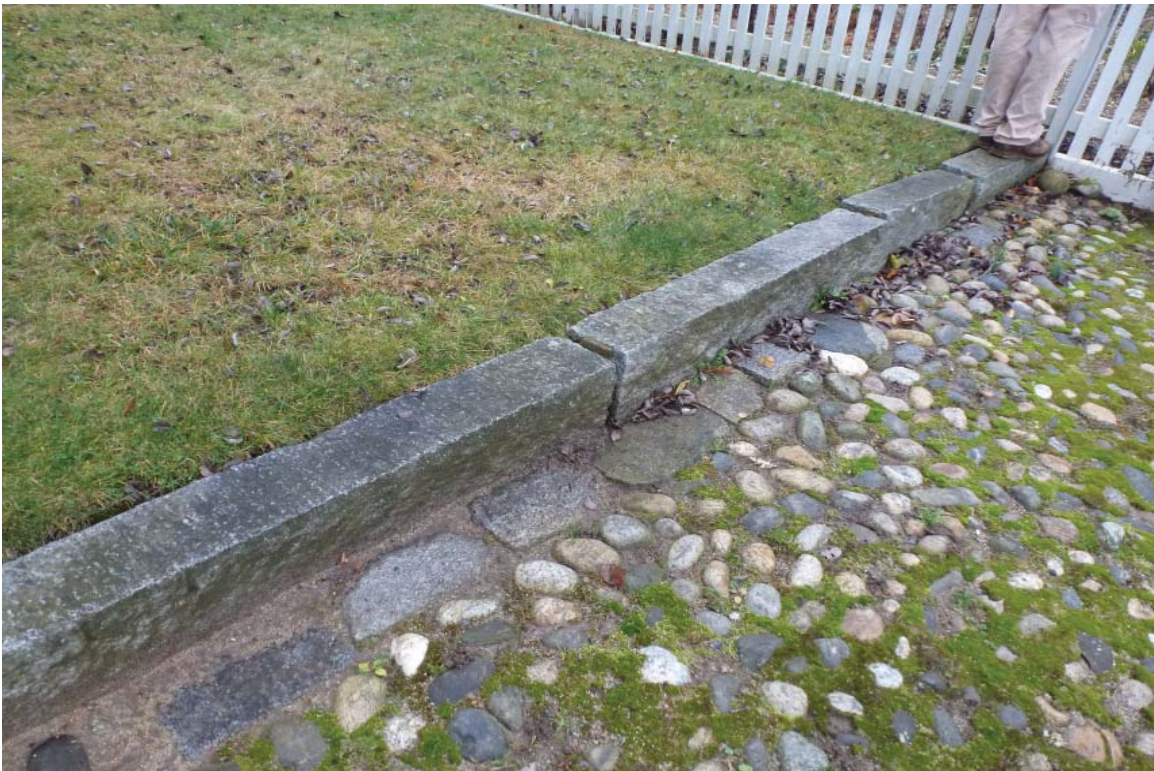
SY4: Detail view of granite step separating Cushing Courtyard from Sideyard

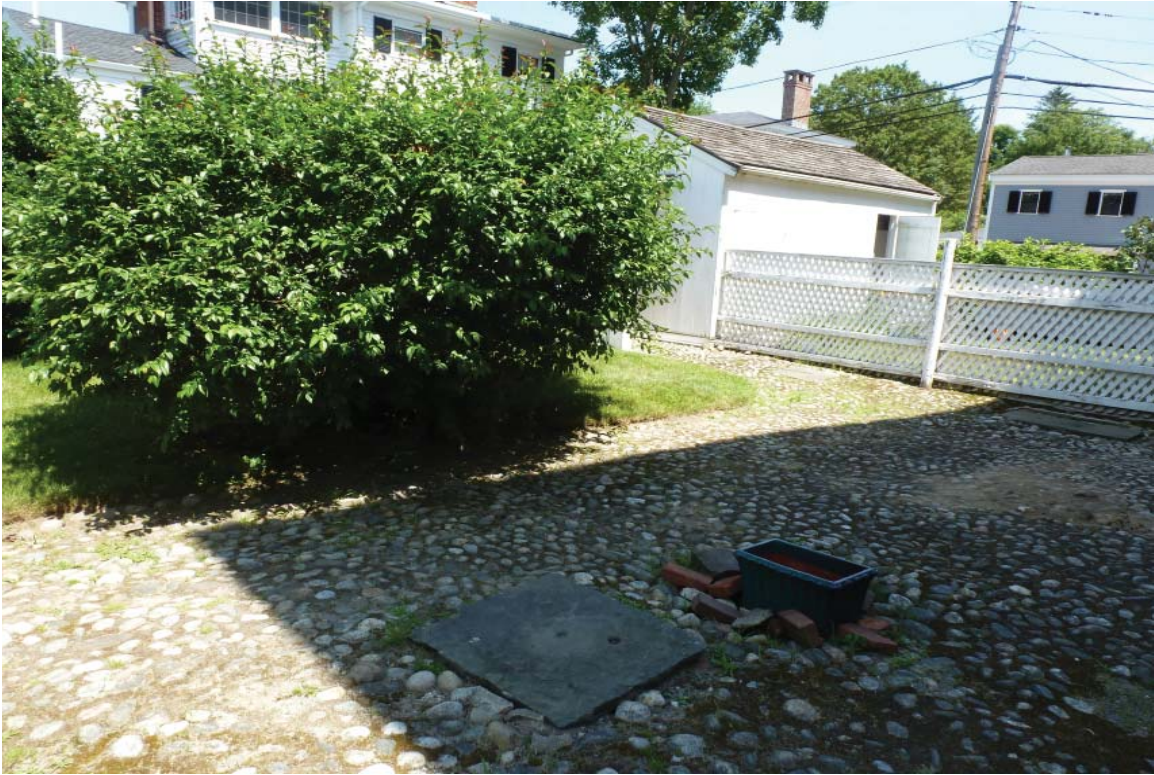
- Courtyard
 - American Holly (*Ilex opaca*) - healthy, but pressing against lattice fence. Not shown on 1936 HABS drawings. Recommend removal.
 - Flowering Quince (*Chaenomeles, sp.*) - healthy, but taking over lawn area. Only one plant is shown on 1936 HABS drawings. Recommend removal
 - Grapevine (*Vitis, sp.*) - poor condition and choking the wood arbor. Shown on 1936 HABS drawings. recommend removal.

Courtyard looking towards Privy. Large quince shrub in left foreground

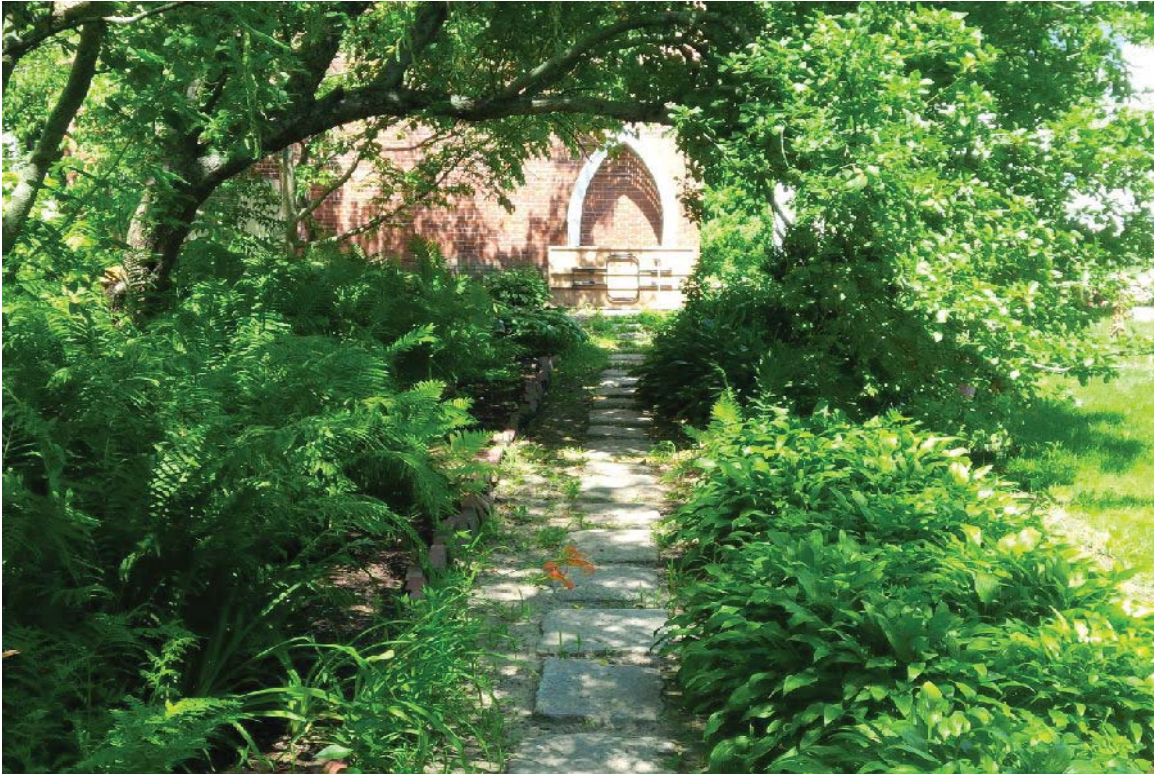
- Nursery-Orchard Area
 - Pear Trees (*Pyrus, sp.*) - there are three (3) existing pear trees. None are in good condition. We recommend removal and replacement with disease-resistant varieties. There were 11 pear trees shown on 1936 HABS drawings. We recommend re-planting 9 trees strategically placed so that roots do not interfere with the walkway.
 - Crabapple Trees (*Malus, sp.*) - these trees are in fair condition. One is suckering badly. One has roots that are intruding into the walkway.

Nursery-Orchard Area: View towards Perkins Mint. Shows ferns, hosta, Pear trees.

We recommend removal of both trees and replanting Pear trees in keeping with the 1936 HABS plan.
